RE: Annual Cap Inspection  
Troh Legacy Landfill (ECSI No. 5257)

**Former Troh Legacy Landfill**  
10010 SE Vradenburg Rd  
Happy Valley, Oregon

Project No.  
351-14002-10

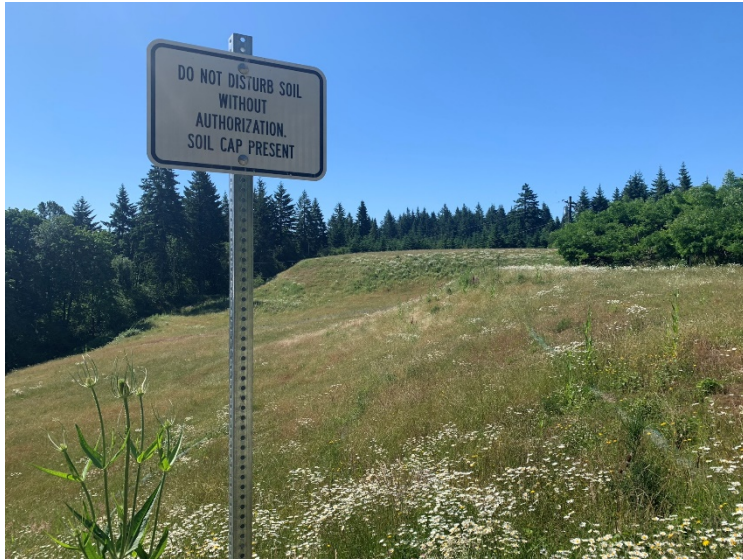
View south across landfill cap showing summer season grass cover to provide stability of slope conditions.

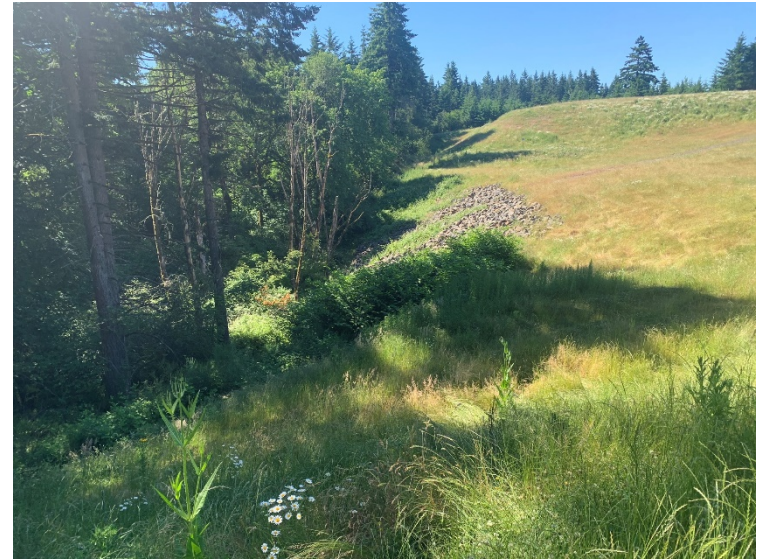
View south showing toe of the landfill. Due to steepness, the toe of the landfill is capped by riprap.

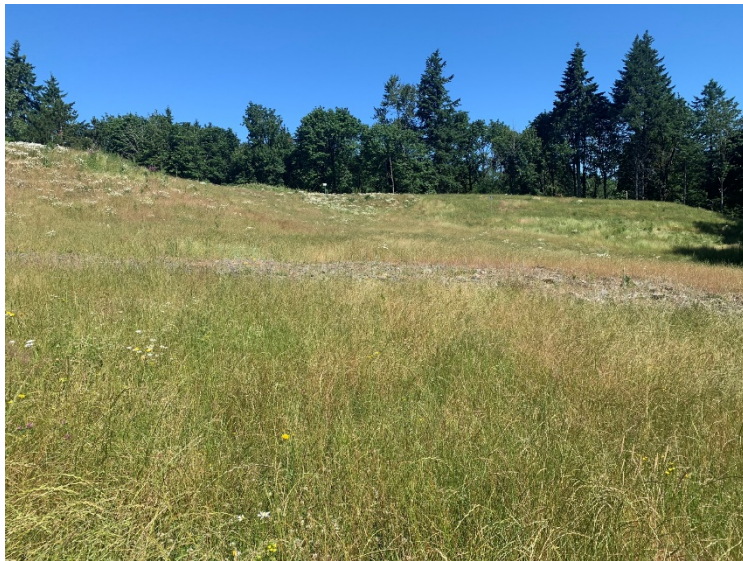
View north at north buttress fill slope.

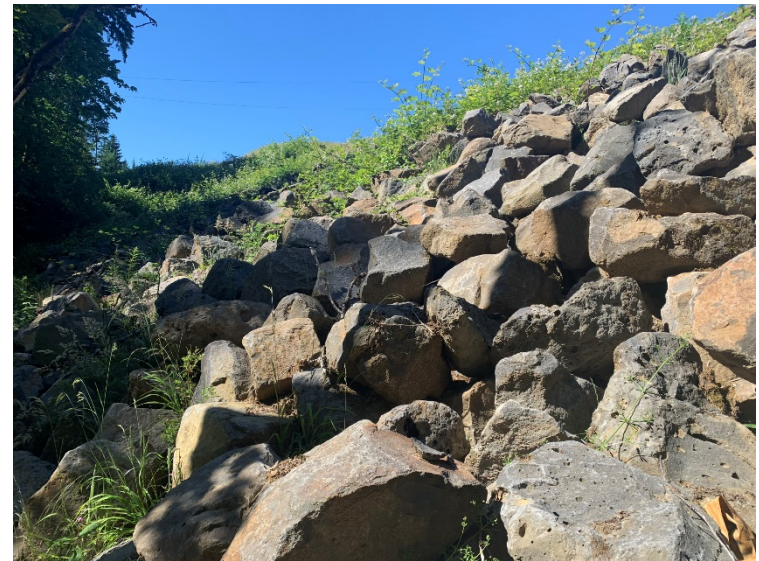
Closer view of landfill toe cap showing riprap with large logs at the toe.

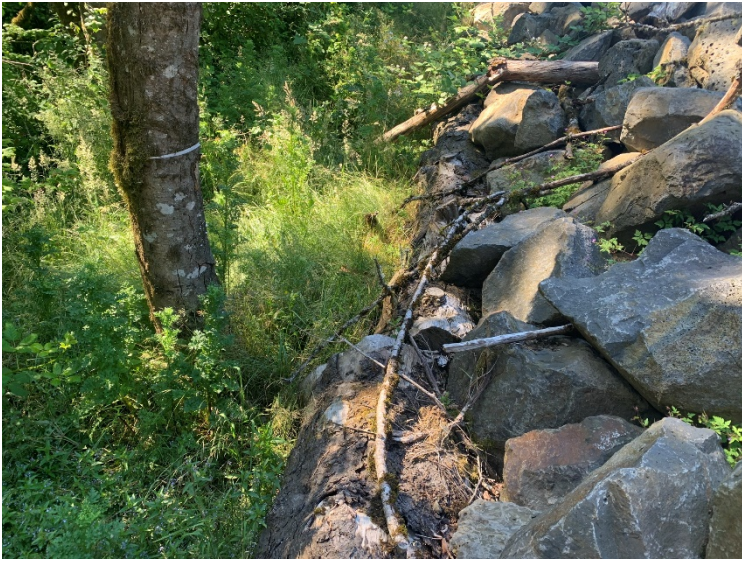
Toe of rip rap slope, looking south.

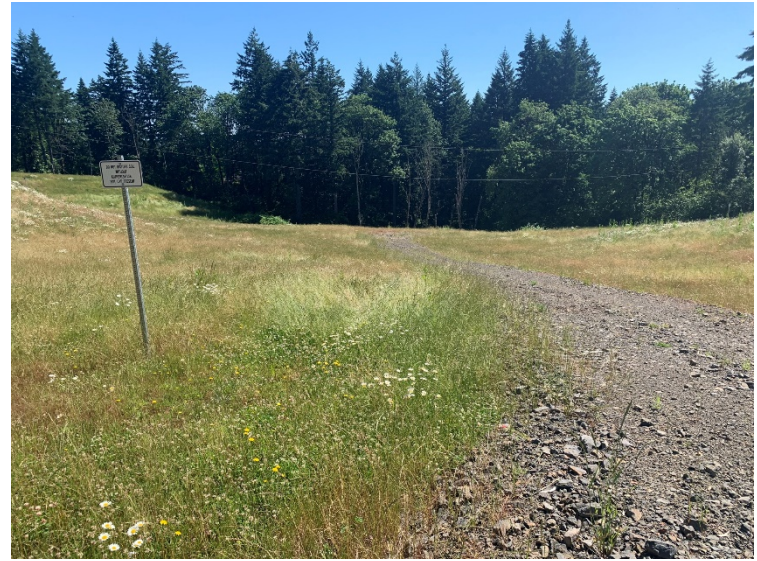
View of signage at top of south access road, looking east.
