RE: 2023 Annual Cap Inspection  
Troh Legacy Landfill (ECSI No. 5257)

**Former Troh Legacy Landfill**  
10010 SE Vradenburg Rd  
Happy Valley, Oregon

## Site Photographs

Project No.  
351-14002-10  
Attachment

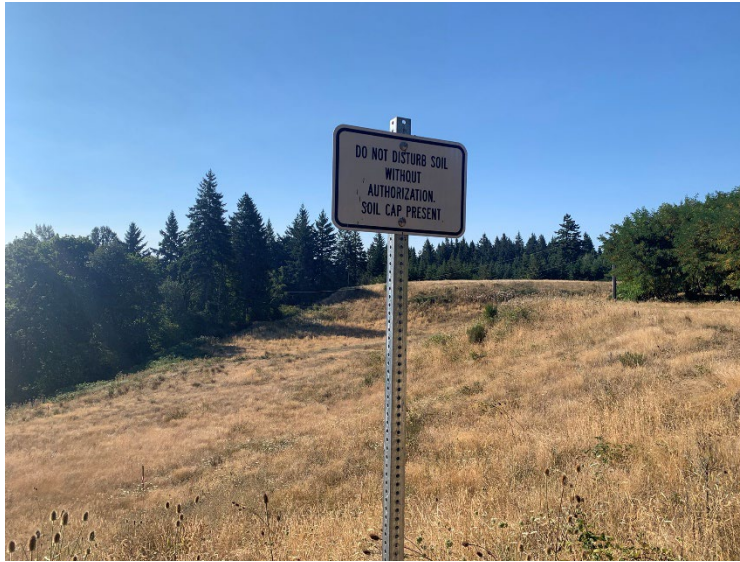
Signs warning of no unauthorized digging were posted as required.

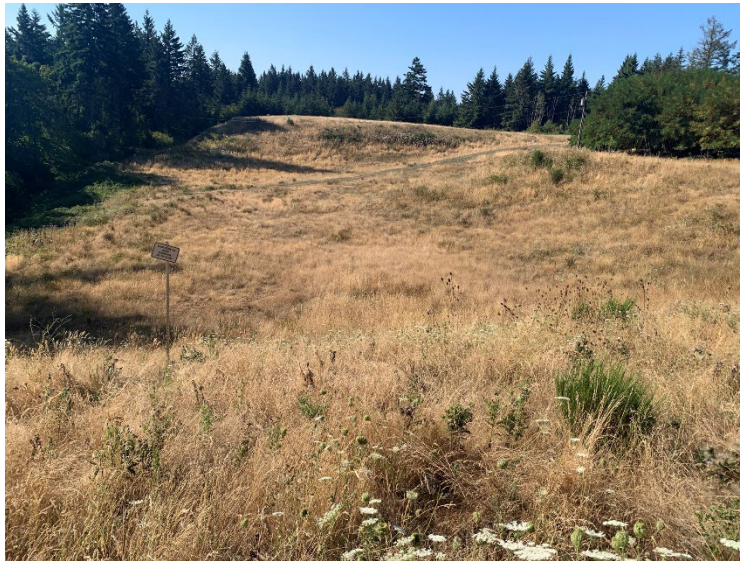
View south across landfill cap showing summer season grass cover stabilizing slope conditions.

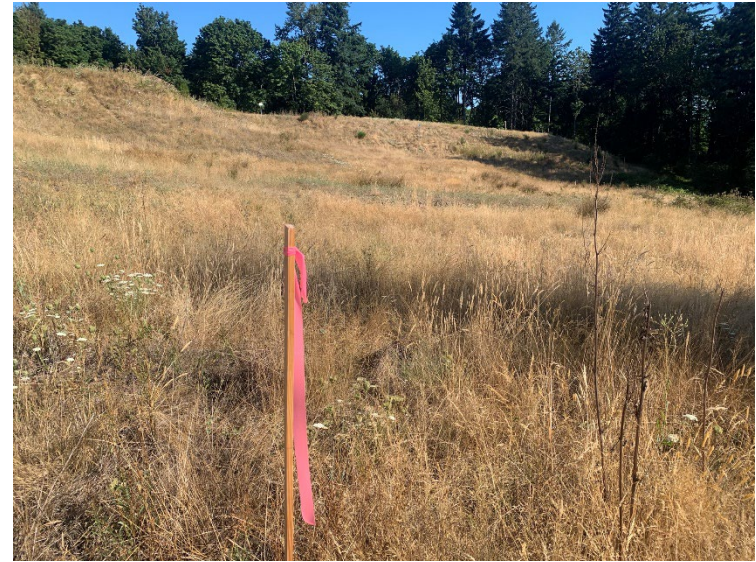
View north at north buttress fill slope. Survey stake marks south edge of landfill.

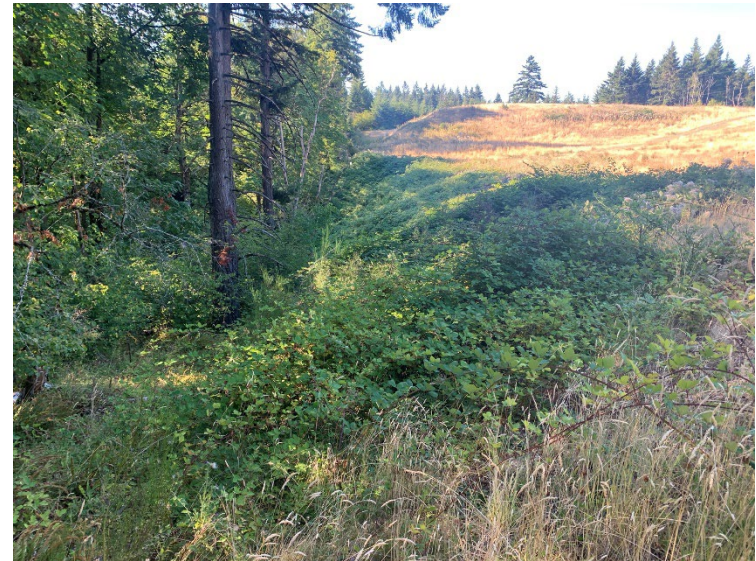
View south showing toe of the landfill. Due to steepness, the toe of the landfill is capped by riprap.

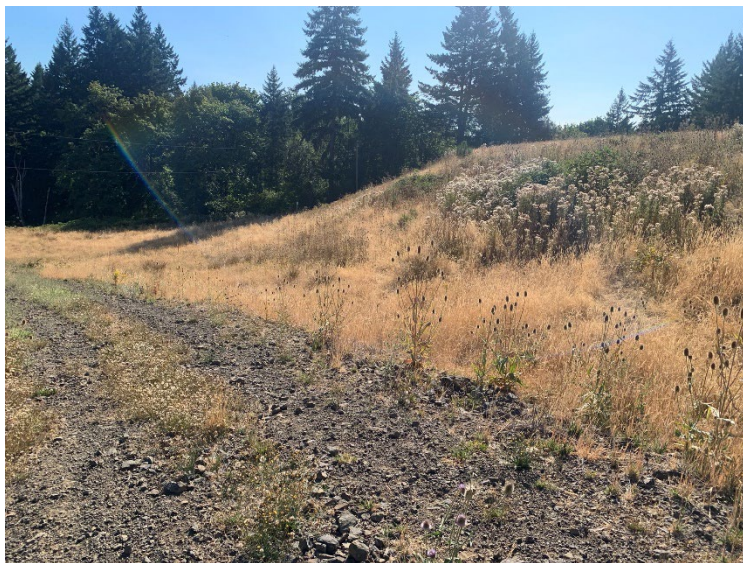
View east showing access road from the former south truck entrance and south buttress slope.

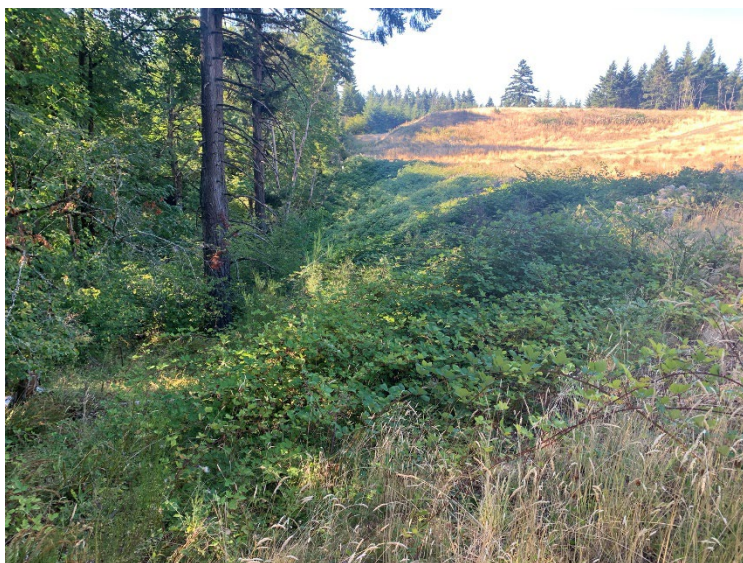
Toe of rip rap slope, looking south.
