February 2, 2024

**SUBJECT: 2024 Environmental Cap Inspection at Streetcar Lofts
Condominiums, 1030 NW 12th Avenue, Portland, Oregon 97209**

Annual Cap Inspection
Streetcar Lofts Condominiums
1030 NW 12th Avenue, Portland, Oregon

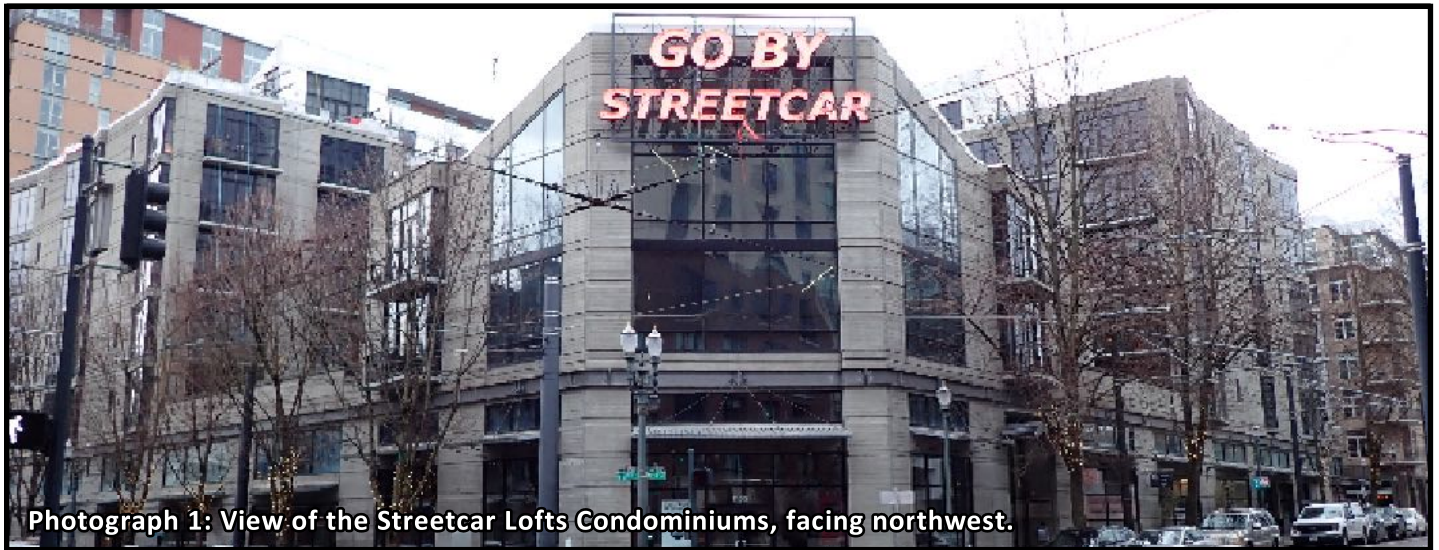
Photograph 1: View of the Streetcar Lofts Condominiums, facing northwest.

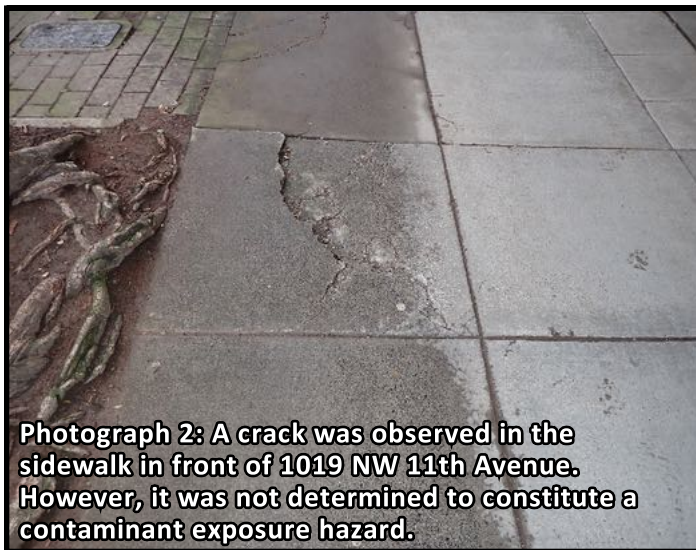
Cracks and/or Settlement in vertical cement or flatwork? Y/N	Exposure Hazard? Y/N	Repair Required? Y/N
No settlement was observed in any of the concrete walls or floors. Although the sidewalk in front of 1019 NW 11 th Avenue was observed to be cracked, it was not determined to constitute a contaminant exposure hazard.	No	No repair required for environmental issues, but the crack may develop into a trip/fall hazard if it gets larger.
Holes or Penetrations? Y/N	Exposure Hazard? Y/N	Repair Required? Y/N
No holes or penetrations were observed.	No	No
Exposed Soil or Fabric Y/N?	Exposure Hazard? Y/N	Repair Required? Y/N
Soil was visible in planters, but no geotextile barrier was observed.	No	No
Problematic Surface Water Drainage Features?	Exposure Hazard? Y/N	Repair Required? Y/N
Problematic surface water drainage features were not observed.	No	No
Cracked or Missing Caulking?	Exposure Hazard? Y/N	Repair Required? Y/N

Photograph 2: A crack was observed in the sidewalk in front of 1019 NW 11th Avenue. However, it was not determined to constitute a contaminant exposure hazard.

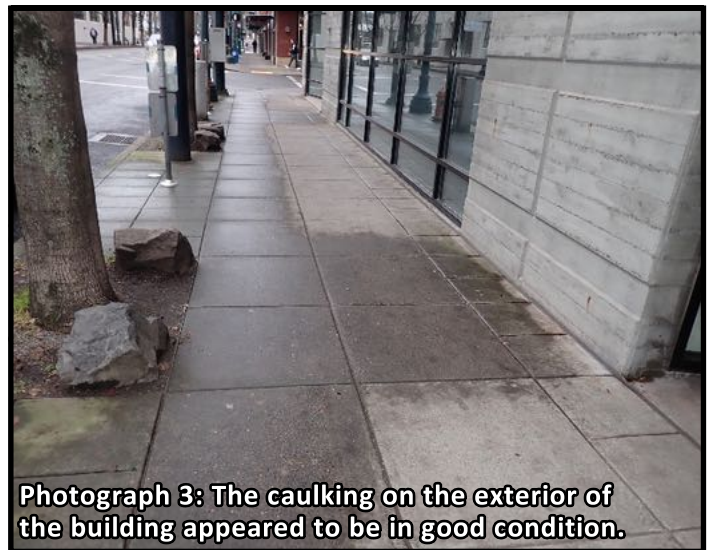
It is our professional opinion that there were no areas where the soil cap or the geotextile membrane used to delineate the top of the cap were visible at any of the inspection points. The silicone caulking between the building and sidewalk was observed to be intact and undamaged, and no areas of groundwater seepage were noted in the walls or floors of the basement parking garage.

Photograph 3: The caulking on the exterior of the building appeared to be in good condition.

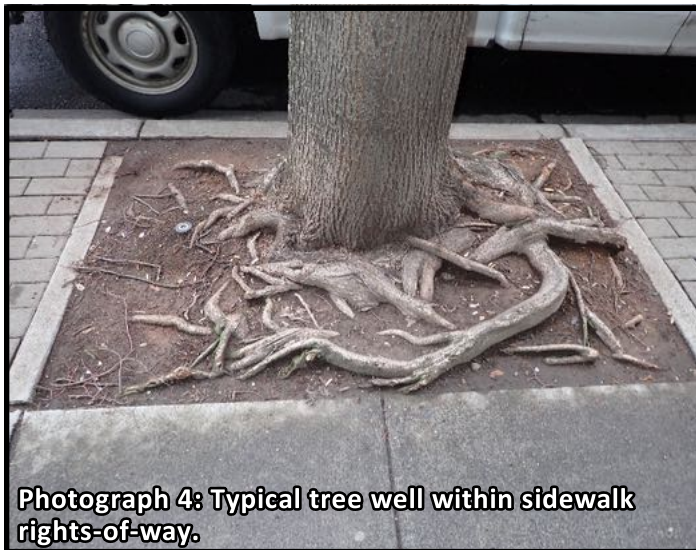
Photograph 4: Typical tree well within sidewalk rights-of-way.

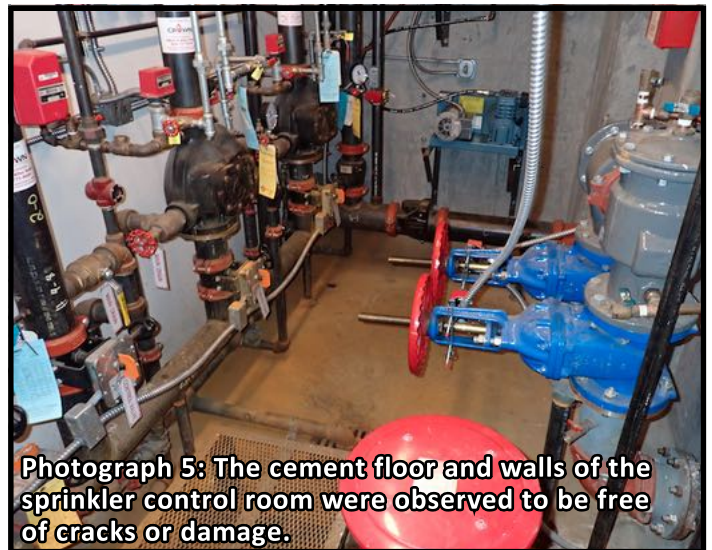
Photograph 5: The cement floor and walls of the sprinkler control room were observed to be free of cracks or damage.
