**SUBJECT: 2023 Environmental Cap Inspection at Metropolitan Condominiums,
1001 NW Lovejoy Street, Portland, Oregon 97209**

Inspection Date: December 19, 2023

Annual Cap Inspection
Metropolitan Condominiums
1001 NW Lovejoy Street, Portland, Oregon

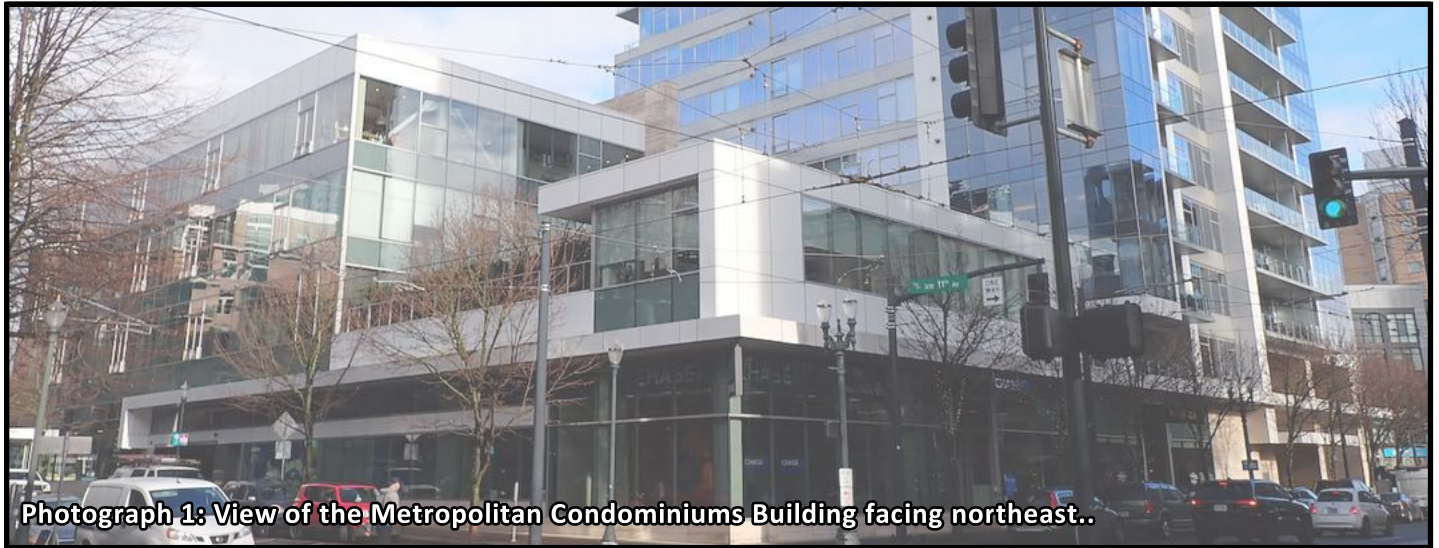
Photograph 1: View of the Metropolitan Condominiums Building facing northeast..

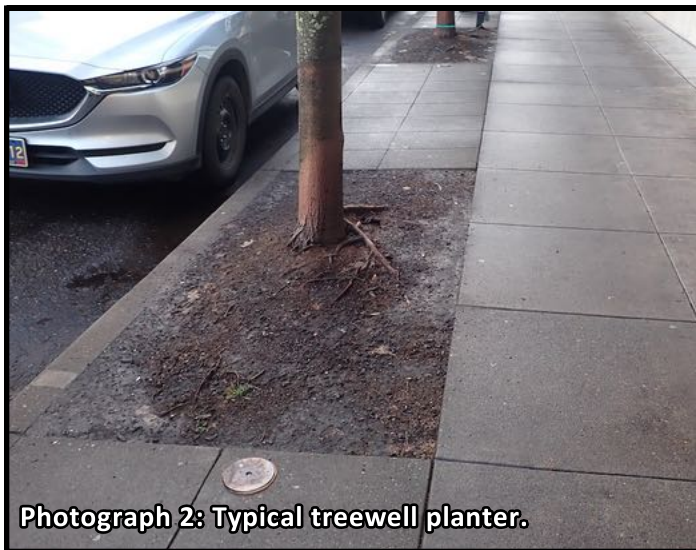
Photograph 2: Typical treewell planter.

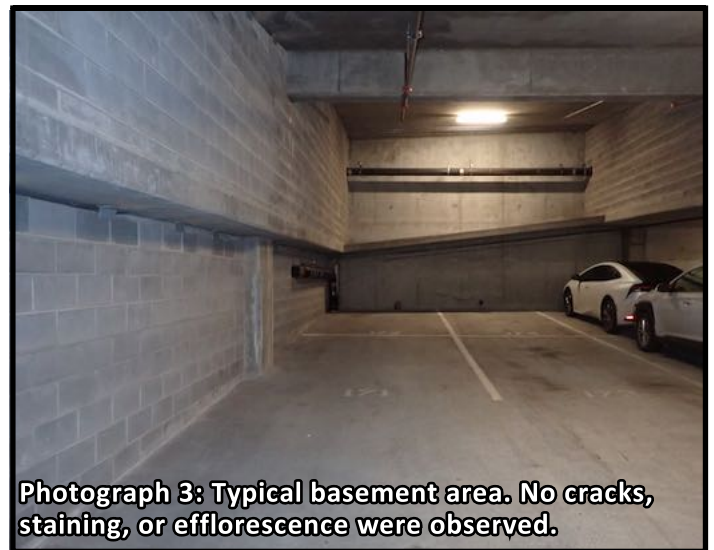
Photograph 3: Typical basement area. No cracks, staining, or efflorescence were observed.

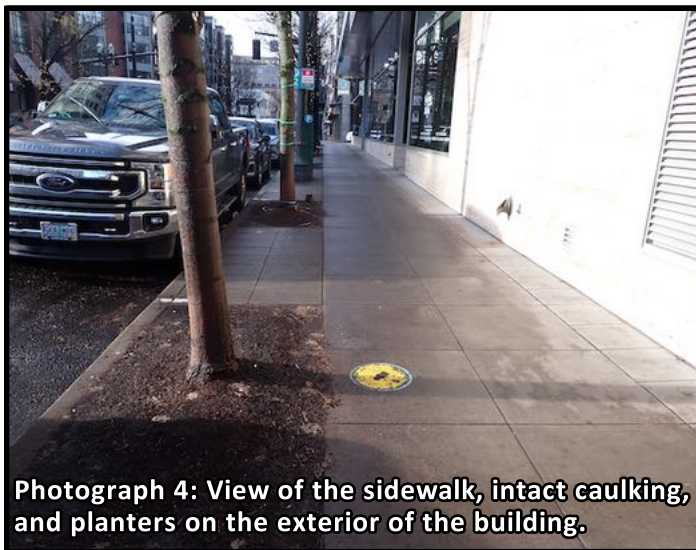
Photograph 4: View of the sidewalk, intact caulking, and planters on the exterior of the building.

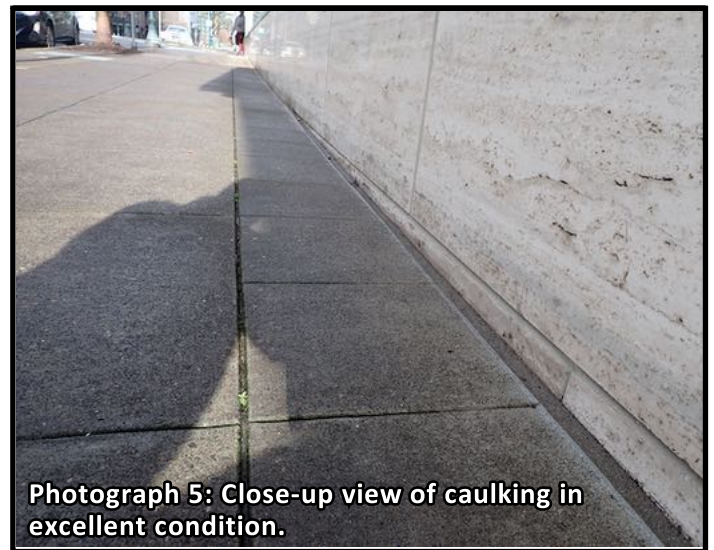
Photograph 5: Close-up view of caulking in excellent condition.
