March 27, 2023

**SUBJECT: 2023 Environmental Cap Inspection at Bridgeport Condominium,
1130 NW 12th Avenue, Portland, Oregon**

Annual Cap Inspection
Bridgeport Condominiums
1130 NW 12th Avenue, Portland, Oregon

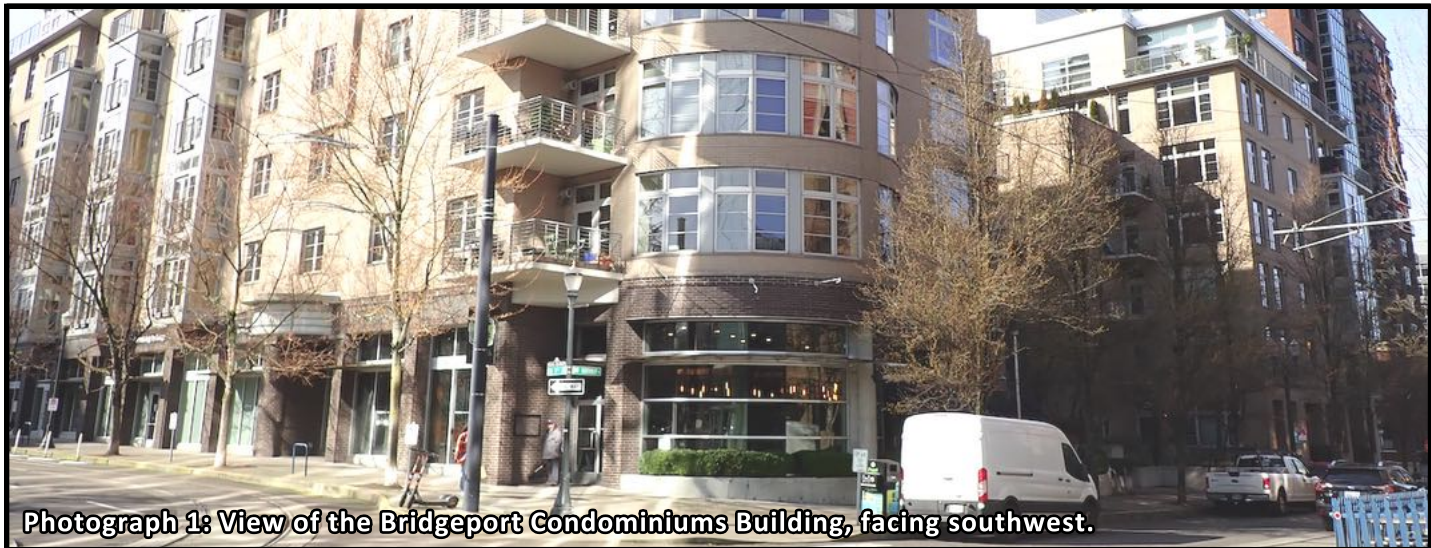
Photograph 1: View of the Bridgeport Condominiums Building, facing southwest.

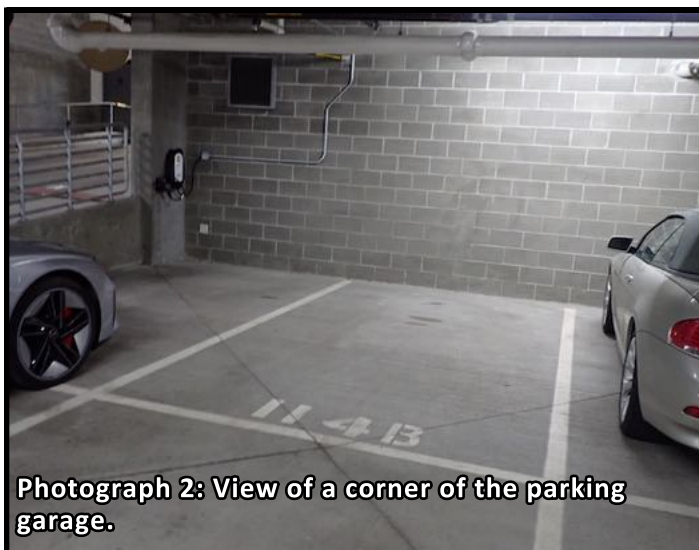
Photograph 2: View of a corner of the parking garage.

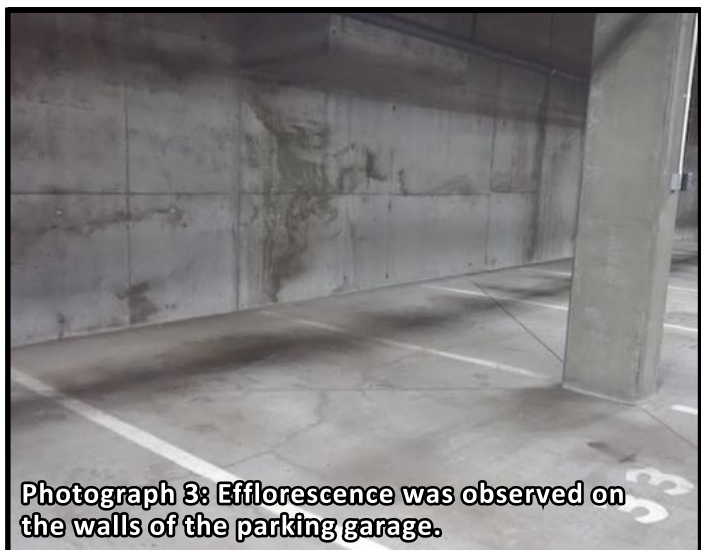
Cracks and/or Settlement in vertical cement or flatwork? Y/N	Exposure Hazard? Y/N	Repair Required? Y/N
No settlement was observed in any of the concrete walls or floors. Fine cracks were noted in vertical areas of the basement parking garage. Several fine cracks exhibited whitish efflorescence running down walls.	Although the fine cracks on the walls of the basement parking garage showed signs of efflorescence, they did not appear to be hazardous.	No
Holes or Penetrations? Y/N	Exposure Hazard? Y/N	Repair Required? Y/N
No holes or penetrations were observed.	No	No
Exposed Soil or Fabric Y/N?	Exposure Hazard? Y/N	Repair Required? Y/N
Soil was visible in planters, but no geotextile barrier was observed.	No	No
Problematic Surface Water Drainage Features?	Exposure Hazard? Y/N	Repair Required? Y/N
No	No	No
Cracked or Missing Caulking?	Exposure Hazard? Y/N	Repair Required? Y/N
Some minor shrinkage of exterior caulking was observed along the west wall where it meets the sidewalk.	No	Yes-the caulking should be repaired to insure building integrity.

Photograph 3: Efflorescence was observed on the walls of the parking garage.

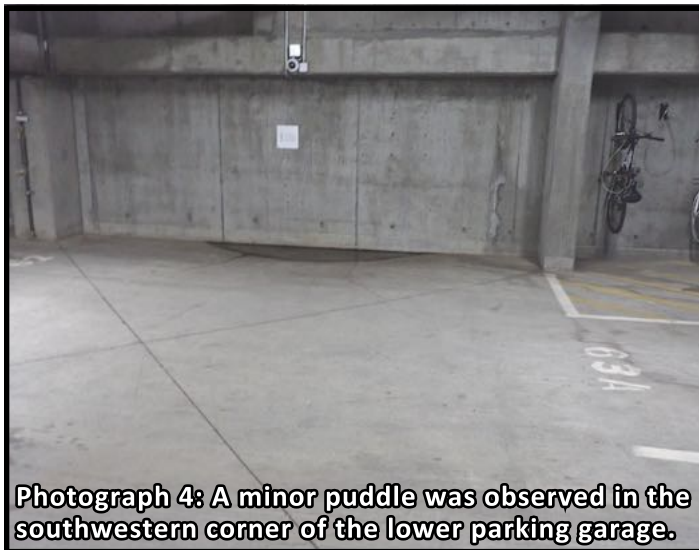
Groundwater Seepage Areas?	Exposure Hazard? Y/N	Repair Required? Y/N
There was a small puddle of water in the southwestern corner of the lowest parking level, at the location of an apparent floor drain. It did not exhibit petroleum odors or an oily sheen, so is unlikely to be contaminated groundwater. Ron indicated that he had notified the property management team that the drain was clogged, but was informed that it "wasn't an actual drain". Ron did not know the source of the water.	The water did not appear to exhibit evidence of petroleum contamination, which is the predominant residual contaminant in the legacy soils beneath the former Hoyt railyards. It is unlikely that the water is groundwater that has infiltrated the cement floor, based upon the thickness of the cement.	The drain should be inspected to determine whether it has a discharge pipe. If so, it should be unclogged. If the drain has no discharge, the water should be removed and disposed in a working drain.

Photograph 4: A minor puddle was observed in the southwestern corner of the lower parking garage.

Recommendation: It is unlikely that the water is groundwater that has infiltrated the cement floor, based upon the thickness of the cement. However, the drain should be inspected to determine whether it has a discharge pipe. If so, it should be unclogged. If the drain has no discharge, the water should be removed and disposed in a working drain.

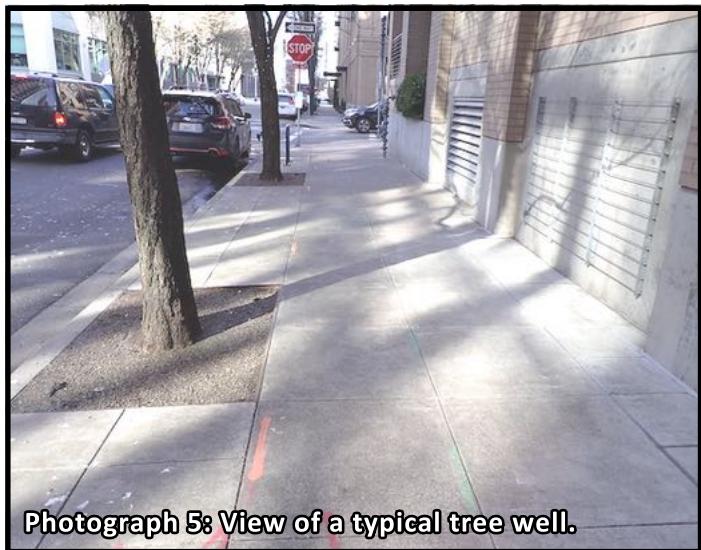
Photograph 5: View of a typical tree well.
