**SUBJECT: 2024 Environmental Cap Inspection at Bridgeport Condominium,  
1130 NW 12th Avenue, Portland, Oregon**

Annual Cap Inspection  
Bridgeport Condominiums  
1130 NW 12th Avenue, Portland, Oregon

Project 1598

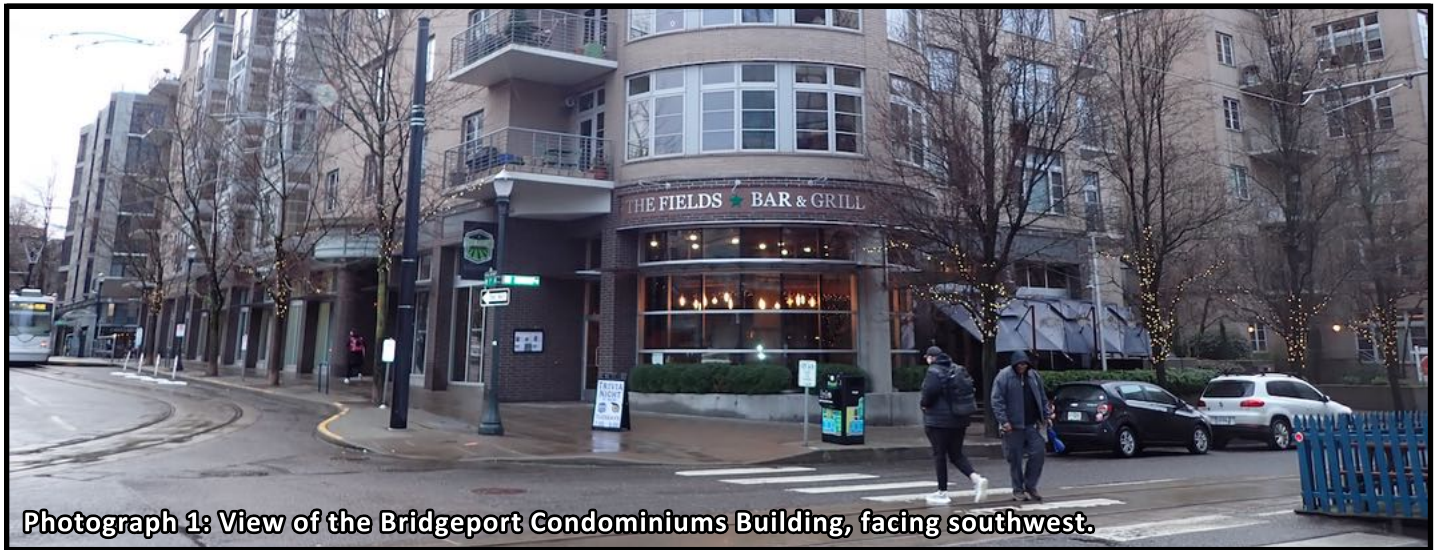
Photograph 1: View of the Bridgeport Condominiums Building, facing southwest.

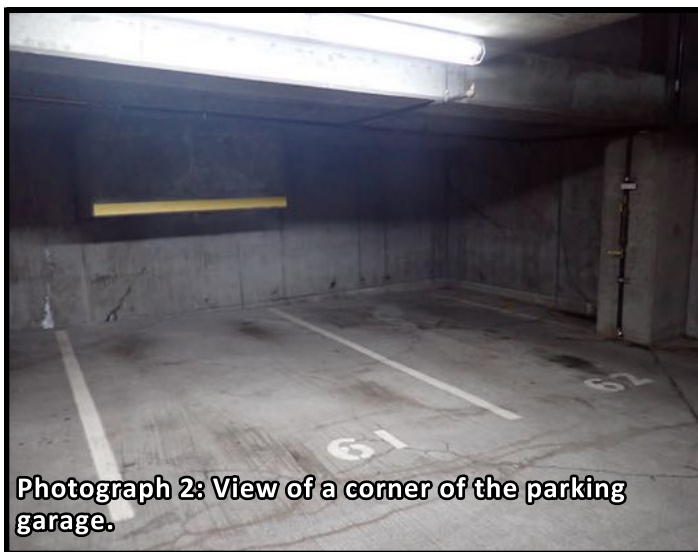
Photograph 2: View of a corner of the parking garage.

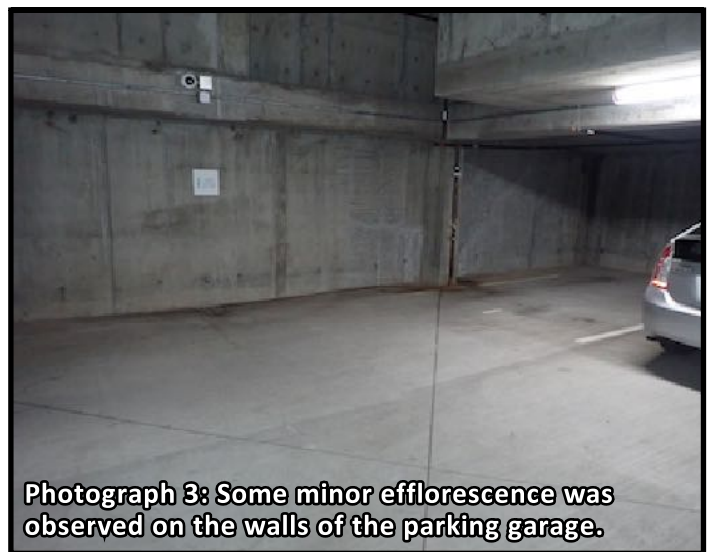
**Conclusion:** It is our professional opinion that there were no areas where the soil cap or the geotextile membrane used to delineate the top of the cap were visible at any of the inspection points, and, although some fine cracks were observed in the vertical walls of the basement parking area, they did not appear to constitute an exposure hazard.

Photograph 3: Some minor efflorescence was observed on the walls of the parking garage.

We do not recommend additional inspections other than an annual re-inspection in 2025. The soil and concrete cap at the Property are apparently intact and are functioning as intended.

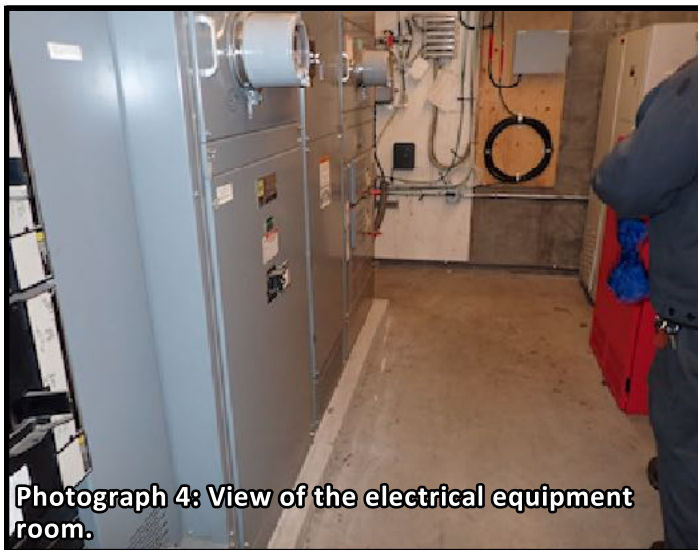
Photograph 4: View of the electrical equipment room.

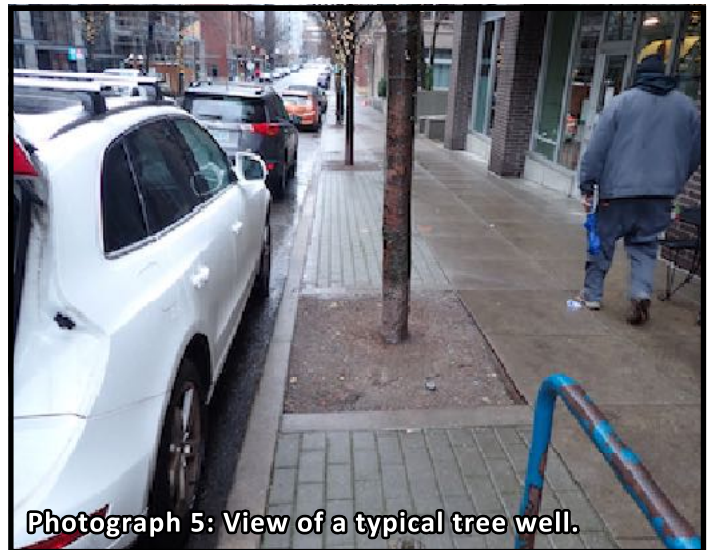
Photograph 5: View of a typical tree well.
