Background: The Tanner Springs Park is a municipal park located in NW Portland. Area soils beneath the cap may contain elevated concentrations of petroleum hydrocarbons, lead, and / or polynuclear aromatic hydrocarbons. For the Tanner Springs Park, the cap consists of landscaped soil, concrete sidewalks, wood walkways, water features, and other hardscaping. This inspection report was completed to assess the condition of the capped area which includes the entire park.

Site: Tanner Springs Park

Inspection Date: 11/18/2019

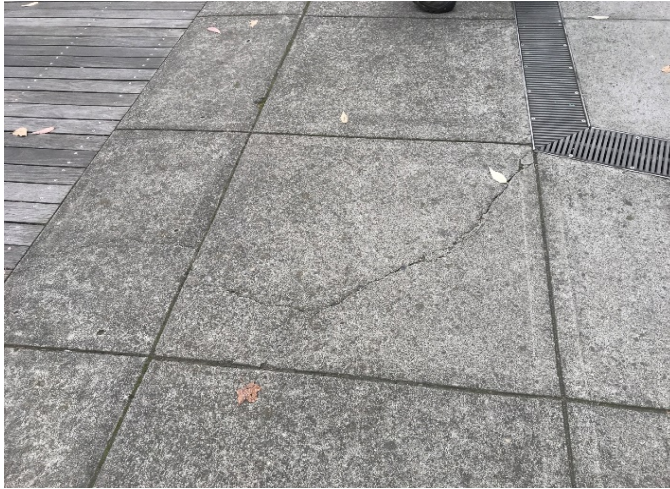
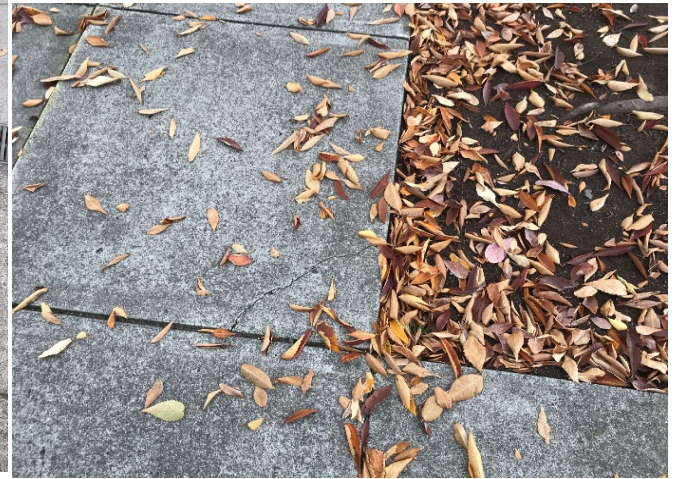
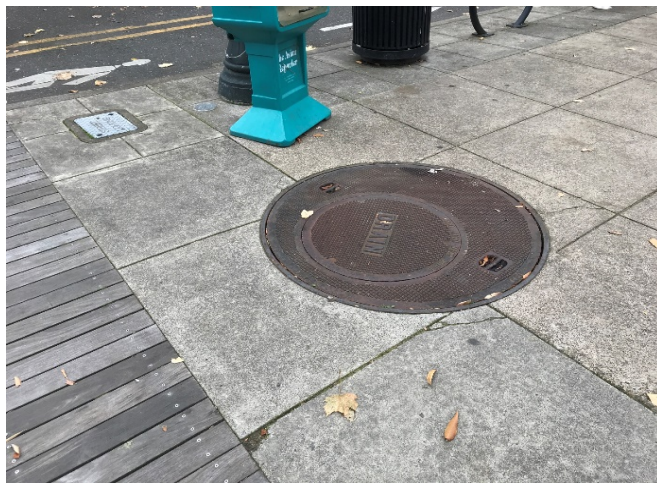
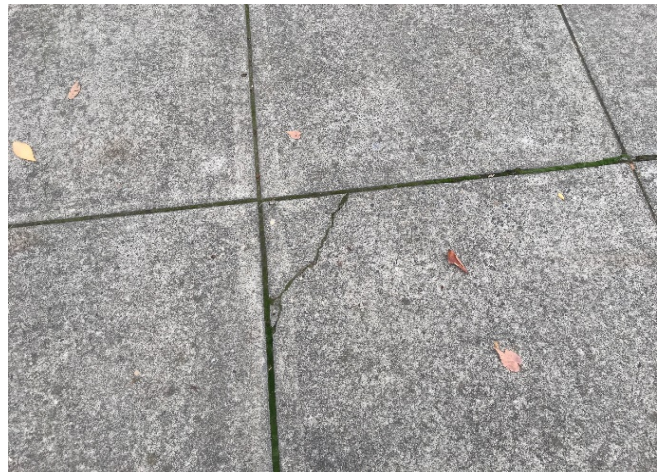
Location: Very minor cracks (less than 0.5 inches) at few locations within concrete sidewalks (see attached photos).

Photos 5-8 : Minor cracking in concrete panels

Maintenance required? Yes ___ No **X**
