Site: Tanner Springs Park

Inspection Date: 10/07/2021

**Background:** Tanner Springs Park is a municipal park located in NW Portland. Area soils beneath the cap may contain elevated concentrations of petroleum hydrocarbons, lead, and/or polynuclear aromatic hydrocarbons. For Tanner Springs Park, the cap consists of landscaped soil, concrete sidewalks, wood walkways, water features, and other hardscaping. This inspection report was completed to assess the condition of the capped area which includes the entire park.

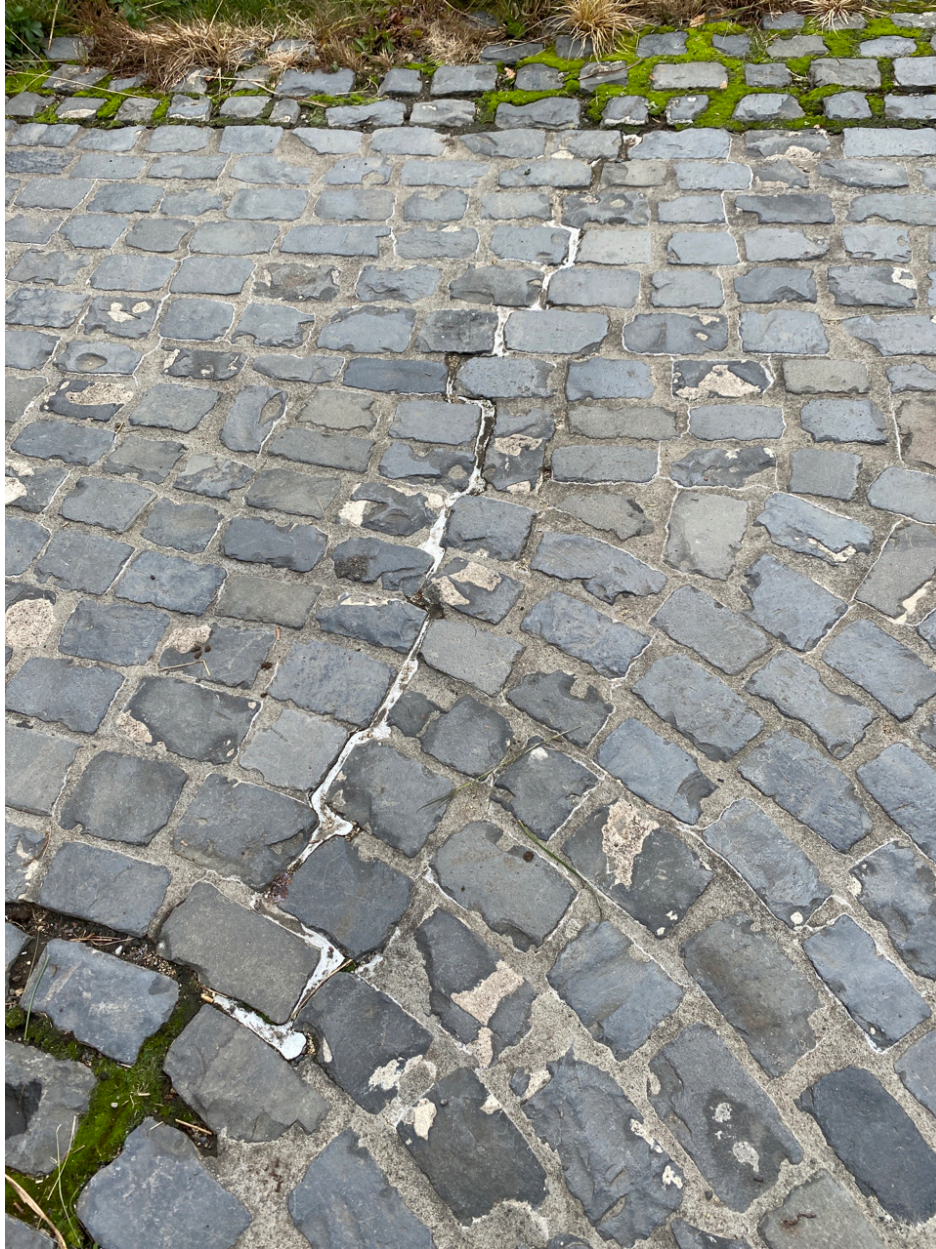
**Photo Point 1** – condition of caulking in path. Fair condition, no cap penetration, no need for repair

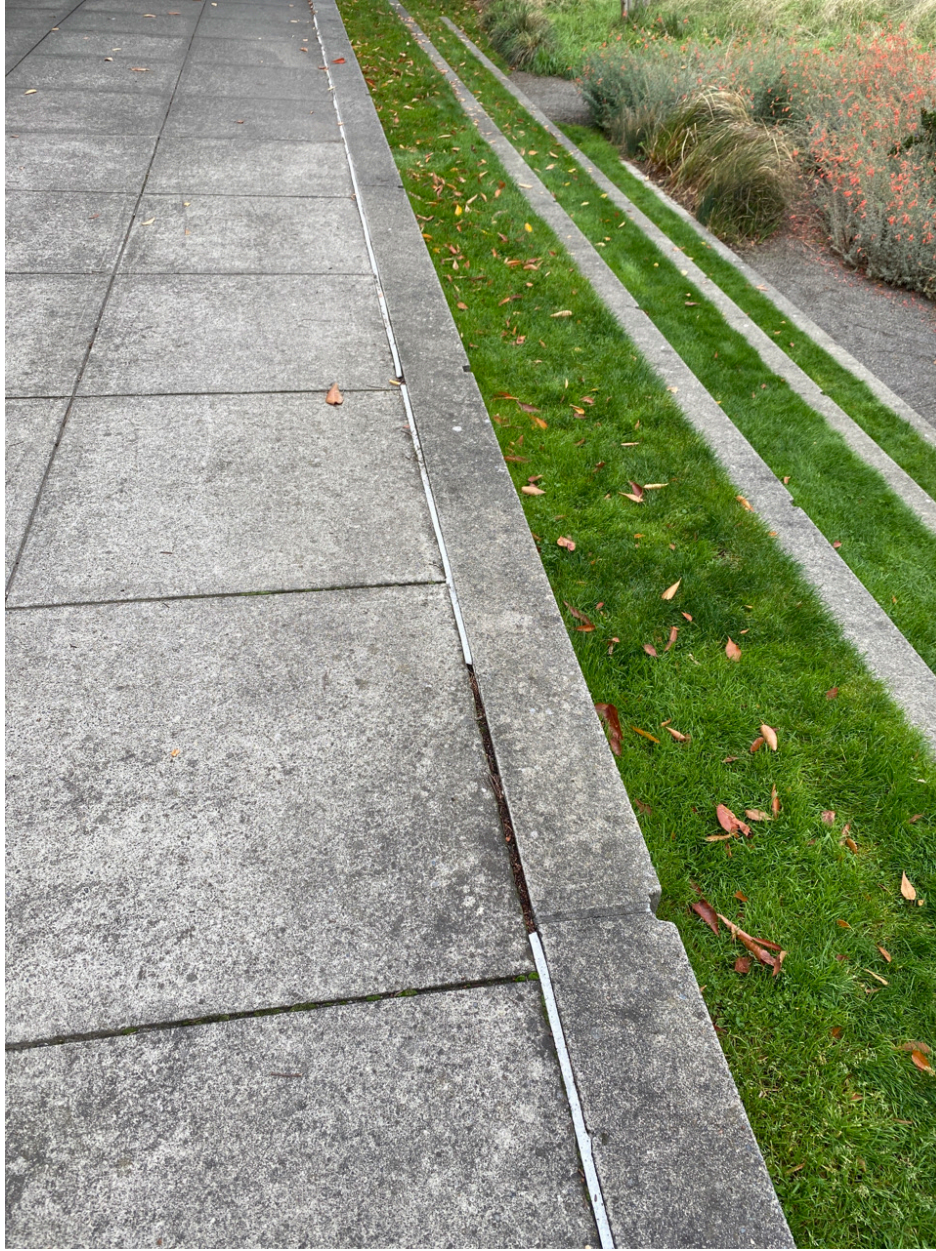
**Photo Point 2** – small section (about 2 ft) of caulking missing from hardscape on top of terraced area.  
Does not penetrate or pose risk to the cap.

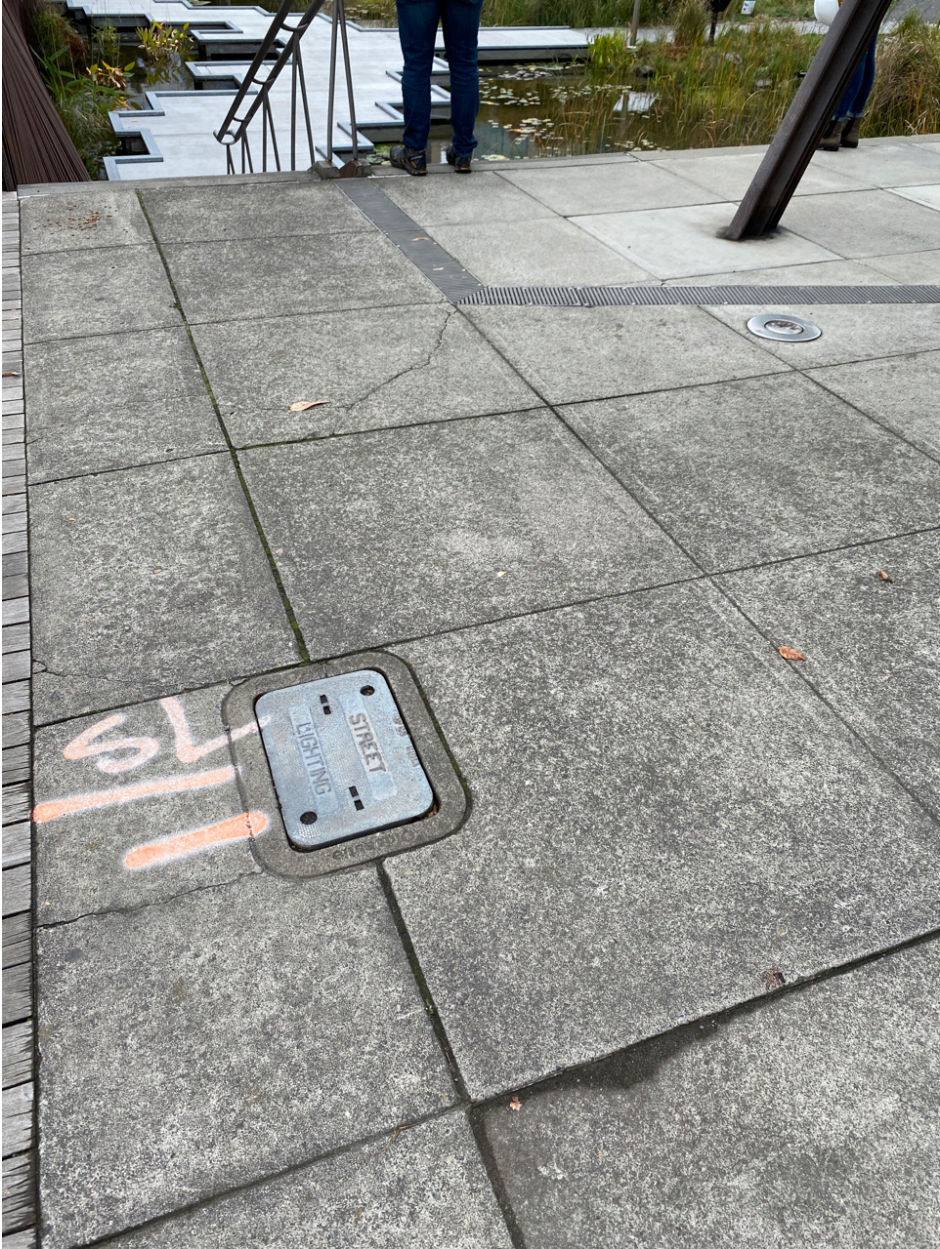
**Photo Point 3** – cracks in asphalt have not changed since last year’s inspection

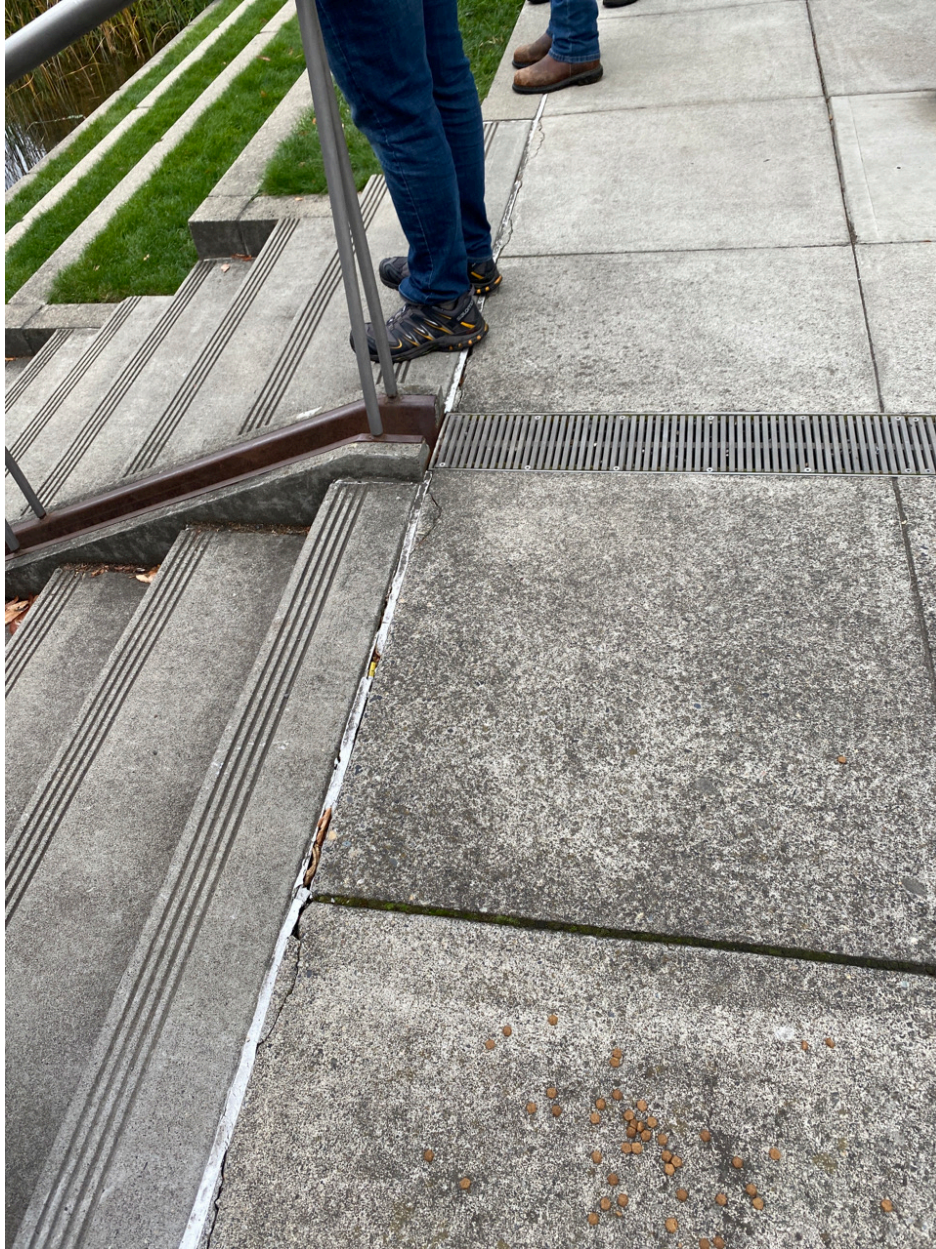
**Photo Point 3** – cracks and worn caulking have not changed since last inspection

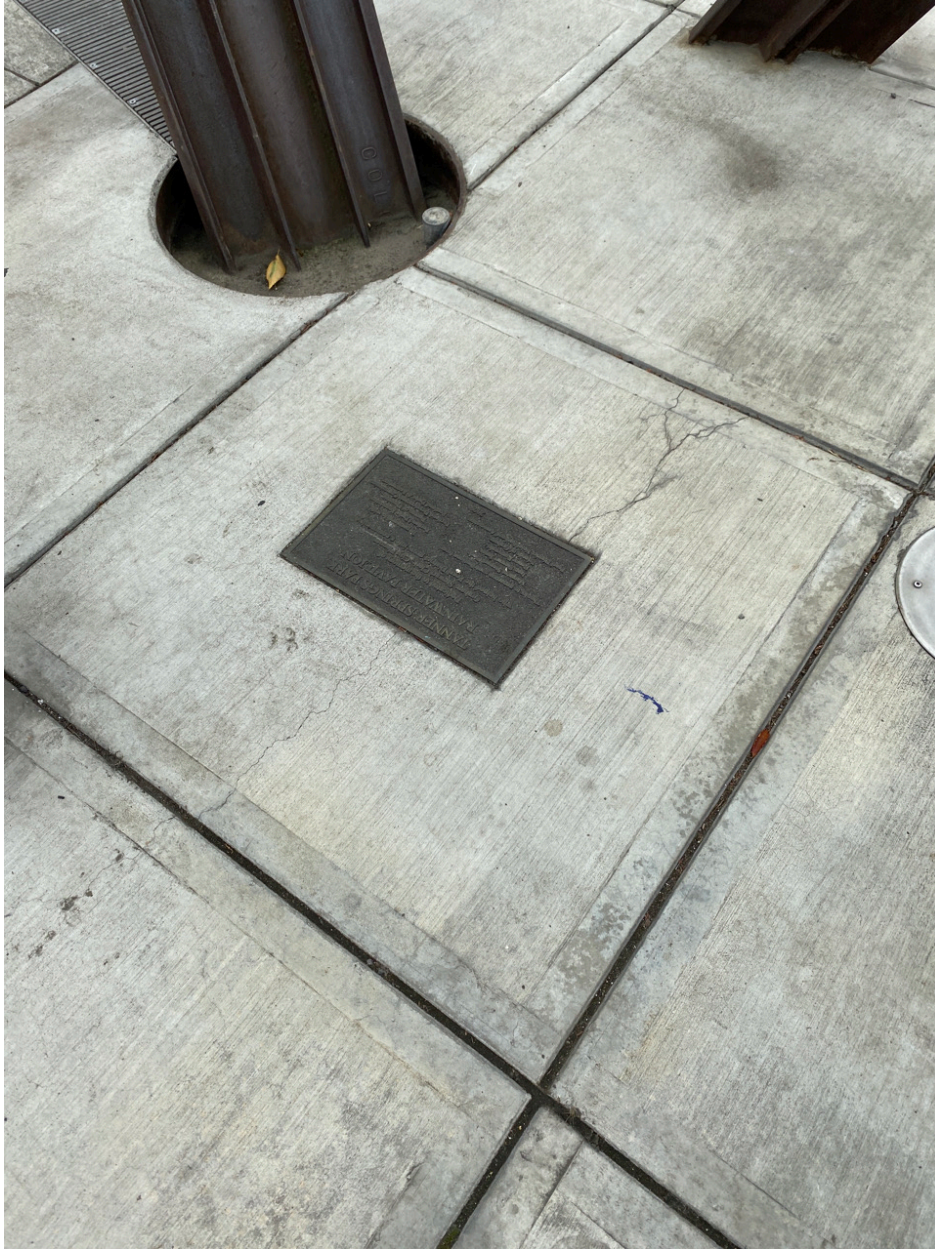
**Photo Point 3** – small cracks in concrete noticed around plaque in sidewalk

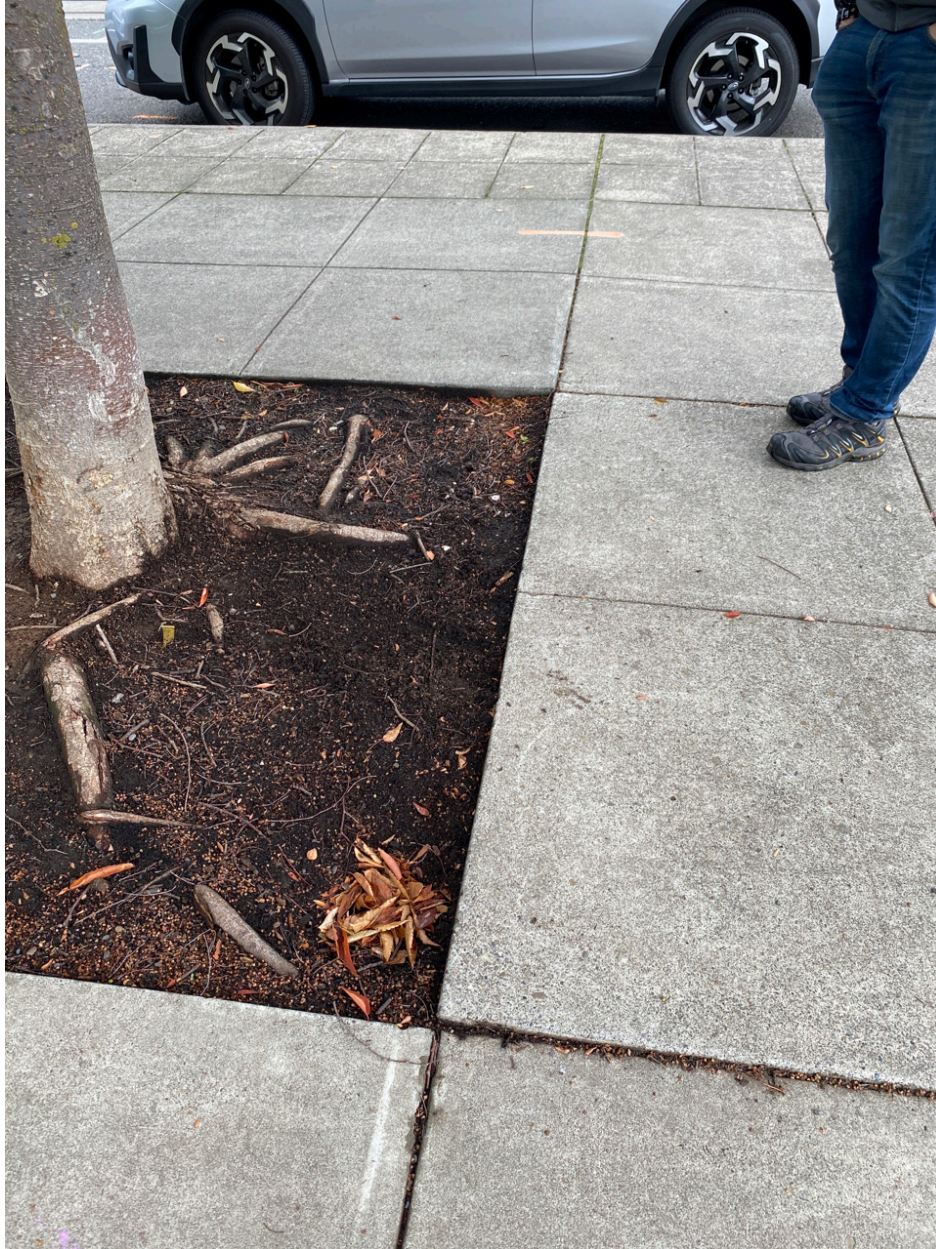
Several minor cracks in concrete were documented in the attached photo log and accompanying map. Many of those cracks were documented in last year's inspection report and have not changed in appearance since last year. Tree roots seem to have caused some minor lift to a few concrete panels. Weathering is likely to have impacted seams in the cobblestone paths that appeared mostly in fair condition, but caulking was missing in a few places. None of these observations appear to have compromised the cap or have allowed subsurface soil to be exposed.

**Photo Point 4** – Raised concrete panels from tree roots.

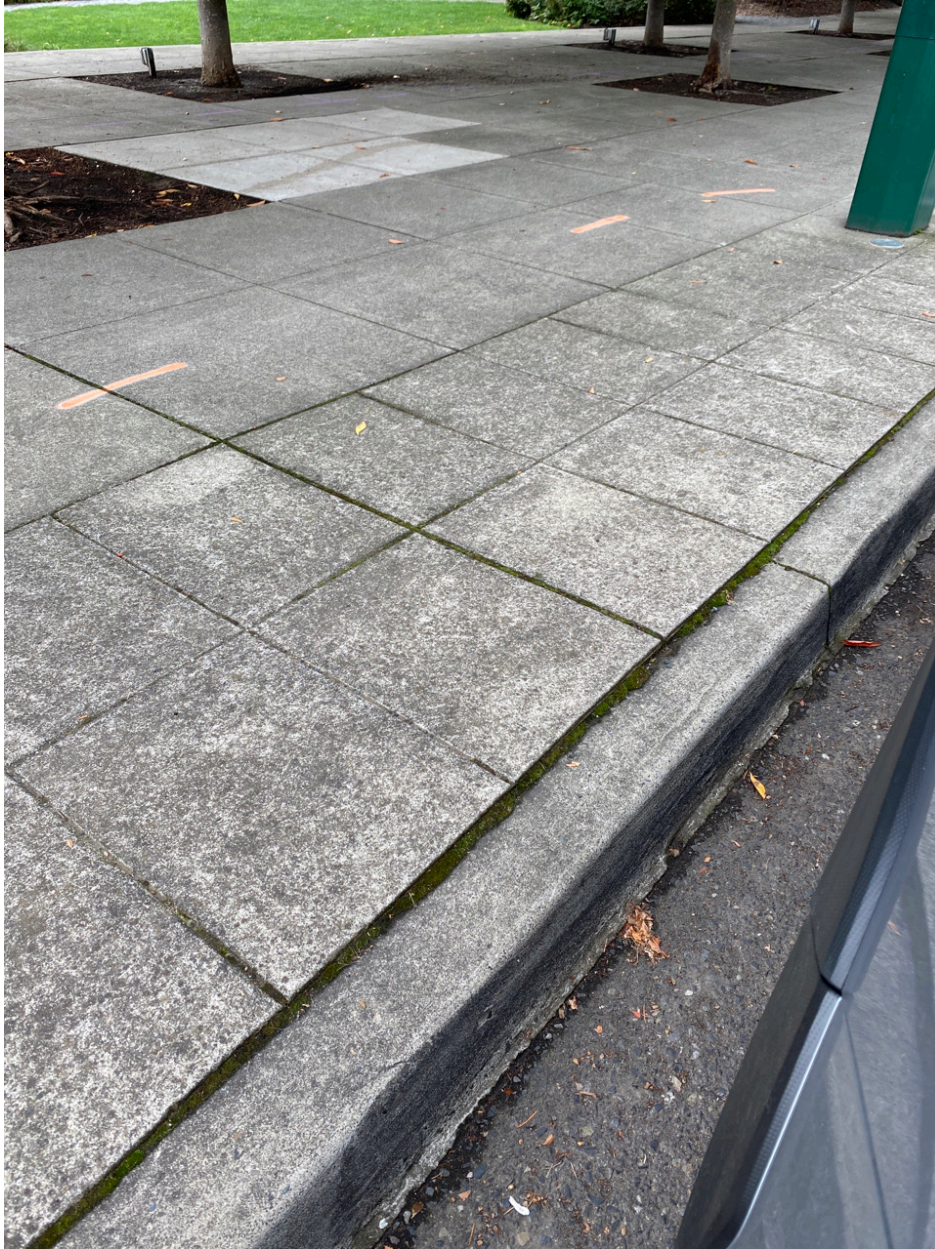
**Photo Point 4** – cement panels uplifted less than 1 inch.

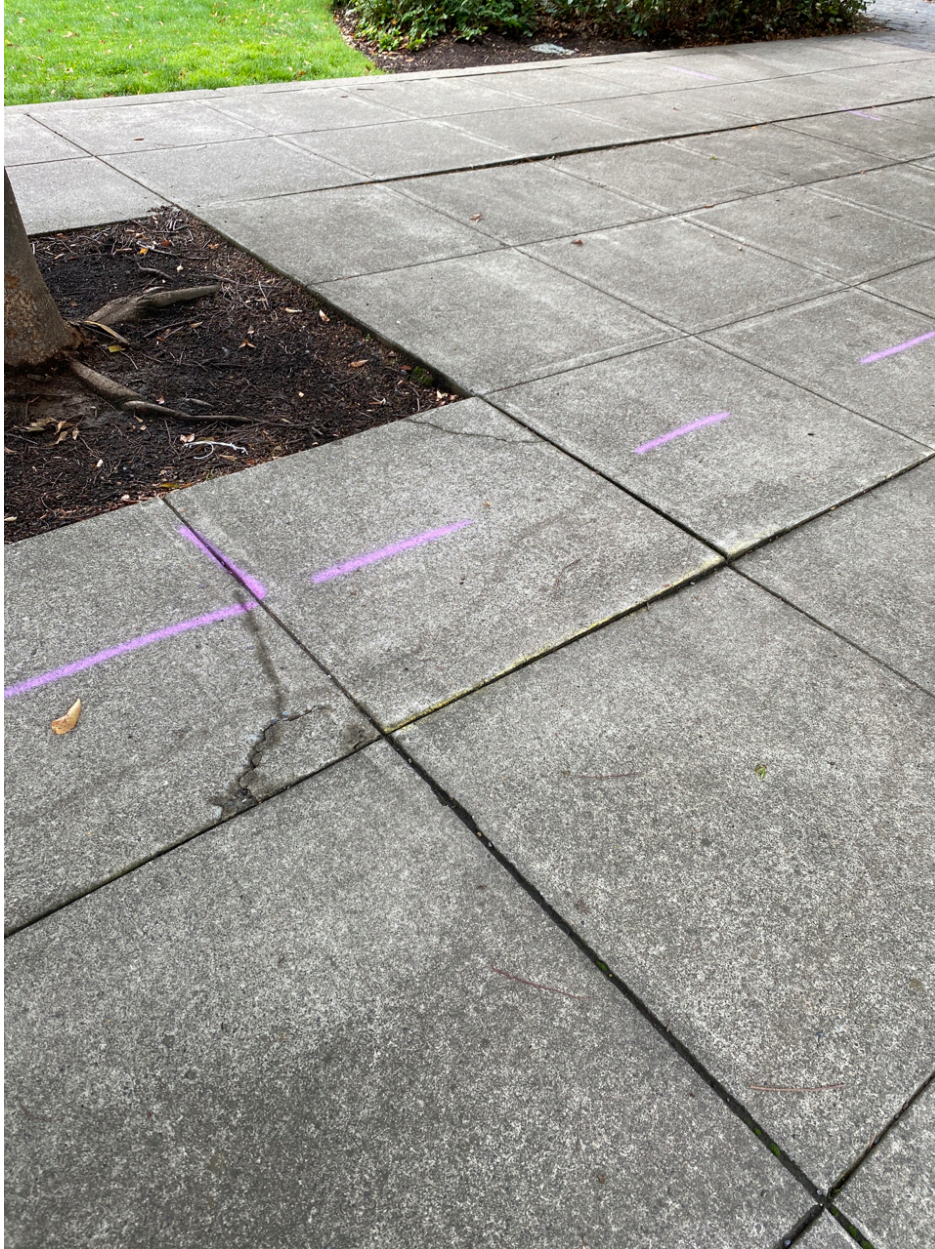
**Photo Point 5** – minor cracks in cement panels around tree base. Likely caused by tree roots.

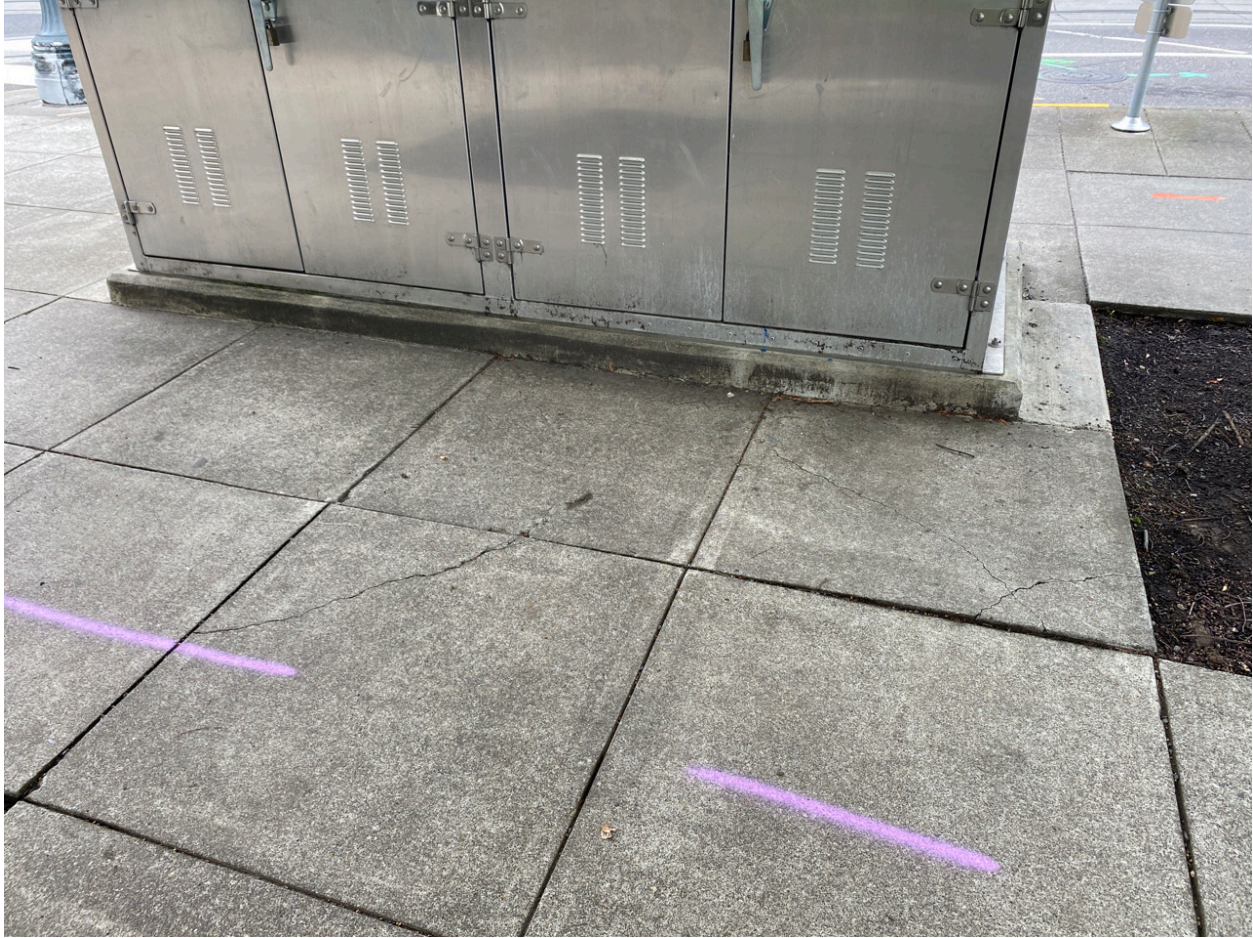
**Photo Point 6** – Cracks in concrete panels near utility vault has not changed noticeably over the last couple of years

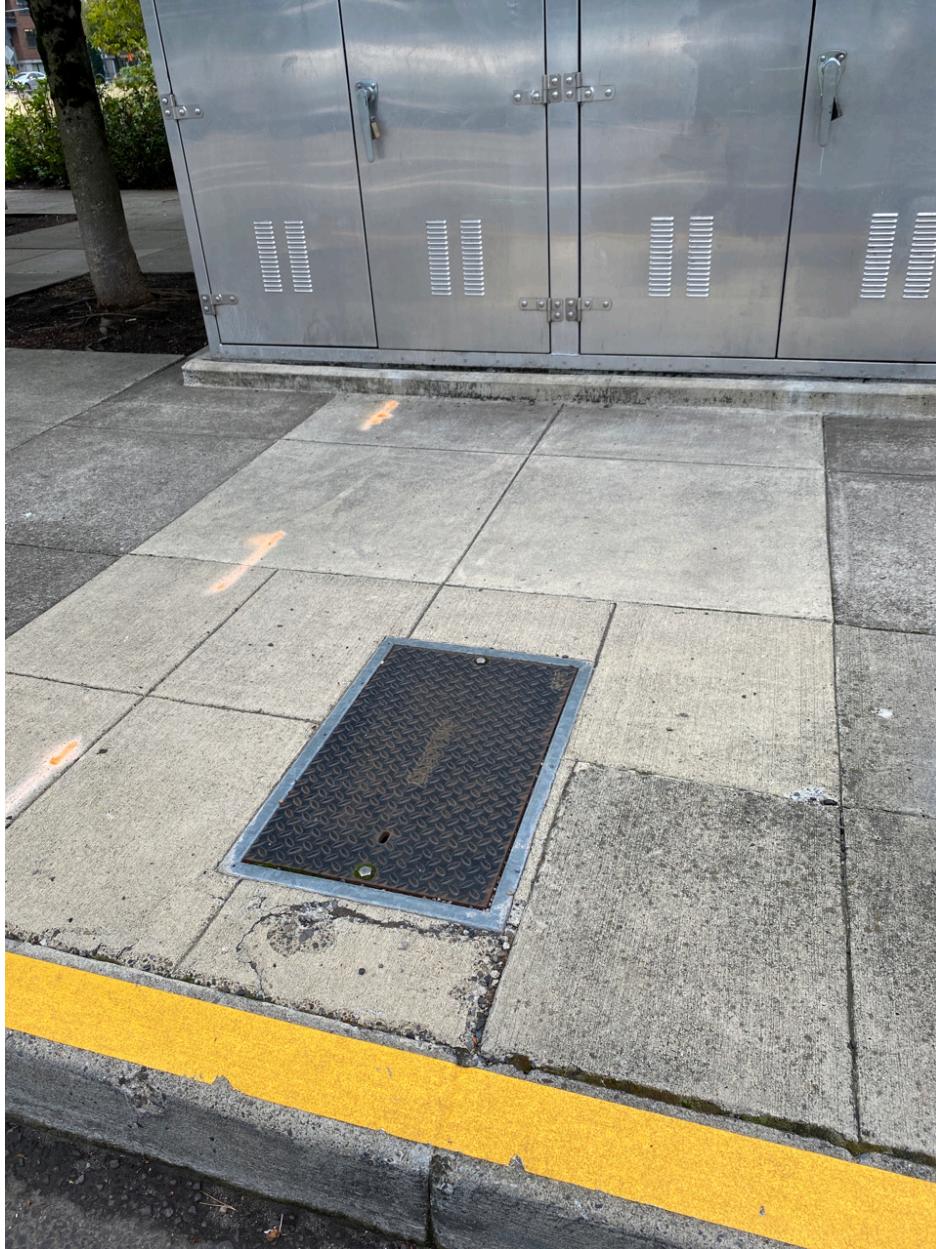
**Photo Point 6** – surficial damage to concrete panel around utility vault near roadway. Does not expose soil.

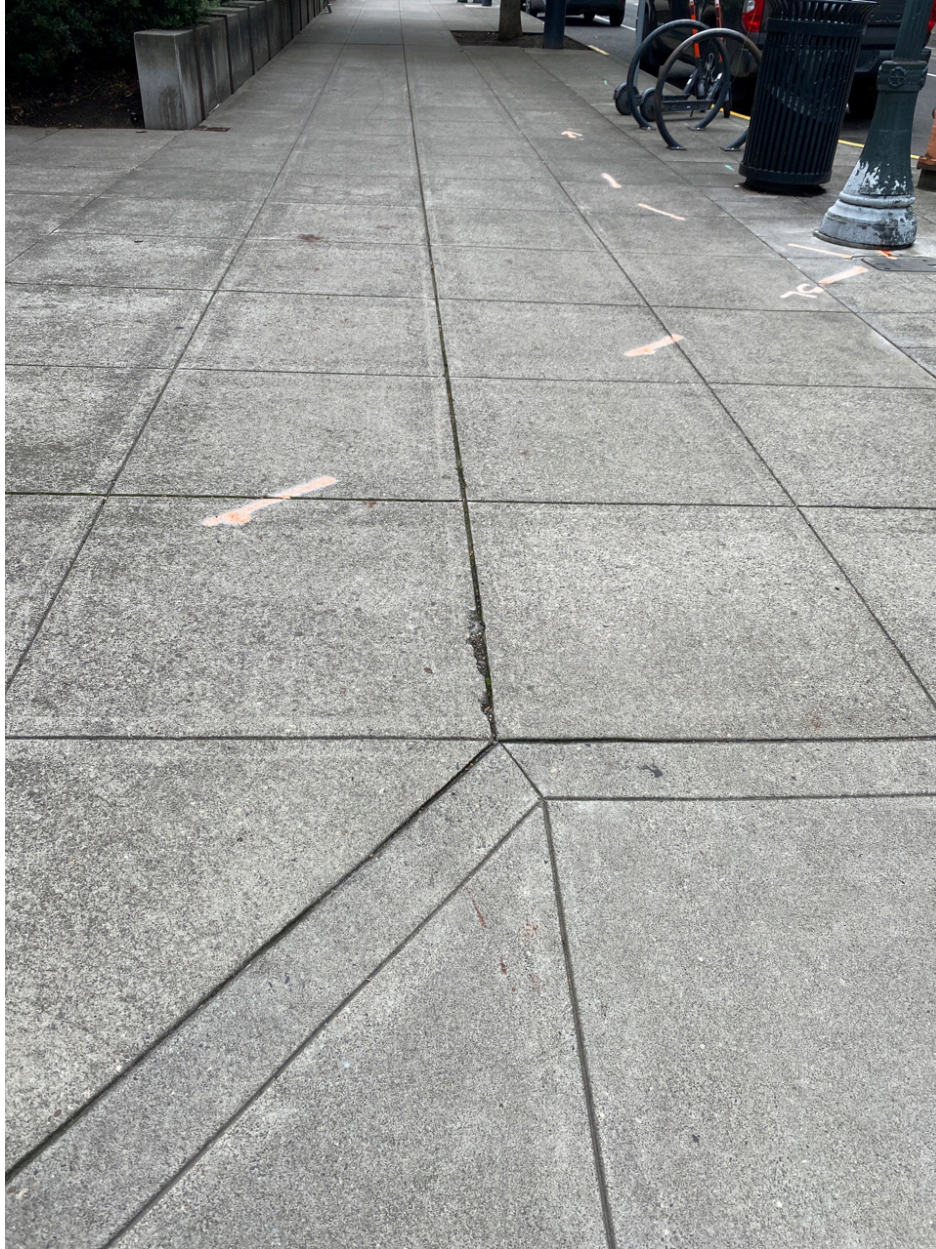
**Photo Point 7** – looking south down sidewalk from northwest corner of the park. Cement in good condition, only minor surficial damage of one panel in this shot.

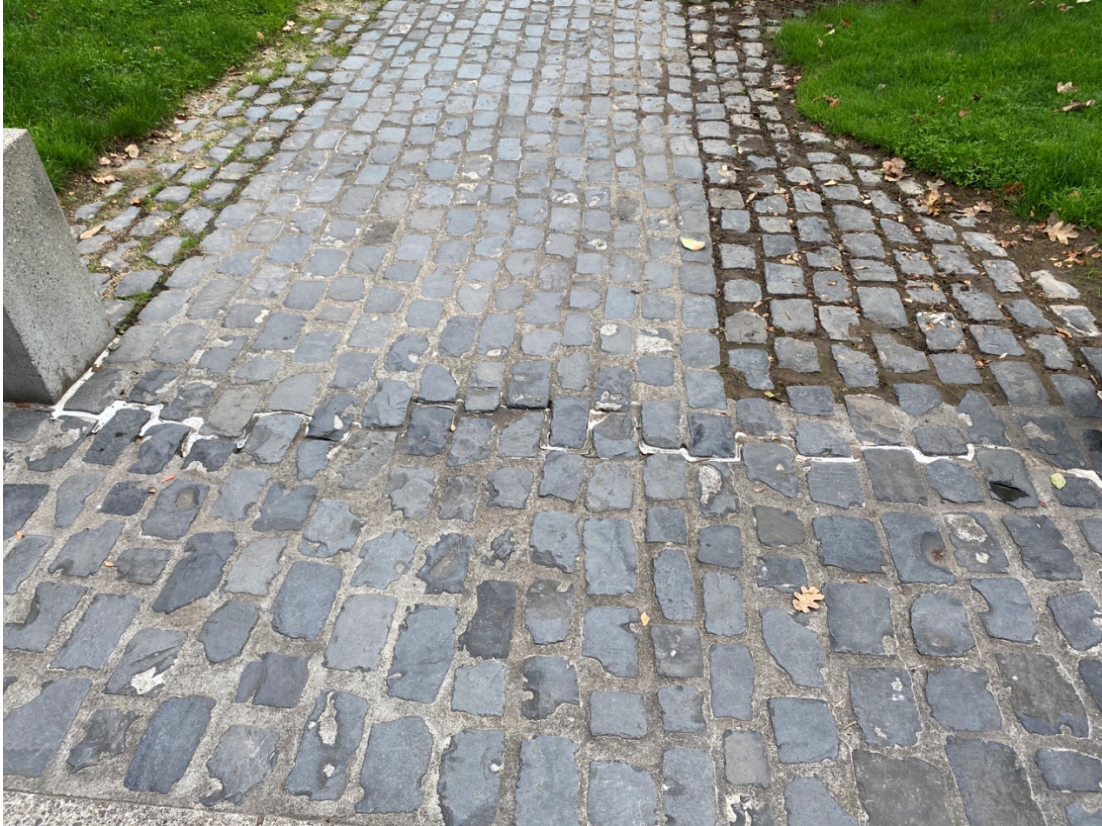
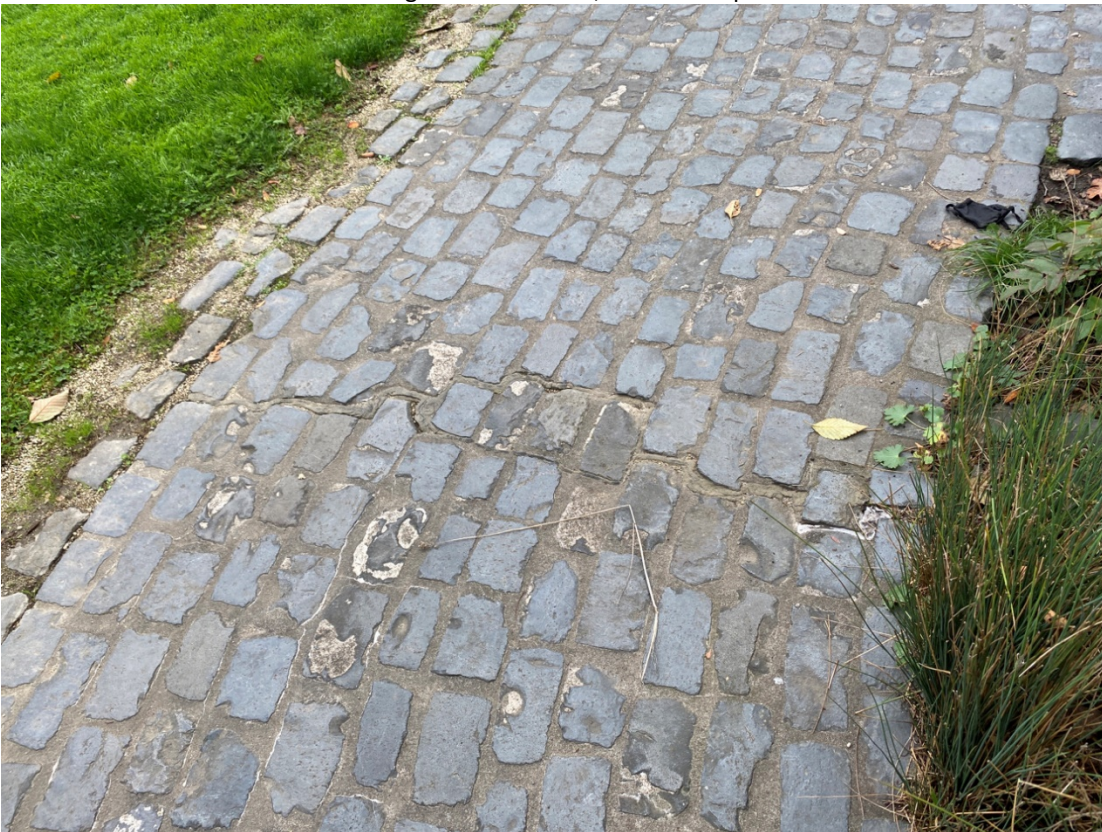
**Photo Point 8** – Caulking in fair condition, does not expose subsurface soil.

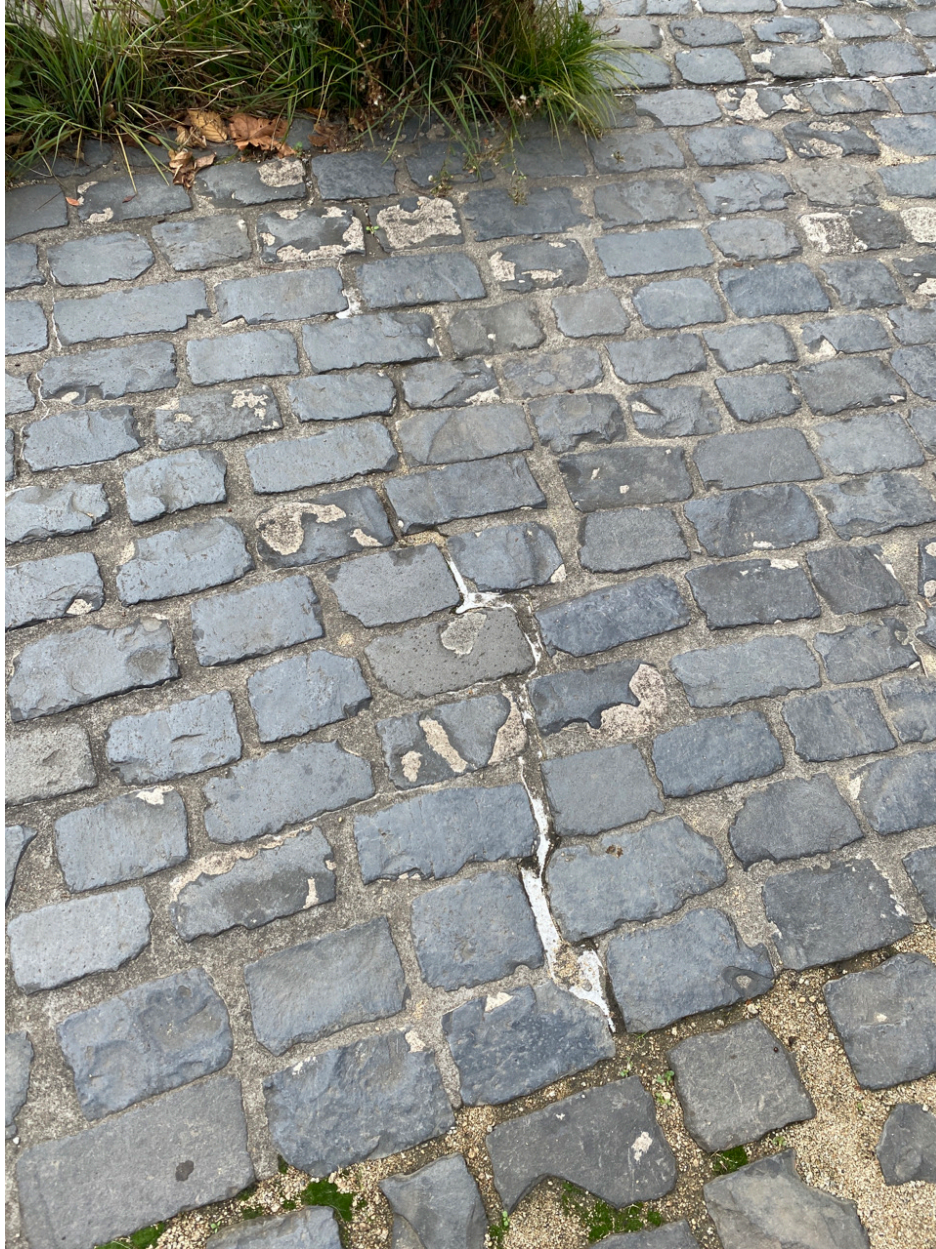
**Photo Point 9** – Caulking used on cobblestone path in fair condition in some places, missing in others. However, none of the seams appear to be penetrating the cap.

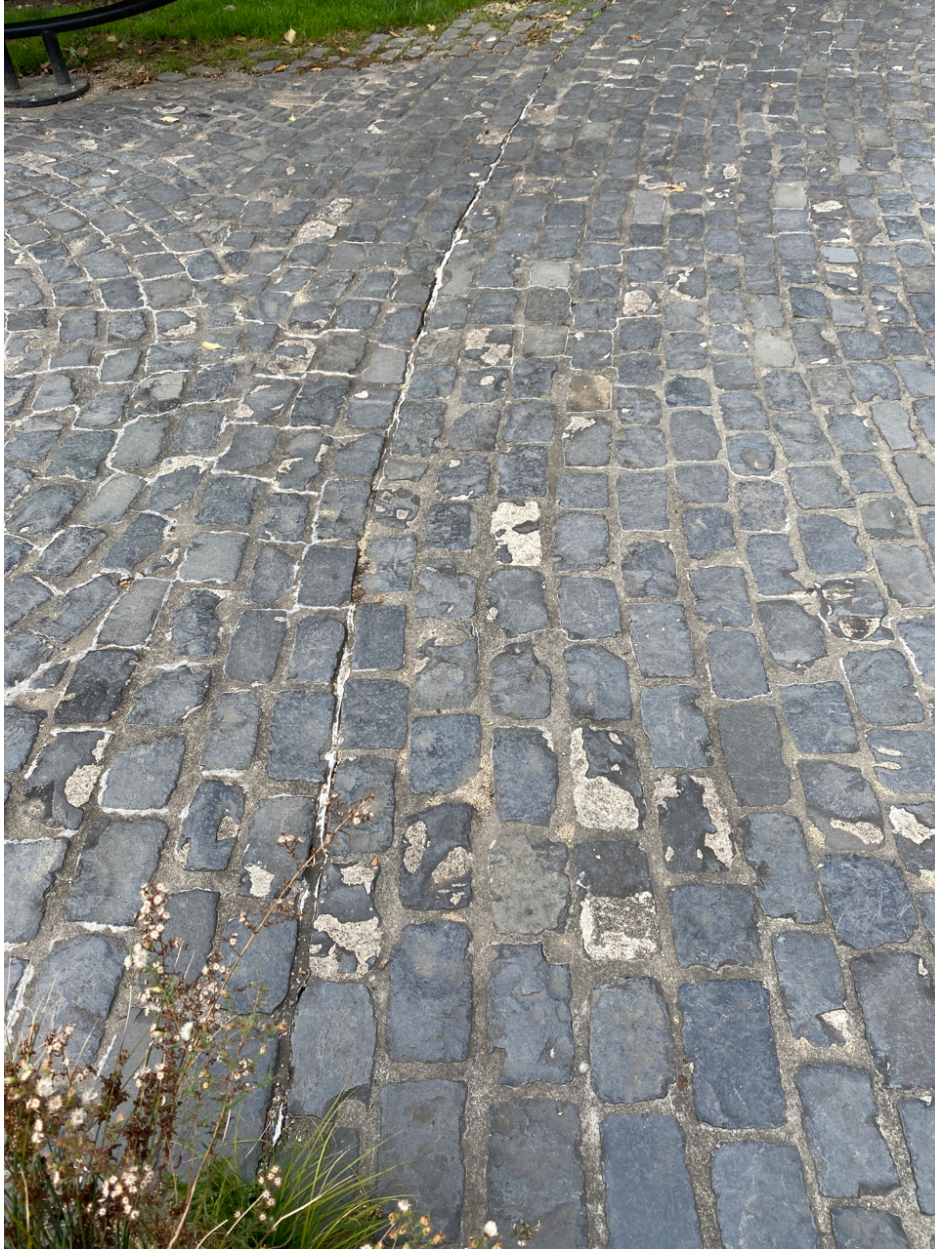
**Photo Point 9** – Cobblestone path and seams in fair condition in most locations

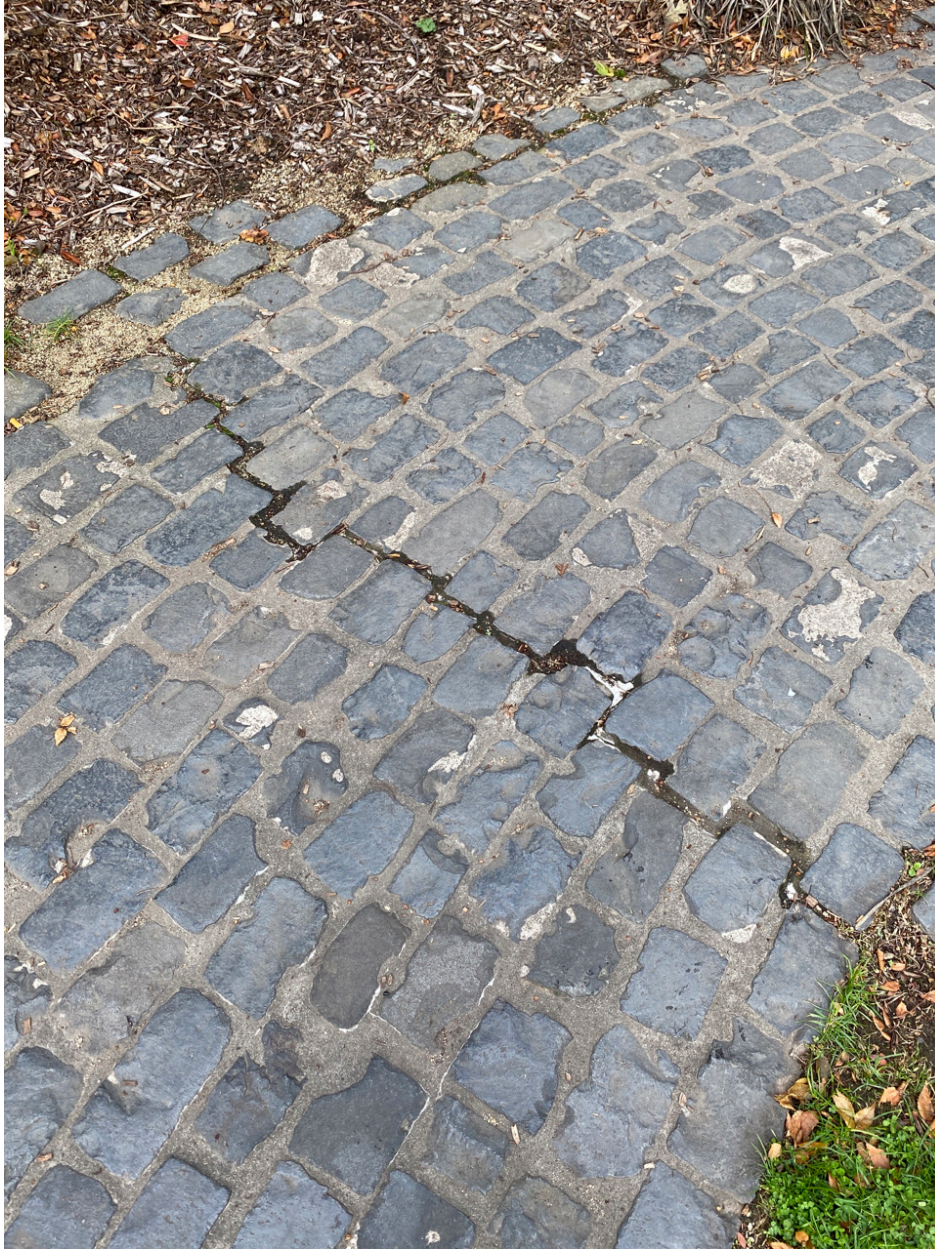
**Photo Point 9** – seams missing in cobblestone path in a couple of locations where caulking appears to have been used before. None of the seams where caulking is missing are deep enough to penetrate the cap.

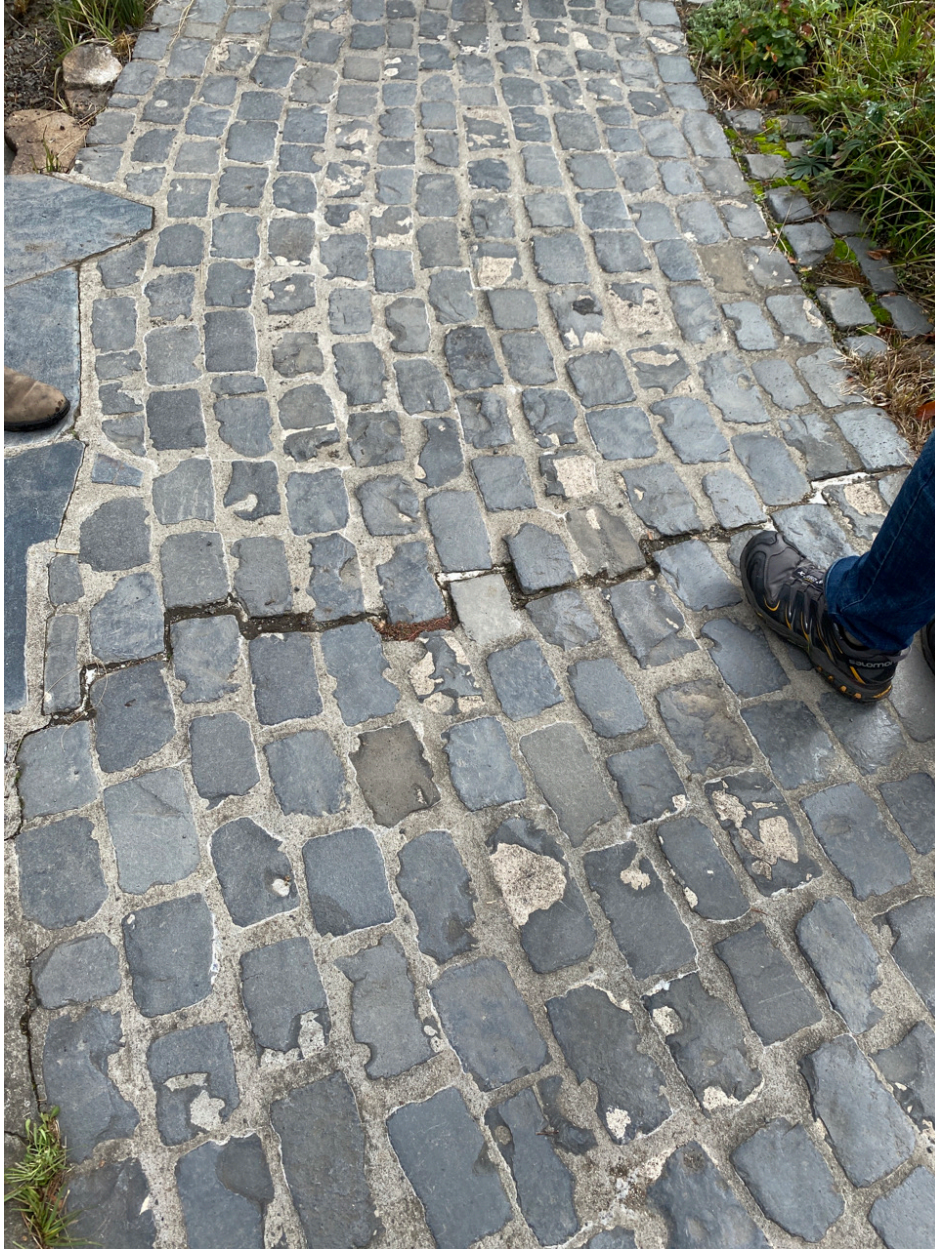
**Photo Point 10** – caulking seam missing, worn, or overgrown with moss. Seam does not penetrate the cap.

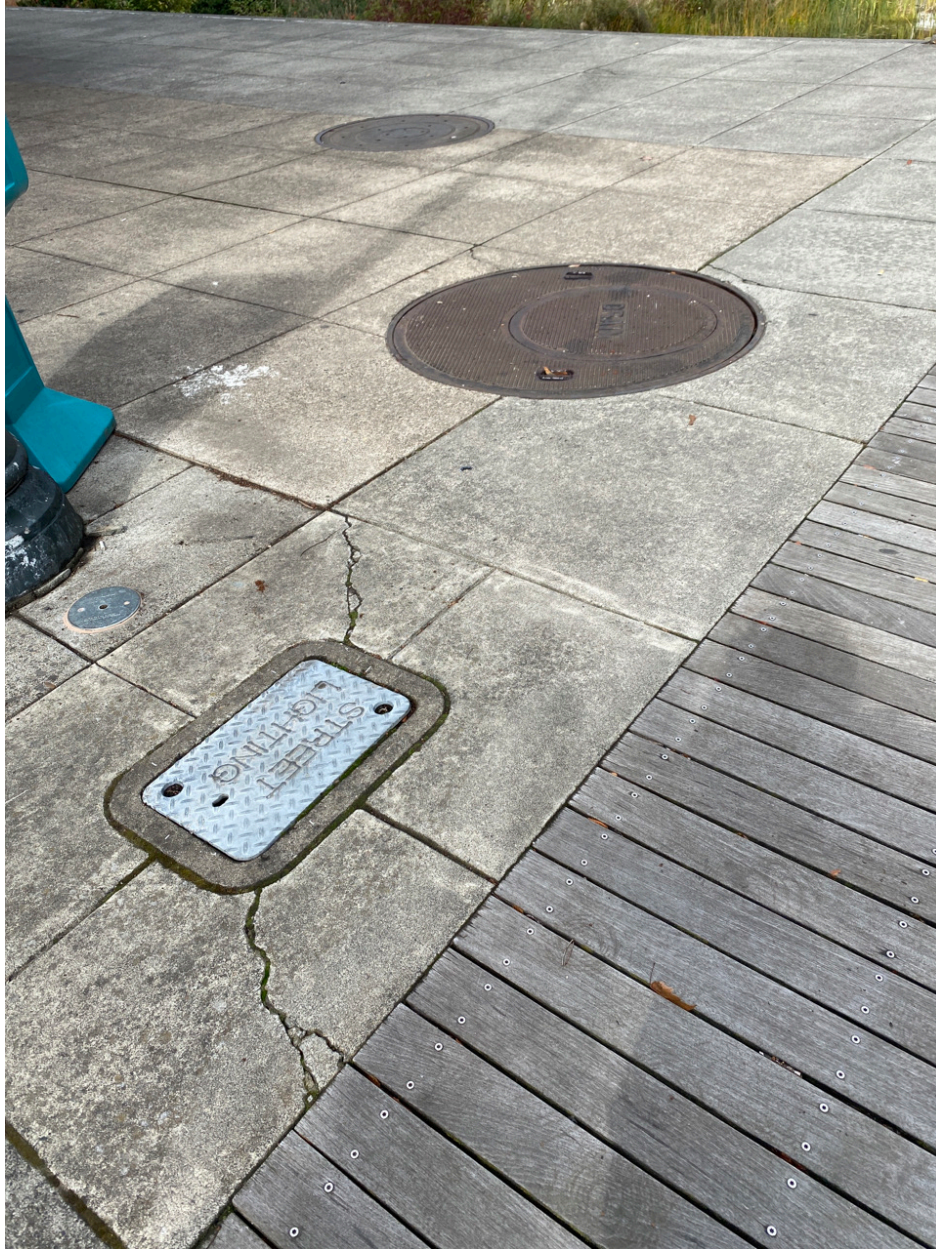
**Photo Point 11** – cracks around street lighting vault have not changed since last year.

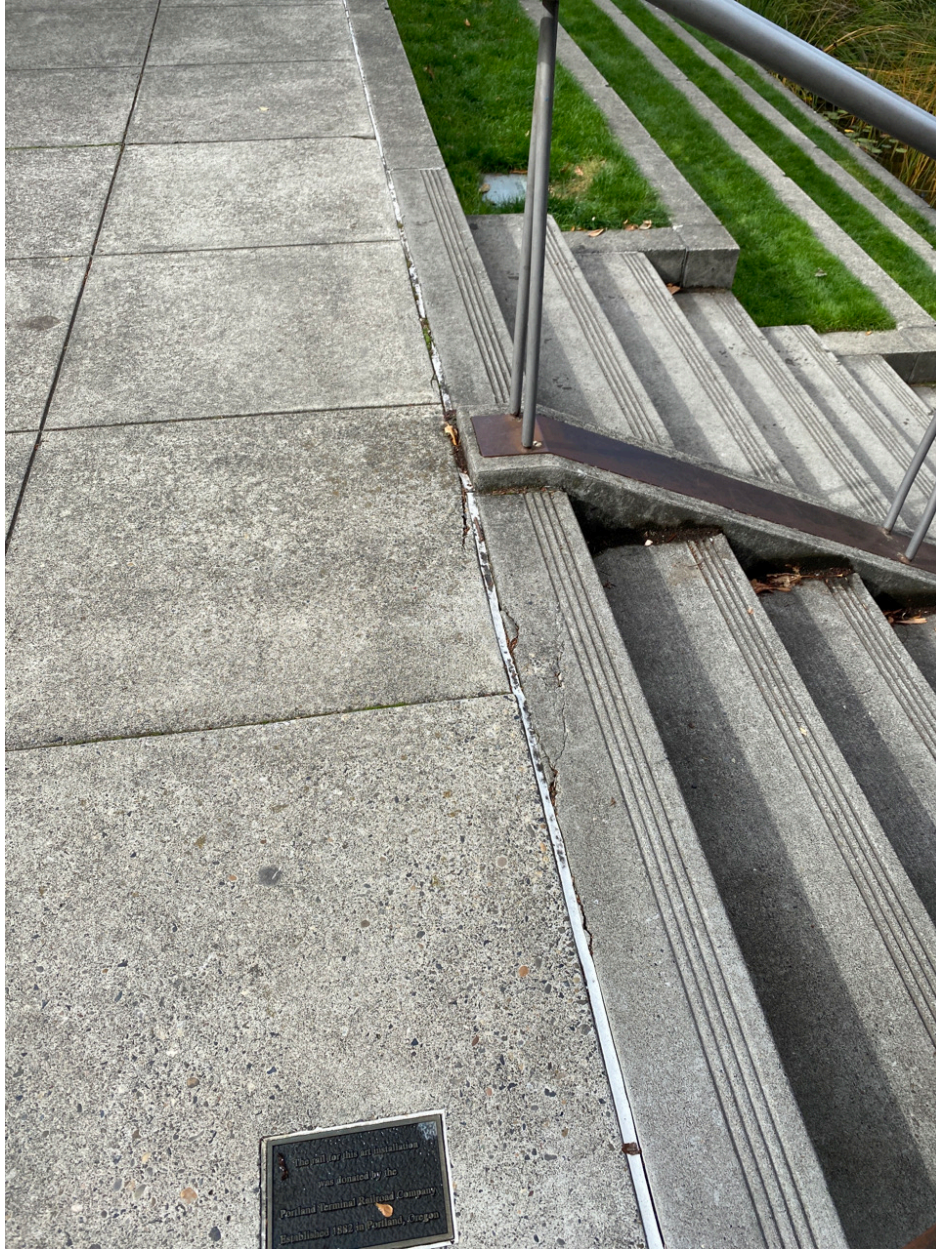
**Photo Point 12** – Concrete and caulking at top of staircase at SEC of the park are in good to fair condition, appear similar in last year inspection report.
