Site: Tanner Springs Park

Inspection Date: 10/07/2021

**Background:** Tanner Springs Park is a municipal park located in NW Portland. Area soils beneath the cap may contain elevated concentrations of petroleum hydrocarbons, lead, and/or polynuclear aromatic hydrocarbons. For Tanner Springs Park, the cap consists of landscaped soil, concrete sidewalks, wood walkways, water features, and other hardscaping. This inspection report was completed to assess the condition of the capped area which includes the entire park.

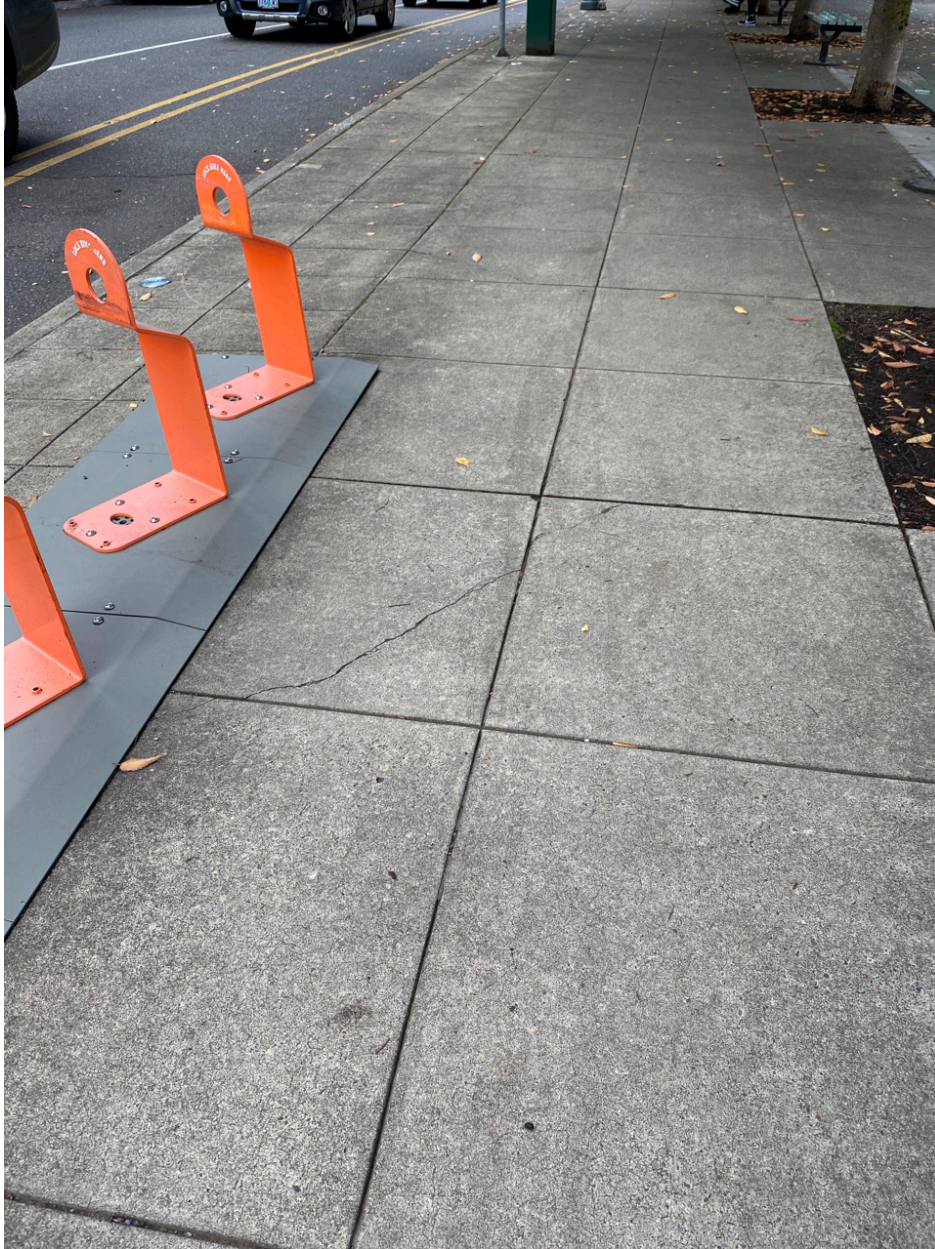
**Photo Point 13** – cracks in concrete near Biketown station looks like last year’s inspection photo.
