Site: Tanner Springs ParkInspection Date: 12/7/2022

**Tanner Springs Park
Annual Cap Inspection
Photo Locations Map**

Attachment 1

Photo Log

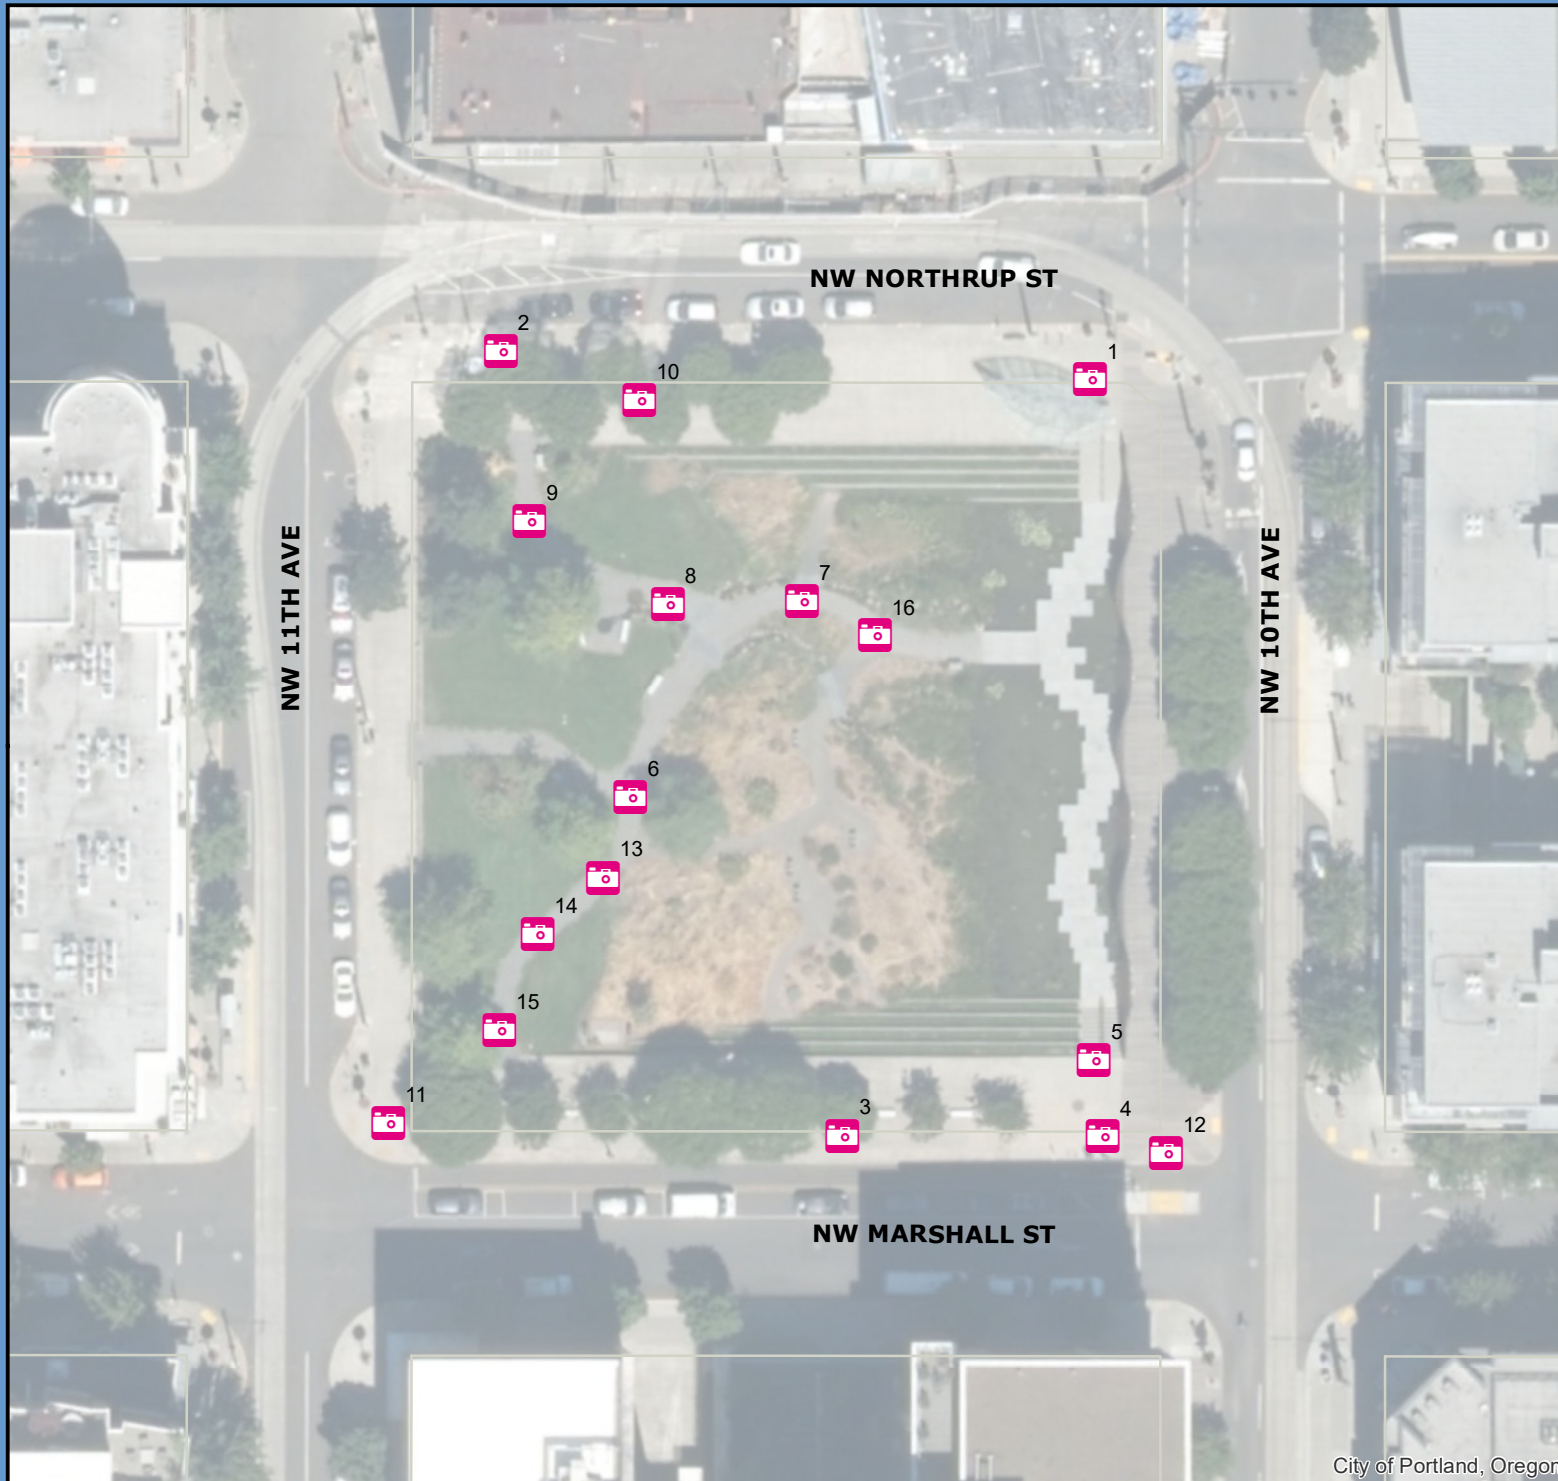
Figure 1

Several minor cracks in concrete were documented in the attached photo log and accompanying map. Many of those cracks were documented in last year's inspection report and have not changed in appearance since last year (photo points 1-4 and 10-12). Several areas of minor separation (0.5 to 1.5 inches) were noted within the cobblestone path (photo points 6-9 13-16). Weathering is likely to have impacted seams in the cobblestone paths that appeared mostly in fair condition, but caulking was missing in a few places. None of these observations appear to have compromised the cap or have allowed subsurface soil to be exposed and no patching is recommended.
