Site: Tanner Springs Park

Inspection Date: 10/3/2023

**Tanner Springs Park  
Annual Cap Inspection  
Photo Locations Map**

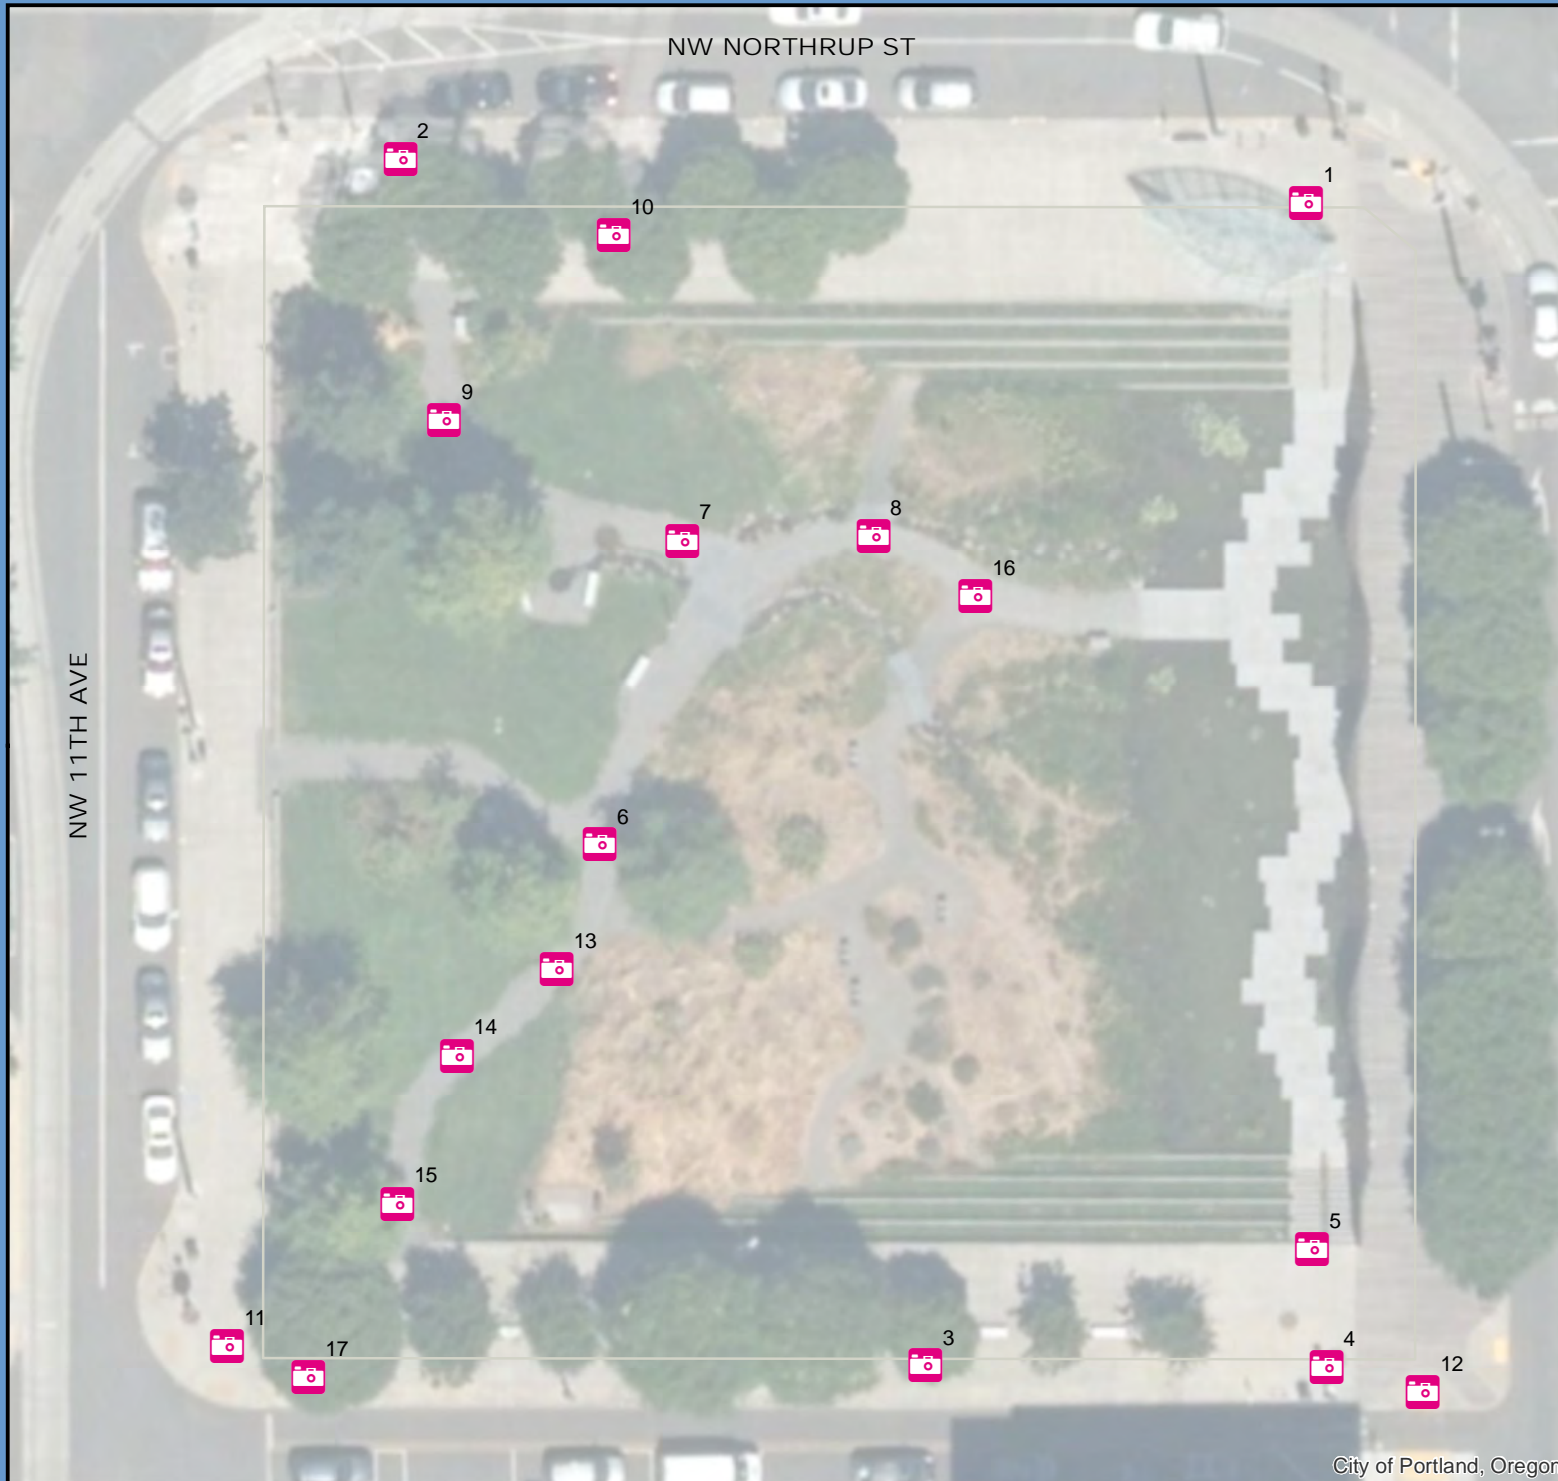
**Figure 1**

Several minor cracks in concrete were documented in the attached photo log and accompanying map. Many of those cracks were documented in previous years inspection reports and have not changed in appearance (photo points 1-4 and 10-12). Several areas of minor separation (0.5 to 1.5 inches) were noted within the cobblestone path (photo points 6-9 13-16). Weathering is likely to have impacted seams in the cobblestone paths that appeared mostly in fair condition, but caulking was missing in a few places. None of these observations appear to have compromised the cap or have allowed subsurface soil to be exposed and no patching is recommended. There is a new photo point (17) that was added this year where sidewalk panels are being lifted near a street tree, likely by roots. This location will be monitored for changes during future inspections.
