Michael T. O'Connor, R.G.
Environmental Consultant
3123 SE 9th Avenue, Portland, Oregon 97202
Phone 971.344.5953 mtopdx@gmail.com

March 27, 2023

**SUBJECT: 2023 Environmental Cap Inspection at Lexis Condominiums,
1125 NW 9th Avenue, Portland, Oregon 97209**

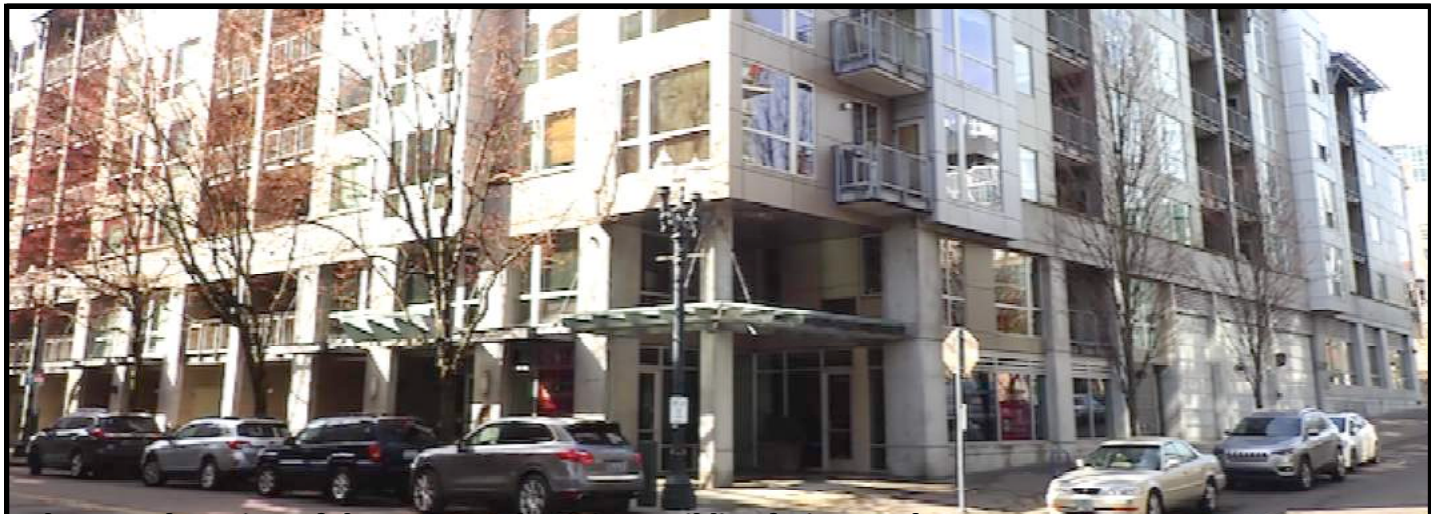
Photograph 1: View of the Lexis Condominium Building facing southwest.

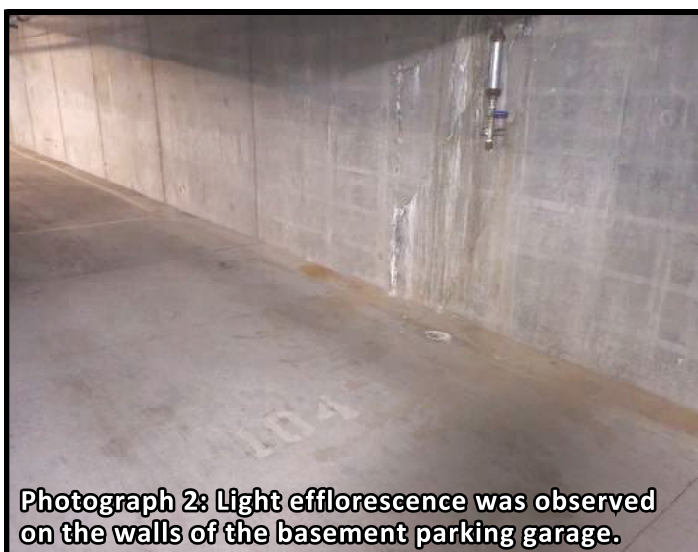
Cracks and/or Settlement in vertical cement or flatwork? Y/N	Exposure Hazard? Y/N	Repair Required? Y/N
No settlement was observed in any of the concrete walls or floors. Cracks were noted on walls and on the undersides of tree planter boxes in the basement parking garage.	Although the fine cracks showed signs of efflorescence, they did not appear to be hazardous.	No
Holes or Penetrations? Y/N	Exposure Hazard? Y/N	Repair Required? Y/N
No holes or penetrations were observed.	No	No
Exposed Soil or Fabric Y/N?	Exposure Hazard? Y/N	Repair Required? Y/N
Soil was visible in planters, but no geotextile barrier was observed.	No	No
Problematic Surface Water Drainage Features?	Exposure Hazard? Y/N	Repair Required? Y/N
Problematic surface water drainage features were not observed.	No	No
Cracked or Missing Caulking?	Exposure Hazard? Y/N	Repair Required? Y/N
No	No	No.
Groundwater Seepage Areas?	Exposure Hazard? Y/N	Repair Required? Y/N

It is our professional opinion that there were no areas where the soil cap or the geotextile membrane used to delineate the top of the cap were visible at any of the inspection points, and, although some fine cracks were observed in the vertical walls of the basement parking area, they did not appear to constitute an exposure hazard. In addition, no areas of groundwater seepage were noted in the walls or floors of the basement parking garage.

Photograph 2: Light efflorescence was observed on the walls of the basement parking garage.

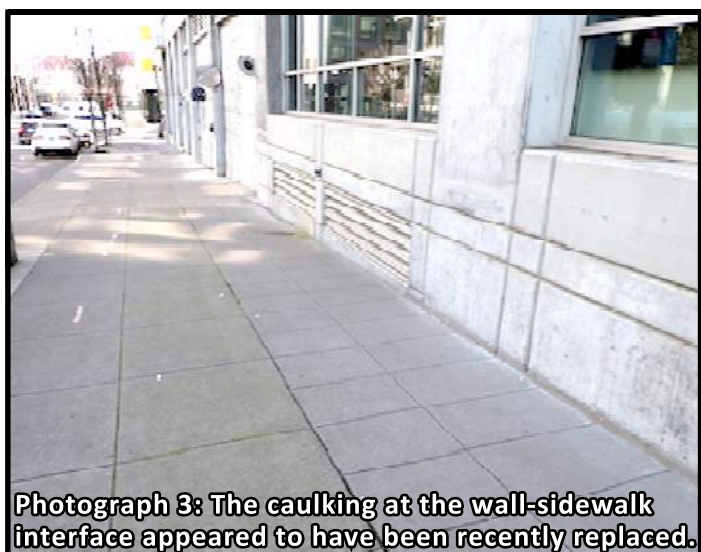
Photograph 3: The caulking at the wall-sidewalk interface appeared to have been recently replaced.

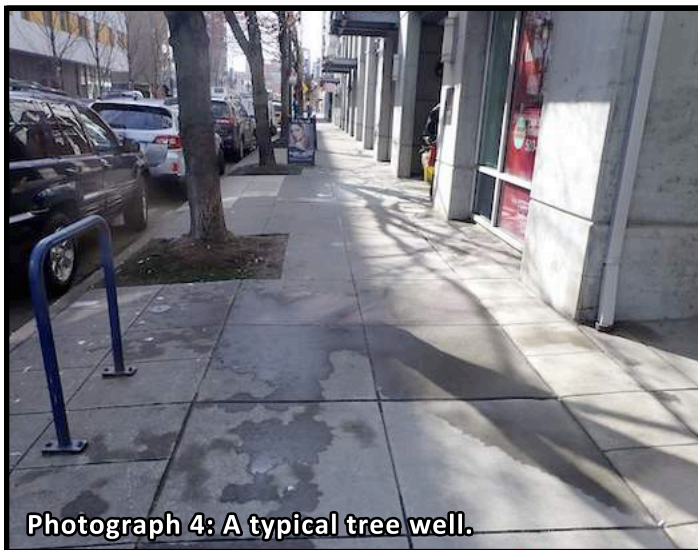
Photograph 4: A typical tree well.

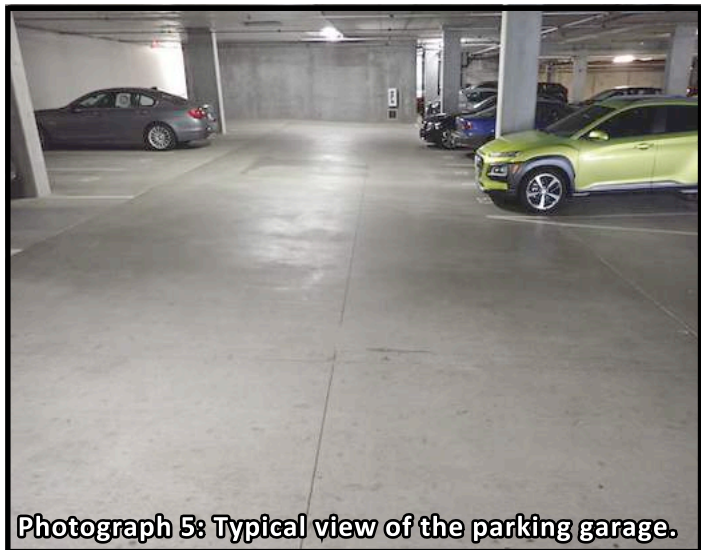
Photograph 5: Typical view of the parking garage.
