**SUBJECT: 2024 Environmental Cap Inspection at Lexis Condominiums,
1125 NW 9th Avenue, Portland, Oregon 97209**

Annual Cap Inspection
Lexis Condominiums
1125 NW 9th Avenue, Portland, Oregon

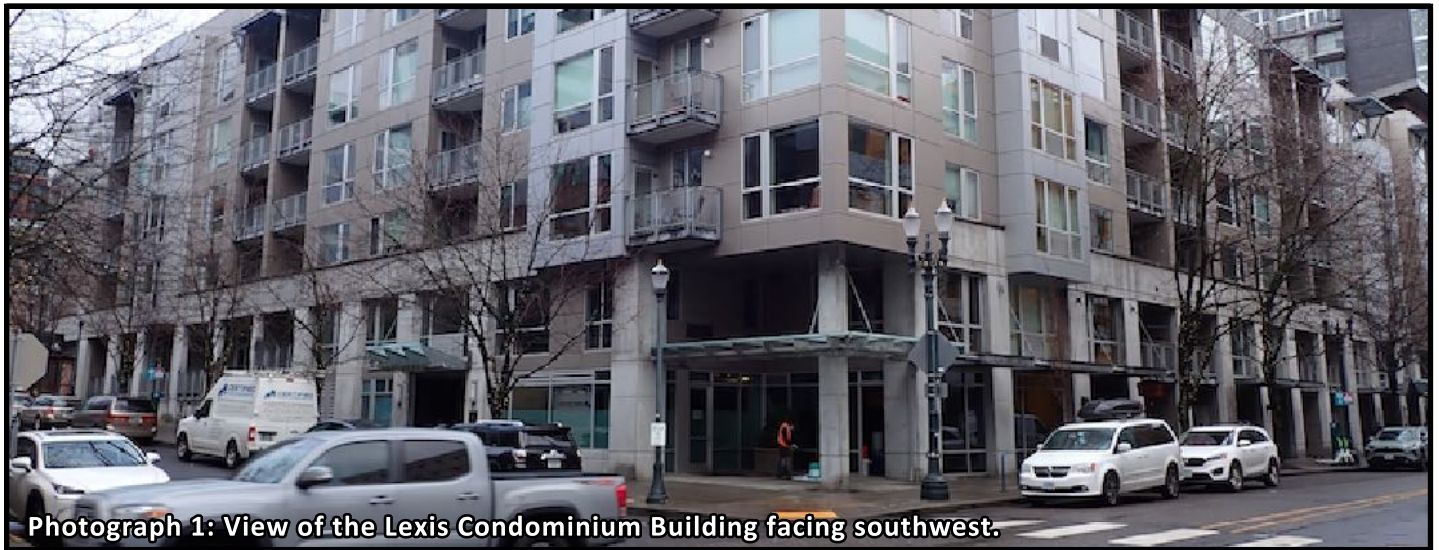
Photograph 1: View of the Lexis Condominium Building facing southwest.

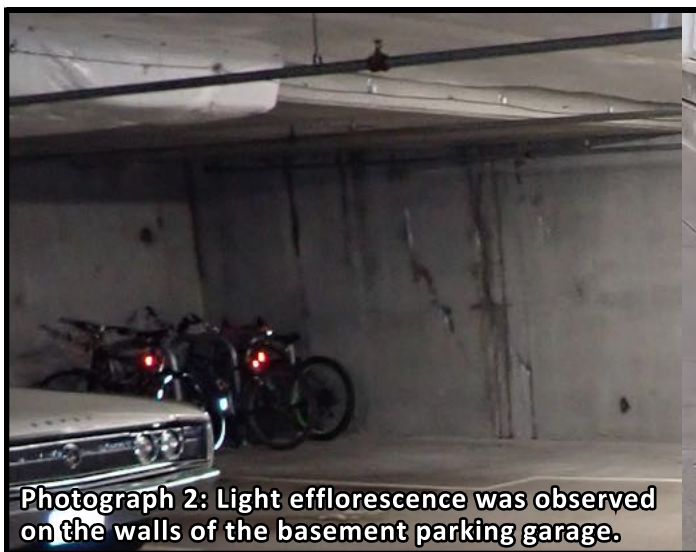
Cracks and/or Settlement in vertical cement or flatwork? Y/N	Exposure Hazard? Y/N	Repair Required? Y/N
No settlement was observed in any of the concrete walls or floors. Cracks were noted on walls and on the undersides of tree planter boxes in the basement parking garage.	Although the fine cracks showed signs of efflorescence, they did not appear to be hazardous.	No
Holes or Penetrations? Y/N	Exposure Hazard? Y/N	Repair Required? Y/N
No holes or penetrations were observed.	No	No
Exposed Soil or Fabric Y/N?	Exposure Hazard? Y/N	Repair Required? Y/N
Soil was visible in planters, but no geotextile barrier was observed.	No	No
Problematic Surface Water Drainage Features?	Exposure Hazard? Y/N	Repair Required? Y/N
Problematic surface water drainage features were not observed.	No	No
Cracked or Missing Caulking?	Exposure Hazard? Y/N	Repair Required? Y/N
No	No	No.
Groundwater Seepage Areas?	Exposure Hazard? Y/N	Repair Required? Y/N

It is our professional opinion that there were no areas where the soil cap or the geotextile membrane used to delineate the top of the cap were visible at any of the inspection points, and, although some fine cracks were observed in the vertical walls of the basement parking area, they did not appear to constitute an exposure hazard. In addition, no areas of groundwater seepage were noted in the walls or floors of the basement parking garage.

Photograph 2: Light efflorescence was observed on the walls of the basement parking garage.

We do not recommend additional inspections other than an annual re-inspection in 2025. The soil and concrete cap at the Property are apparently intact and are functioning as intended.

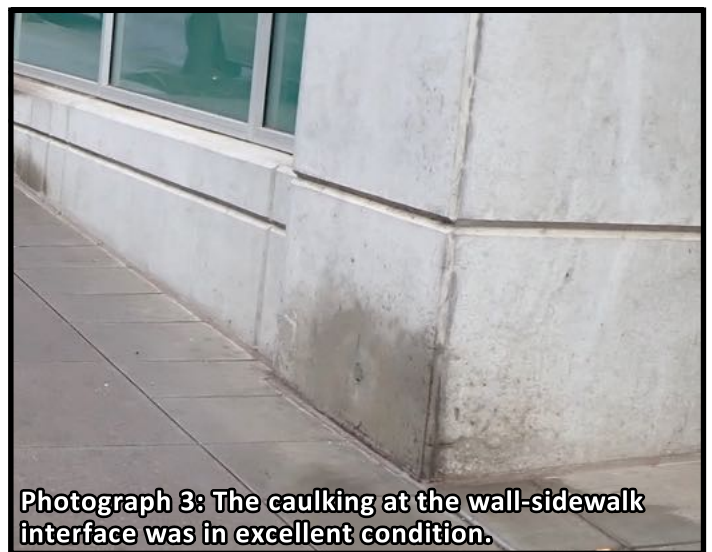
Photograph 3: The caulking at the wall-sidewalk interface was in excellent condition.

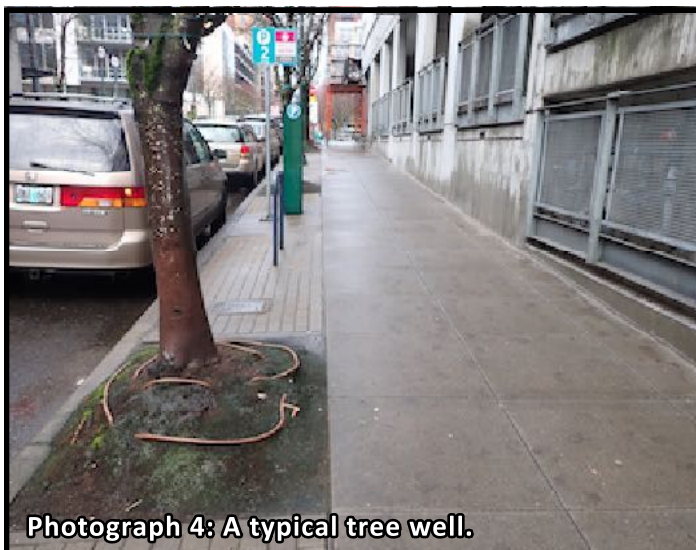
Photograph 4: A typical tree well.

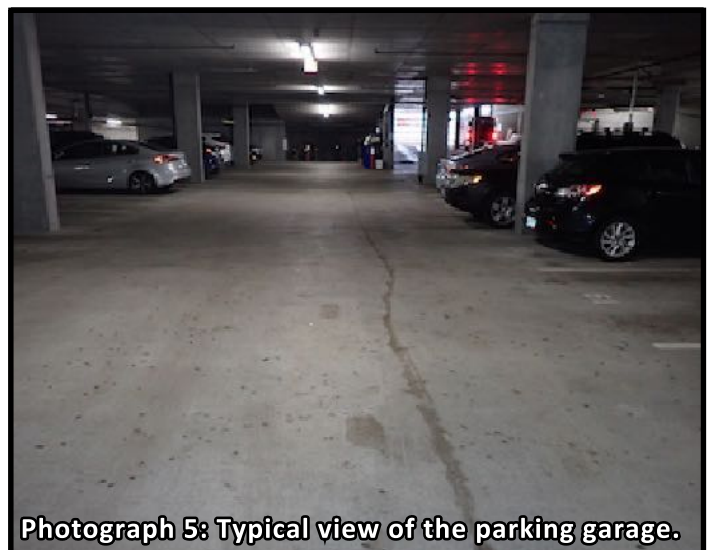
Photograph 5: Typical view of the parking garage.
