**Michael T. O'Connor, R.G.**  
**Environmental Consultant**  
3123 SE 9<sup>th</sup> Avenue, Portland, Oregon 97202  
Phone 971.344.5953 mtopdx@gmail.com

March 27, 2023

**SUBJECT: 2023 Environmental Cap Inspection at Pinnacle Condominiums,  
1255 NW 9th Avenue, Portland, Oregon 97209**

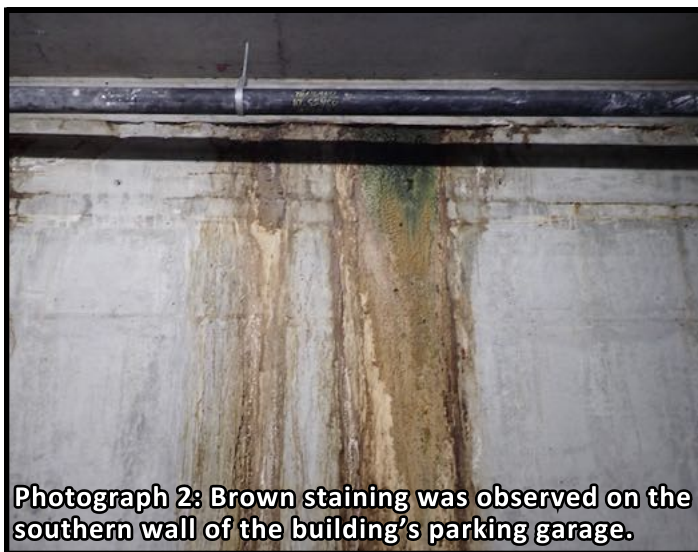
Problematic surface water drainage features were not observed.	No	No
<b>Cracked or Missing Caulking?</b>	<b>Exposure Hazard? Y/N</b>	<b>Repair Required? Y/N</b>
Cracked or missing caulking was not observed.	No	No
<b>Groundwater Seepage Areas?</b>	<b>Exposure Hazard? Y/N</b>	<b>Repair Required? Y/N</b>
Brown staining was observed on the southern wall of the basement parking garage. Ms. Jessyca Porter, Maintenance Supervisor, previously indicated that the staining was due to a since-repaired leak in a planter in the courtyard.	The courtyard planter is located above the environmental cap and is filled with imported soil. It does not constitute an exposure hazard. The leak has been repaired.	No

**Photograph 2: Brown staining was observed on the southern wall of the building's parking garage.**

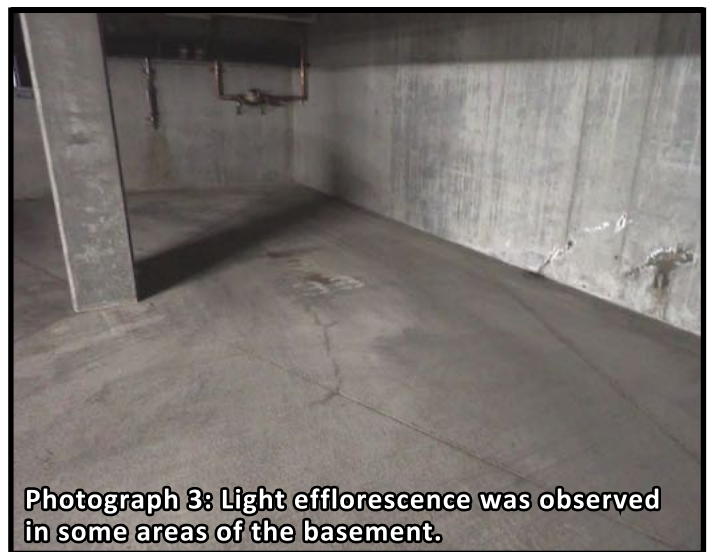
**Photograph 3: Light efflorescence was observed in some areas of the basement.**

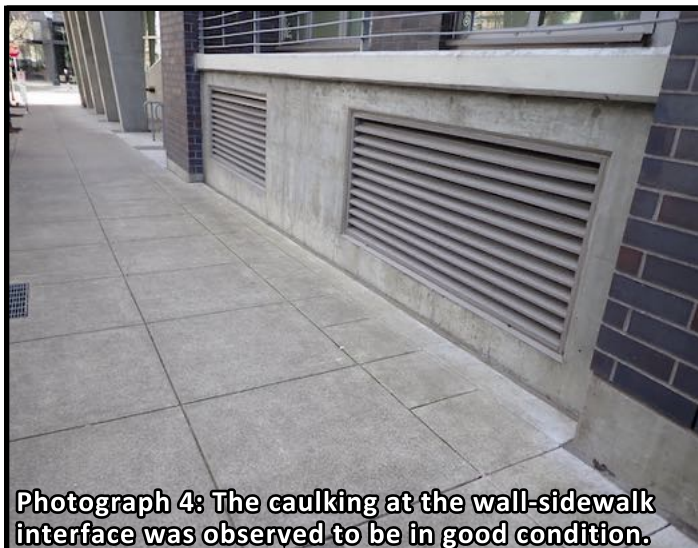
**Photograph 4: The caulking at the wall-sidewalk interface was observed to be in good condition.**

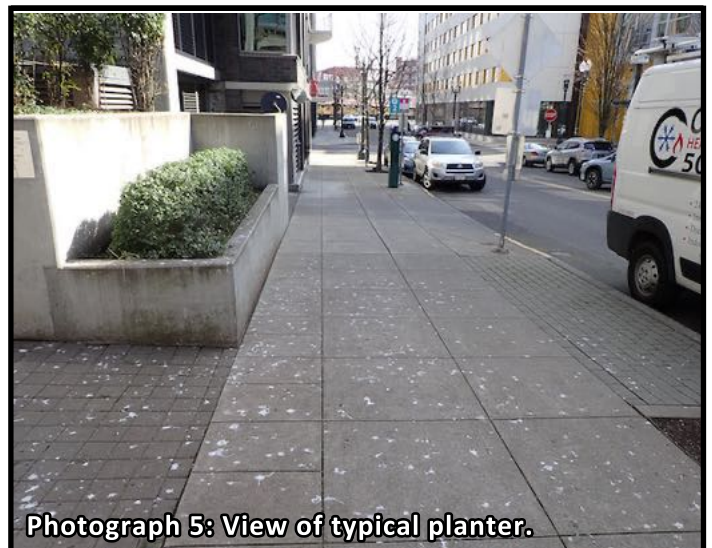
**Photograph 5: View of typical planter.**
