**SUBJECT: 2024 Environmental Cap Inspection at Pinnacle Condominiums,
1255 NW 9th Avenue, Portland, Oregon 97209**

Annual Cap Inspection
Pinnacle Condominiums
1255 NW 9th Avenue, Portland, Oregon

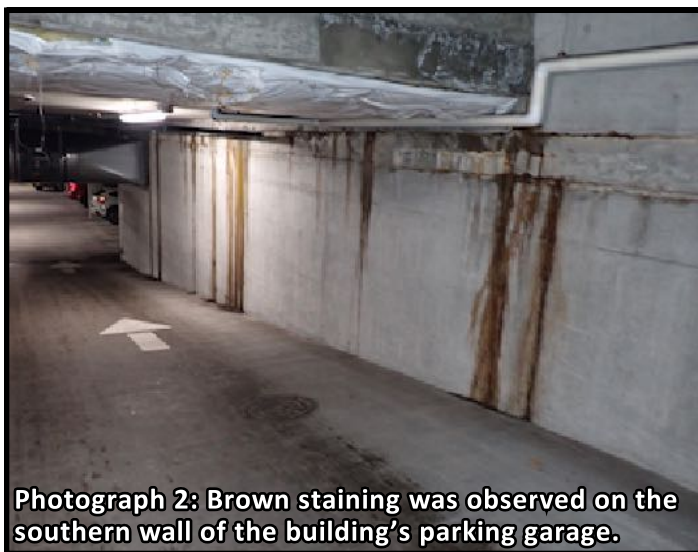
Problematic surface water drainage features were not observed.	No	No
Cracked or Missing Caulking?	Exposure Hazard? Y/N	Repair Required? Y/N
Cracked or missing caulking was not observed.	No	No
Groundwater Seepage Areas?	Exposure Hazard? Y/N	Repair Required? Y/N
Brown staining was observed on the southern wall of the basement parking garage. Ms. Jessyca Porter, Maintenance Supervisor, previously indicated that the staining was due to a since-repaired leak in a planter in the courtyard.	The courtyard planter is located above the environmental cap and is filled with imported soil. It does not constitute an exposure hazard. The leak has been repaired.	No

Photograph 2: Brown staining was observed on the southern wall of the building's parking garage.

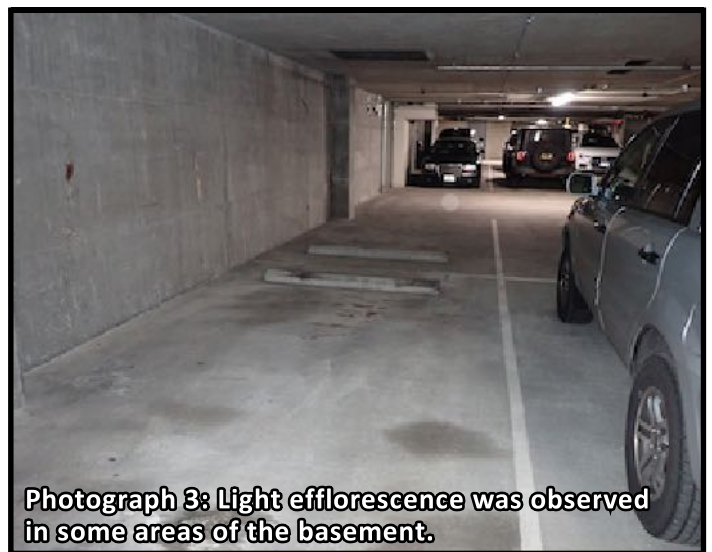
Photograph 3: Light efflorescence was observed in some areas of the basement.

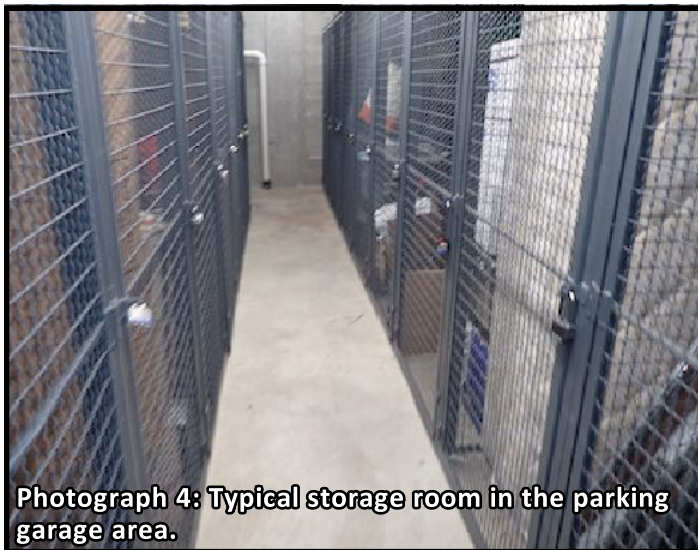
Photograph 4: Typical storage room in the parking garage area.

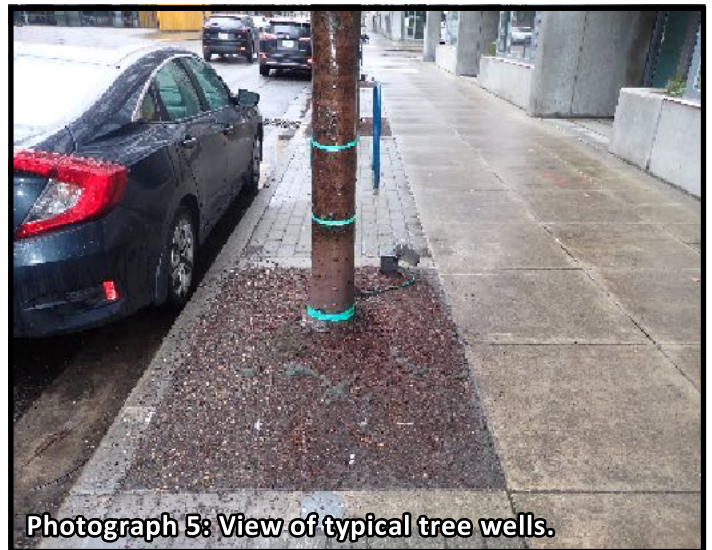
Photograph 5: View of typical tree wells.
