March 27, 2023

**SUBJECT: Environmental Cap Inspection at The Encore Condominiums, 949  
NW Overton Street, Portland, Oregon 97209**

**Inspection Date:** March 23, 2023

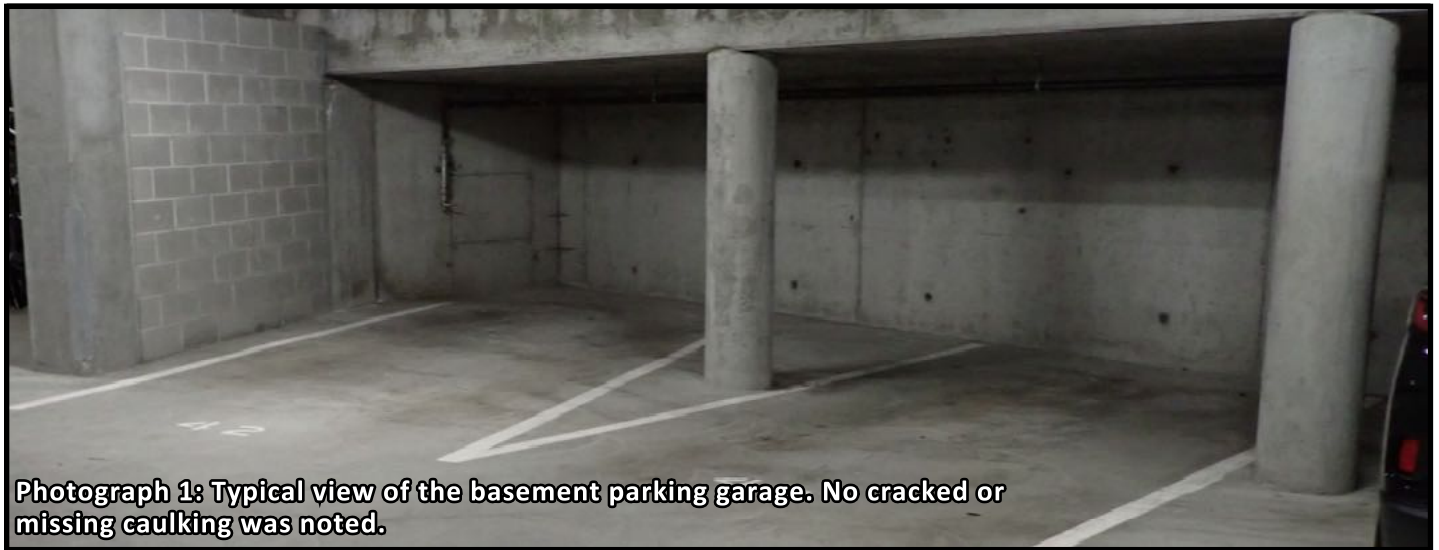
**Photograph 1: Typical view of the basement parking garage. No cracked or missing caulking was noted.**

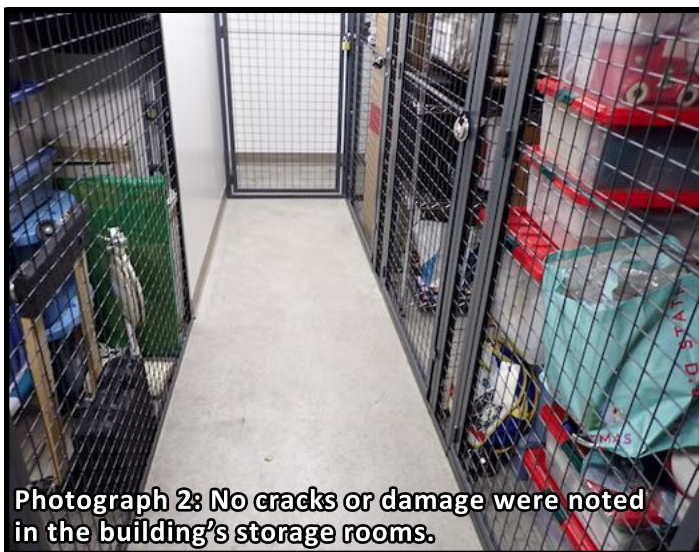
**Photograph 2: No cracks or damage were noted in the building's storage rooms.**

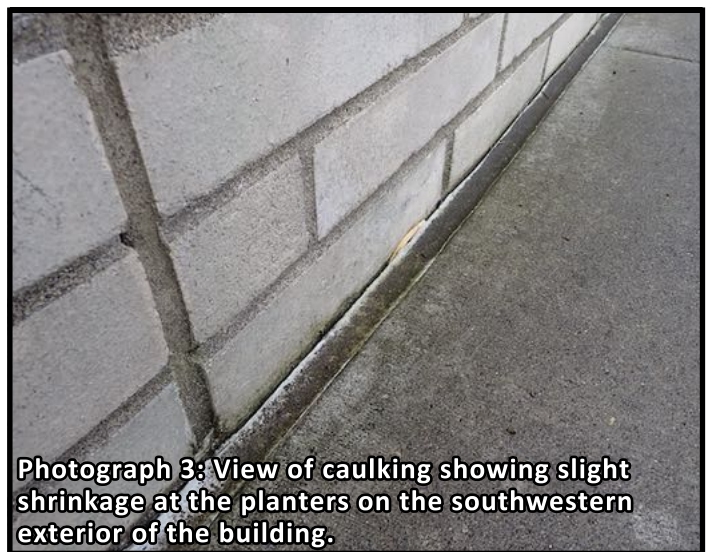
It is our professional opinion that there were no areas where the soil cap or the geotextile membrane used to delineate the top of the cap were visible at any of the inspection points. No visible cracks or settling have occurred with respect to the building and sidewalk, and no areas of groundwater seepage were noted in the walls or floors of the basement parking garage. I did not identify any human or ecological contaminant exposure hazards at the property with regard to the contaminated soil beneath the condominium building. However, a few minor areas of caulking, particularly around the planters on the southwestern exterior of the building, showed signs of shrinkage.

**Photograph 3: View of caulking showing slight shrinkage at the planters on the southwestern exterior of the building.**

**Recommendation:** It may be prudent to conduct a full inspection of the caulking at the interface between the building and sidewalks and planters and sidewalks and replace the caulking in the areas where it has exhibited shrinkage.

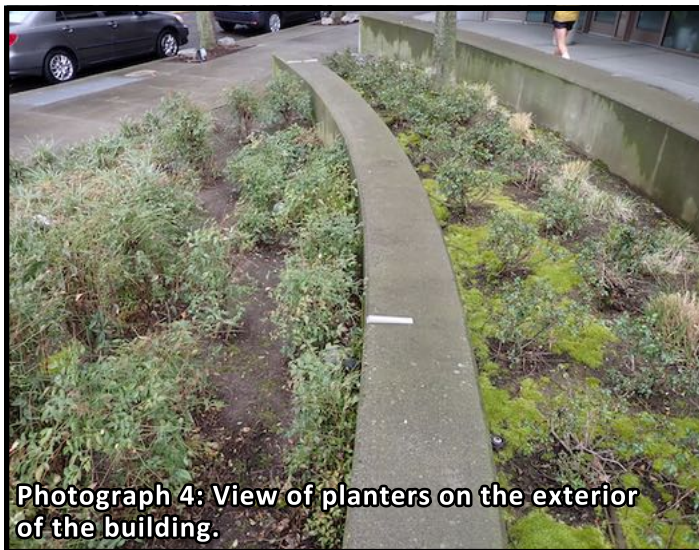
**Photograph 4: View of planters on the exterior of the building.**
