**SUBJECT: 2024 Environmental Cap Inspection at The Encore Condominiums,  
949 NW Overton Street, Portland, Oregon 97209**

**Property Name:** The Encore Condominiums.

**Inspection Date:** February 14, 2024

Annual Cap Inspection  
Encore Condominiums  
949 NW Overton Street, Portland, Oregon

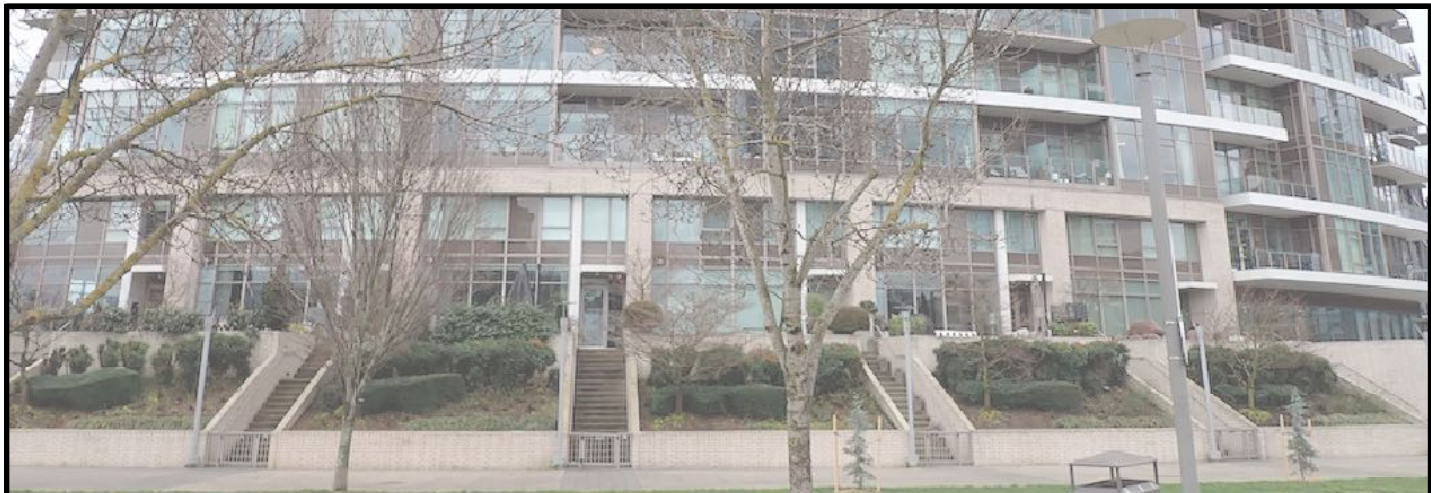
**Photograph 1: Wide-angle view of the western exterior of the Encore Condominiums**

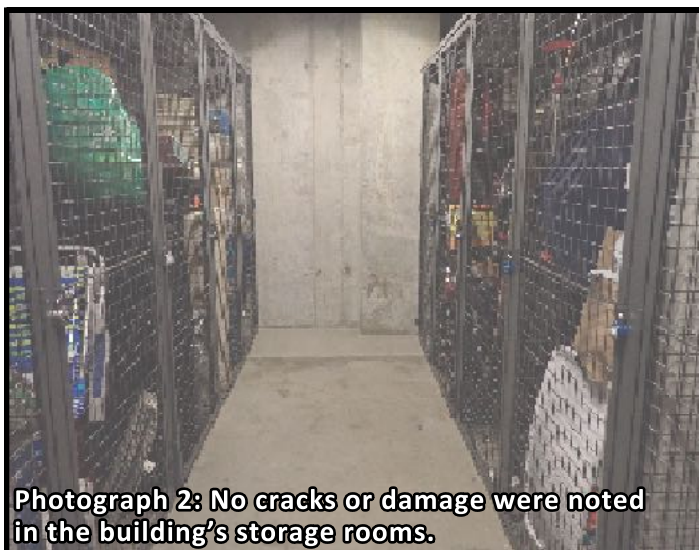
**Photograph 2: No cracks or damage were noted in the building's storage rooms.**

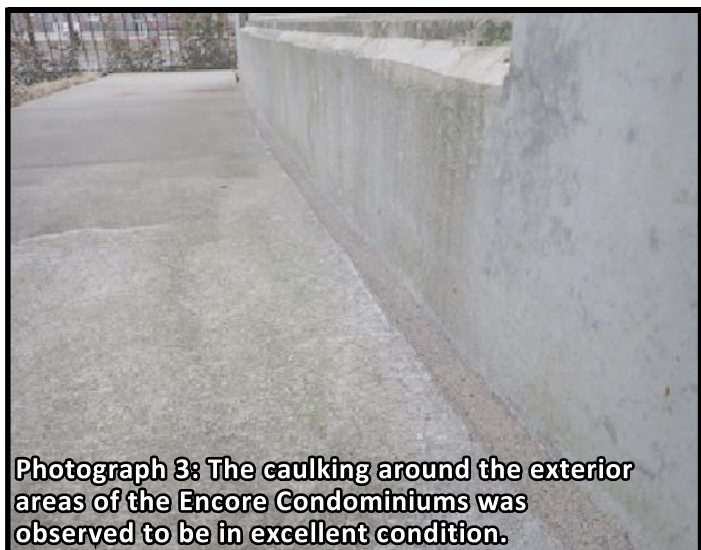
**Photograph 3: The caulking around the exterior areas of the Encore Condominiums was observed to be in excellent condition.**

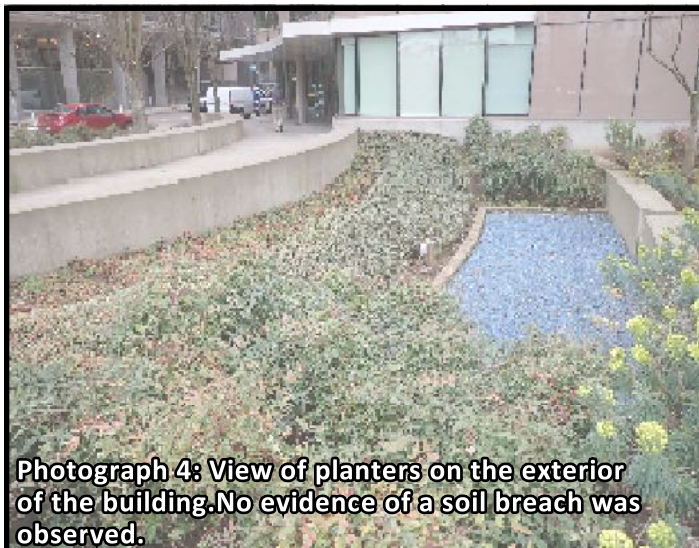
**Photograph 4: View of planters on the exterior of the building. No evidence of a soil breach was observed.**

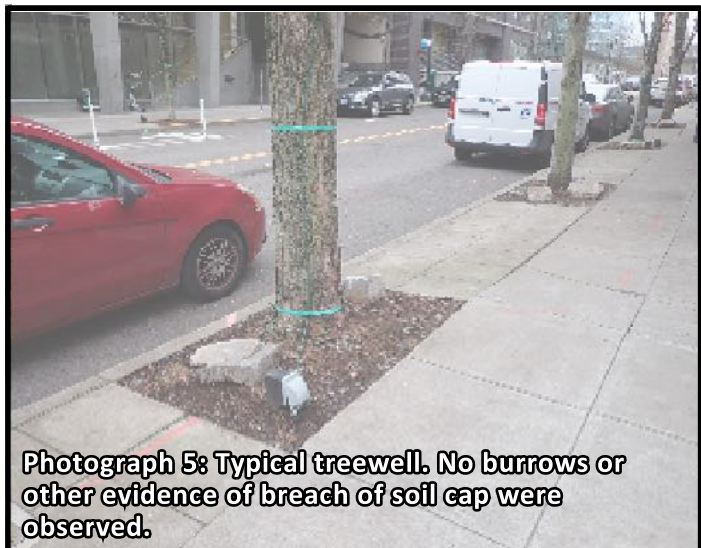
**Photograph 5: Typical treewell. No burrows or other evidence of breach of soil cap were observed.**
