April 3, 2023

**SUBJECT: 2023 Environmental Cap Inspection at Cosmopolitan on the Park
Condominium 1075 NW Northrup Street, Portland, Oregon**

Site Photographs
Annual Cap Inspection
Cosmopolitan on the Park
1075 NW Northrup Street, Portland, Oregon

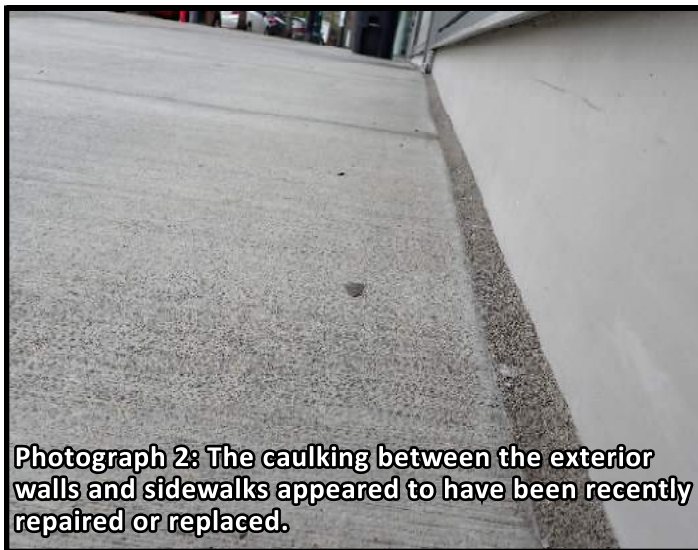
Photograph 2: The caulking between the exterior walls and sidewalks appeared to have been recently repaired or replaced.

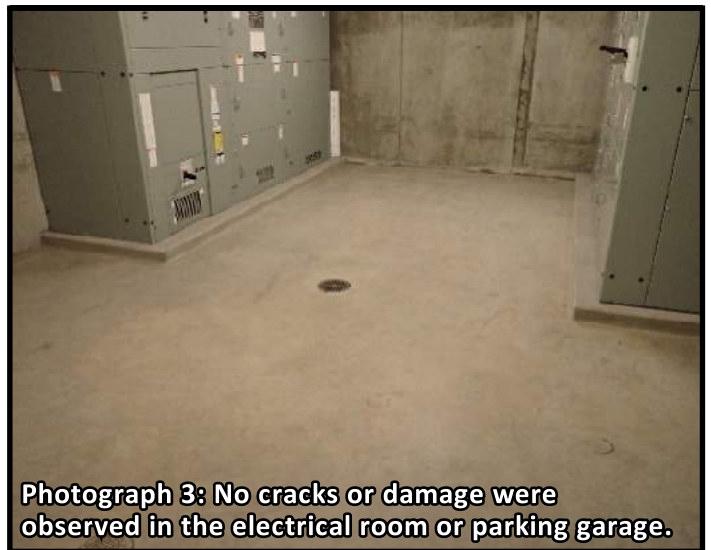
Photograph 3: No cracks or damage were observed in the electrical room or parking garage.

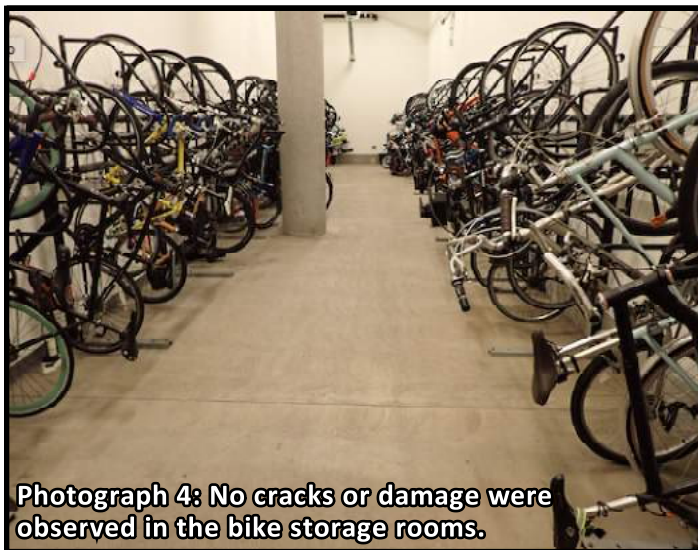
Photograph 4: No cracks or damage were observed in the bike storage rooms.
