February 2, 2024

**SUBJECT: 2024 Environmental Cap Inspection at Cosmopolitan on the Park
Condominium 1075 NW Northrup Street, Portland, Oregon**

Annual Cap Inspection
Cosmopolitan on the Park
1075 NW Northrup Street, Portland, Oregon

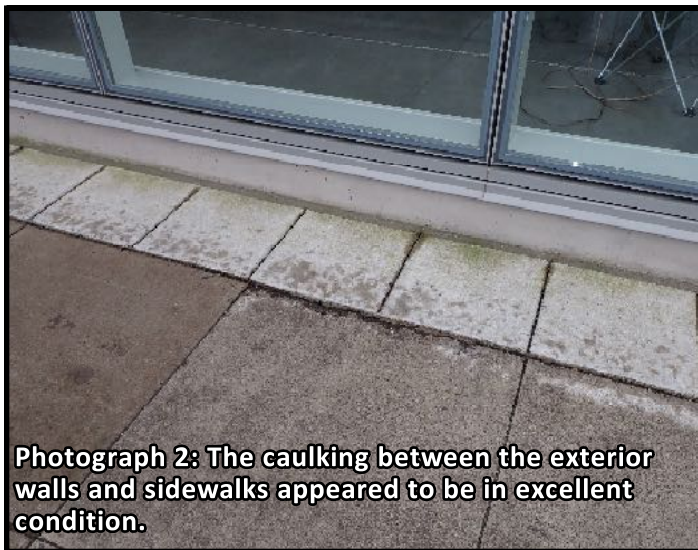
Photograph 2: The caulking between the exterior walls and sidewalks appeared to be in excellent condition.

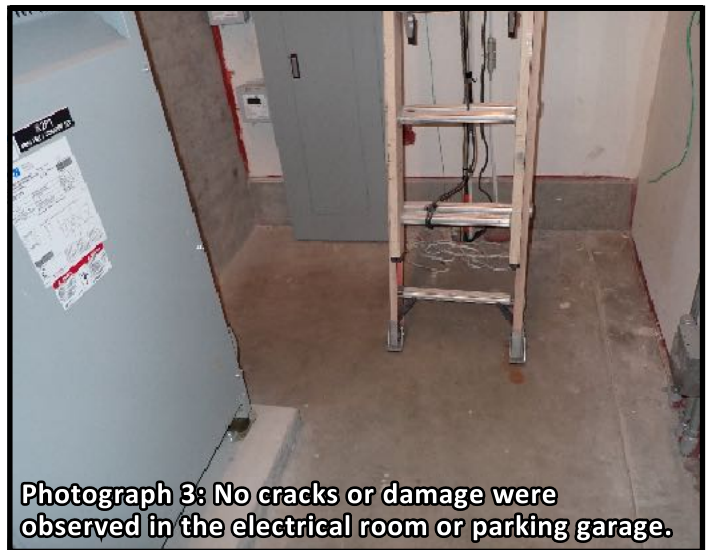
Photograph 3: No cracks or damage were observed in the electrical room or parking garage.

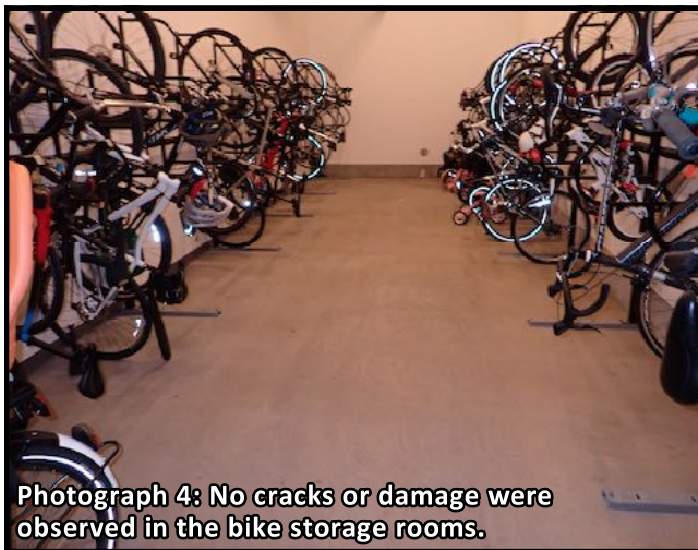
Photograph 4: No cracks or damage were observed in the bike storage rooms.

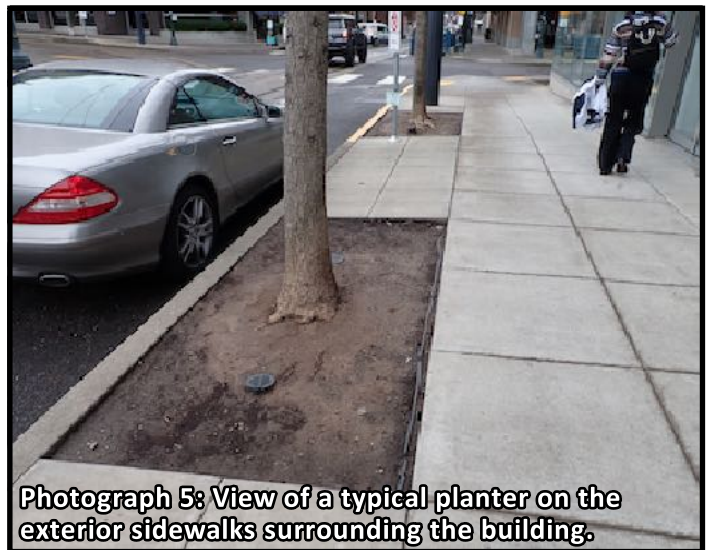
Photograph 5: View of a typical planter on the exterior sidewalks surrounding the building.
