April 10, 2023

**SUBJECT: 2023 Environmental Cap Inspection at Block 17 Apartments,
1315 NW 11th Avenue, Portland, Oregon 97209**

Annual Cap Inspection
Block 17 Apartments
1315 NW 11th Avenue, Portland, Oregon

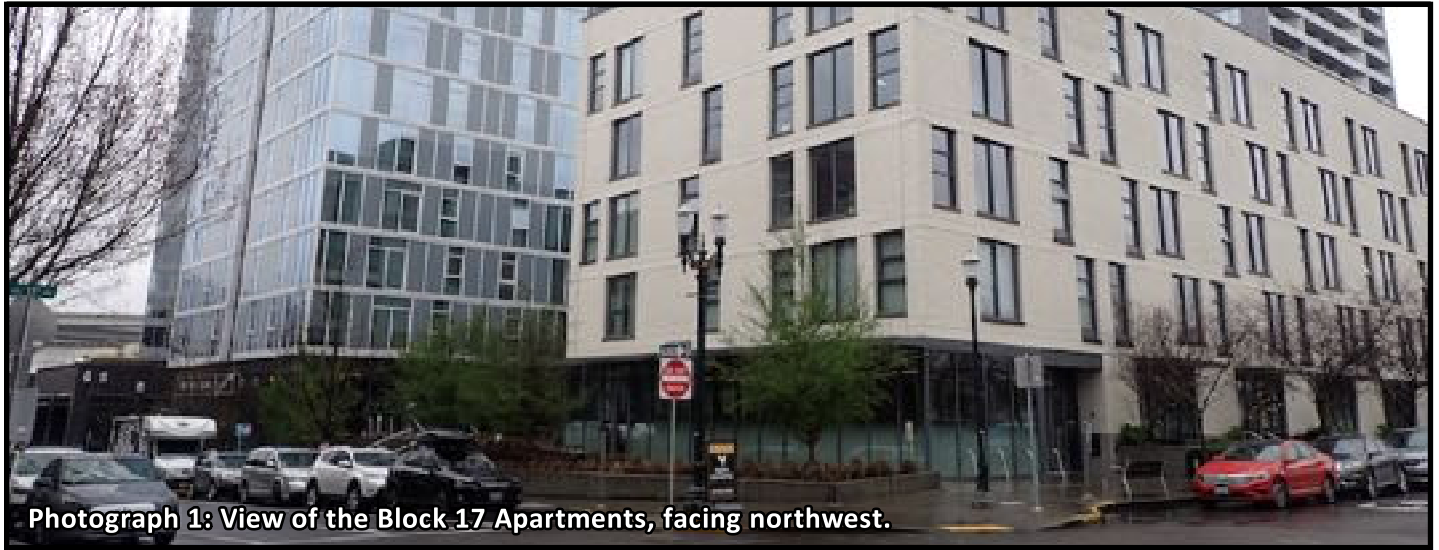
Photograph 1: View of the Block 17 Apartments, facing northwest.

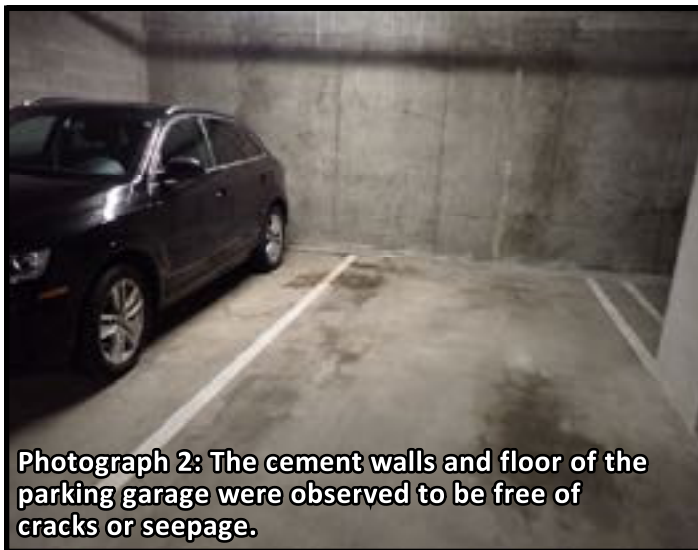
Photograph 2: The cement walls and floor of the parking garage were observed to be free of cracks or seepage.

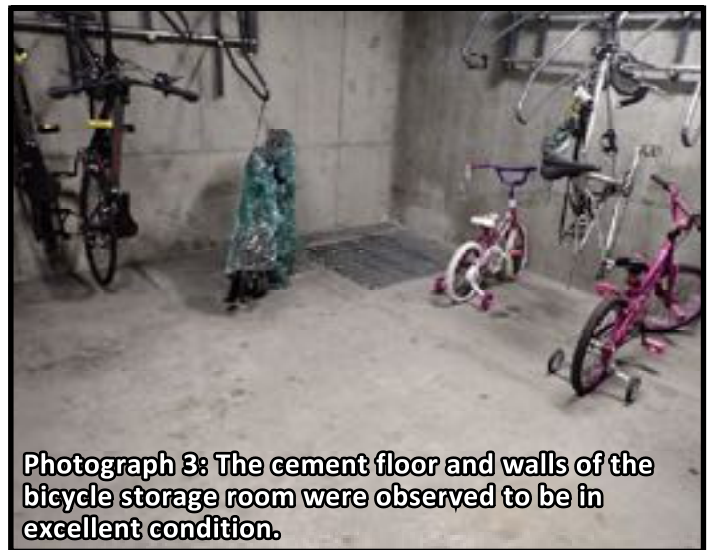
Photograph 3: The cement floor and walls of the bicycle storage room were observed to be in excellent condition.

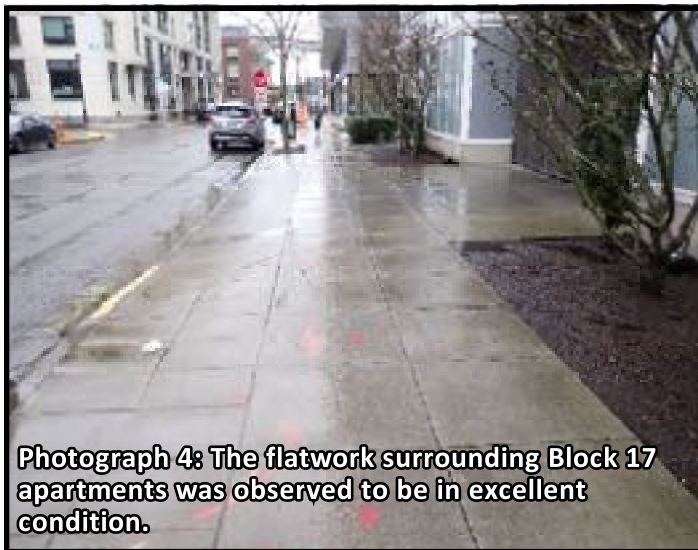
Photograph 4: The flatwork surrounding Block 17 apartments was observed to be in excellent condition.

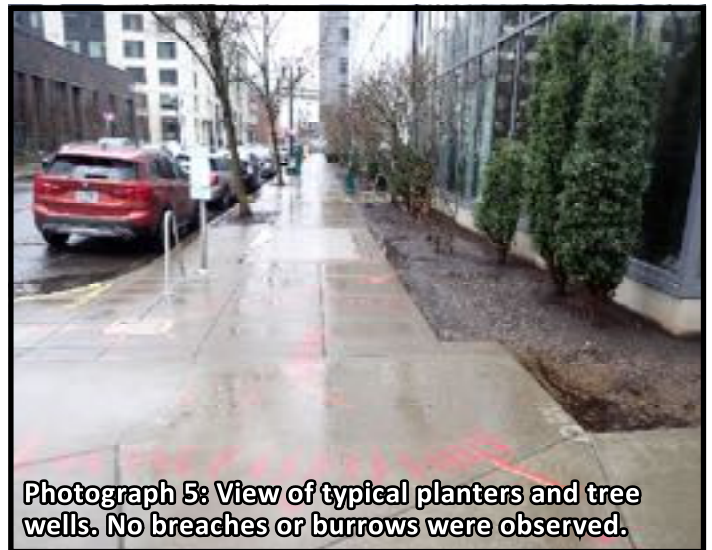
Photograph 5: View of typical planters and tree wells. No breaches or burrows were observed.
