**RE: 2024 ANNUAL POST CONSTRUCTION CAP INSPECTION  
BLOCK 17 URBAN DEVELOPMENT  
1161 NW OVERTON STREET  
PORTLAND, MULTNOMAH COUNTY, OREGON  
ECSI #5867  
NOVA PROJECT NO. V24-0239**

### Cap Inspection Form

| Facility Name | Hoyt Street Railyard – Block 17 |
| Facility Address | 1161 NW Overton Street, Portland, Oregon<br>Multnomah County tax lot 1N1E34BB 2630-2633 |

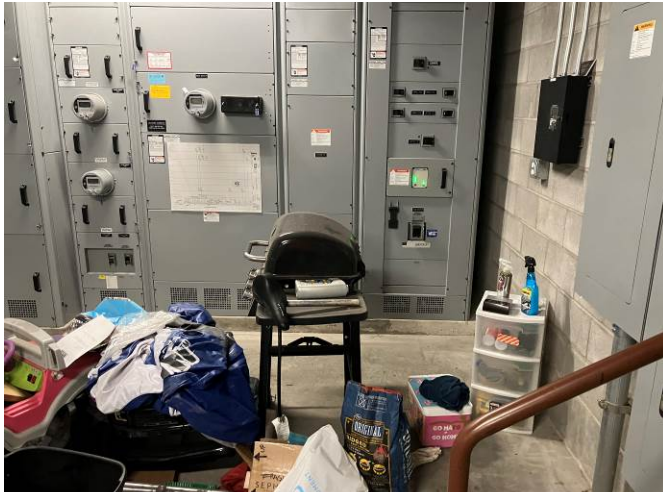
1. Electrical room in subterranean parking garage.

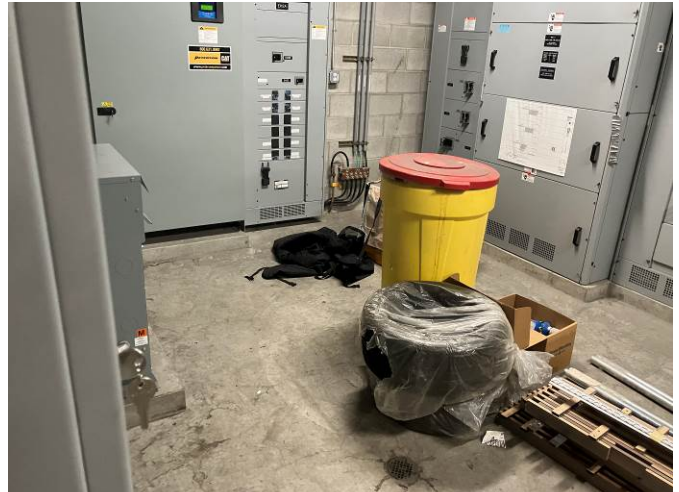
2. Electrical room in subterranean parking garage/building foundation.

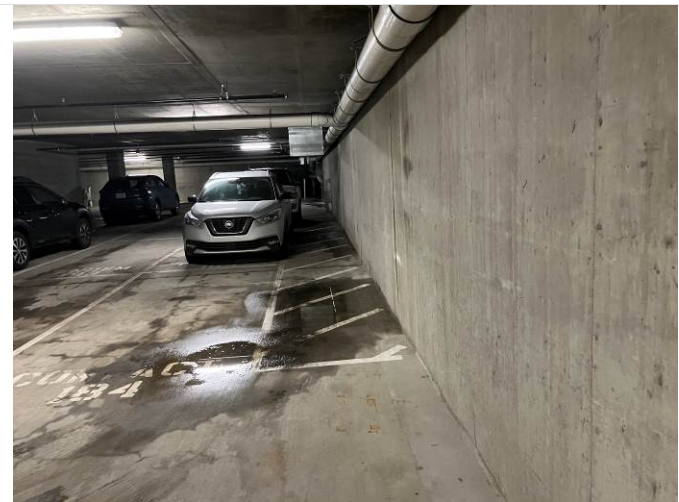
4. Parking garage/building foundation view A.

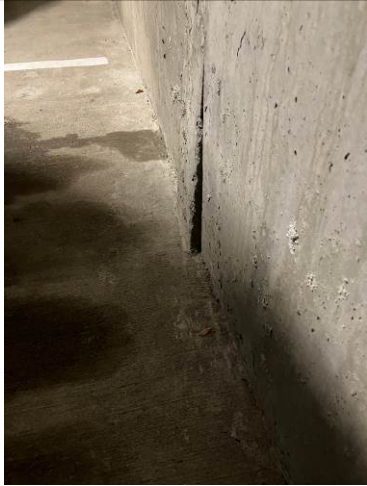
| CAP ELEMENT | INSPECTION OBSERVATIONS | MAINTENANCE REQUIRED? |
|---|---|---|
| <b>Parking Garage Walls</b> | Cracks and/or Settlement <input checked="" type="radio"/> YES <input checked="" type="radio"/> NO<br><i>Parking space 100 &amp; 110</i><br>Holes and/or Penetrations YES <input checked="" type="radio"/> NO | No immediate repairs needed. Check at next inspection |

7. Parking garage wall – parking space 110.

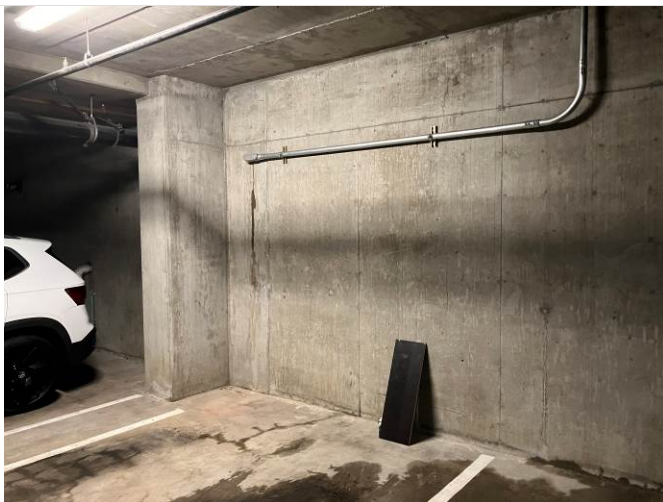
| CAP ELEMENT | INSPECTION OBSERVATIONS | MAINTENANCE REQUIRED? |
|---|---|---|
| <b>Groundwater Seepage Areas</b> | Groundwater Seepage Observed? YES <input checked="" type="radio"/> NO<br><i>Water observed at Ramp to B1 and parking space 100</i> | No immediate repairs needed. Observe ramp during dry weather condition. |

11. Parking garage wall – parking space 100.

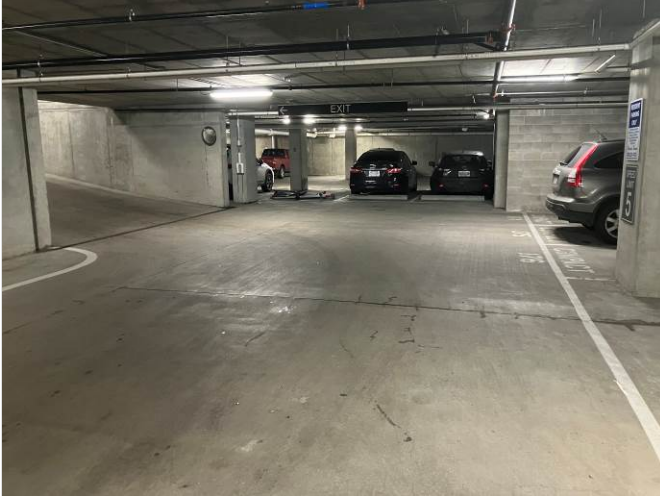
13. Parking garage/foundation view.

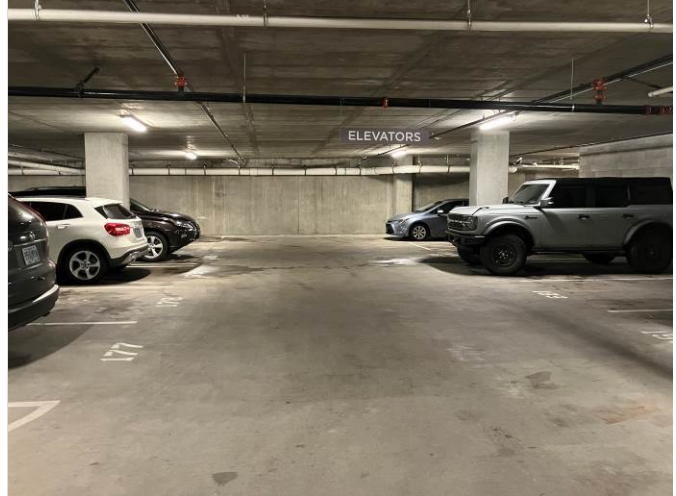
14. Parking garage/foundation view.

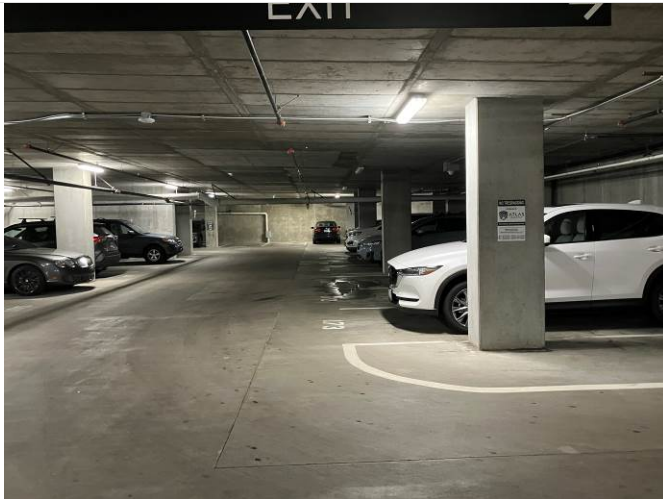
15. Parking garage/foundation view.

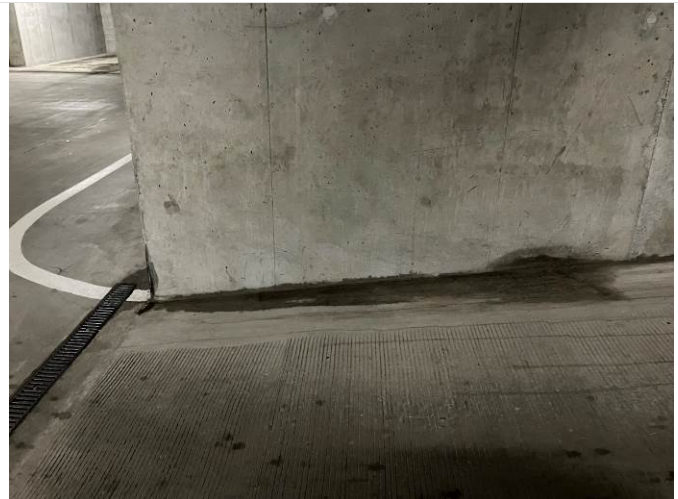
| CAP ELEMENT | INSPECTION OBSERVATIONS | MAINTENANCE REQUIRED? |
|---|---|---|
| <b>Notes:</b> <i>Water pooling observed-likely due to rain at time of inspection. Observe garage ramp during dry weather to see if water pooling persists.</i> | | |

16. Parking garage ramp.

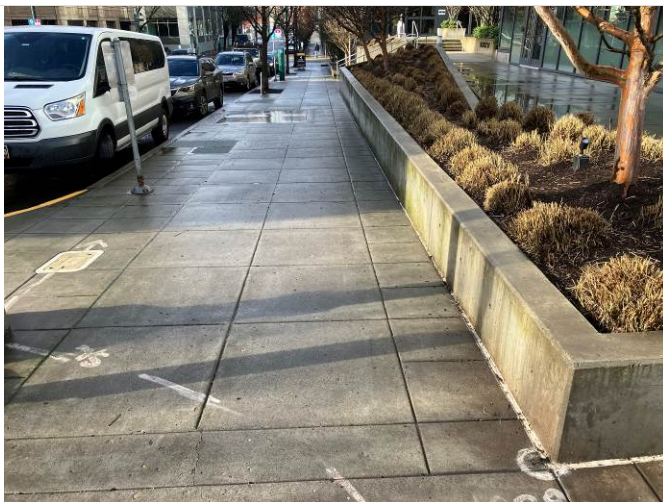
17. Landscape and hardscape along NW Overton Street, facing west.

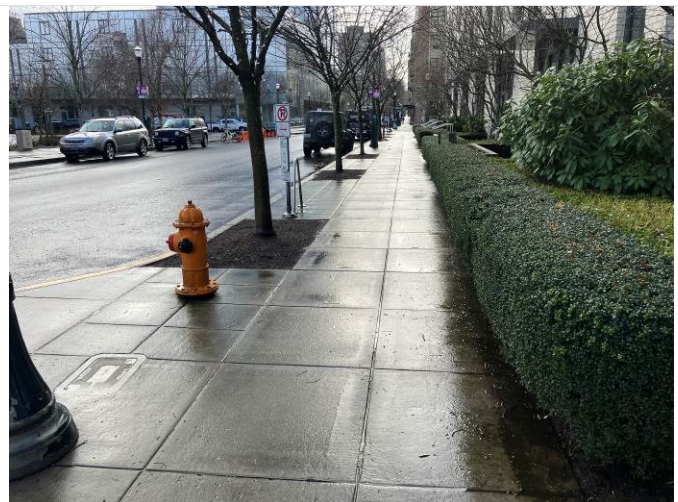
18. Landscape and hardscape along NW 11<sup>th</sup> Avenue, facing south.

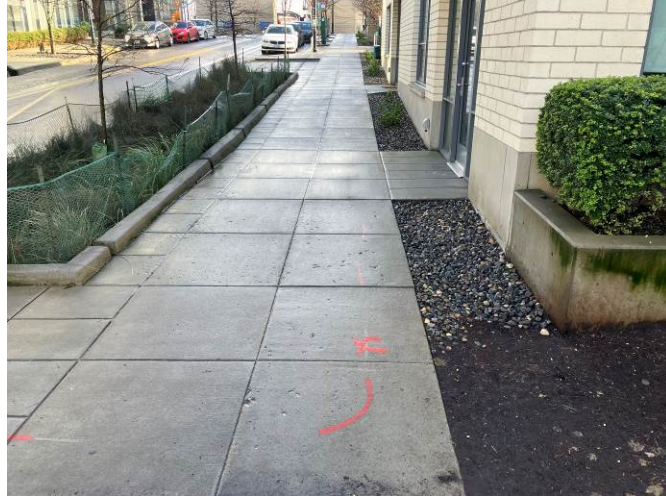
19. Landscape and hardscape along NW Pettygrove Street, facing east.

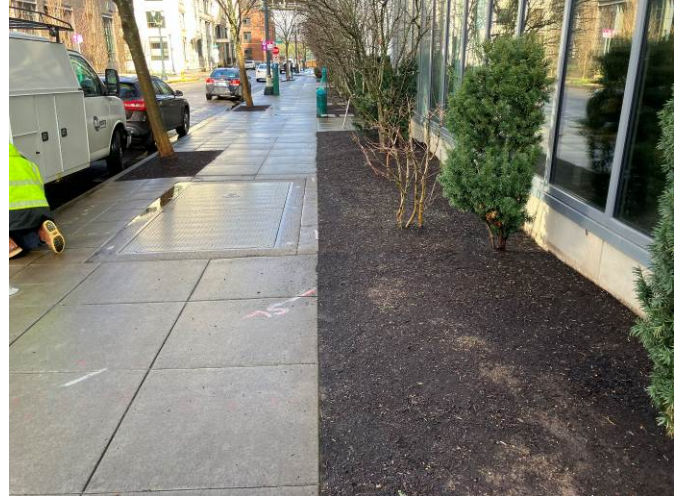
20. Landscape and hardscape along NW 12<sup>th</sup> Avenue, facing north.
