**RE: 2024 ANNUAL POST CONSTRUCTION CAP INSPECTION  
BLOCK 17 URBAN DEVELOPMENT  
1161 NW OVERTON STREET  
PORTLAND, MULTNOMAH COUNTY, OREGON  
ECSI #5867  
NOVA PROJECT NO. V24-0239**

## Cap Inspection Form

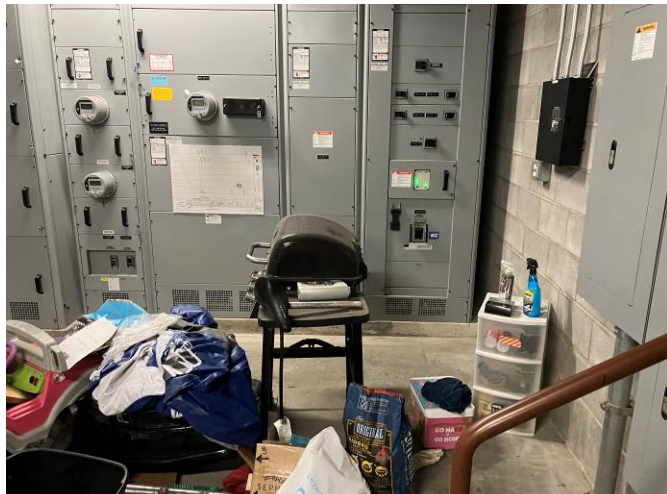
1. Electrical room in subterranean parking garage.

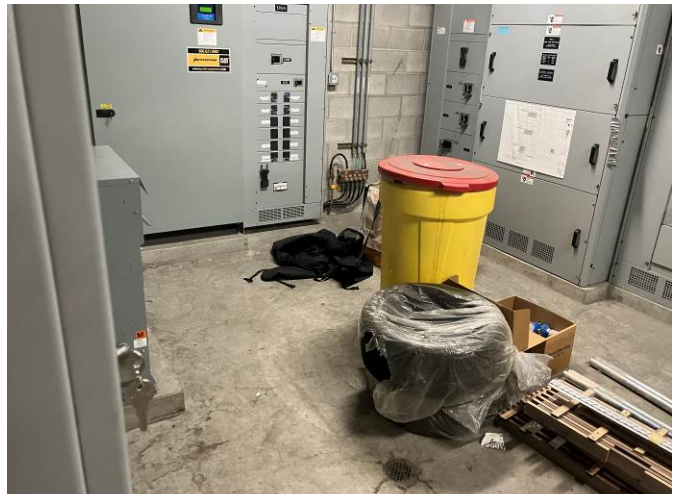
2. Electrical room in subterranean parking garage/building foundation.

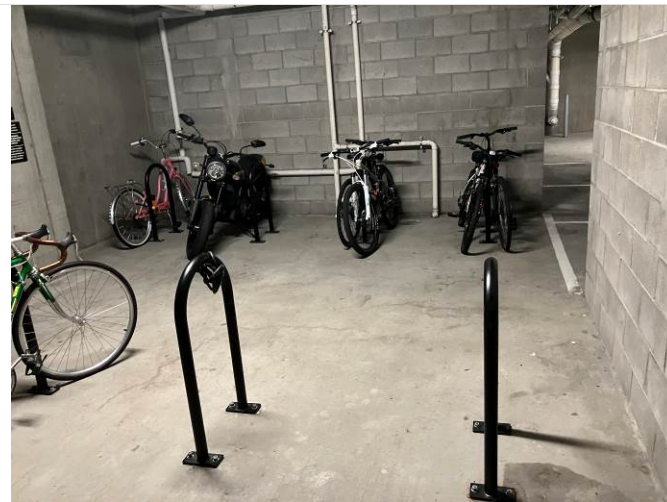
3. Bicycle storage area, southwest corner.

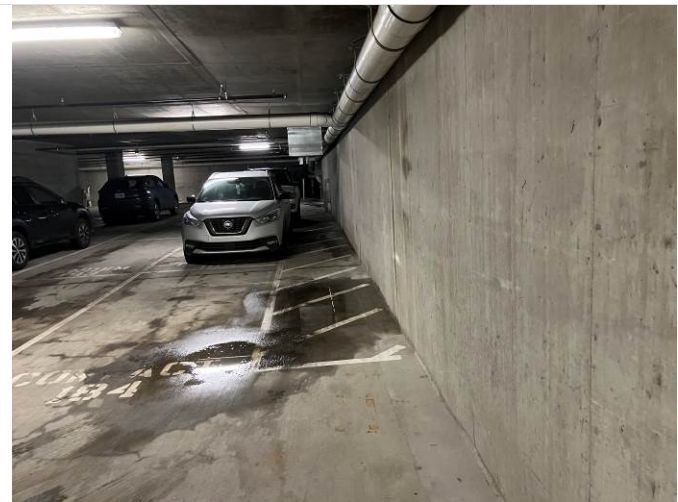
4. Parking garage/building foundation view A.

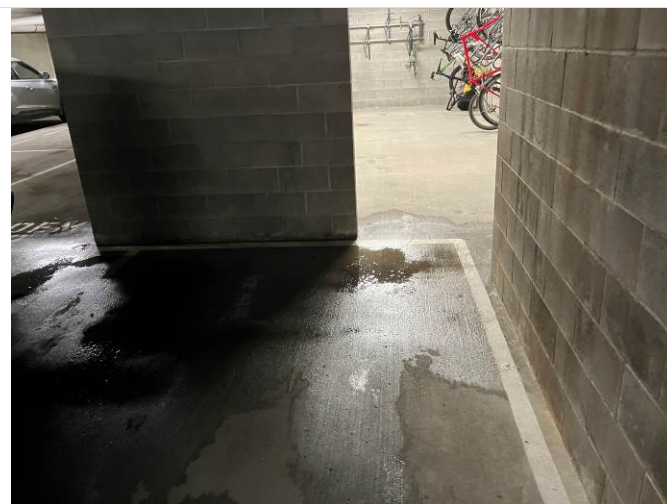
5. Bicycle storage area, southeast corner.

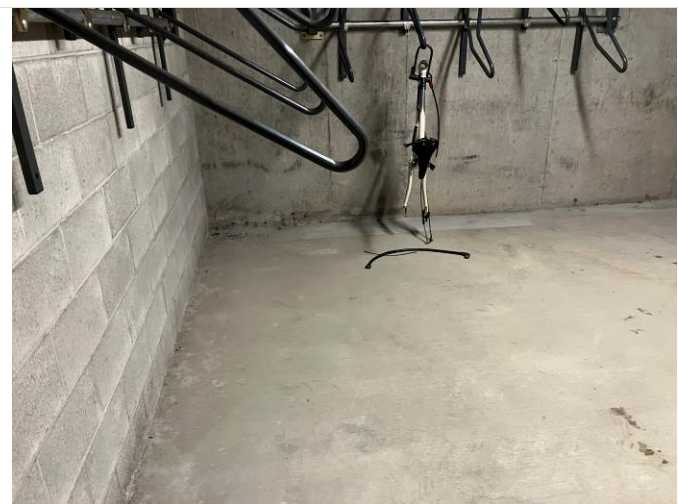
6. Bicycle storage area, northeast corner.

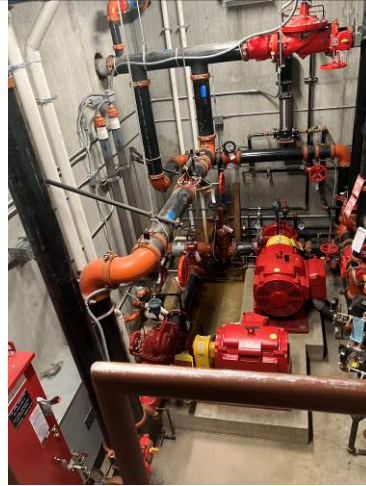
8. Fire pump room.

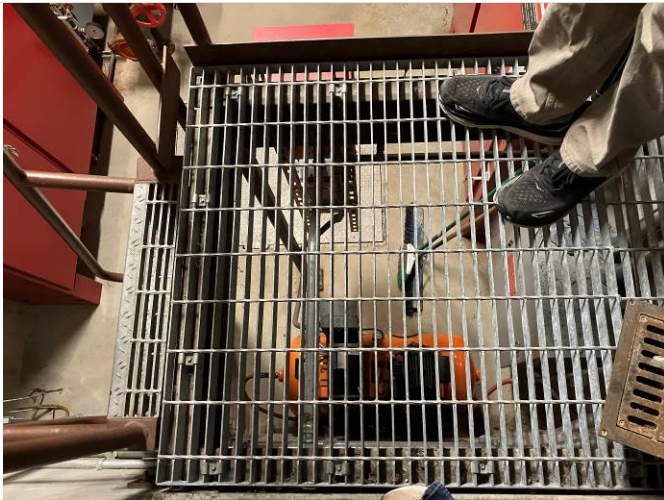
9. Fire pump room.

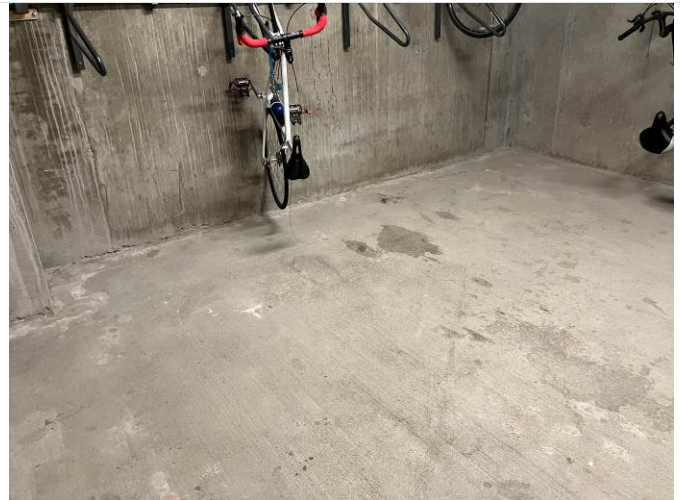
10. Bicycle storage room, northwest corner.

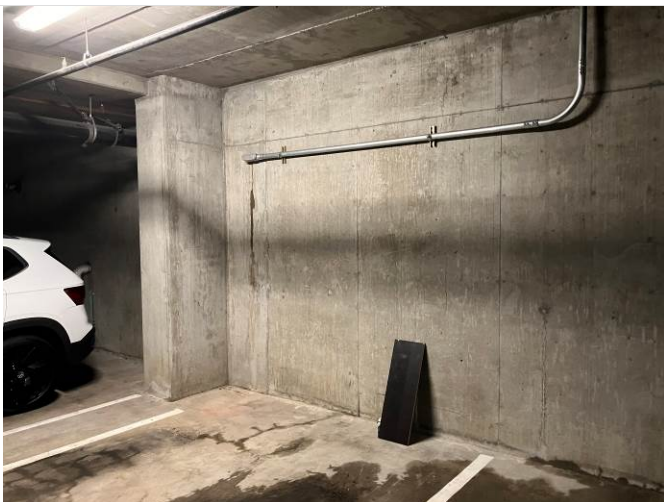
Evidence of surface water drainage issues which may damage the cap? YES <input type="radio"/> NO <input checked="" type="radio"/>	
Groundwater Seepage Areas	Groundwater Seepage Observed? YES <input type="radio"/> NO <input checked="" type="radio"/> Water observed at Ramp to B1 and parking space 100	No immediate repairs needed. Observe ramp during dry weather condition.
<b>Notes:</b> Water pooling observed-likely due to rain at time of inspection. Observe garage ramp during dry weather to see if water pooling persists.

11. Parking garage wall – parking space 100.

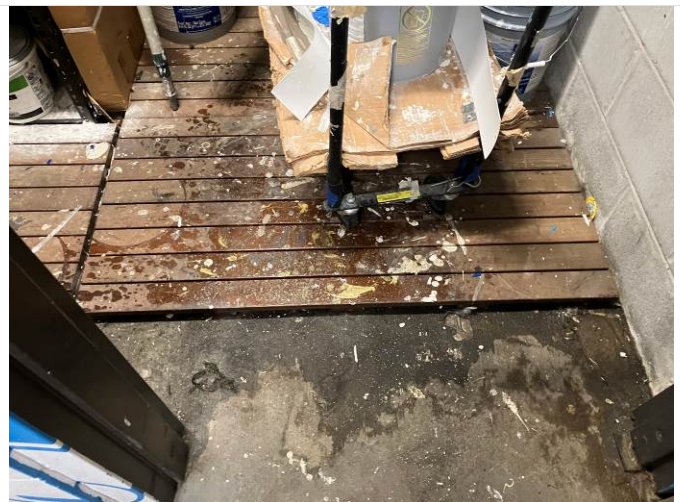
12. Paint storage room.

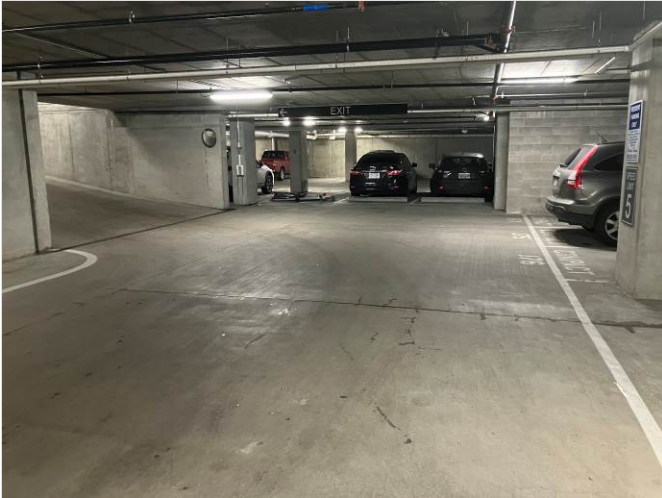
13. Parking garage/foundation view.

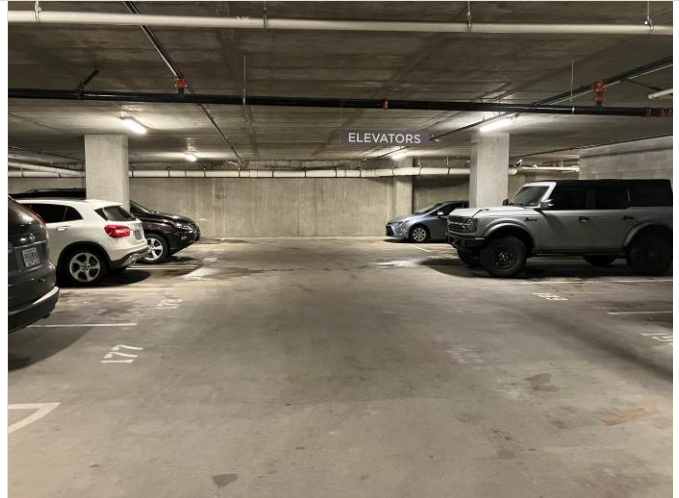
14. Parking garage/foundation view.

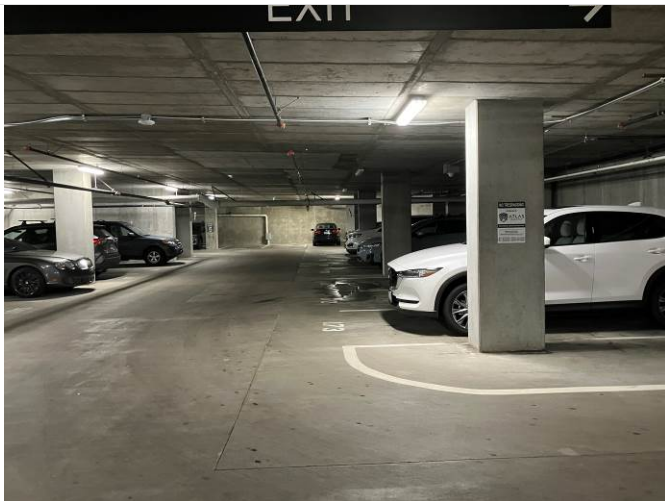
15. Parking garage/foundation view.

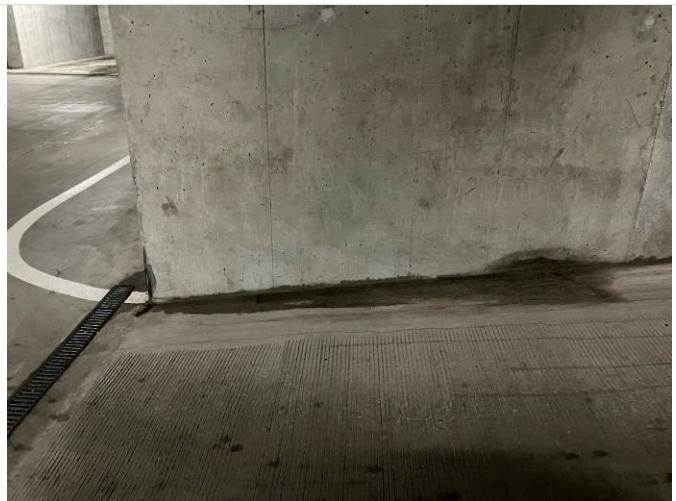
16. Parking garage ramp.

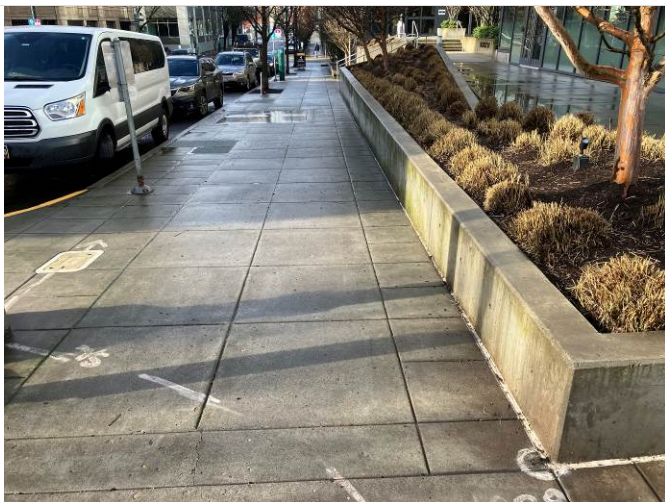
17. Landscape and hardscape along NW Overton Street, facing west.

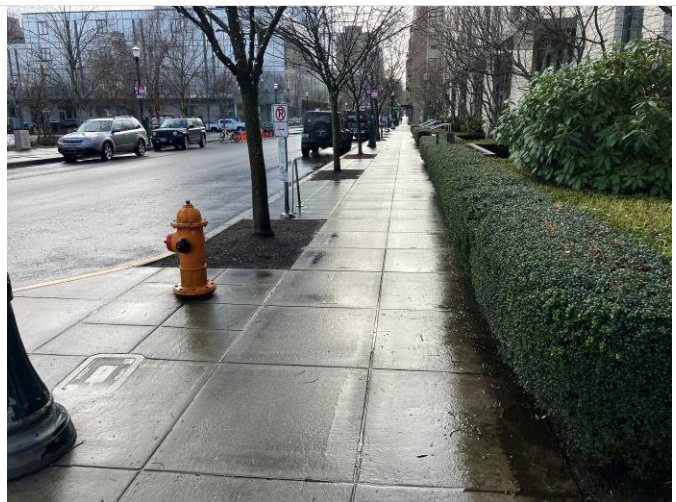
18. Landscape and hardscape along NW 11th Avenue, facing south.

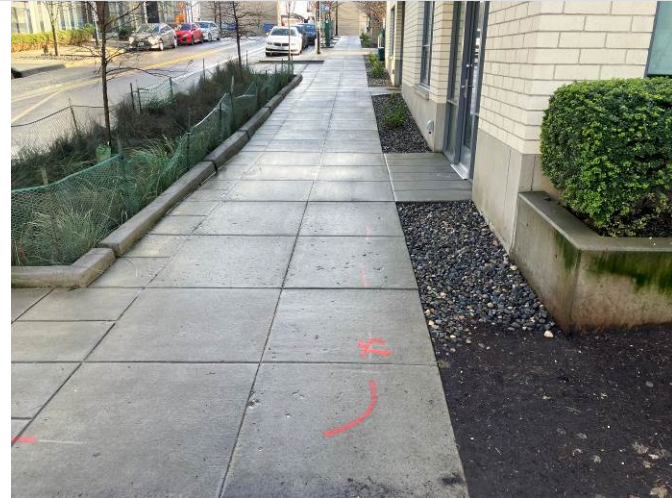
19. Landscape and hardscape along NW Pettygrove Street, facing east.

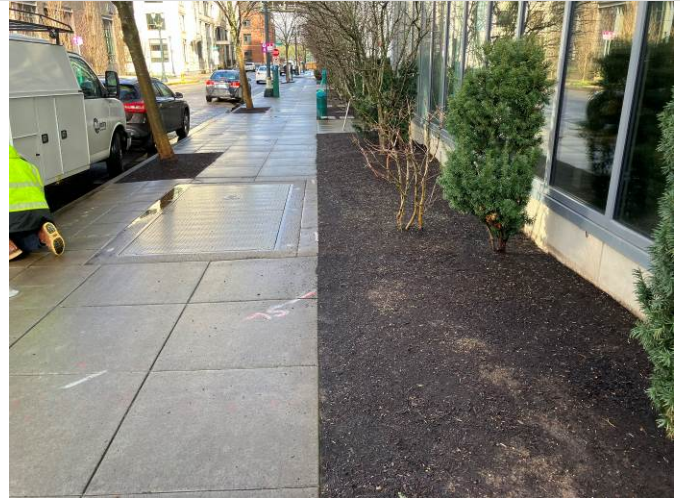
20. Landscape and hardscape along NW 12<sup>th</sup> Avenue, facing north.
