**SUBJECT: 2024 Environmental Cap Inspection at Metropolitan Condominiums,  
1001 NW Lovejoy Street, Portland, Oregon 97209**

Annual Cap Inspection  
Metropolitan Condominiums  
1001 NW Lovejoy Street, Portland, Oregon

**Project 1598**

**October 2024**

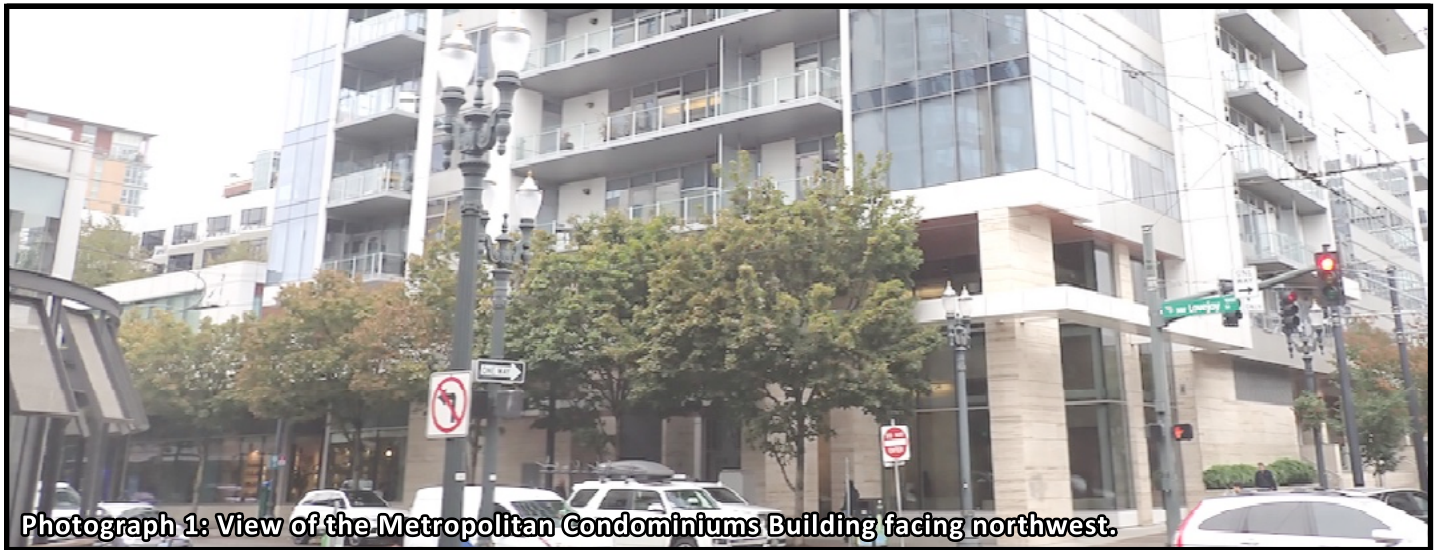
**Photograph 1: View of the Metropolitan Condominiums Building facing northwest.**

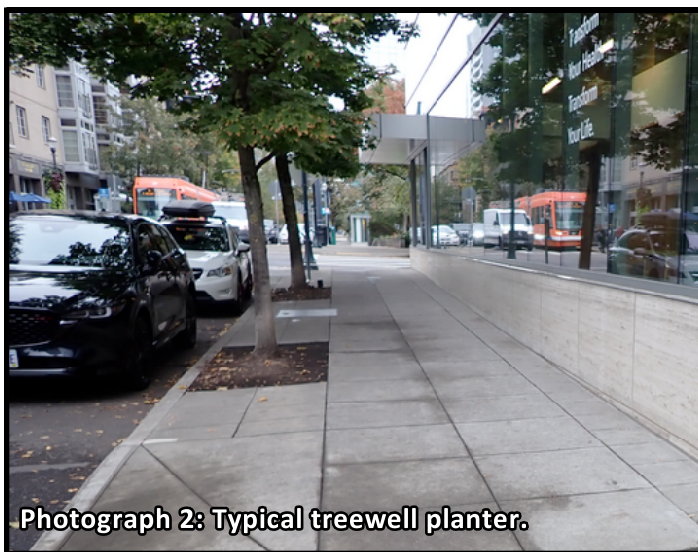
**Photograph 2: Typical treewell planter.**

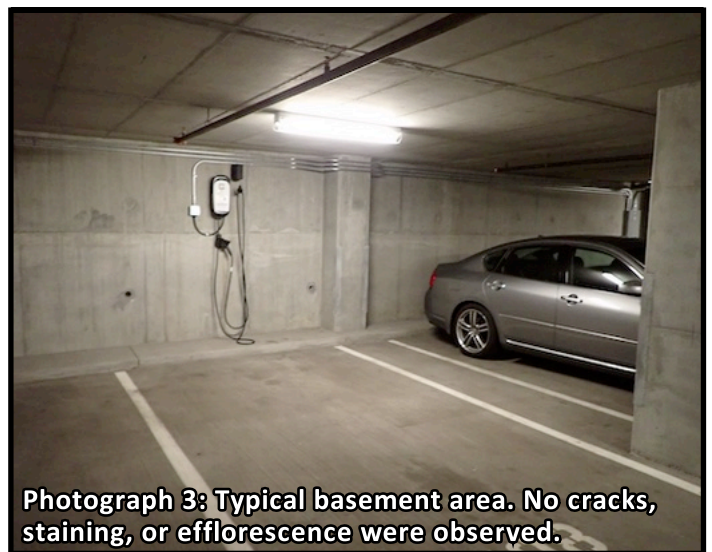
**Photograph 3: Typical basement area. No cracks, staining, or efflorescence were observed.**

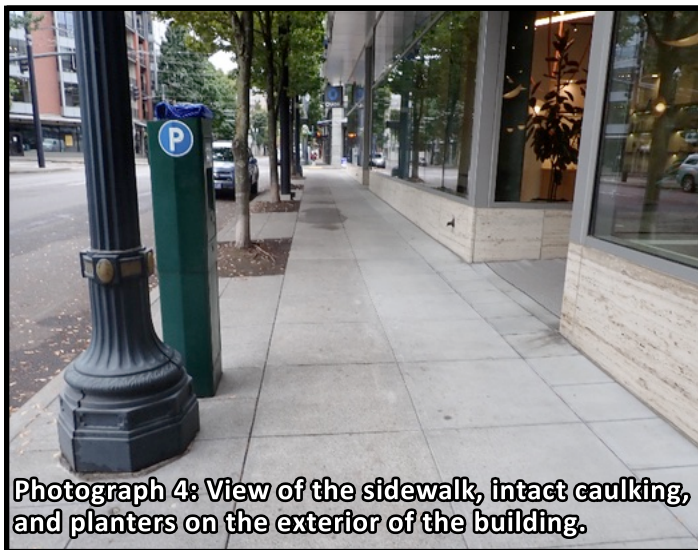
It is my professional opinion that there were no areas where the soil cap or the geotextile membrane used to delineate the top of the cap were visible at any of the inspection points. The silicone caulking between the building and sidewalk was observed to be intact and undamaged. No areas of significant groundwater seepage were noted in the walls or floors of the basement parking garage.

**Photograph 4: View of the sidewalk, intact caulking, and planters on the exterior of the building.**

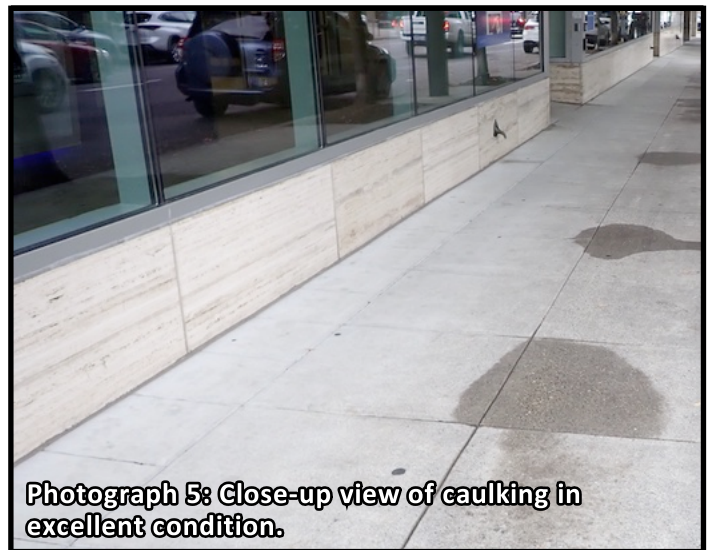
**Photograph 5: Close-up view of caulking in excellent condition.**
