To:	Kevin Dana	From:	Kyle R. Sattler, L.G. (Washington) Jason O'Donnell, R.G.
Company:	Oregon Department of Environmental Quality, Northwest Region	Date:	April 30, 2020
Address:	700 NE Multnomah Street, Suite 600 Portland, OR 97232		
cc:	Tiffany Sweitzer, Hoyt Street Properties (via email only)		
GDI Project:	HoytStProp-4-07-01		
RE:	February 2020 Performance Sub-Slab Vapor Monitoring Event Vista Condominiums 1150 NW Quimby Street Portland, Oregon

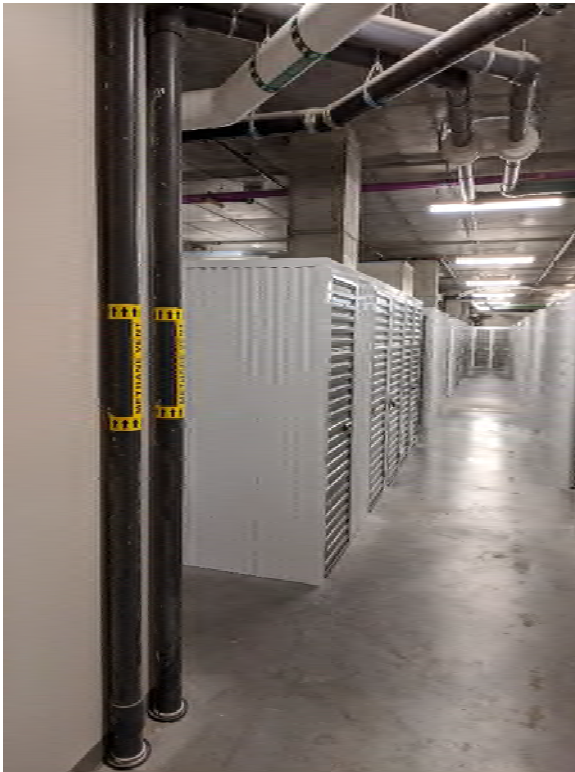
METHANE VENT RISERS WITH PLACARDS AT THE 5<sup>TH</sup> FLOOR STORAGE UNIT SPACE. PHOTOGRAPH TAKEN FACING EAST.

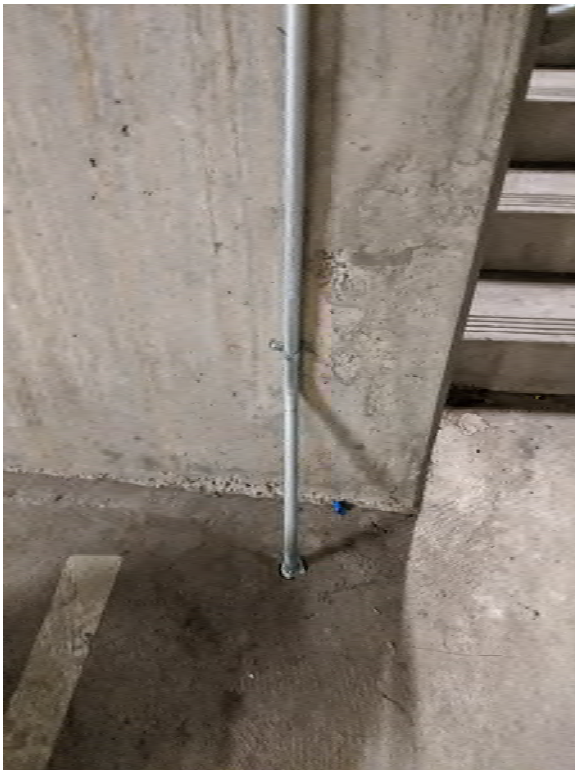
SLAB PENETRATION IN THE PARKING GARAGE SEALED TO THE CONCRETE SLAB WITH CAULKING. PHOTOGRAPH TAKEN FACING WEST.

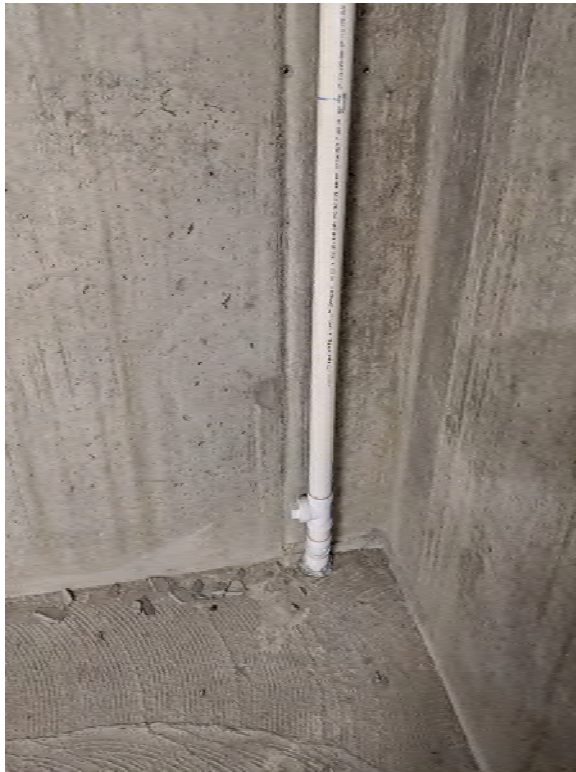
SLAB PENETRATION IN THE PARKING GARAGE  
SEALED TO THE CONCRETE SLAB WITH CAULKING.  
PHOTOGRAPH TAKEN FACING NORTH.

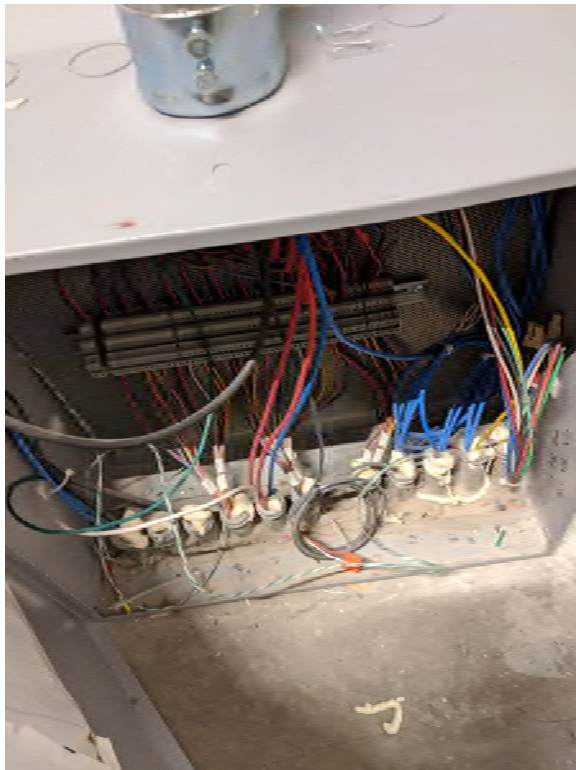
CONDUITS SEALED USING CLOSED CELL  
POLYURETHANE SPRAY FOAM. PHOTOGRAPH  
TAKEN FACING NORTH.

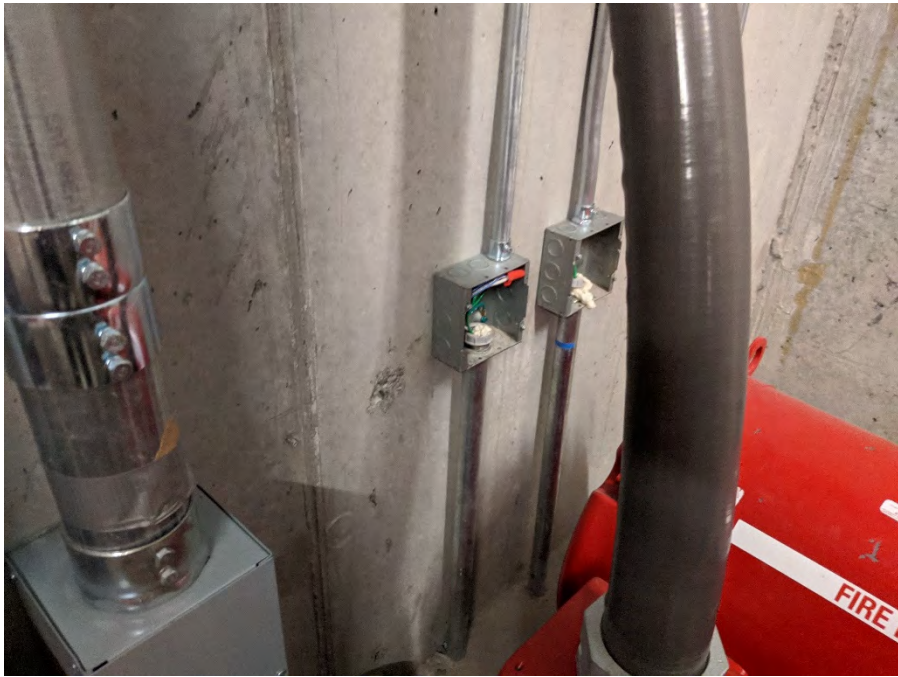
CONDUITS SEALED USING CLOSED CELL POLYURETHANE SPRAY FOAM. PHOTOGRAPH TAKEN FACING NORTHWEST.

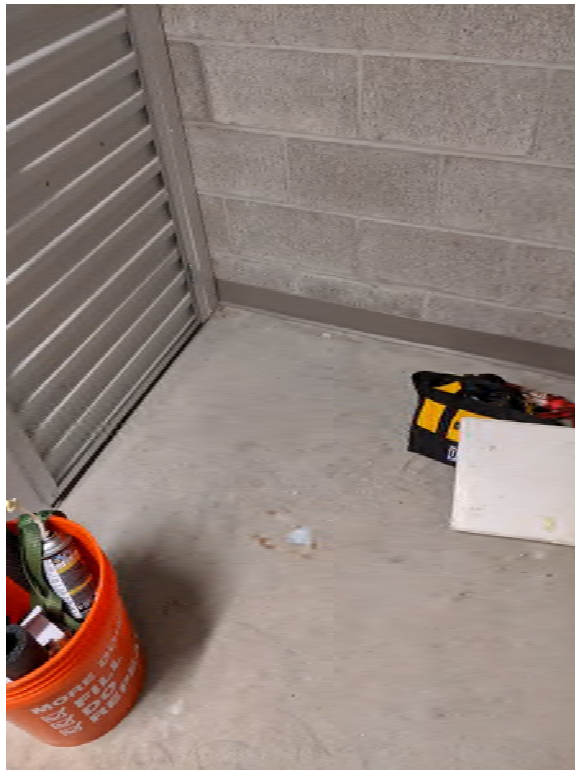
SEALED HOLE IN CONCRETE SLAB, LOCATED IN THE STORAGE UNIT ROOM IN THE PARKING GARAGE. PHOTOGRAPH TAKEN FACING WEST.

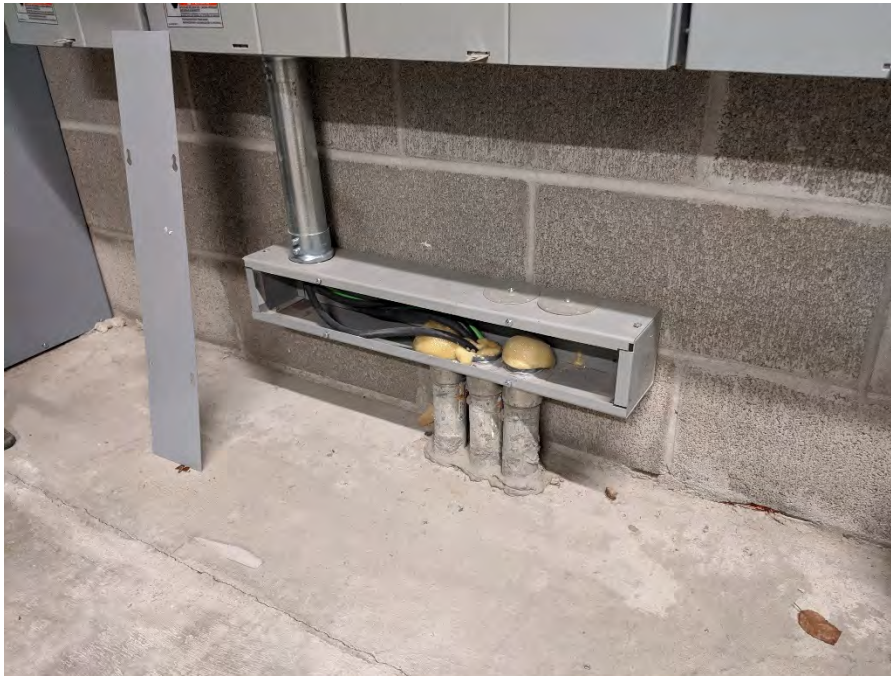
CONDUITS SEALED USING CLOSED CELL POLYURETHANE SPRAY FOAM. PHOTOGRAPH TAKEN FACING NORTHWEST.

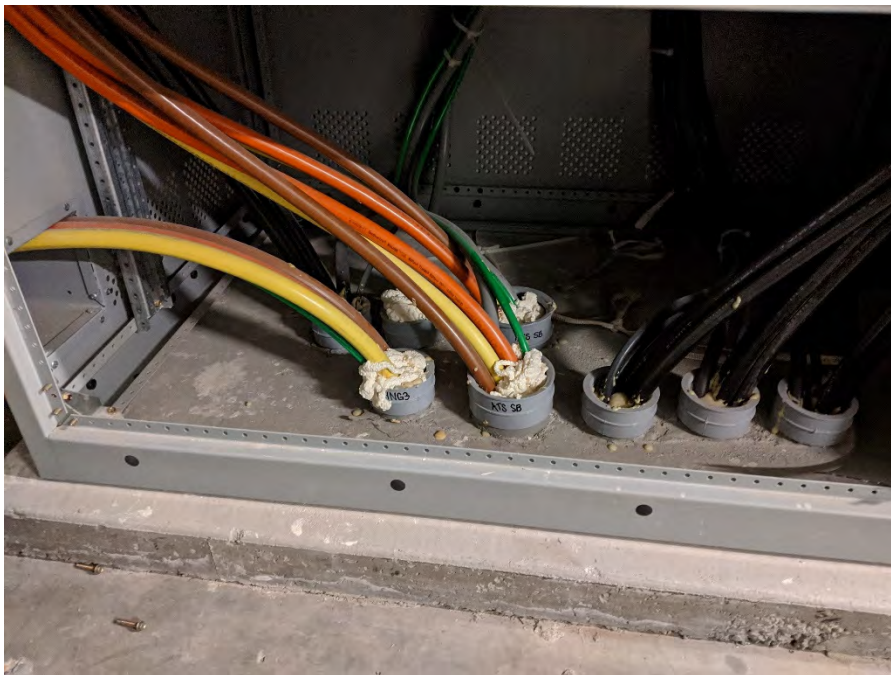
CONDUITS SEALED USING CLOSED CELL POLYURETHANE SPRAY FOAM. PHOTOGRAPH TAKEN FACING SOUTH.

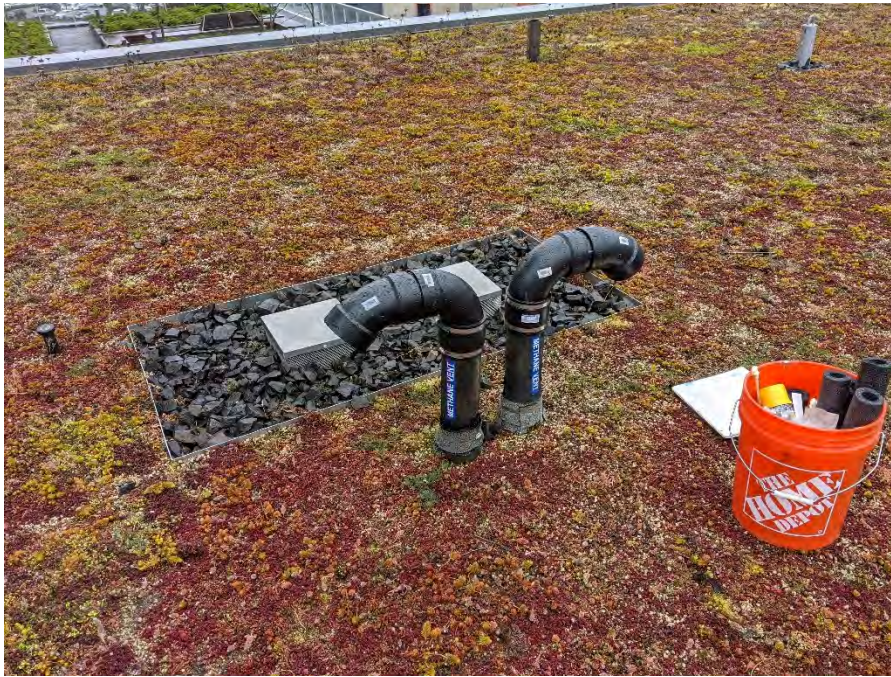
SUB-SLAB VENTILATION SYSTEM ROOF VENTS WITH RAIN GUARDS AND PLACARDS.  
PHOTOGRAPH TAKEN FACING NORTH.

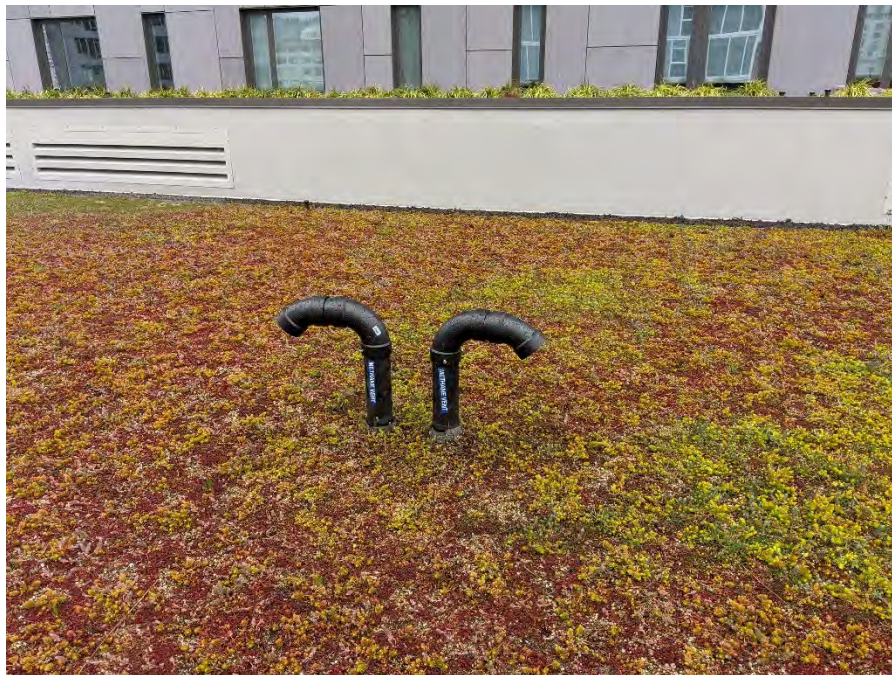
SUB-SLAB VENTILATION SYSTEM ROOF VENTS WITH RAIN GUARDS AND PLACARDS.  
PHOTOGRAPH TAKEN FACING NORTH.

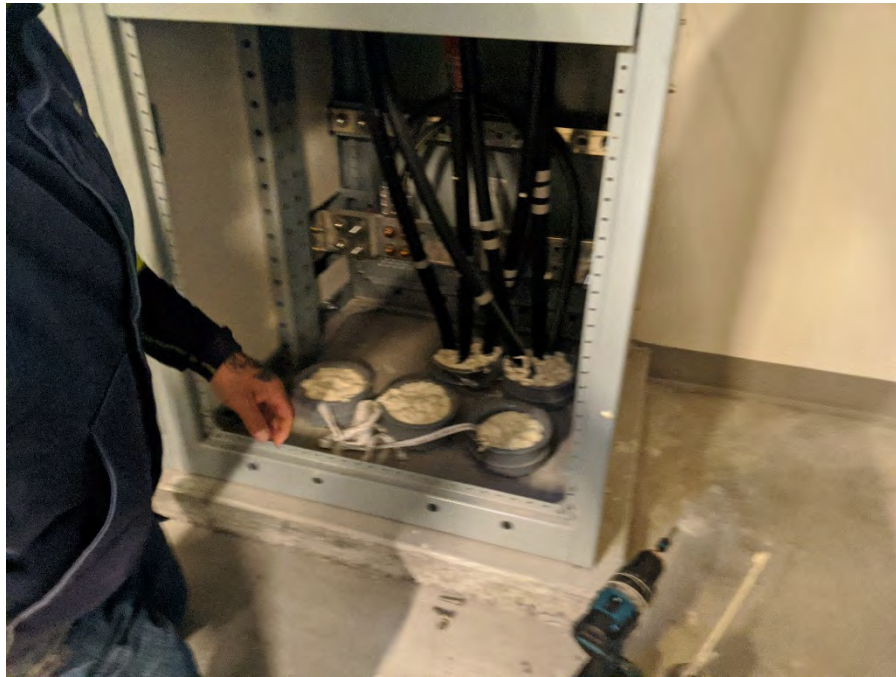
PGE CONDUITS SEALED USING CLOSED CELL POLYURETHANE SPRAY FOAM.  
PHOTOGRAPH TAKEN FACING WEST.

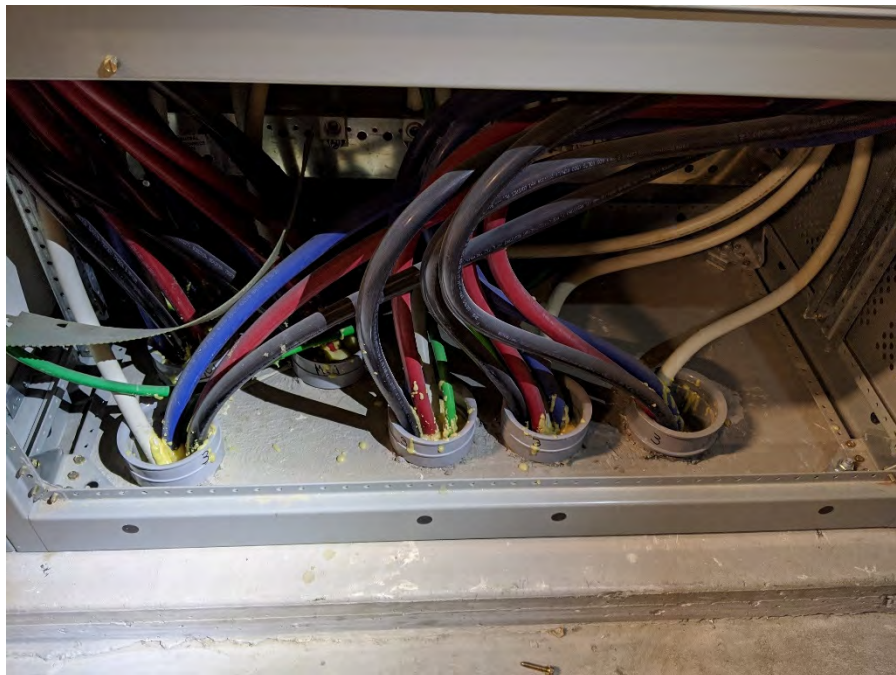
CONDUITS SEALED USING CLOSED CELL POLYURETHANE SPRAY FOAM. PHOTOGRAPH  
TAKEN FACING SOUTH.
