**SUBJECT: 2024 Environmental Cap Inspection at Vista North Pearl
Condominiums, 1150 NW Quimby Street, Portland, Oregon 97209**

Annual Cap Inspection
Vista North Pearl Condominiums
1150 NW Quimby Street, Portland, Oregon

Project 1598

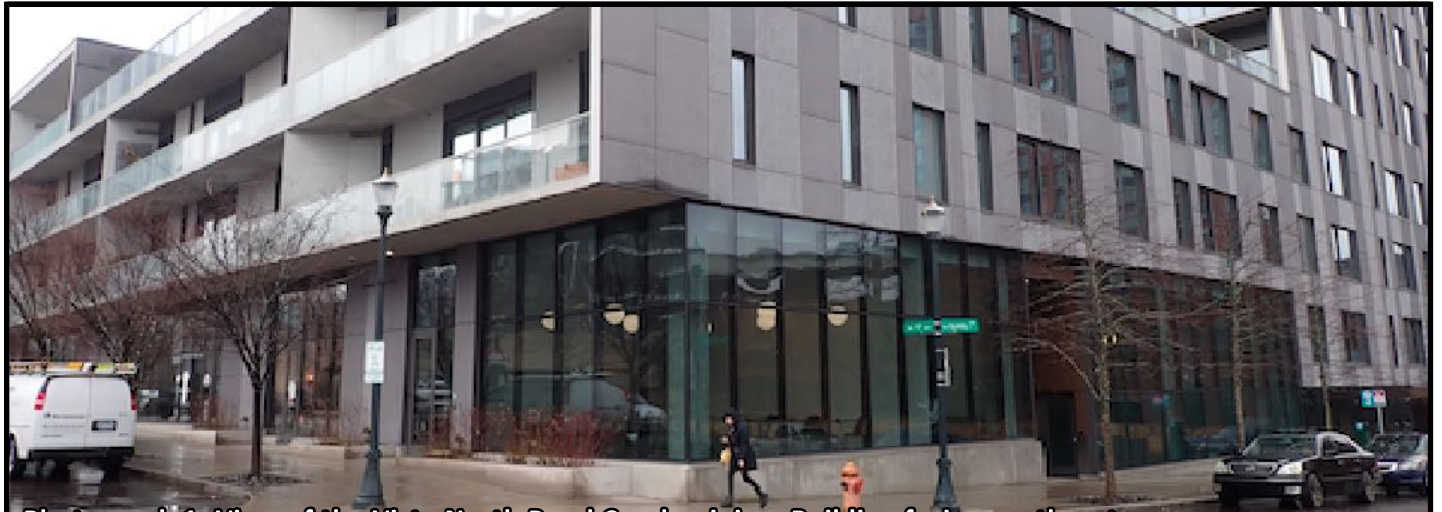
Photograph 1: View of the Vista North Pearl Condominium Building facing southeast.

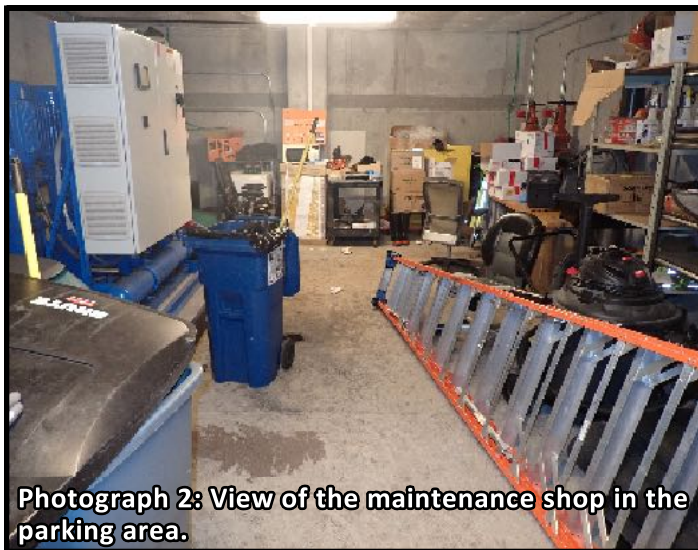
Photograph 2: View of the maintenance shop in the parking area.

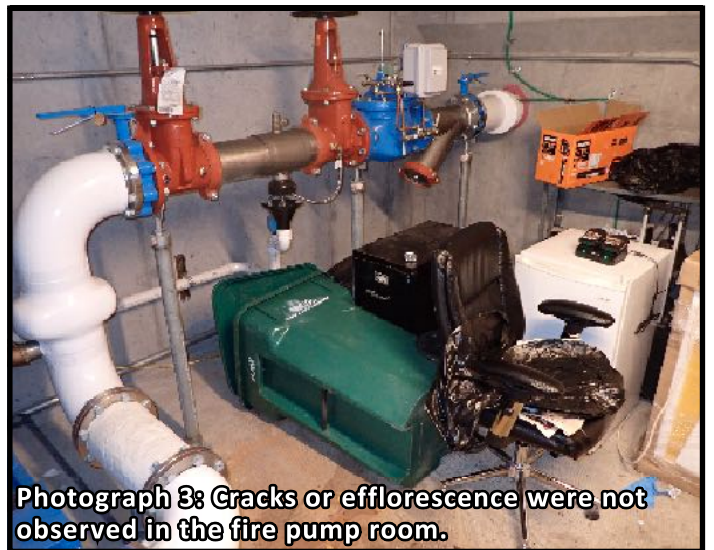
Photograph 3: Cracks or efflorescence were not observed in the fire pump room.

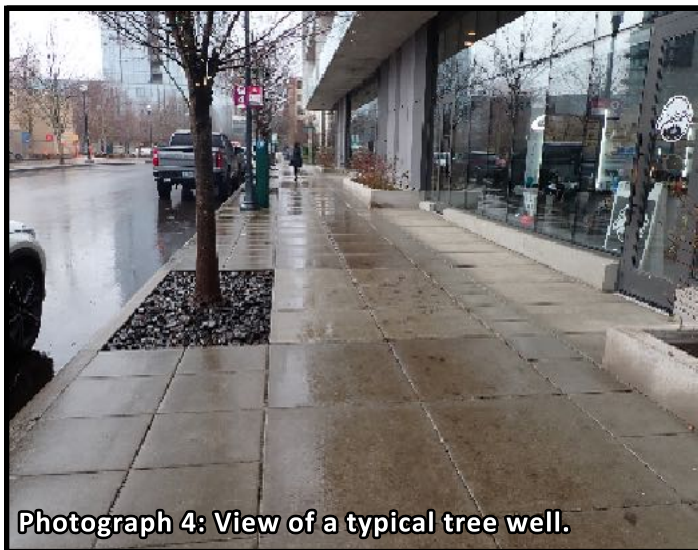
Photograph 4: View of a typical tree well.

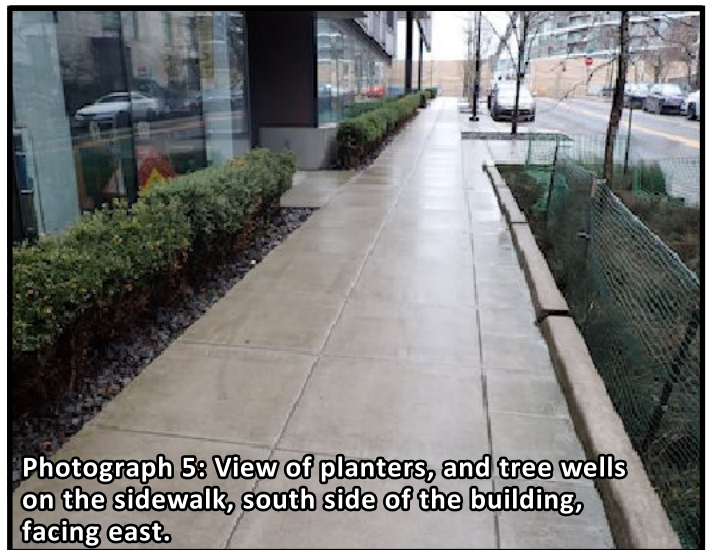
Photograph 5: View of planters, and tree wells on the sidewalk, south side of the building, facing east.
