**Michael T. O'Connor, R.G.**  
**Environmental Consultant**  
3123 SE 9<sup>th</sup> Avenue, Portland, Oregon 97202  
Phone 971.344.5953 mtopdx@gmail.com

March 27, 2023

**SUBJECT: 2023 Environmental Cap Inspection at Vista North Pearl  
Condominiums, 1150 NW Quimby Street, Portland, Oregon 97209**

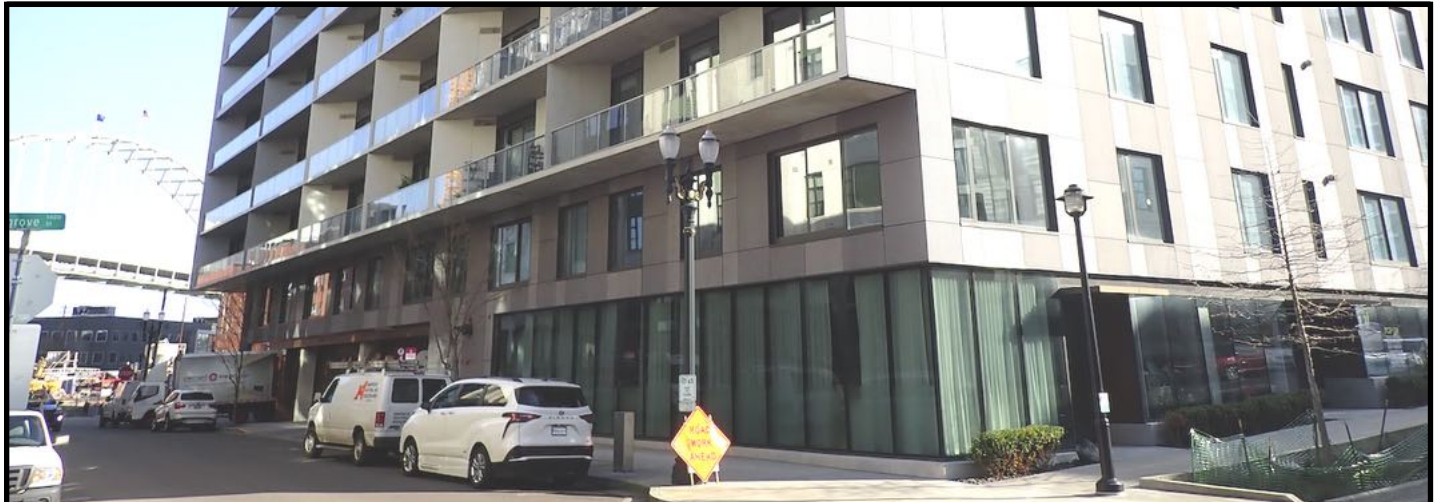
**Photograph 1: View of the Vista North Pearl Condominium Building facing northeast.**

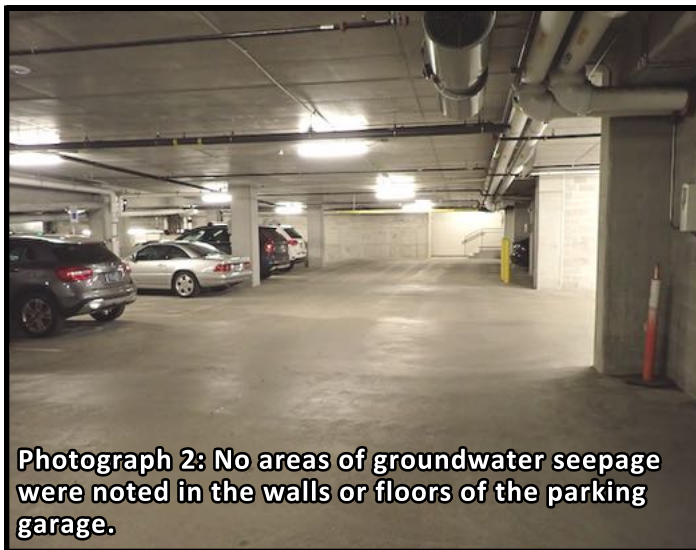
It is our professional opinion that there were no areas where the soil cap or the geotextile membrane used to delineate the top of the cap were visible at any of the inspection points. The silicone caulking between the building and sidewalk was observed to be essentially undamaged. No areas of groundwater seepage were noted in the walls or floors of the basement parking garage.

**Photograph 2: No areas of groundwater seepage were noted in the walls or floors of the parking garage.**

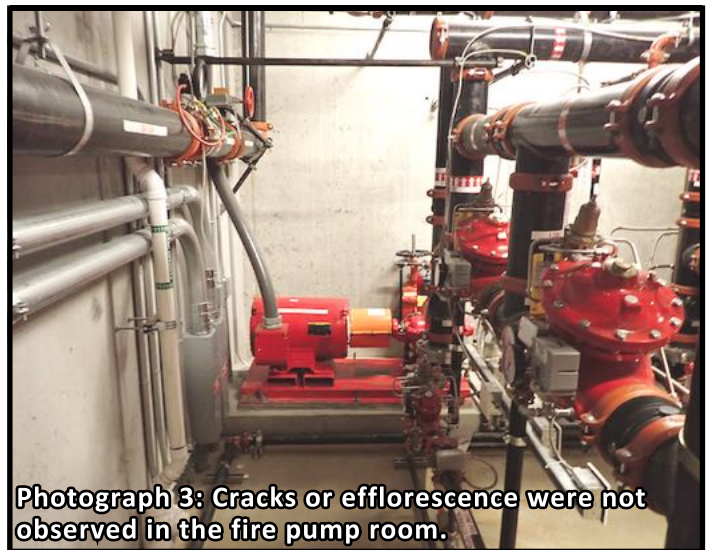
**Photograph 3: Cracks or efflorescence were not observed in the fire pump room.**

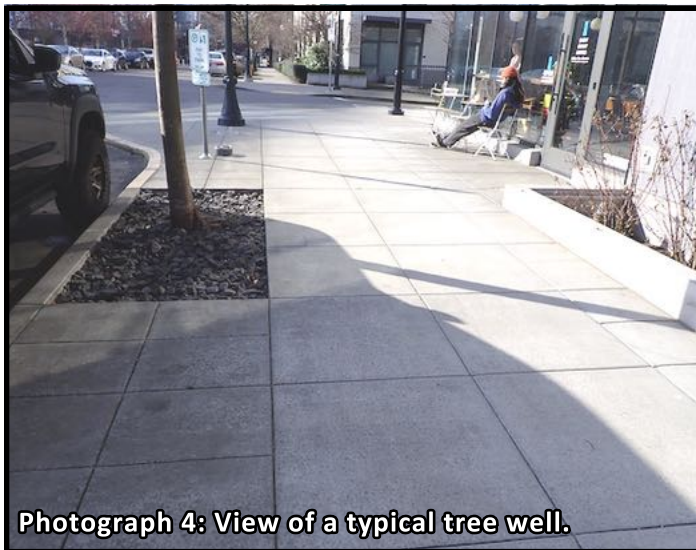
**Photograph 4: View of a typical tree well.**

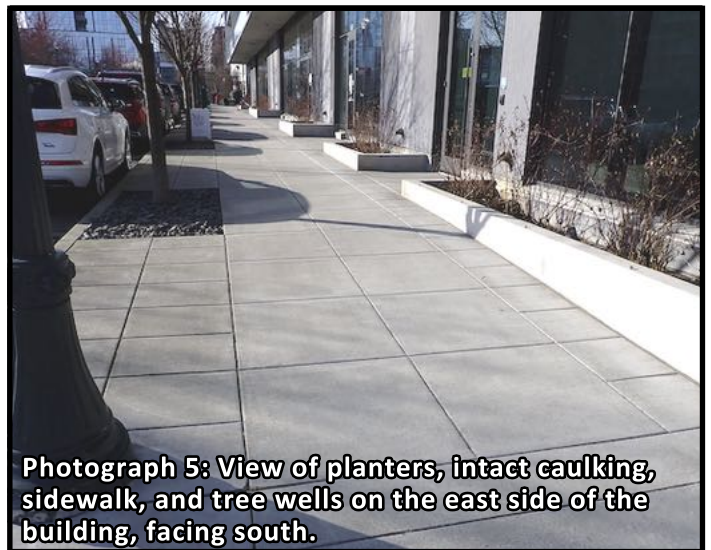
**Photograph 5: View of planters, intact caulking, sidewalk, and tree wells on the east side of the building, facing south.**
