**Michael T. O'Connor, R.G.**  
**Environmental Consultant**  
3123 SE 9<sup>th</sup> Avenue, Portland, Oregon 97202  
Phone 971.344.5953 mtopdx@gmail.com

**SUBJECT: 2024 Environmental Cap Inspection at Vibrant! Apartments, 1620 NW 14th Avenue, Portland, Oregon 97209**

Annual Cap Inspection  
Vibrant! Apartments  
1620 NW 14th Avenue, Portland, Oregon

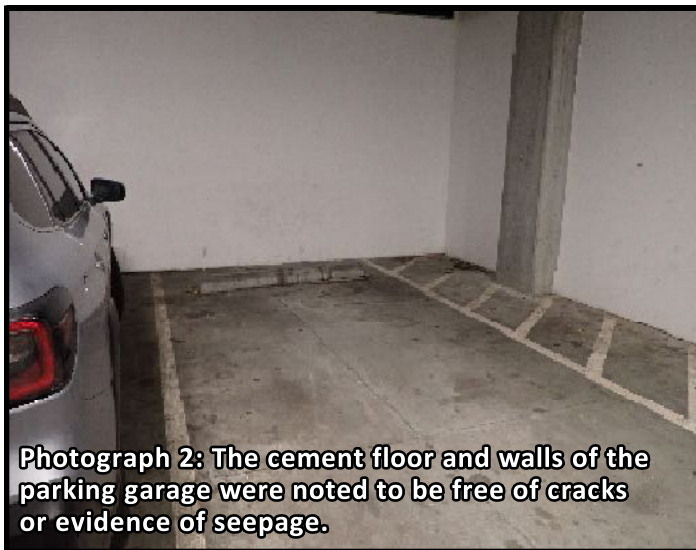
It is my professional opinion that there were no areas where the soil cap or the geotextile membrane used to delineate the top of the cap were visible at any of the inspection points. The silicone caulking between the building and sidewalk was observed to be intact and undamaged, and no areas of groundwater seepage were noted in the walls or floors of the basement parking garage.

**Photograph 2: The cement floor and walls of the parking garage were noted to be free of cracks or evidence of seepage.**

I do not recommend additional inspections other than an annual re-inspection in 2025. The soil and concrete cap at the Property are apparently intact and are functioning as intended.

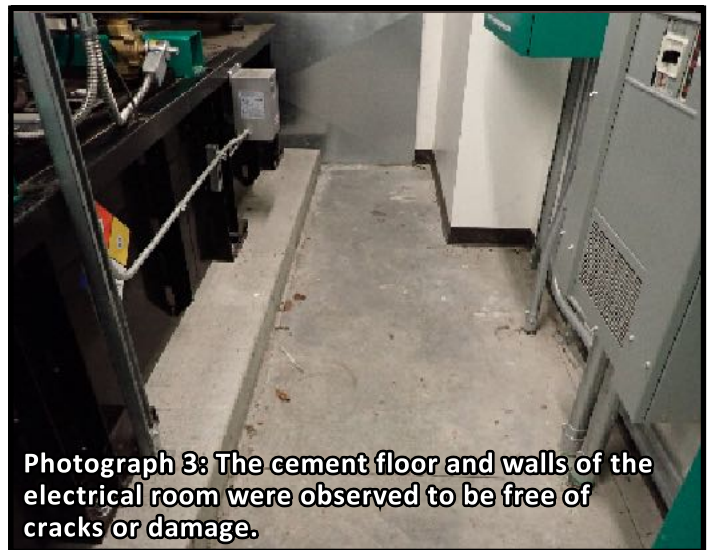
**Photograph 3: The cement floor and walls of the electrical room were observed to be free of cracks or damage.**

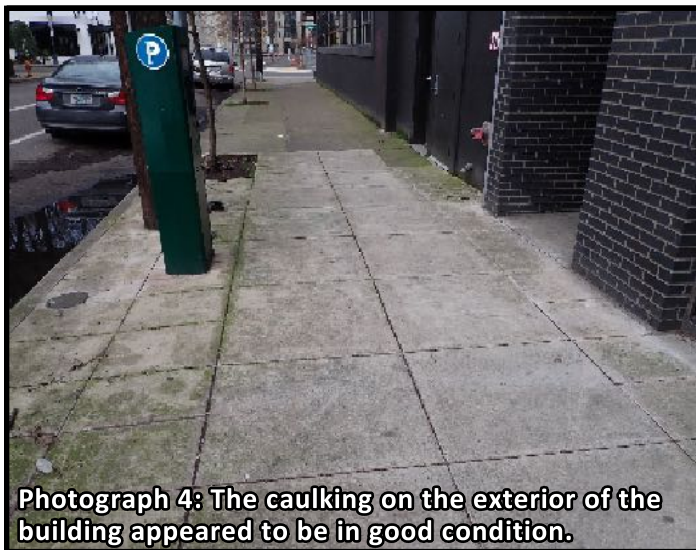
**Photograph 4: The caulking on the exterior of the building appeared to be in good condition.**

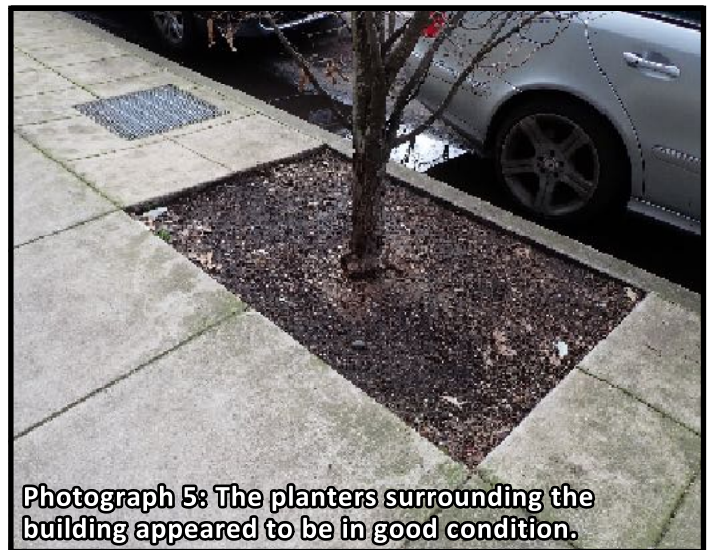
**Photograph 5: The planters surrounding the building appeared to be in good condition.**
