Annual Cap Inspection – 2020

The Abigail
1650 NW 13th Avenue
Portland, Oregon
DEQ ECSI File No. 5856
Project: BridgeHous-1-13

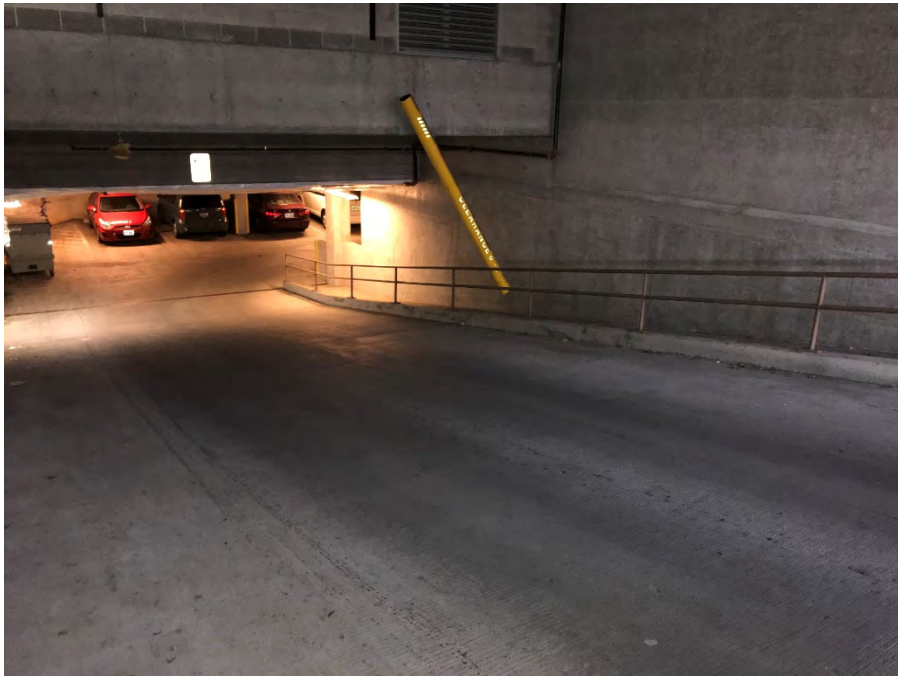
ENTRANCE RAMP TO SUBSURFACE PARKING LEVEL

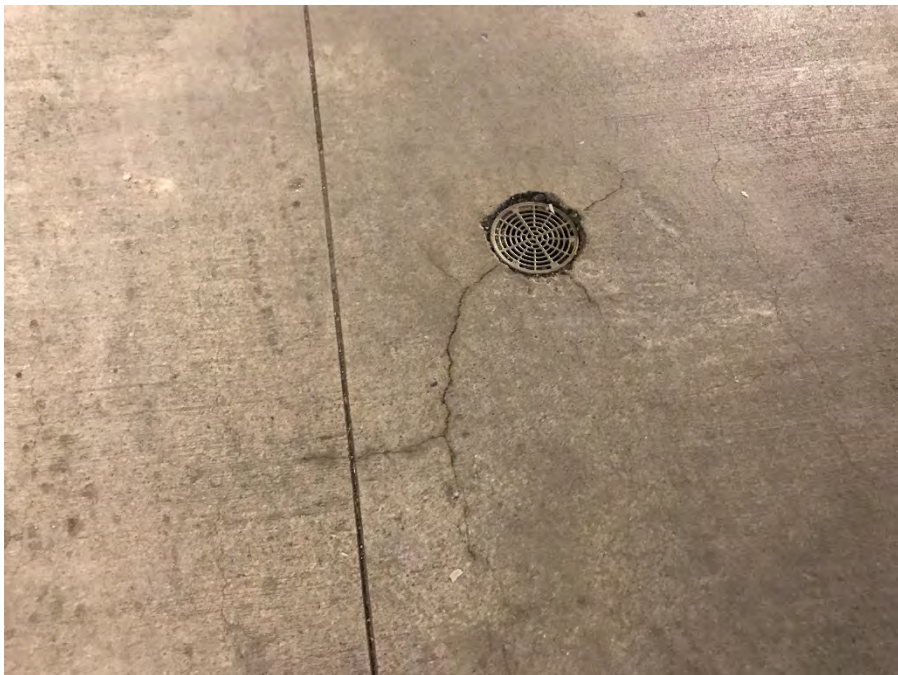
MINOR CRACK AROUND FLOOR DRAIN IN SUBSURFACE PARKING LEVEL

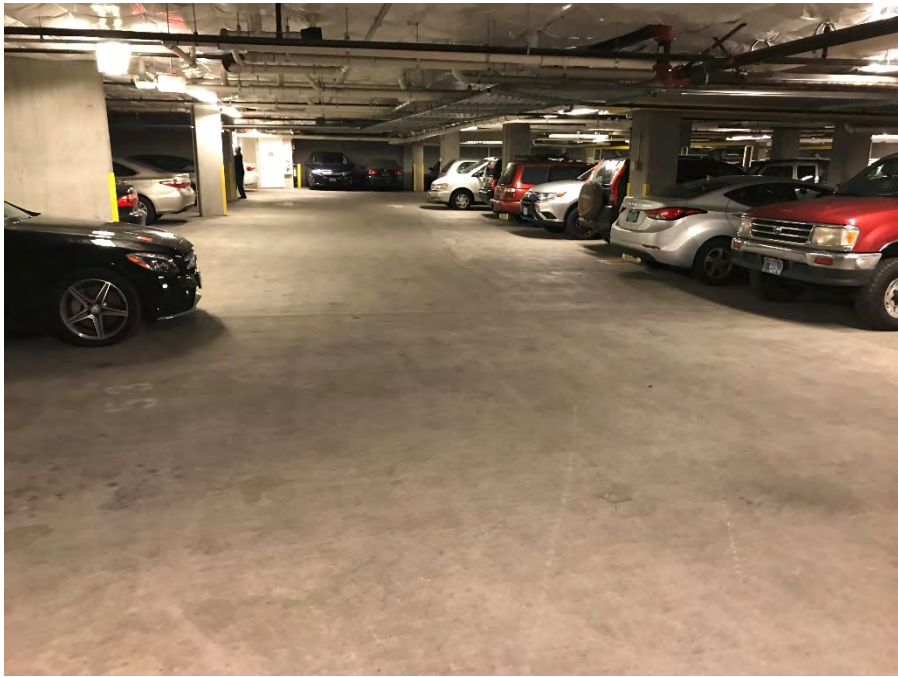
CAP CONSISTING OF CONCRETE FLOOR SLAB IN SUBSURFACE PARKING LEVEL

Condition of basement floor slab: Observed basement floor slab in good condition with minor hairline cracks that did not penetrate the slab.

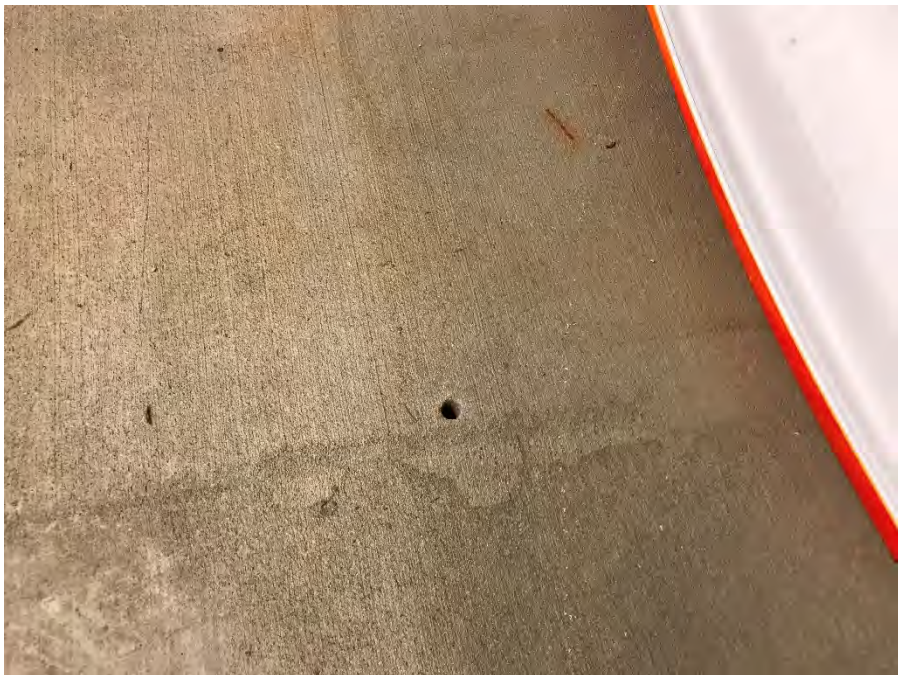
SMALL, APPROXIMATELY 2- TO 3-INCH-DEEP HOLE IN CONCRETE FLOOR SLAB. HOLE DID NOT PENETRATE THE FLOOR SLAB.

- Approximately 1-inch-diameter holes, 2 to 3 inches deep were observed on the northeastern portion of garage room PO2, on parking spot #51, and on the eastern portion of garage room PO4A.

These features did not penetrate the cap.

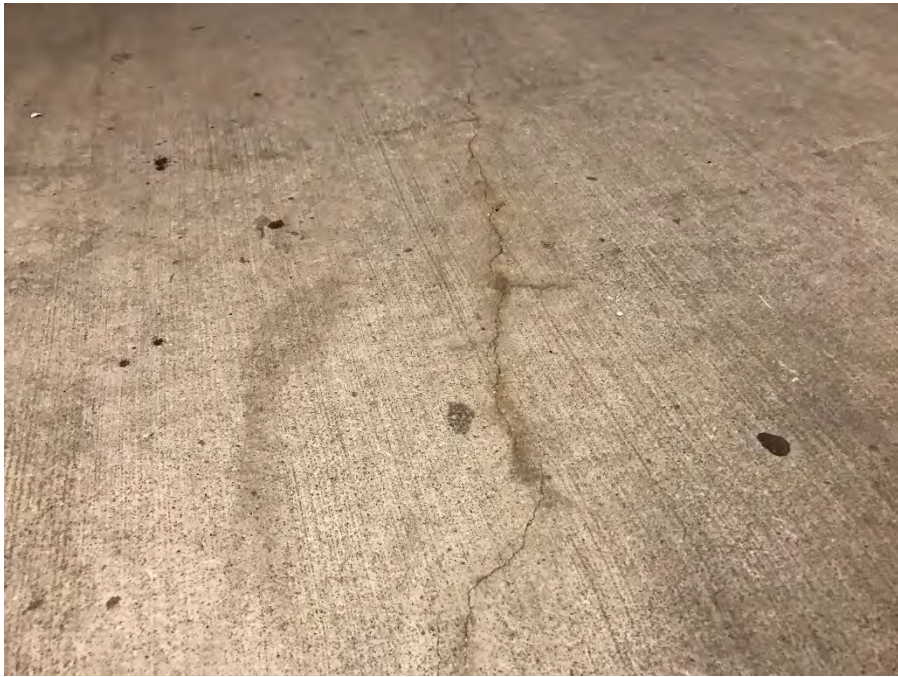
MINOR CRACK IN CONCRETE FLOOR SLAB

Hairline cracks that did not penetrate the cap were observed on the garage slab in the following locations:

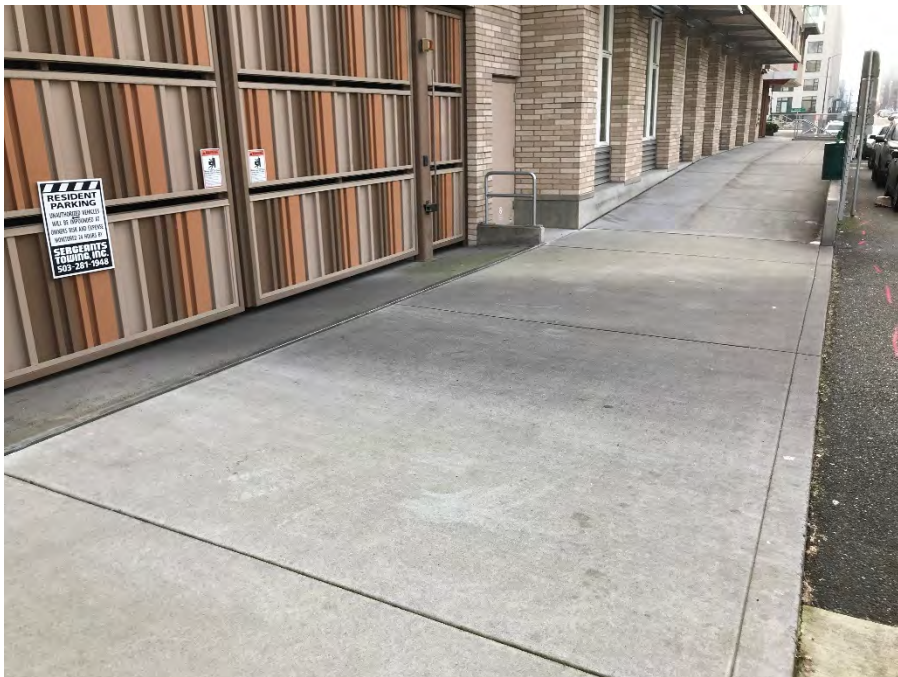
CONCRETE SIDEWALKS ALONG BUILDING EXTERIOR
