Site: The Fields Neighborhood Park

Inspection Date: 10/25/2019

Attachment 1: Photo Log

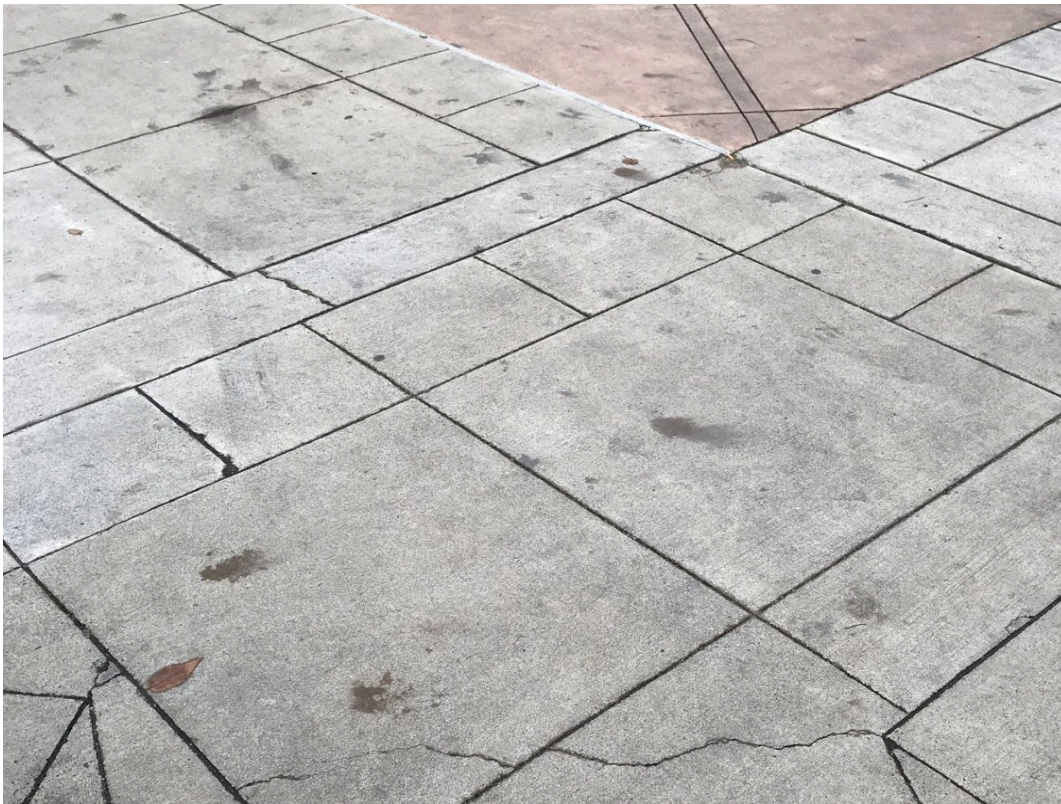
Location: Various locations within the hardscaped areas (concrete, asphalt, bricks). Minor cracks were observed (generally less than 0.5 inches) that do not appear to penetrate the cap. One brick pathway is slightly separating. Damage does not appear to penetrate the cap. (see attached photos)

Photo 1: Minor cracks in concrete panels at NW Overton St and NW 11th Ave

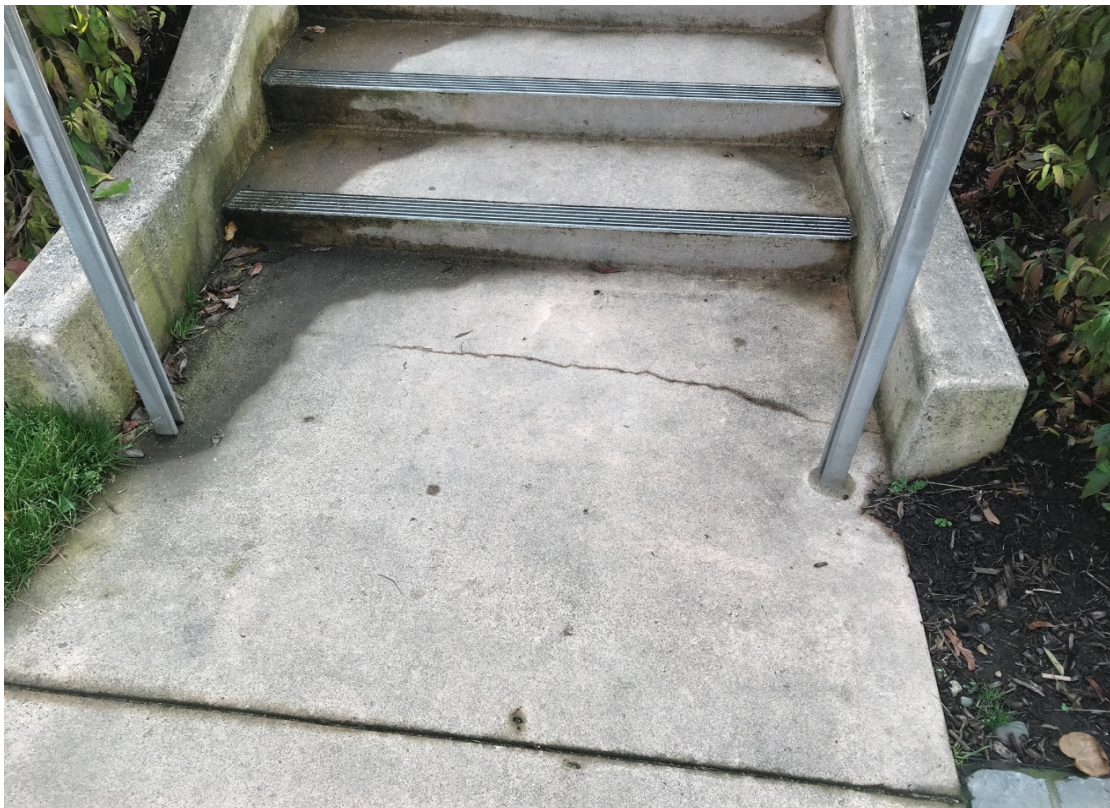
Photo 2: Minor crack in concrete at northern stairs

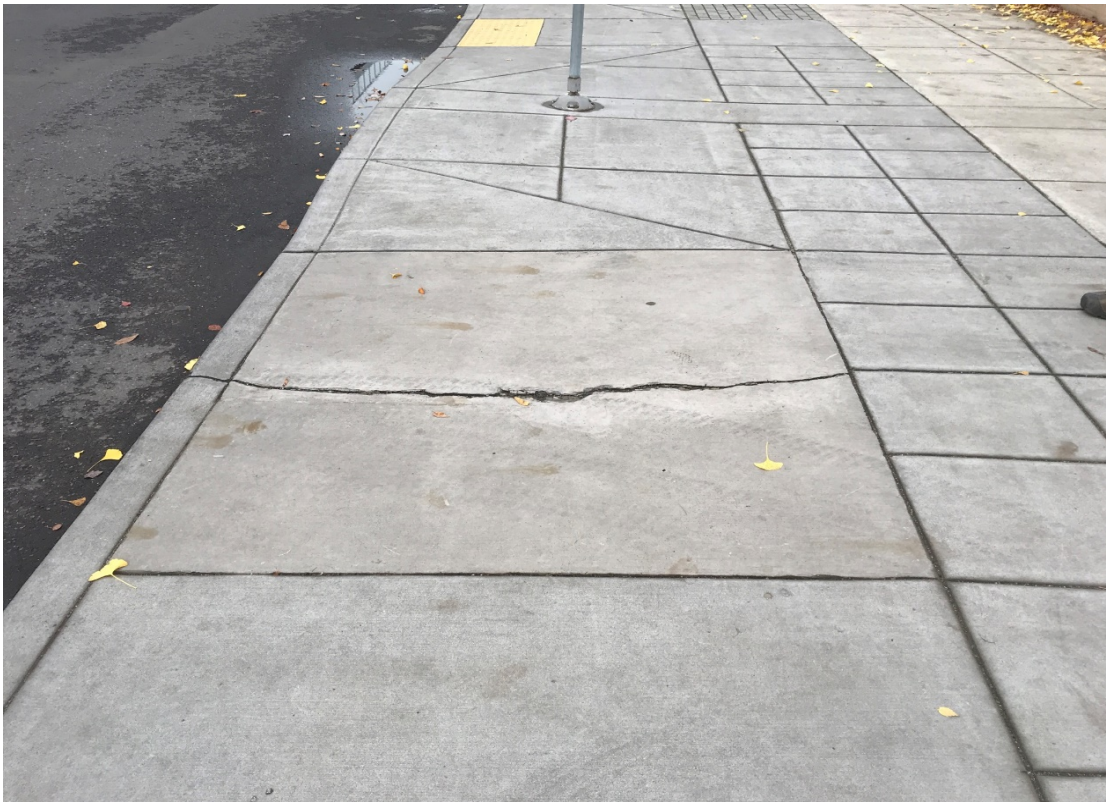
Photo 5: Cracked concrete panel on NW 11th Ave

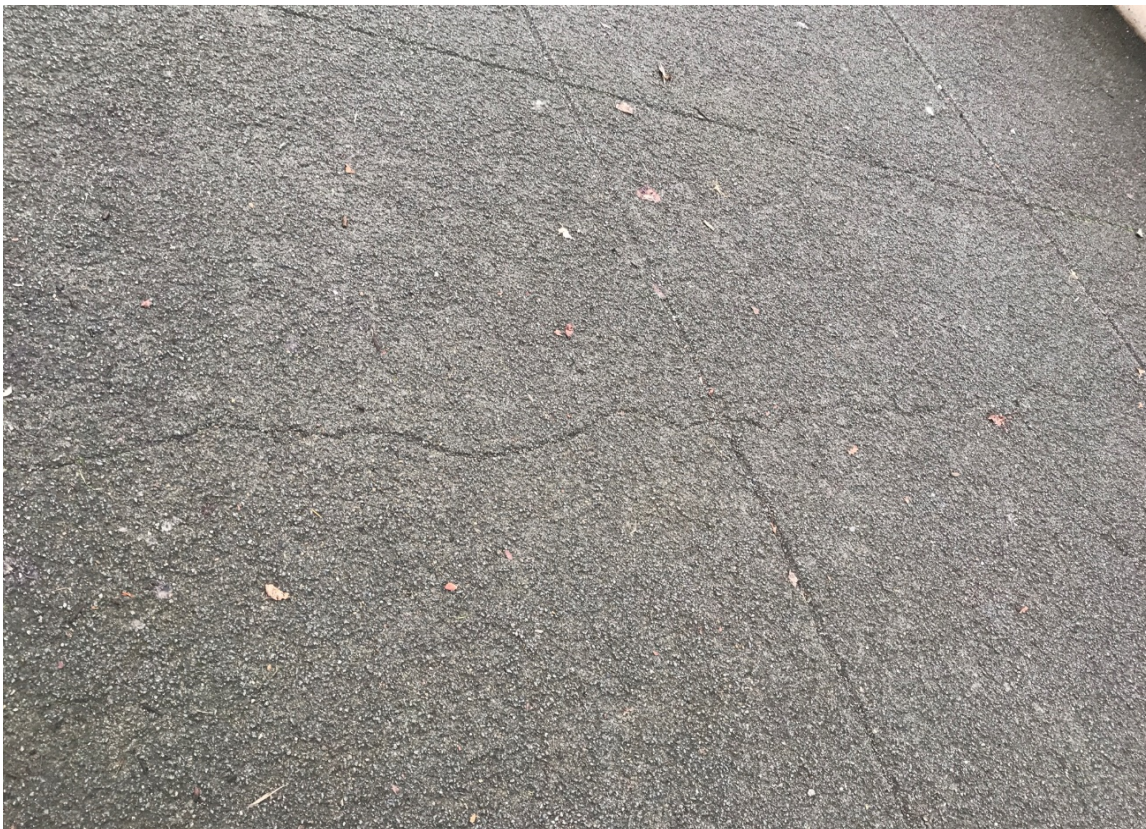
Photo 6: Surficial crack in concrete

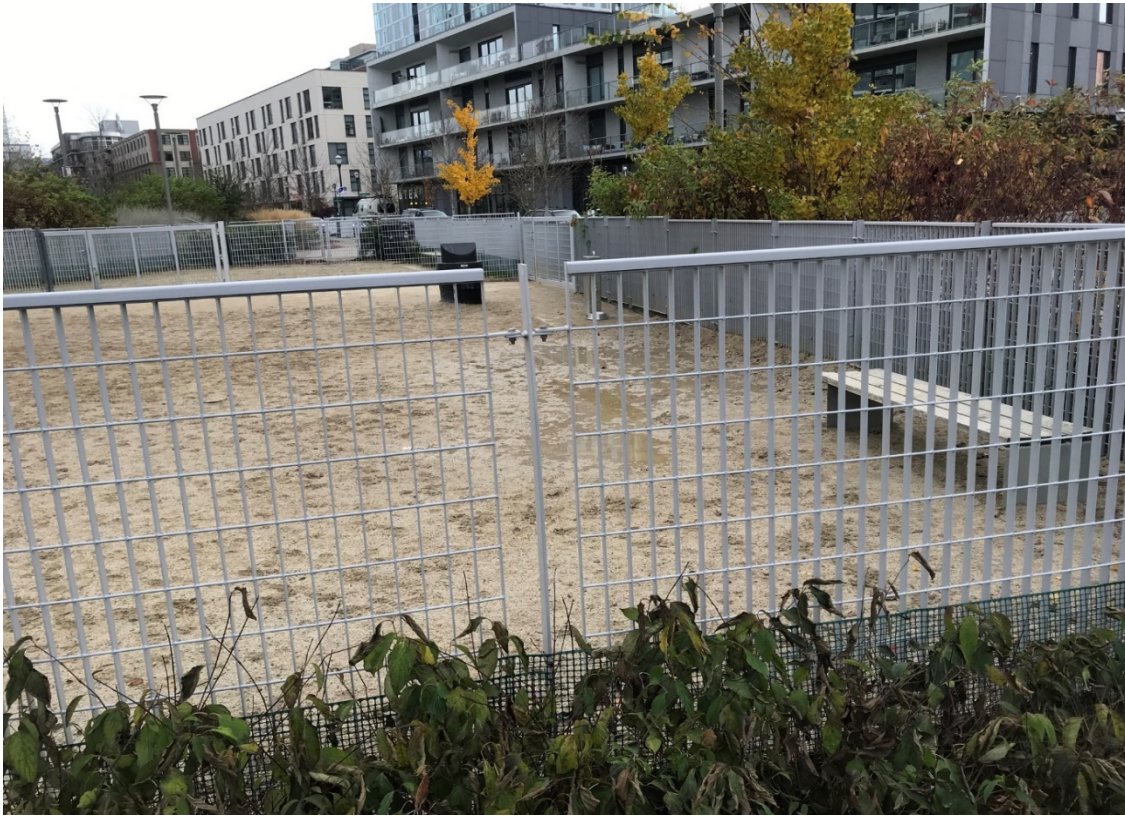
The dog area has been repaired and no fabric was observed. (see attached photos)

Photo 9: Dog park exterior fence

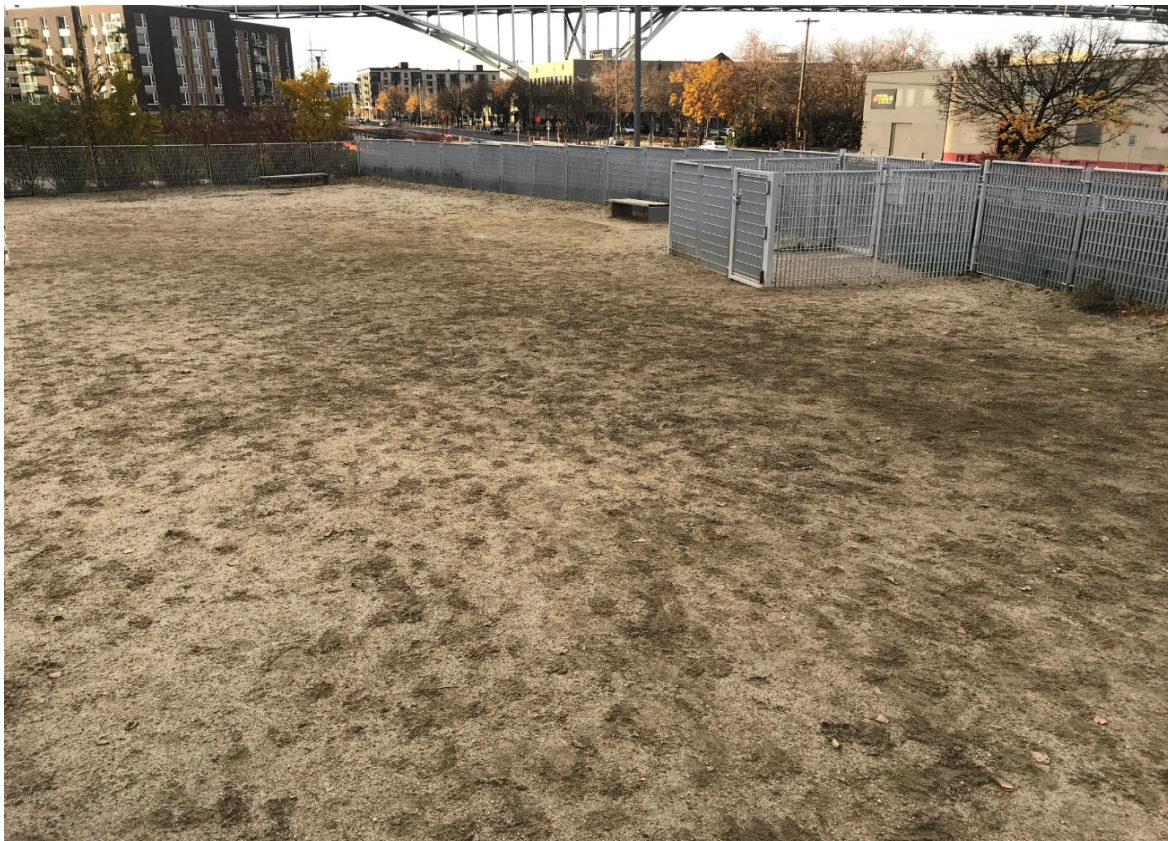
Photo 10: Dog park interior

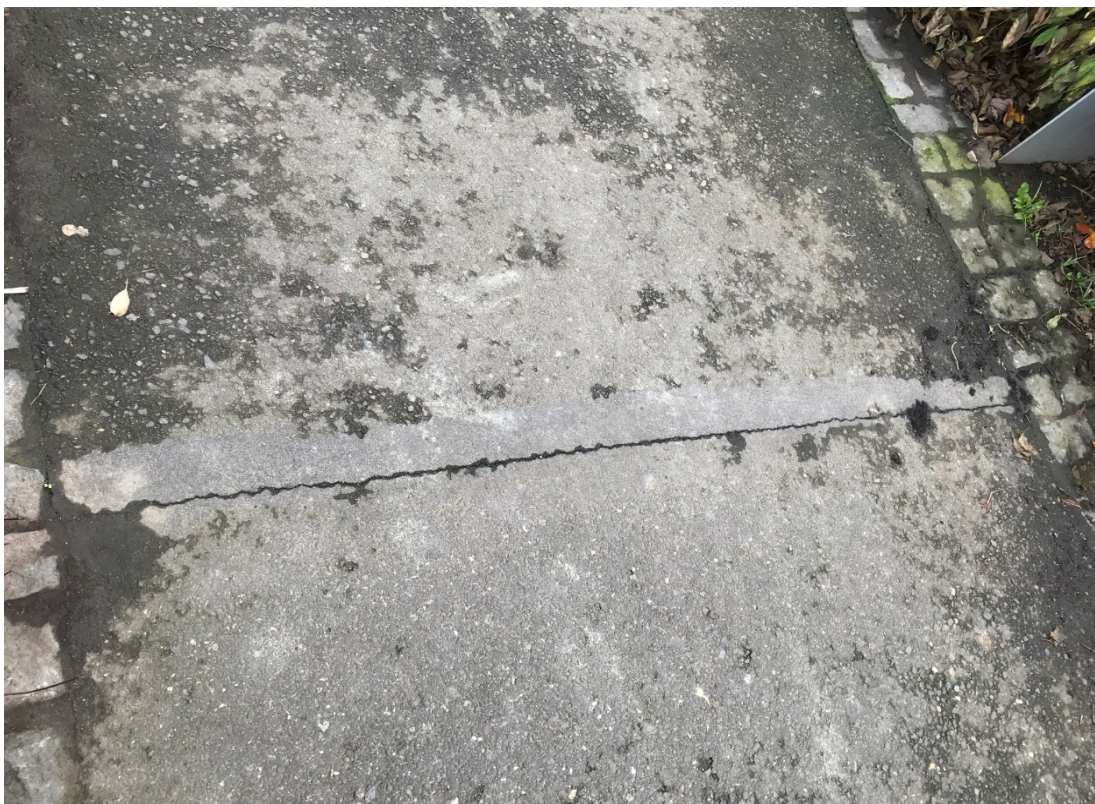
Photo 3: Crack in concrete path adjacent to rail line

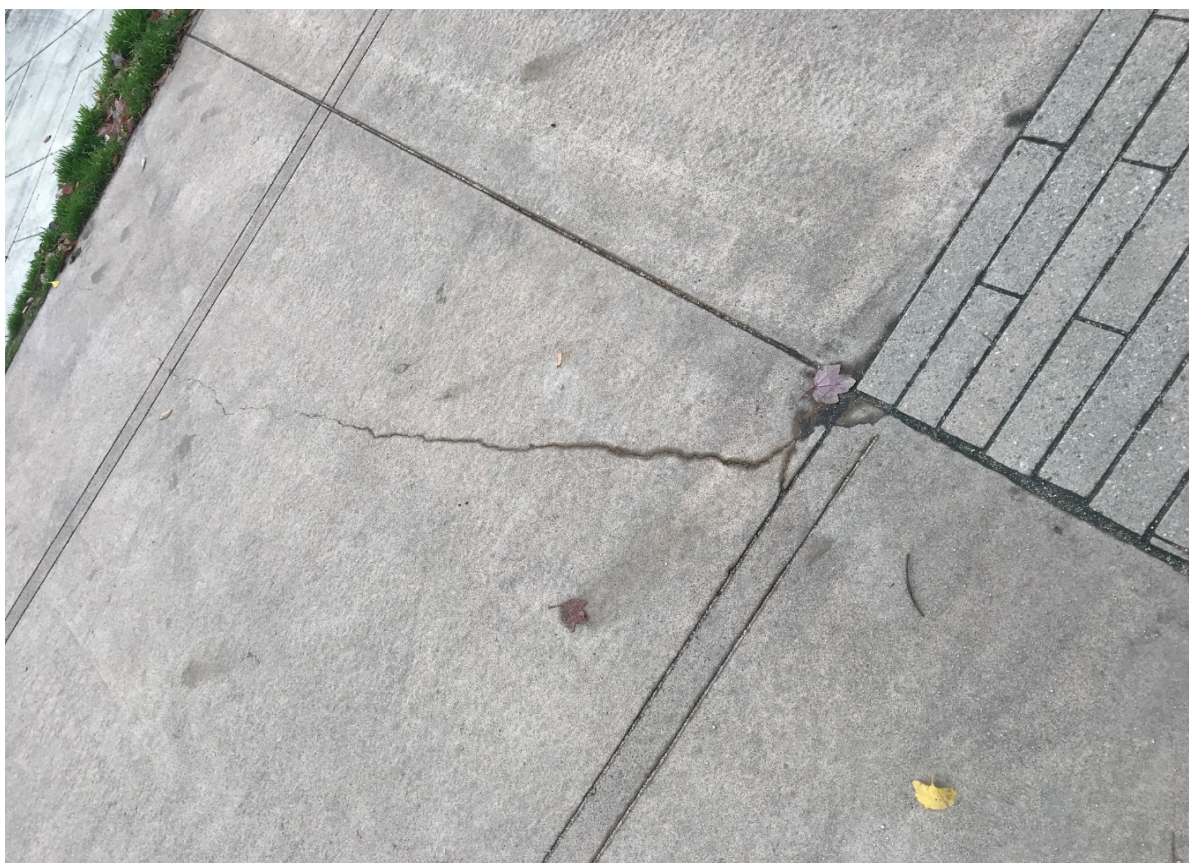
Photo 4: Minor crack in concrete panel

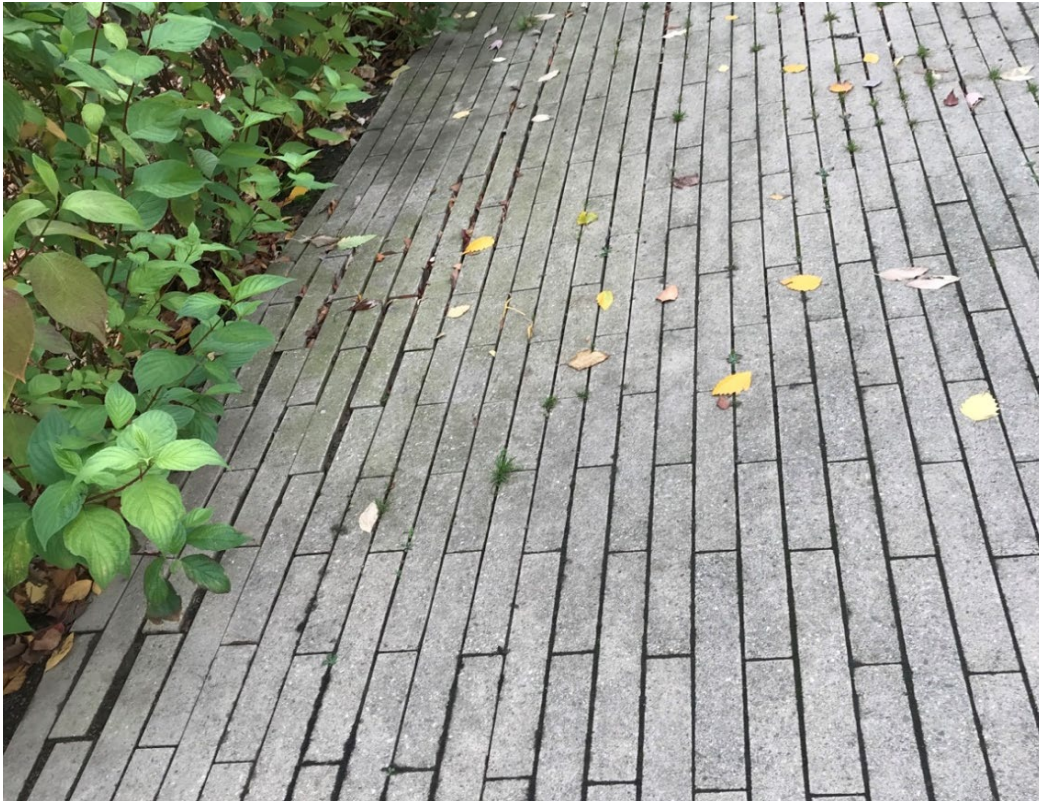
Photo 7: Brick pathway at NW Overton Street and NW 11th Ave

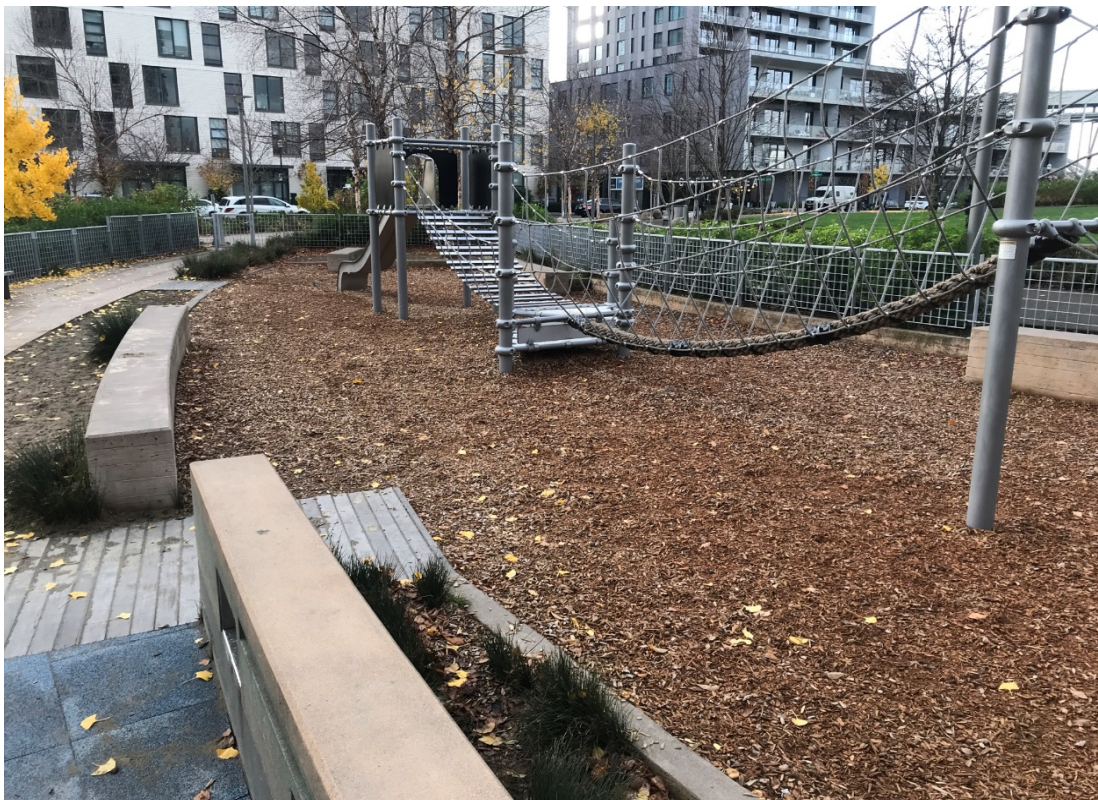
Condition is good.

Photo 8: Children's play area

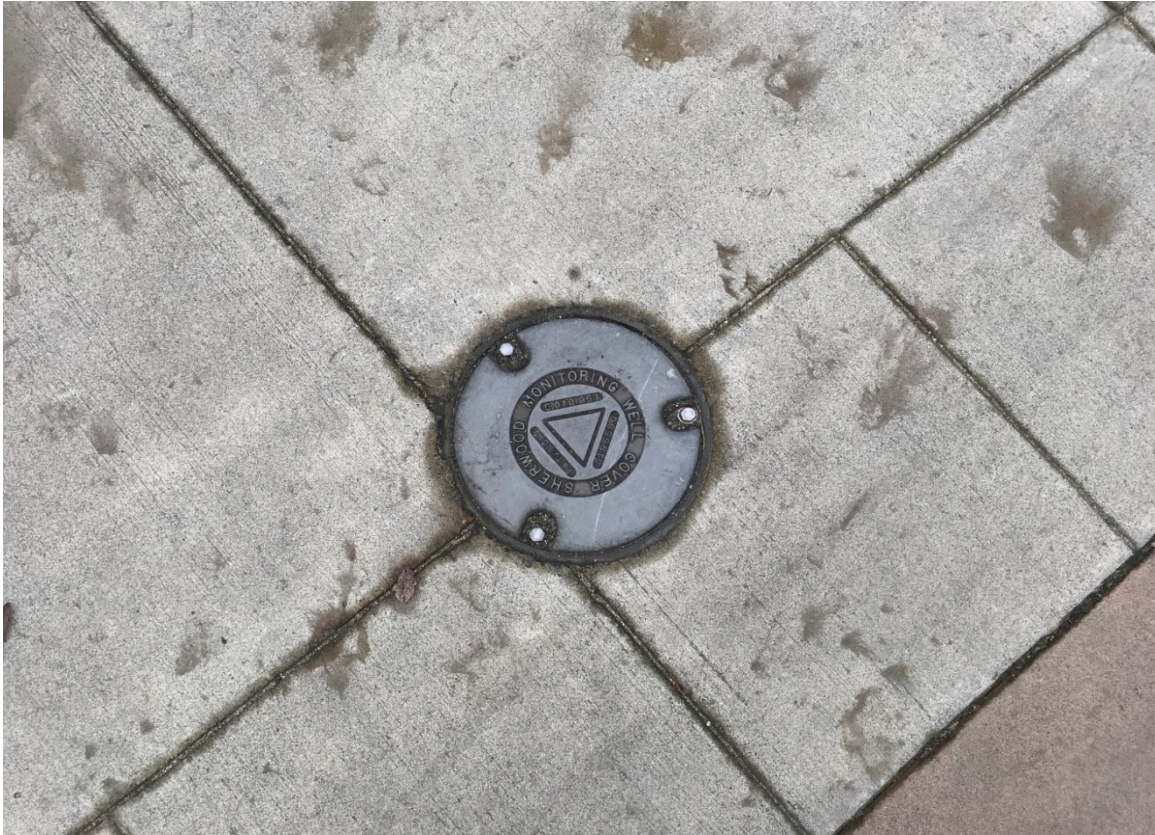
Monitoring well monuments at The Fields Park site were located, photographed, and were found to be in excellent condition. MW-2 was located and is in good condition. (see attached photos)

Photo 11: Monitoring well adjacent to NW 11th Ave

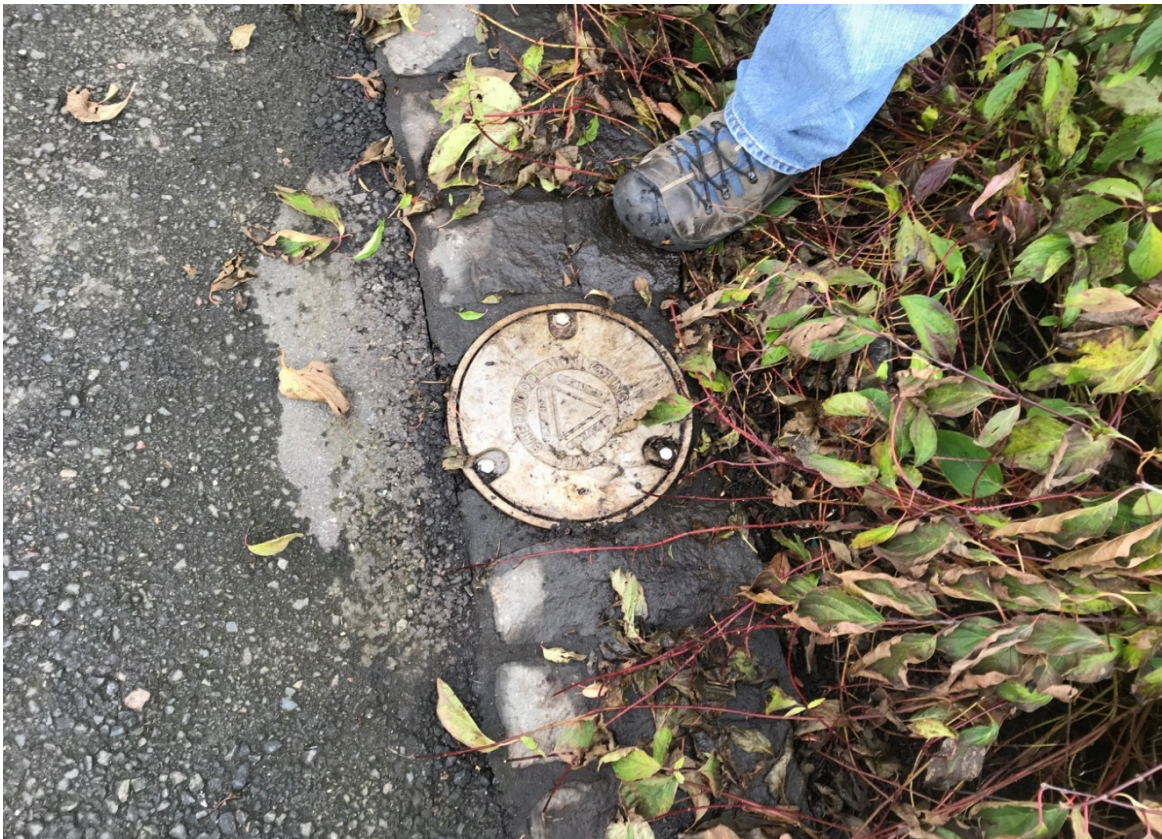
Photo 12: Monitoring well located in northeastern area of site
