Site: The Fields Neighborhood Park

Inspection Date: 10/3/2023

**Fields Park  
Annual Cap Inspection  
Photo Locations Map**

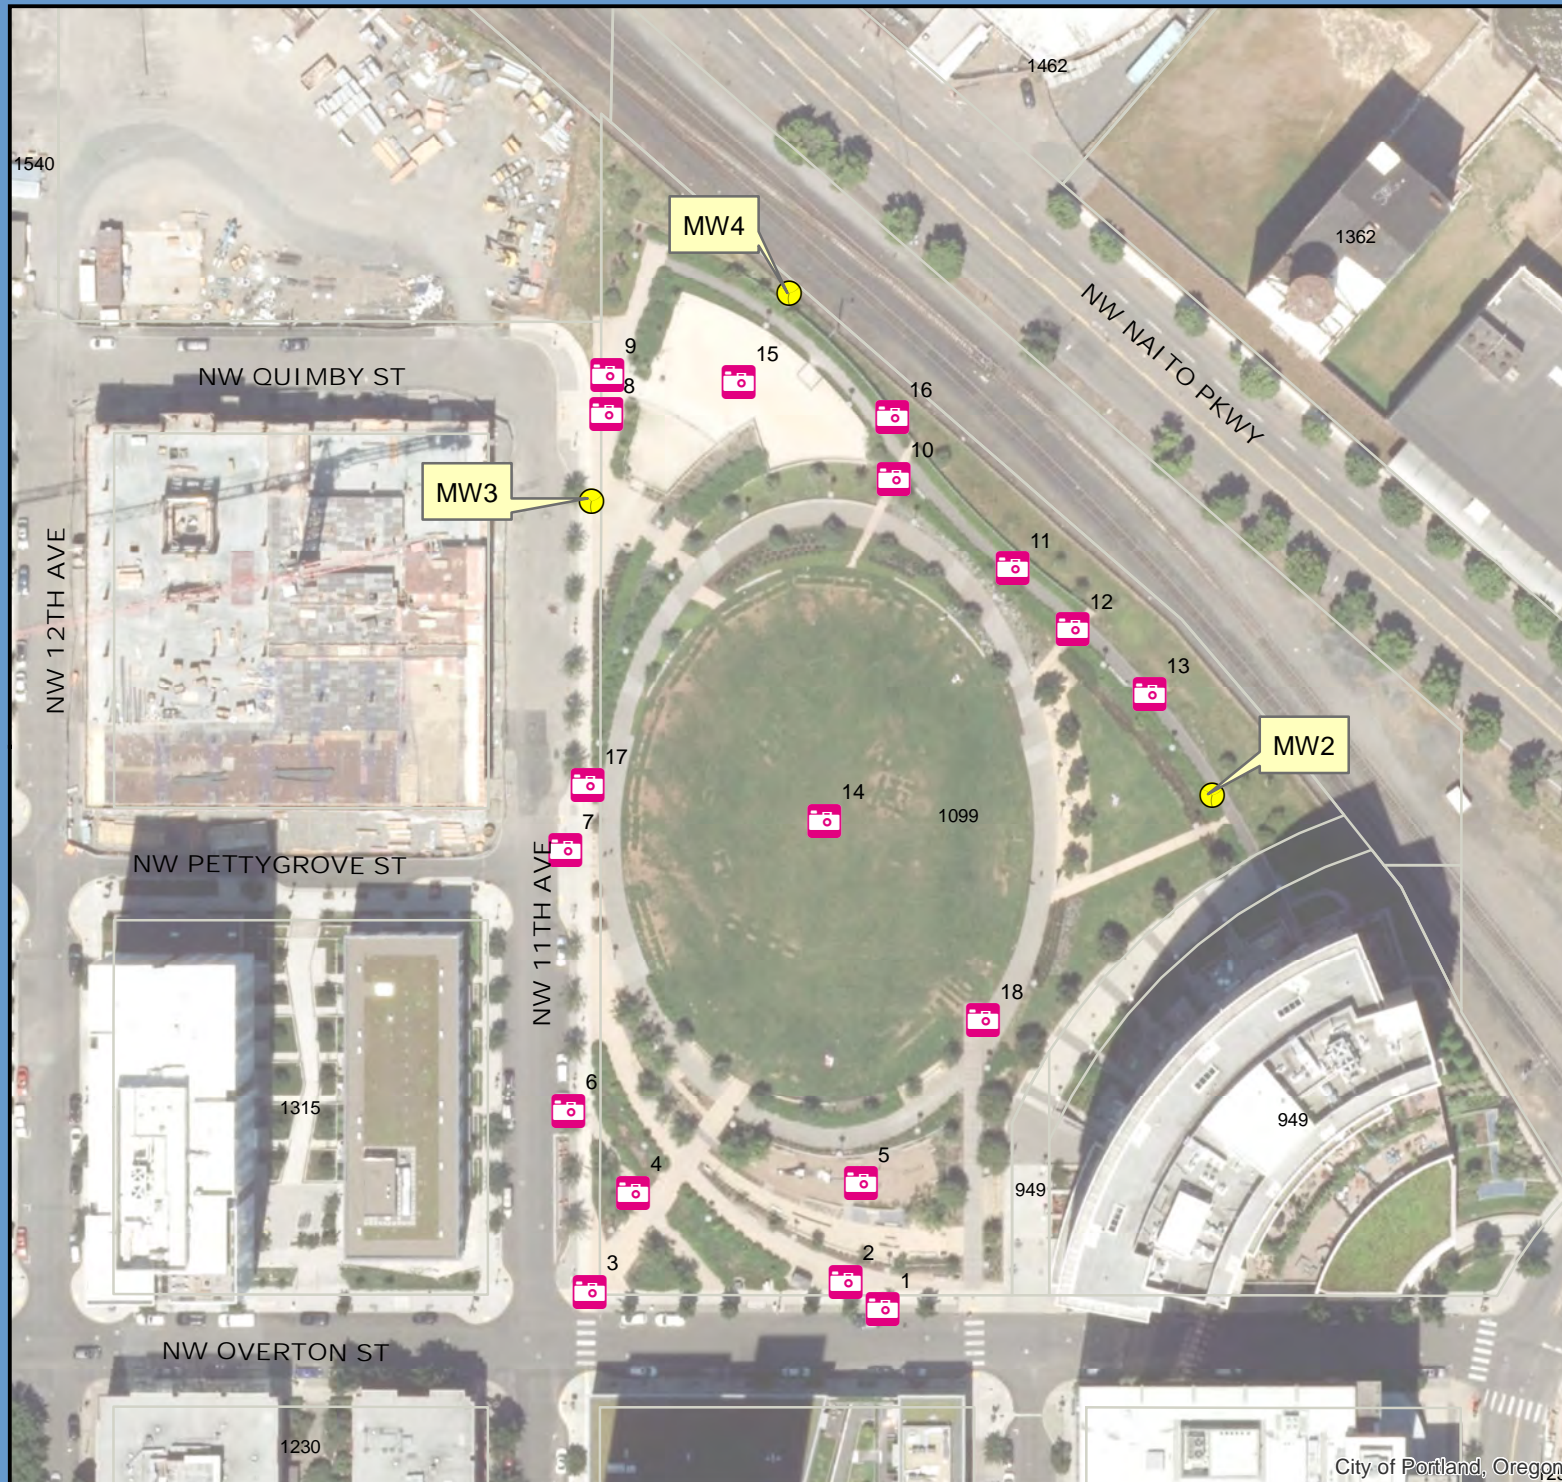
**Figure 1**

Hardscaped areas are in good condition. Based on our assessment, the cap is not compromised in the hardscape areas of the park. See attached Figure 1 and Photo Log.

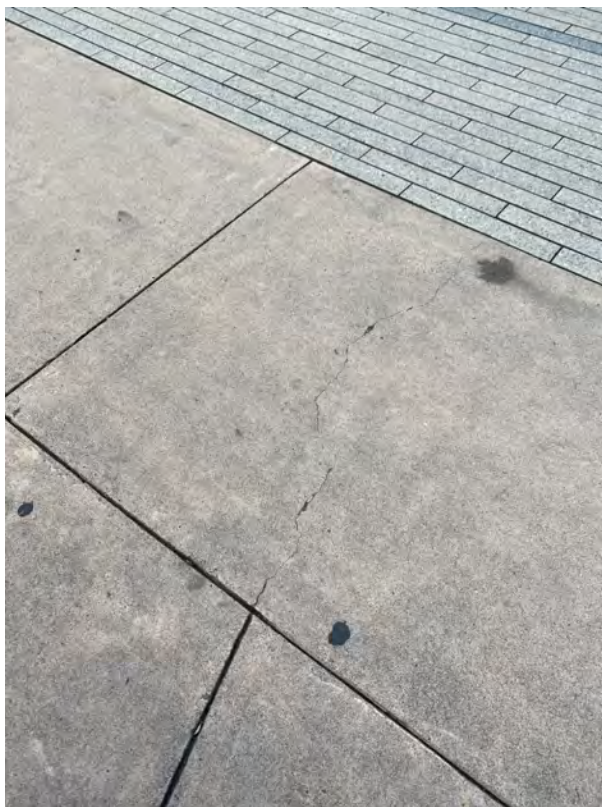
### **Photo Point #2**

Only minor cracking and evidence of settling was observed in the concrete sidewalks and structural foundations on the perimeter of the park (photo points 1-3, 6-13, and 18). These minor cracks (generally <0.5 inches) have been observed in previous inspections and do not appear to penetrate the cap. Separation at the cracks was not observed. One (1) brick pathway is separating slightly but the separation has not changed in the past few years (photo point #4) and does not appear to penetrate the cap. Monitoring wells 2, 3, and 4 were also inspected for cracking, separation, and signs of damage. All monitoring well monuments were in good condition. See attached Photo Log for copies of previous and current year inspection photos. BES will continue to monitor these locations in the following years.

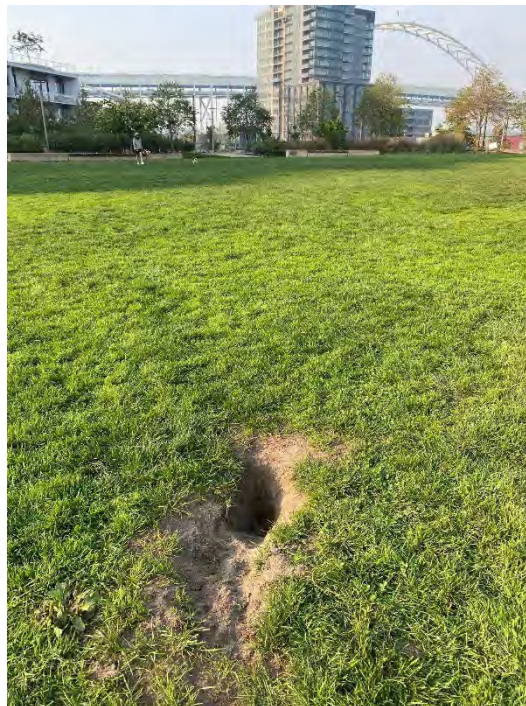
- 2022 hole #1 prior to inspection:

Hole #1 pre-fill

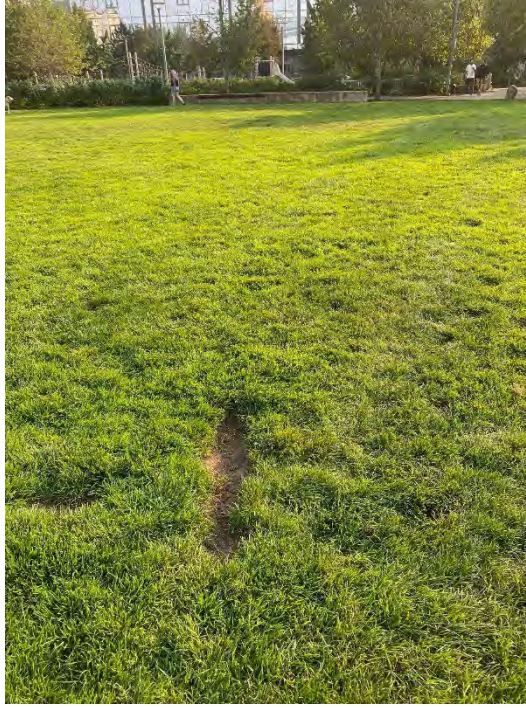
- 2022 hole #2 prior to inspection:

Hole #2 pre-fill

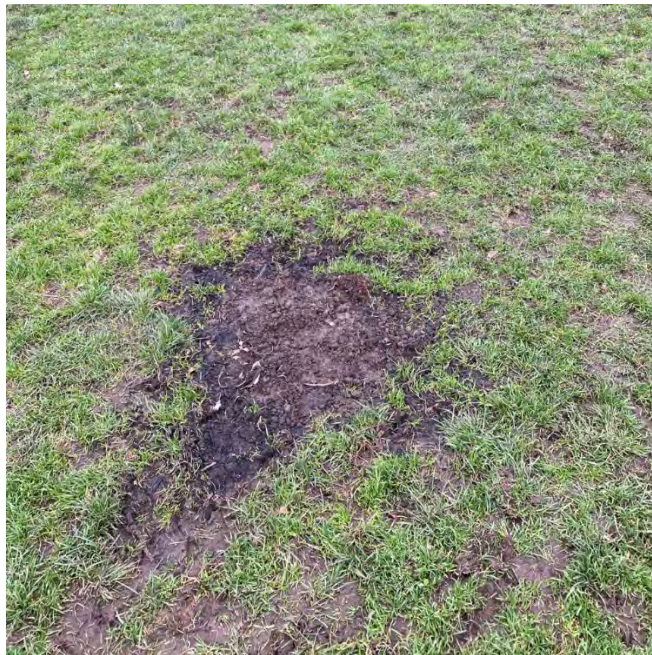
Hole #1 filled

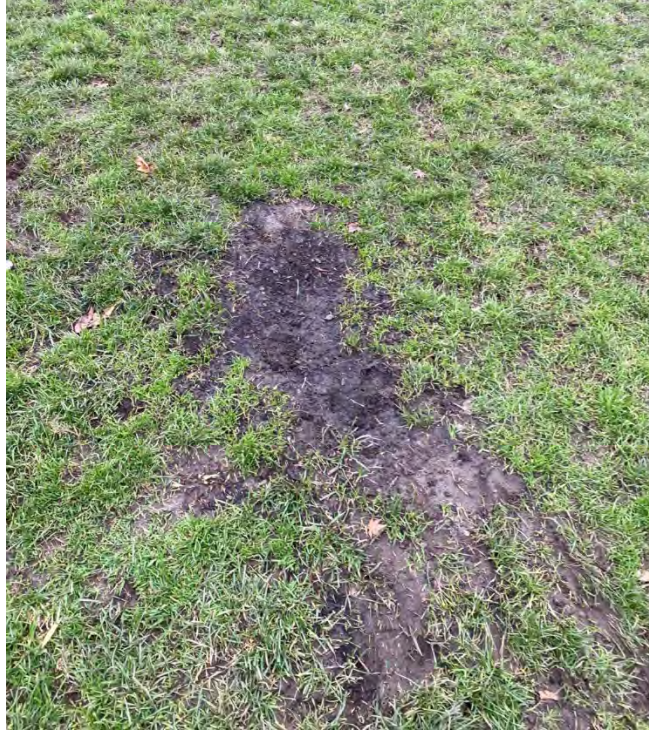
Hole #2 filled

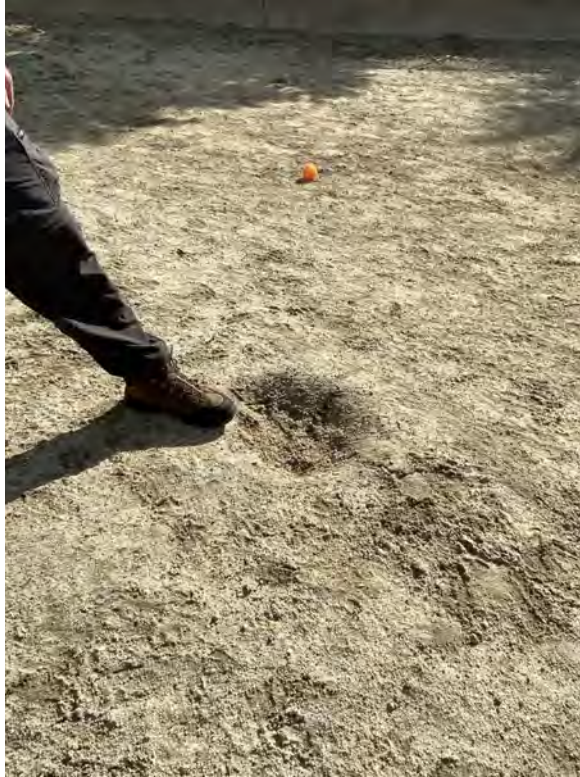
- 2023 inspection photo, close-up of dog dig hole:

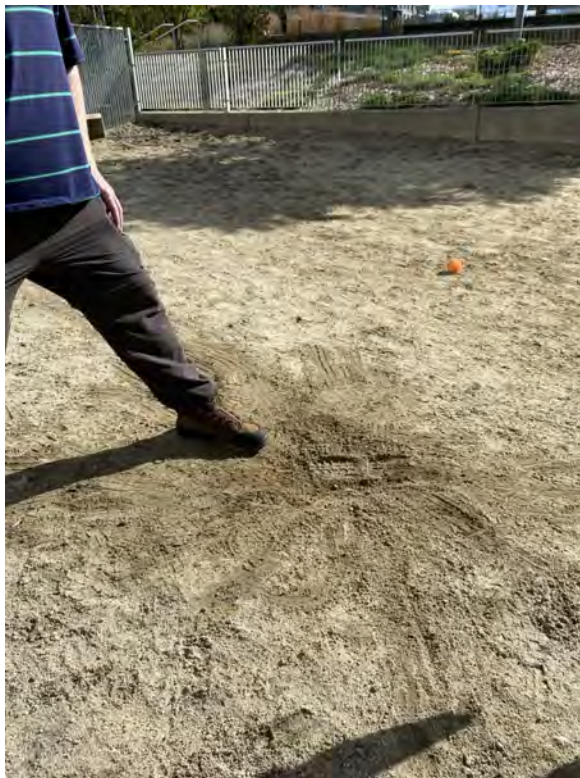
- 2023 inspection photo, close-up of regraded dog dig hole:

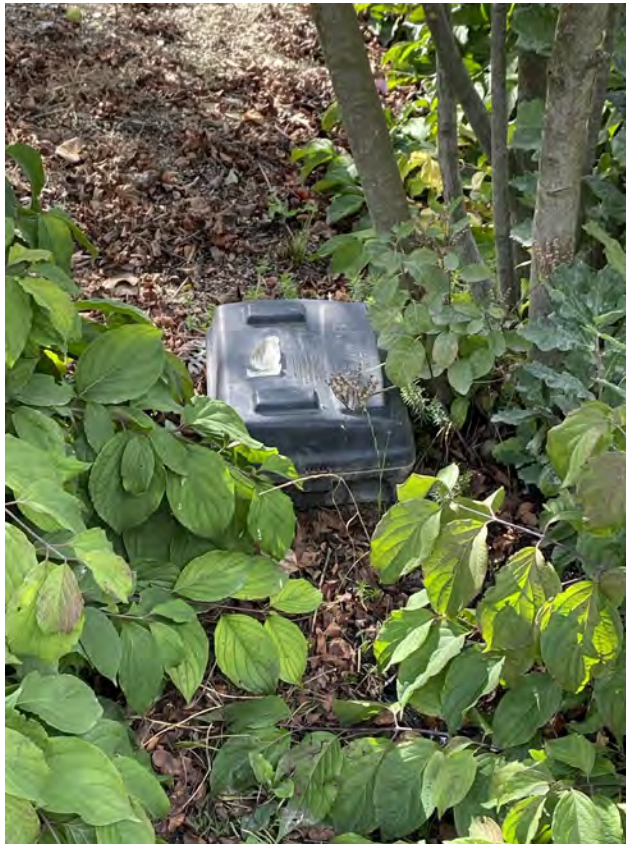
**Photo Point #16 (rodent hole monitoring/vector control, many located around park)**

Landscaped areas, including the central grass area, other areas with plantings, as well as the dog off-leash area in the northern end of the park and the children's playground in the southern end of the park, were inspected for holes, cracks, and visual evidence of exposed demarcation geotextile fabric. No damage was observed in the landscaped areas. The dog off-leash area had one dog dig hole that was approximately 2 inches deep. The surface was regraded with extra surface material at the time of the inspection. The children's playground was in excellent condition and no damage was observed. Evidence of animal burrows were not observed this year and Parks staff continues to control for rodents in the park (photo point 16). See attached Photo Log for copies of previous and current year inspection photos.

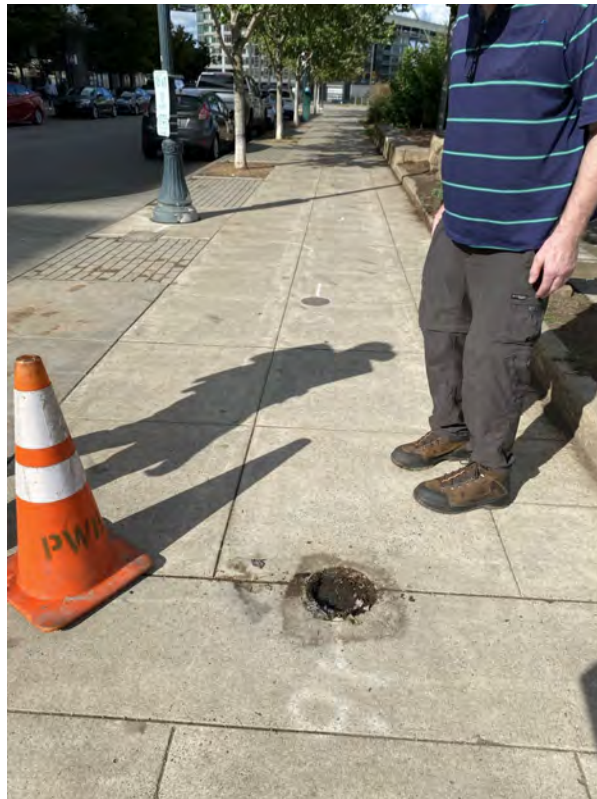
### Photo Point #17

There were two observed utility potholes located on the W sidewalk of the park during the 2022 inspection (photo point 17). These potholes were identified as being completed as part of the upcoming Pacific Power Willamette River Crossing project. The objective of the potholing was to verify the depth of existing utilities in the area and finalize design plans. According to the contractor the potholes were advanced to 29 inches below surface. No demarcation fabric was encountered, and the potholes were backfilled with ¾-inch minus compact rock and patched with asphalt. During this year's inspection the asphalt in the southern pothole location was missing, and a hard, concrete-like surface was encountered about ¼ inch below ground surface. No exposed subsurface soil was observed during the inspection. The Pacific Power Willamette River Crossing project is set to begin October 2023 and patching this pothole will be required as part of the restoration work. BES will continue to monitor these locations and other areas of the park impacted by this project in the following years.

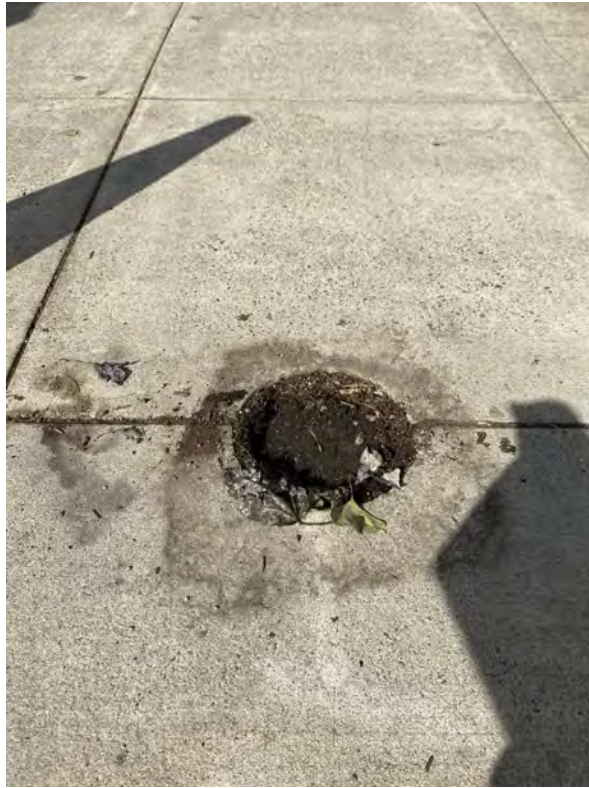
- 2023 inspection photo, close-up of damaged pothole patch. Repair will be required as part of the Pacific Power Willamette River Crossing project.
