Date: July 16, 2024
To: Sarah Van Glubt – Oregon Department of Environmental Quality
Cc: John O'Donovan, P.E. - BES Coordinated Site Assessment Program
From: Brian Marcum, P.E. - BES Coordinated Site Assessment Program
RE: ECSI #404 - Guilds Lake Landfill 2023 Annual Cap Inspection

Guild Lake Landfill
Remediation Project
ECSI 404

2023 Cap Inspection

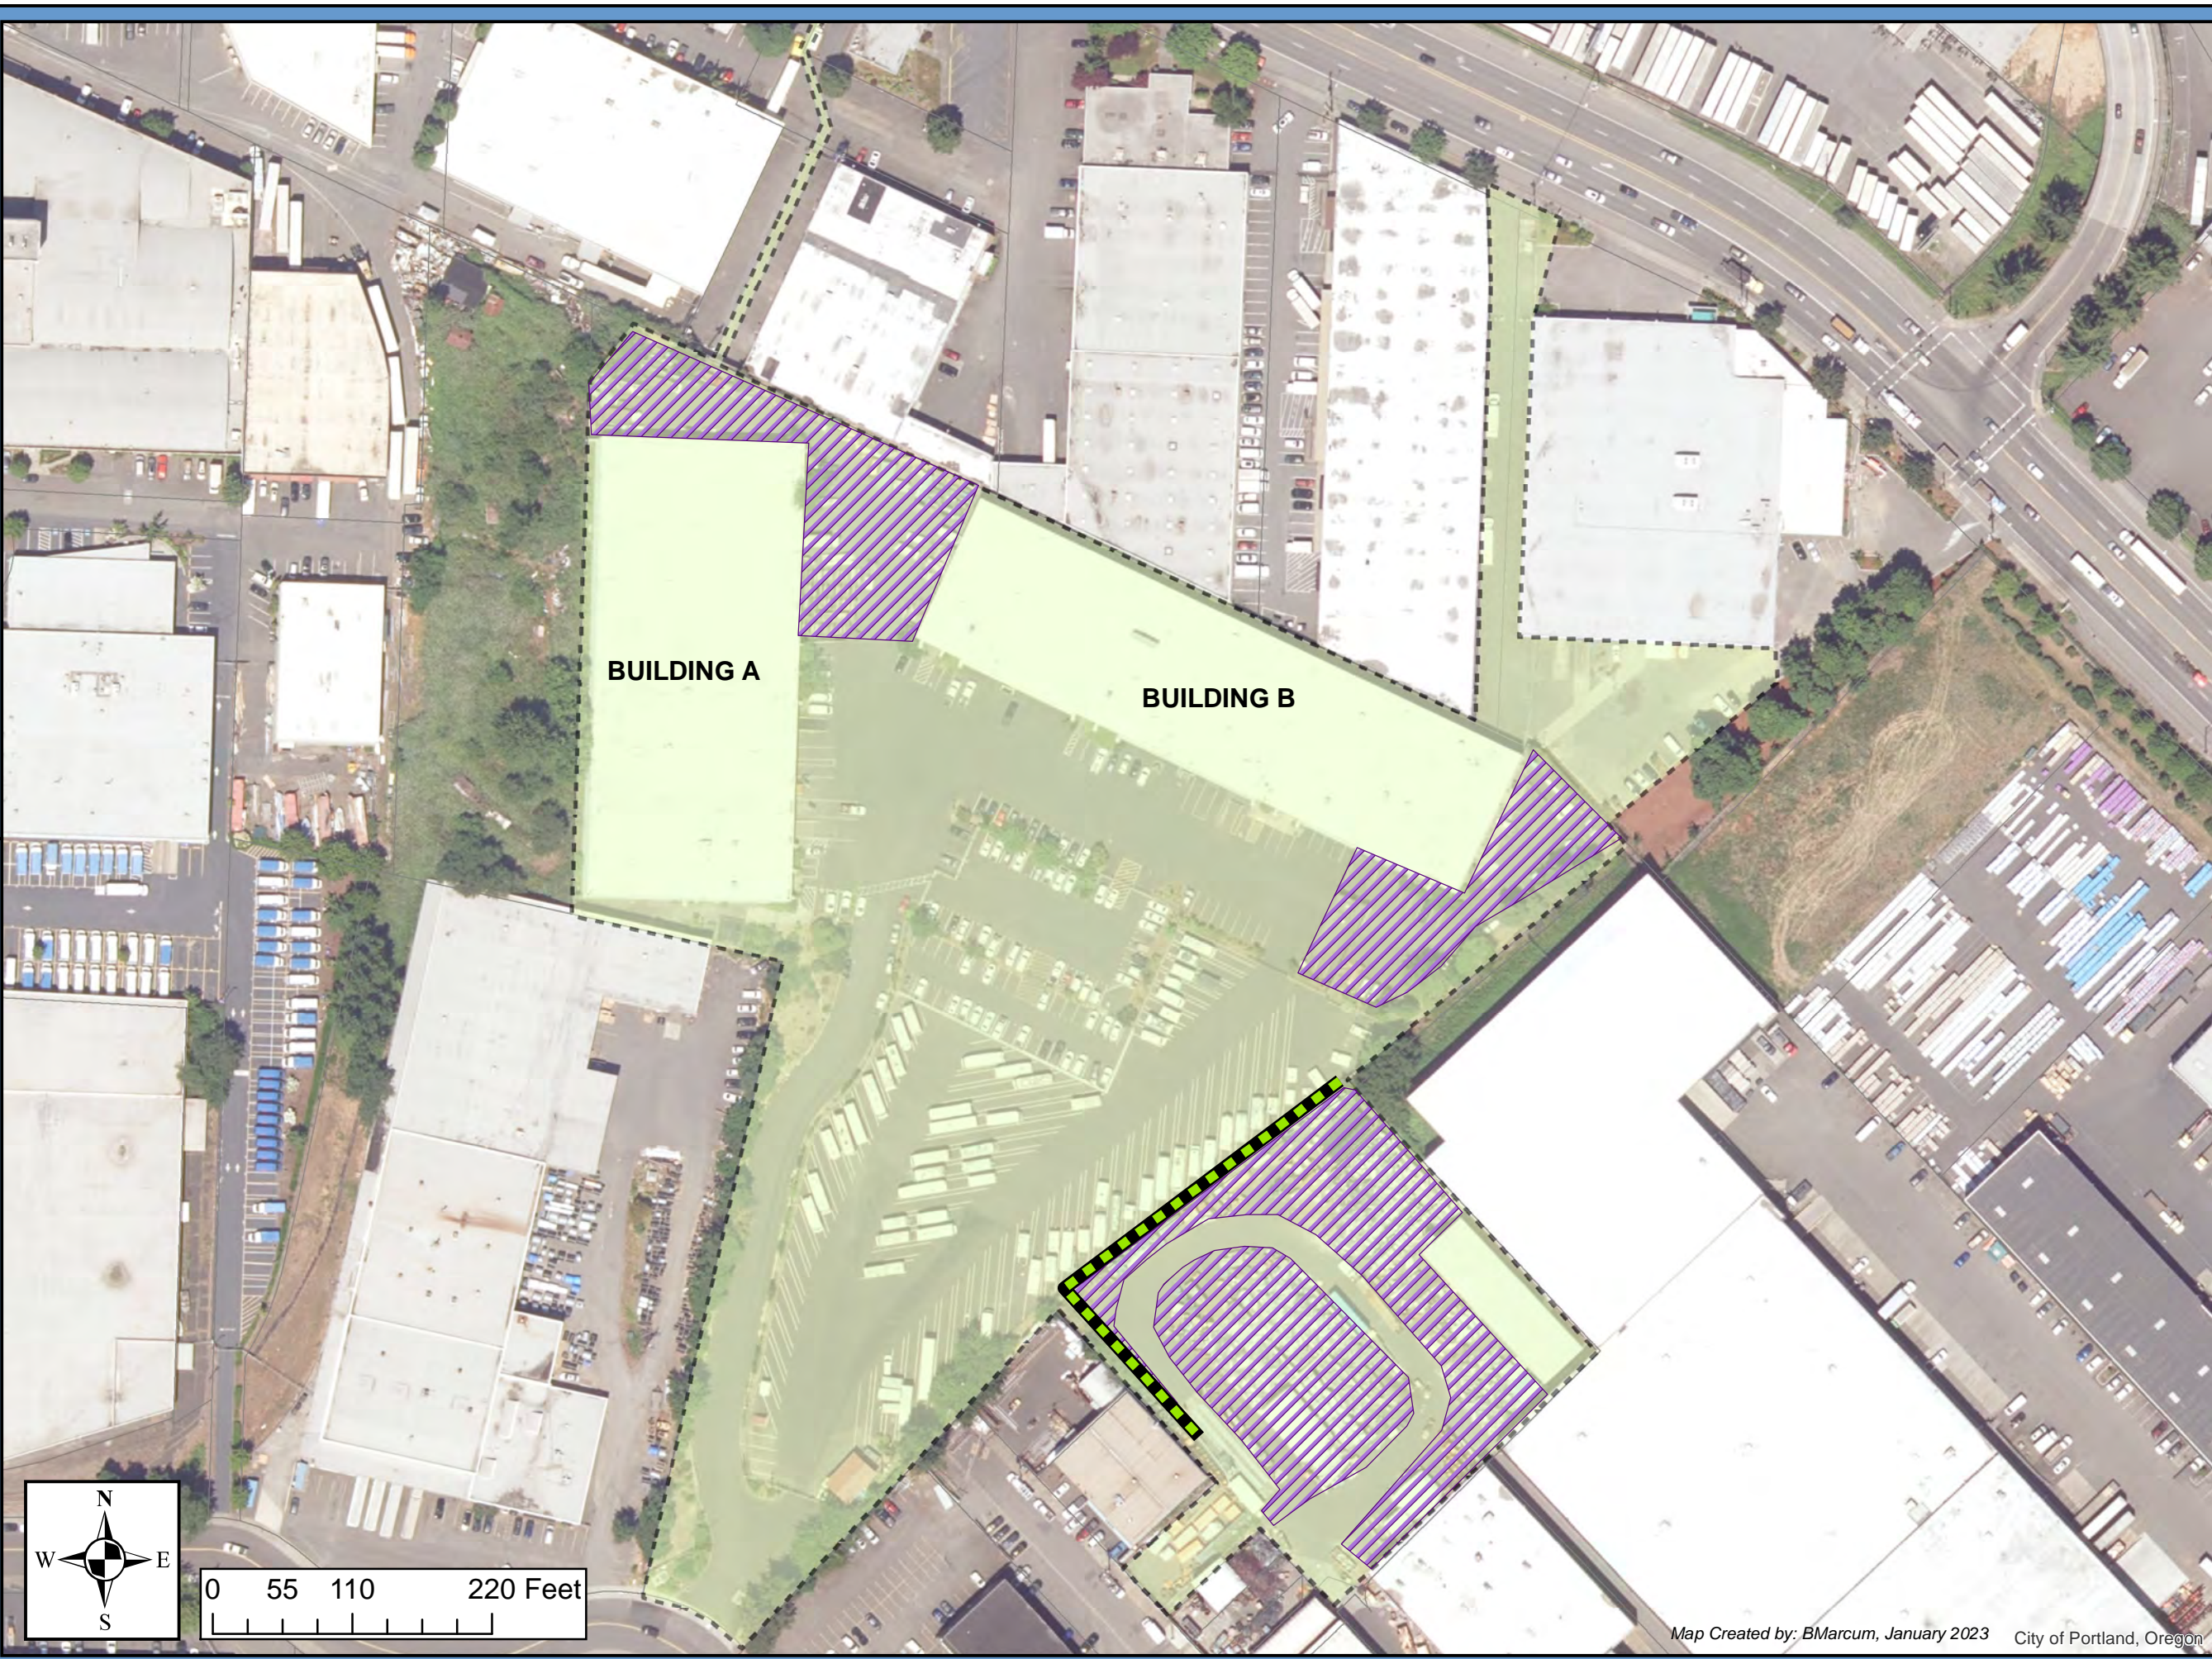
Figure 1 - Site Area

The entire cap, including fenced and unfenced areas, and gabion wall were visually inspected. Cap features are presented in Figure 1.

- Legend**
- Site Cap
 - Gabion Wall
 - Areas of Localized Cracking

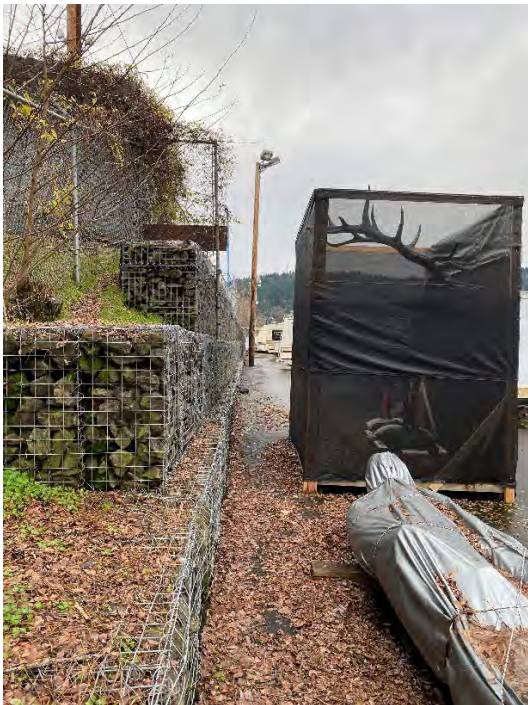
The gabion wall is in good condition, operating as designed, and does not have any wire damage or aggregate loss. An oblique protrusion is present in one section; however, the protrusion has been present for some time and does not appear to be shifting. The remainder of the wall appears plumb. Depending on the results of subsequent inspections, repair of this section may be required in the future.

Photo 4 - Gabion Wall Looking South with Elk Statue

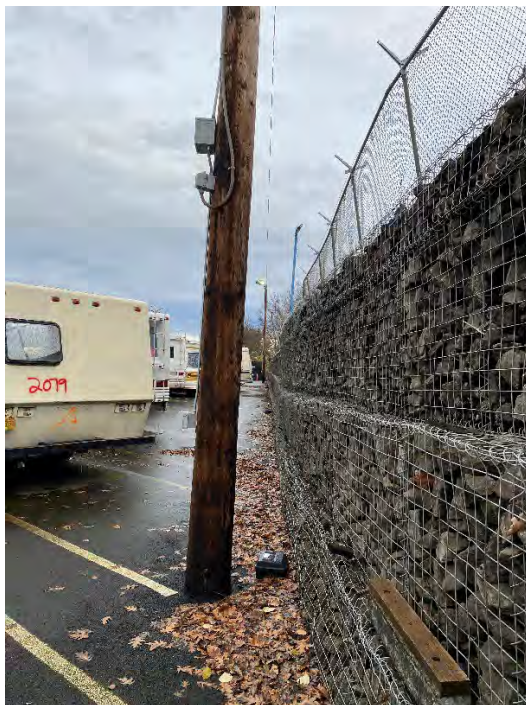
Photo 5 - Gabion Wall Looking North

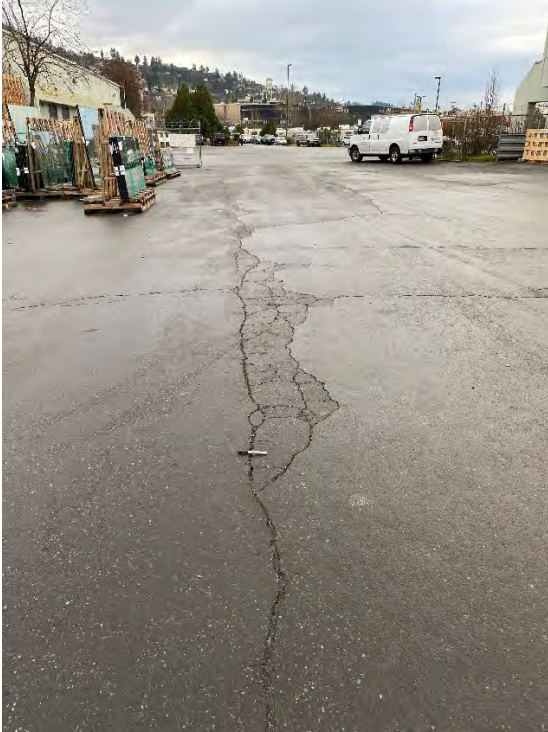
Photo 6 - Cracking in NW of Site Looking South

Recommendations: Overall, the cap is in very good condition. Localized linear cracks and alligator cracking are present in areas that were not repaved in 2019. BES is planning to apply crack sealant to linear cracks in the second half of 2024. More extensive asphalt repairs at Calbag metals may be required in the next 2 - 4 years. BES will work with the tenant to complete the repairs and continue to monitor any changes in surface cracks.

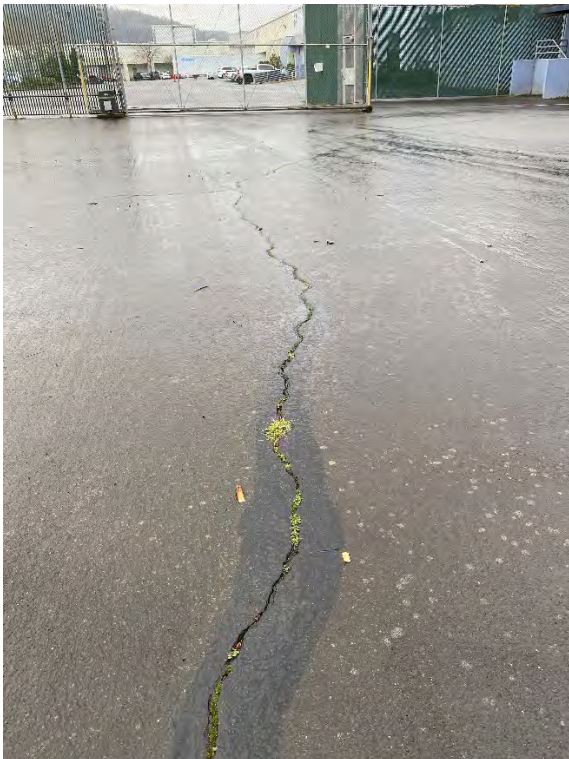
Photo 7 - Cracking in NE of Site Looking West

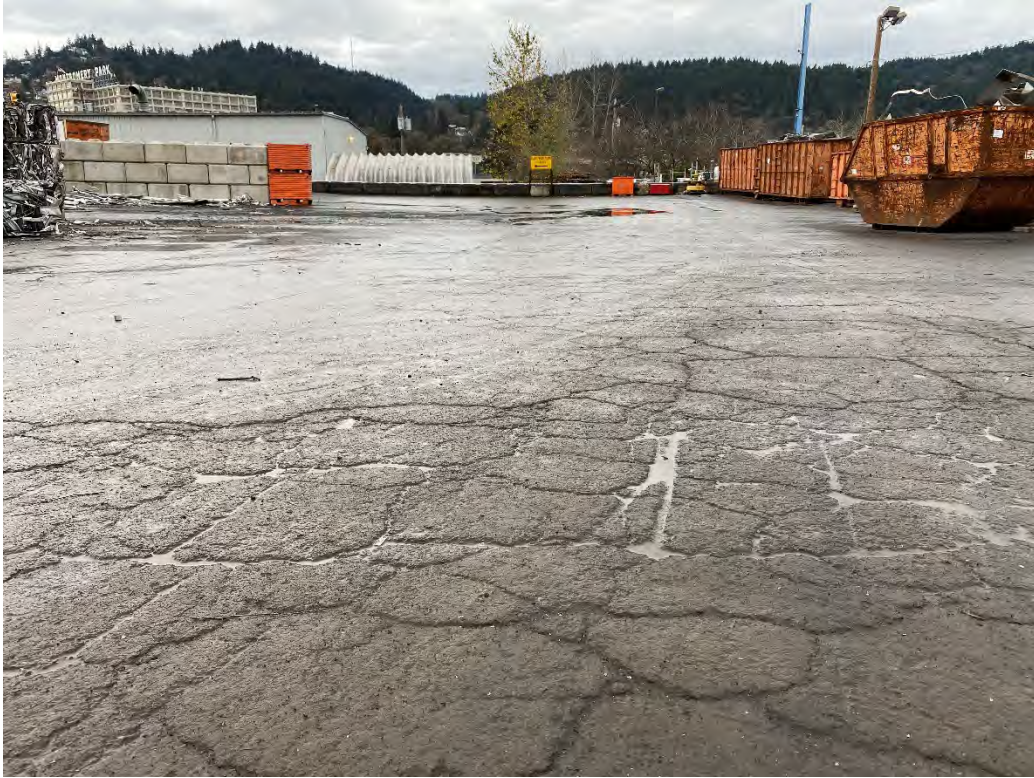
Overall, the cap is in very good condition. The majority of the asphalt cap was repaved in the summer and fall of 2019. The 2019 paved area is excellent condition and shows no evidence of surface cracking or excessive wear. Due to access restrictions and ongoing business operations, secure tenant areas could not be repaved in 2019. Inspection of these areas revealed localized linear and alligator cracking in areas that were not recently repaved. The cracks observed during the 2023 inspection are surficial and do not penetrate the uppermost AC layer or the underlying AC layer that predated the 1995 remedy. However, the number of and size of the cracks has increased compared to previous inspections. Asphalt cracking at the Calbag metals portion of the site, behind the gabion wall, appears more widespread and is attributed the cyclical truck and equipment loading and materials staging.

Photo 8 – Cracking on Calbag Metals Lot looking SW, outside of area paved in 2019

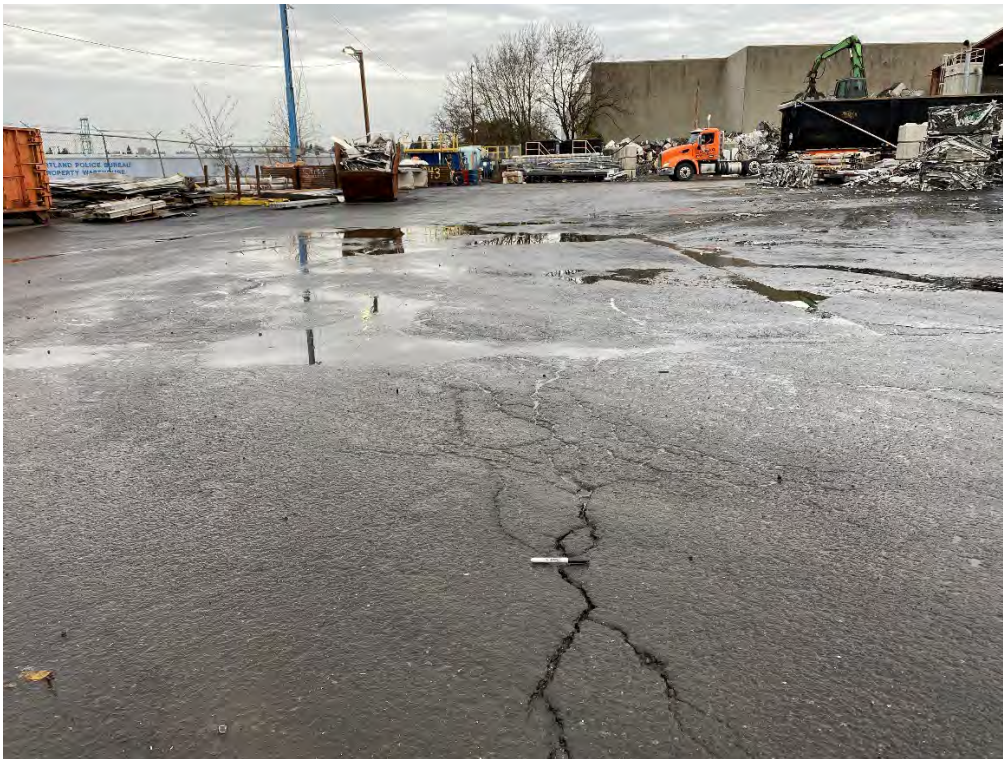
Photo 9 – Cracking on Calbag Metals Lot looking NE, outside of area paved in 2019
