SUBJECT: REQUEST FOR CONCURRENCE WITH ENVIRONMENTAL  
CONDITION OF PROPERTY, NAVY OPERATIONAL SUPPORT  
CENTER, EUGENE, OREGON

Enclosure: (1) Environmental Condition of Property,  
Eugene Navy Operational Support Center

***Navy & Marine Corps Reserve Center  
Environmental Baseline Survey  
Eugene, Oregon***

***May 14, 1999  
J-7057-06***

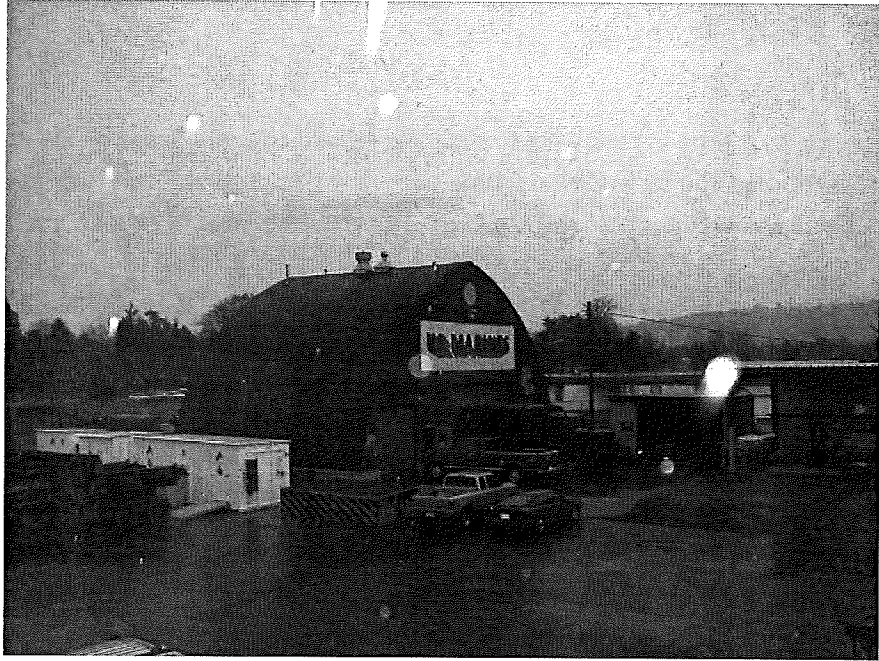
- Hart Crowser performed soil investigation for the Navy in 1999. Prior to the investigation, the former gun shed (Building 6) had been converted to vehicle maintenance, but was no longer in use. The exterior of the building is shown below in Figure 1, and the interior is shown in Figure 2. Both photos show that the building has a concrete foundation/floor, so spilled material would not have been in contact with soil. In addition, soil under the mechanic's pits inside the building was sampled and analyzed for VOCs. Groundwater was included in some of the test pits and was screened. No VOCs were detected.

Figure 1: Bldg 6, Maintenance Barn (Former Gun Shed), NW Side

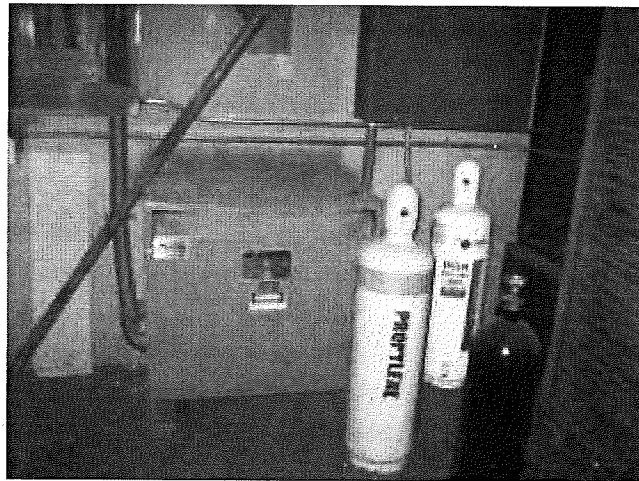
Figure 2: Electrical equipment in Maintenance Barn and propylene tanks

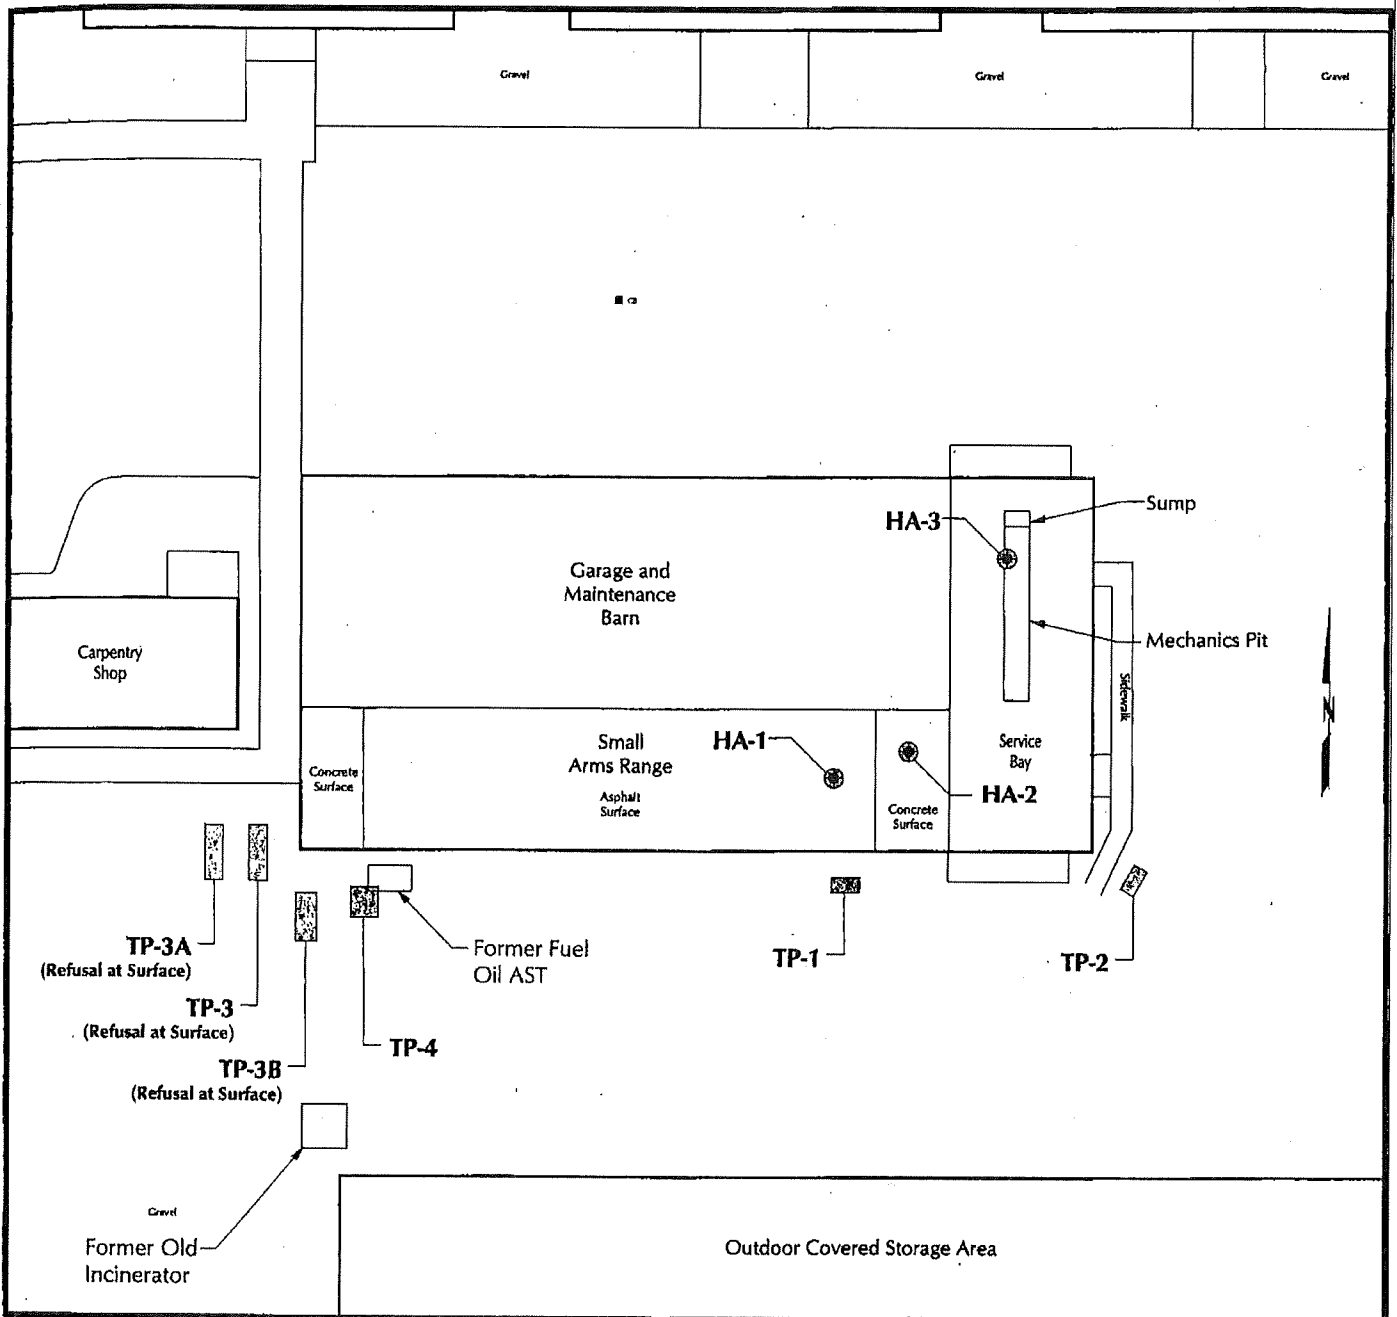
# Small Arms Range/Garage and Maintenance Barn Sampling Location Plan

**Small Arms Range.** Soil samples from the small arms range area were analyzed for total lead and Hazardous Waste Toxicity Characteristic Leaching Potential (TCLP) lead.

- Total Lead: Lead was detected in all five soil samples (HA-1/S-1, HA-2/S-1, TP-1/S-1, TP-2/S-1, and TP-4/S-1) collected beneath and around the Small Arms Range. Concentrations for lead in soil ranged from 5.6 mg/kg (HA1/S-1) to 8.1 mg/kg (TP-2/S-1). Sample HA-2 was collected from soil beneath the concrete floor in the bullet drop area. These lead concentrations are typical of background concentrations (Ecology 1994).
- TCLP Lead: Because we anticipated high levels of total lead in soil collected in and near the bullet drop area, those soil samples (HA-1/S-1 and HA-2/S-1) were also analyzed for leachable lead. Leachable lead was not detected in either sample. Soil lead chemical results are listed in Table 5.

**Mechanic's Pit.** Soil from a hand auger boring (HA-3/S-1) was analyzed for the presence of petroleum hydrocarbons, VOCs, cadmium, chromium, and lead.

- Petroleum Hydrocarbons: Petroleum hydrocarbons were not detected in HA-3/S-1.
- VOCs: VOCs were not detected in HA-3/S-1 (Table 6).

- Metals: Chromium and lead were detected in HA-3/S-1 at concentrations of 20 mg/kg and 3.9 mg/kg, respectively. Cadmium was not detected. These metal concentrations are typical of background concentrations (Ecology, 1994).

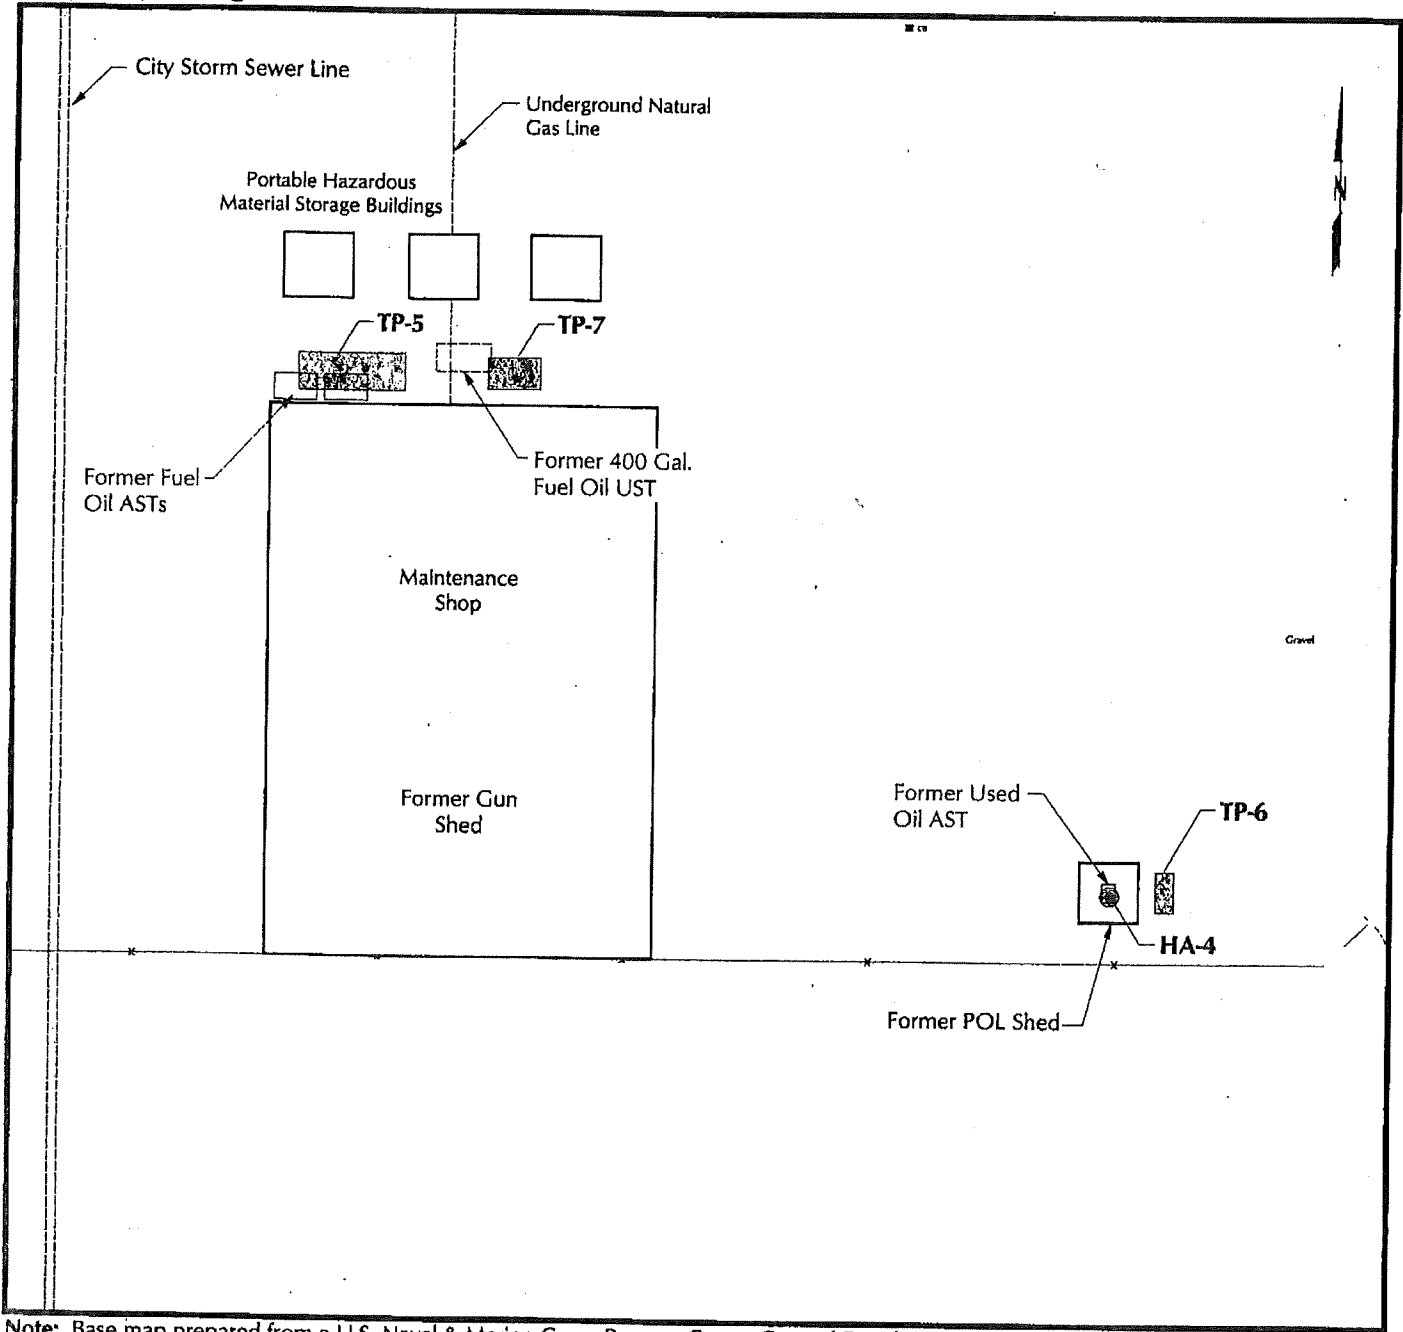
# Maintenance Shop (Former Gun Shed) and Former POL Shed Sampling Location Plan

**Two Former ASTs and Potential UST at Maintenance Shop (Former Gun Shed).** Soil samples from test pits TP-5 and TP-7 were analyzed for the presence of petroleum hydrocarbons. Soil from TP-5 was analyzed for diesel and oil.

indications for petroleum, sample TP-5/S-1 was analyzed for diesel and oil range hydrocarbons. Diesel was detected in TP-5/S-1 at a concentration of 37.7 mg/kg. This concentration is less than the DEQ Level 1 soil matrix cleanup standard (100 mg/kg) for diesel releases from USTs. This standard is often used in other situations such as a release from an AST. Oil was not detected. Soil petroleum hydrocarbon chemical results are listed in Table 4.

- Potential UST: A potential UST was not encountered during installation of TP-5 and TP-7. These test pits were installed as close as practical to the potential UST location due to an existing gas line. TP-7 was placed along the eastern edge of the potential UST location.

**Former Used Oil AST and Former POL Shed.** Soil from a hand auger boring (HA-4/S-1) was analyzed for the presence of petroleum hydrocarbons, VOCs, cadmium, chromium, and lead.

- Petroleum Hydrocarbons: Petroleum hydrocarbons were not detected in HA-4/S-1.
- • VOCs: VOCs were not detected in HA-4/S-1.
- Metals: Chromium and lead were detected in HA-4/S-1 at concentrations of 44 mg/kg and 9.5 mg/kg, respectively. Cadmium was not detected. These metal concentrations are typical of background concentrations (Ecology, 1994).
