# Technical Memorandum

To: Kara Master, Oregon DEQ Date: October 23, 2024  
From: Julie Pace, Maul Foster & Alongi Project No.: M0785.30.001  
Re: Limited Pre-Renovation Asbestos Survey – Burns Downtown

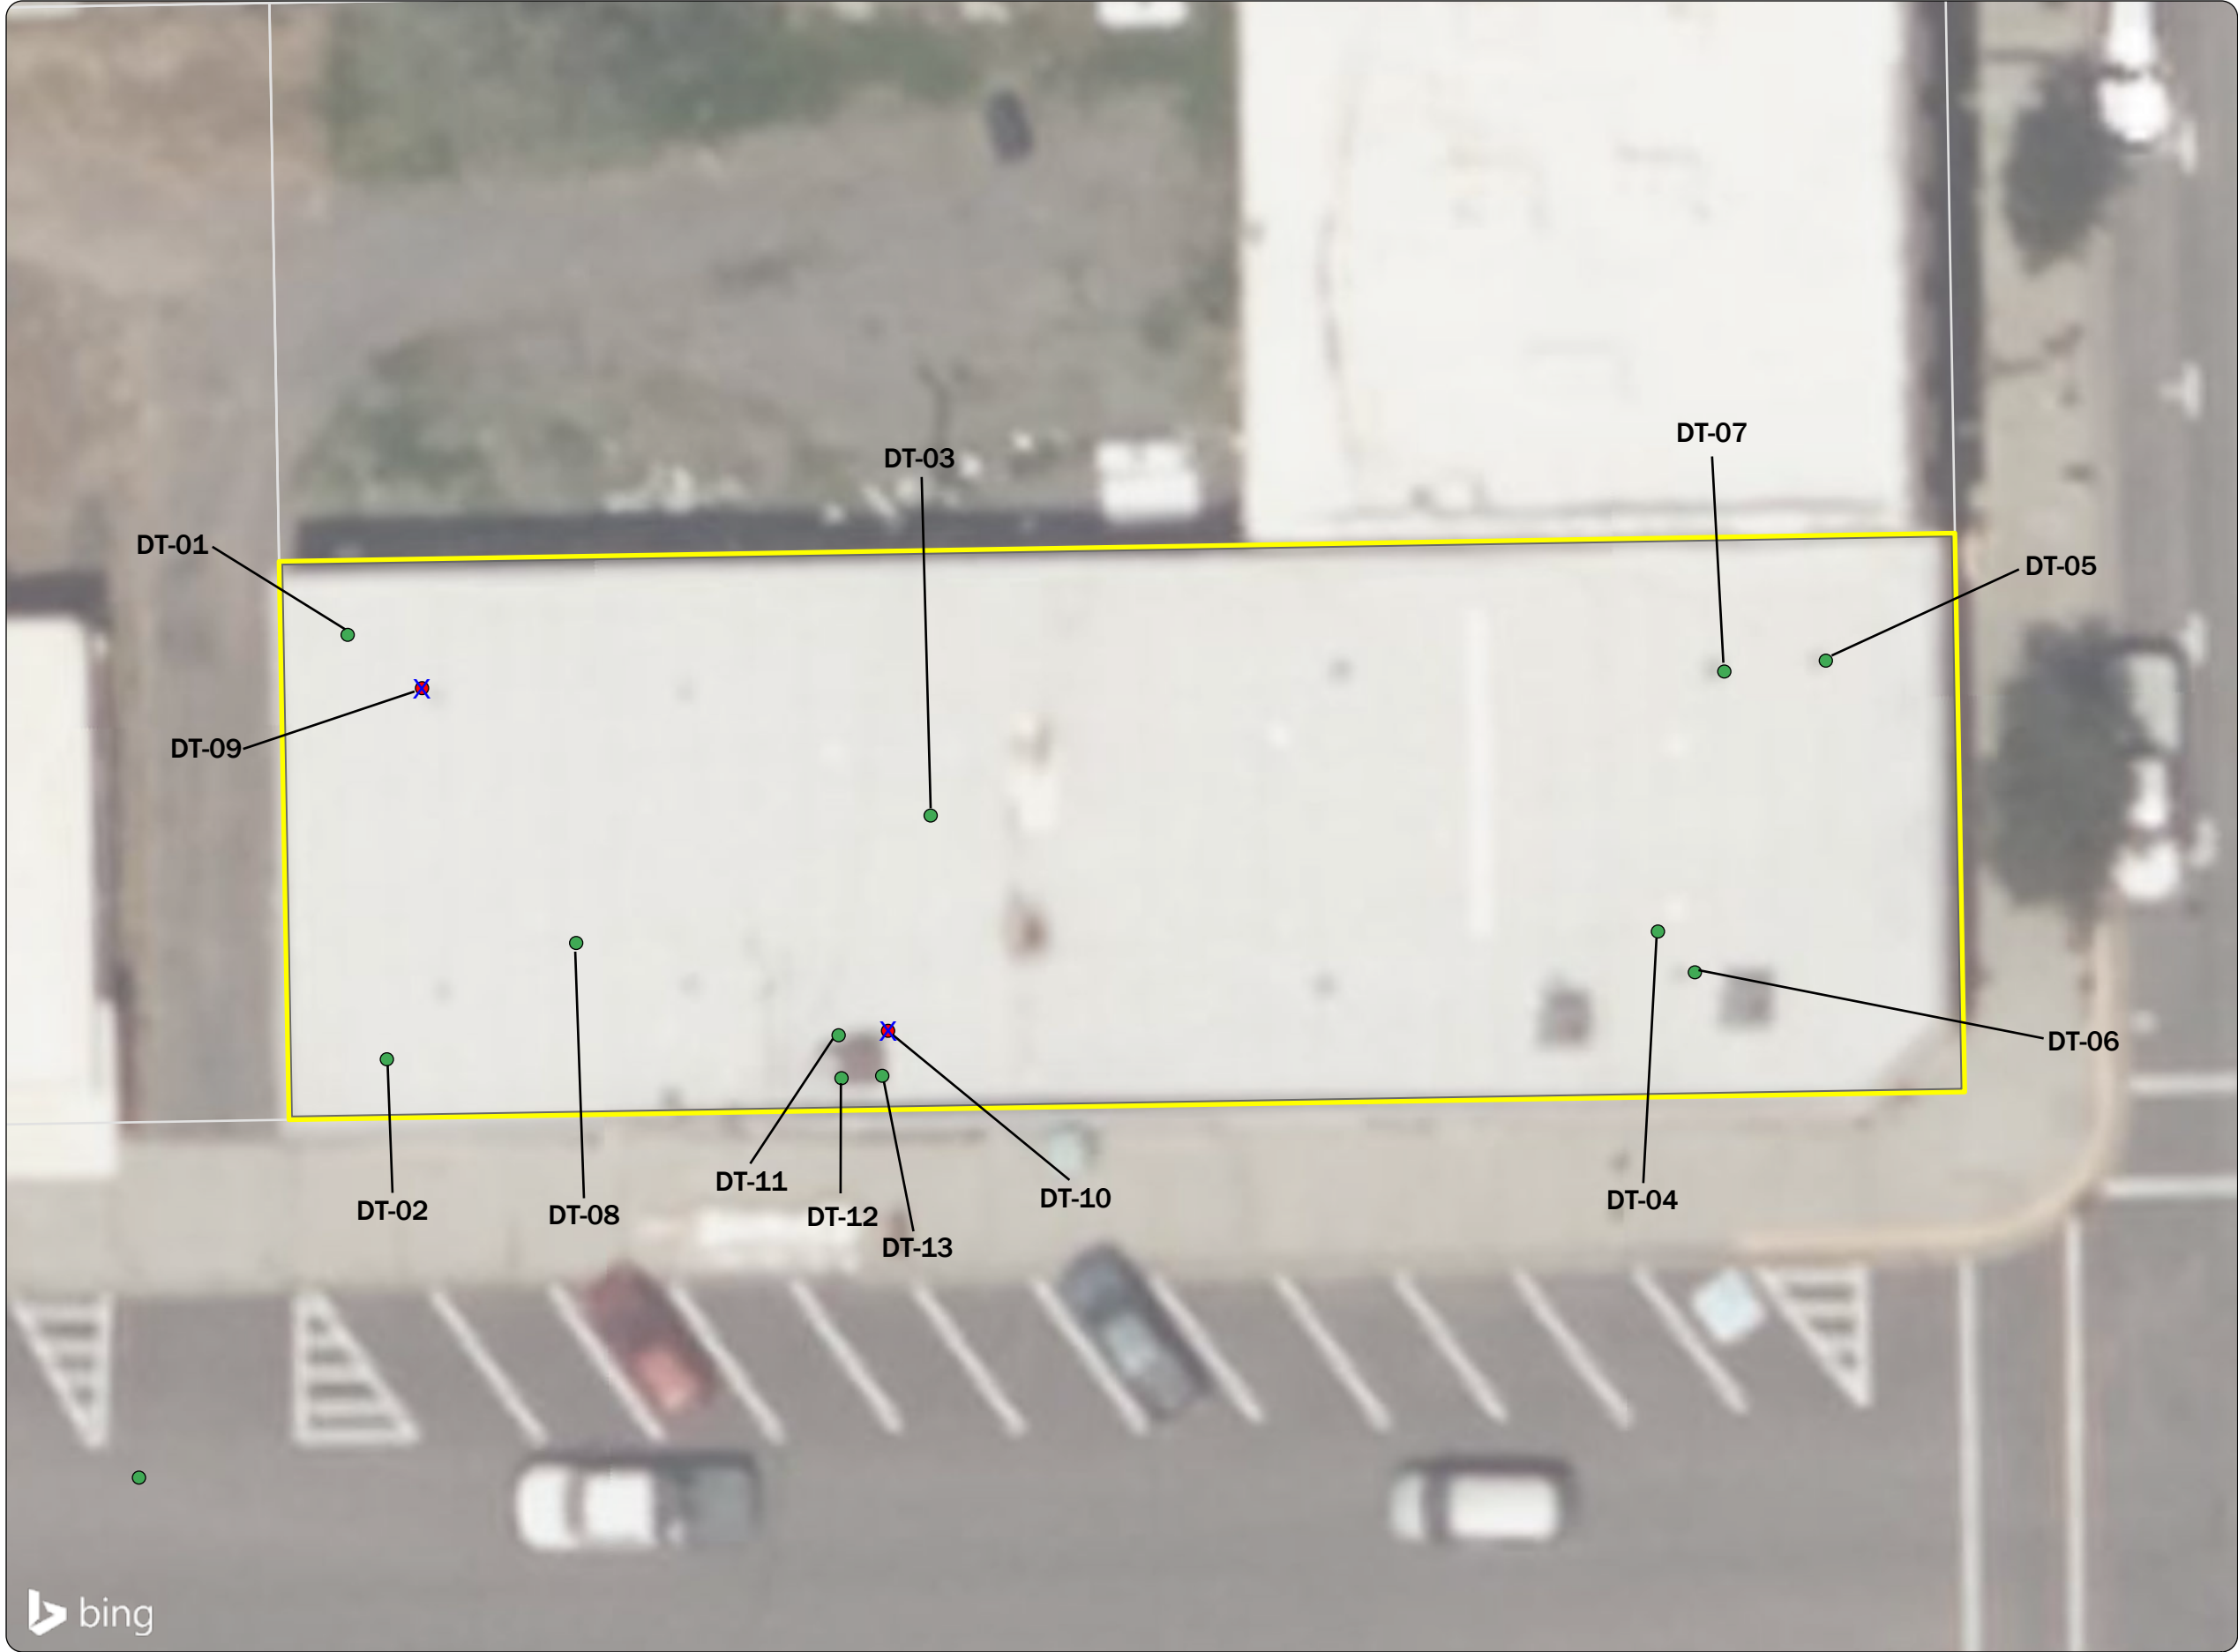
## Figure 2 Sample Locations

Table 1 summarizes the asbestos laboratory results and field data about building material types, color, and condition, and the sample locations are shown in the attached Figure 2. Photographs are provided in Attachment B. The laboratory analytical report is presented in Attachment C. The data are considered acceptable for their intended use.

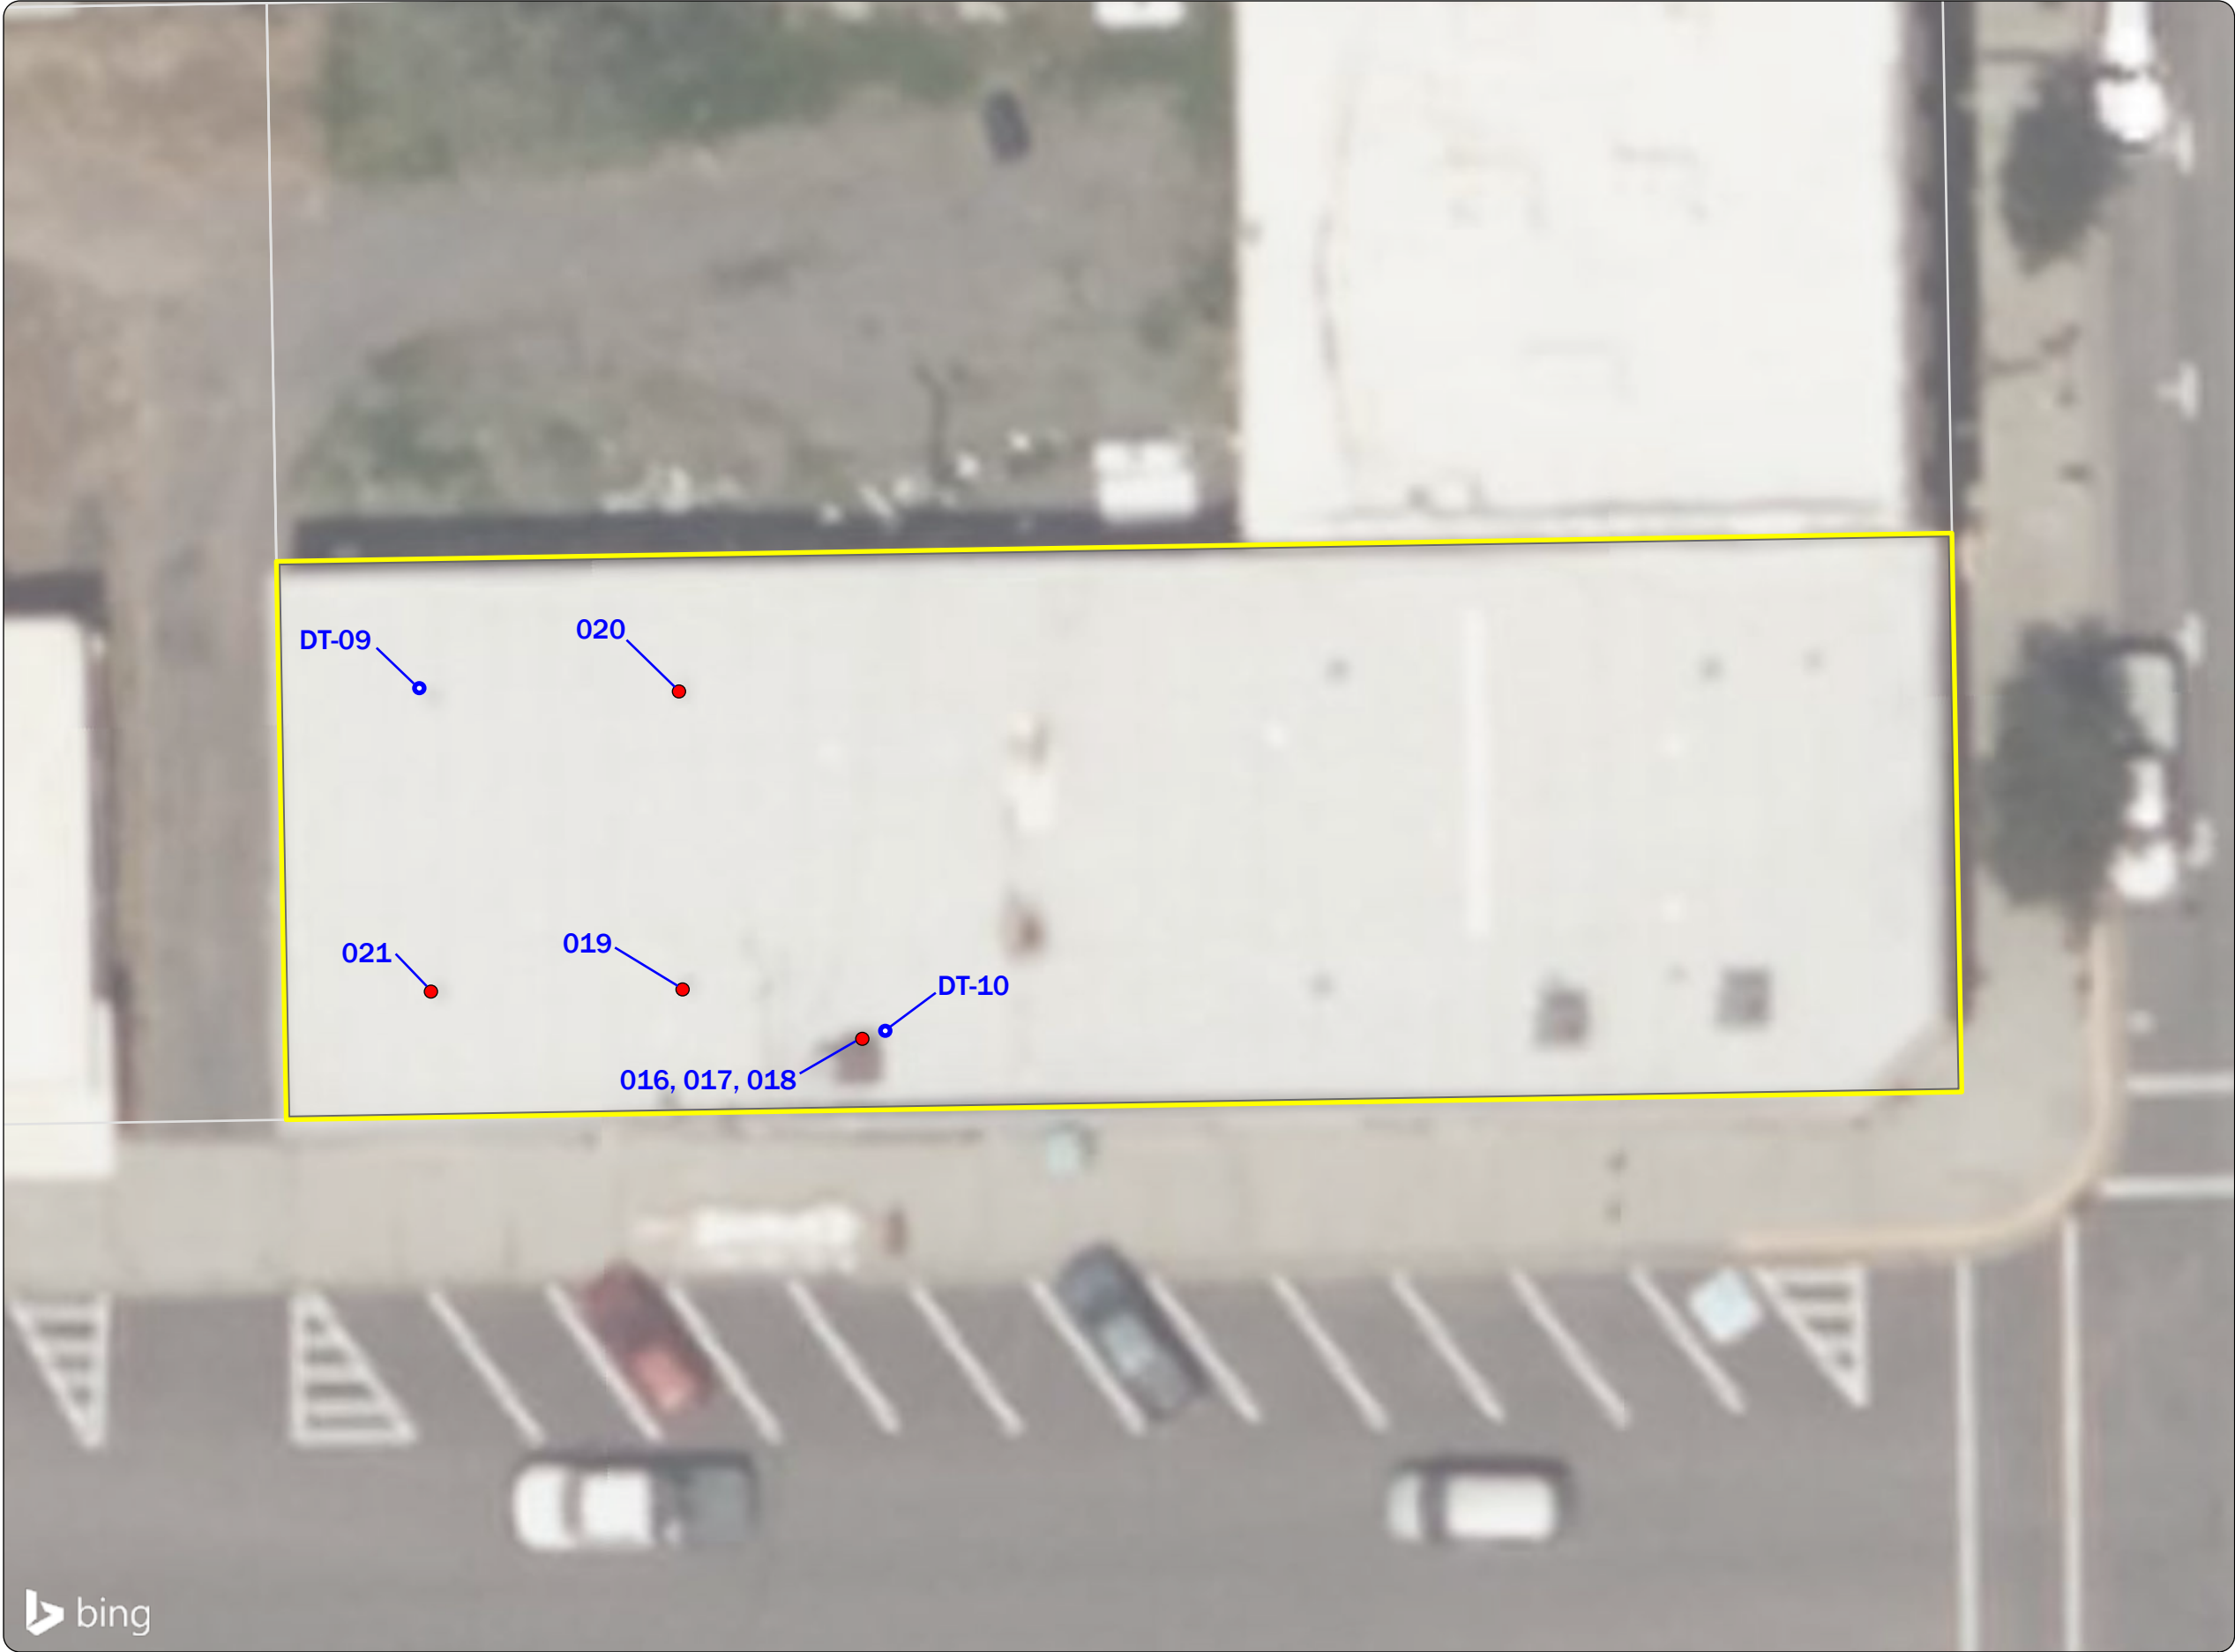
### Figure 3 Roof - Summary of Asbestos Detections

This report should be made available to contractors during bidding on abatement, construction, or renovation work that will be conducted on the structure listed above. A summary of regulated ACM surveyed by MFA and PBS is included in Table 2 and presented on Figure 3.

Based on the presence of friable ACM present at the Site, the identified hazardous building materials must be abated by a DEQ-licensed asbestos abatement contractor prior to renovations or safely managed in place consistent with a written operations and maintenance plan to prevent human exposure or release to the environment. Please note that this survey document does not meet the requirements of an abatement specification.

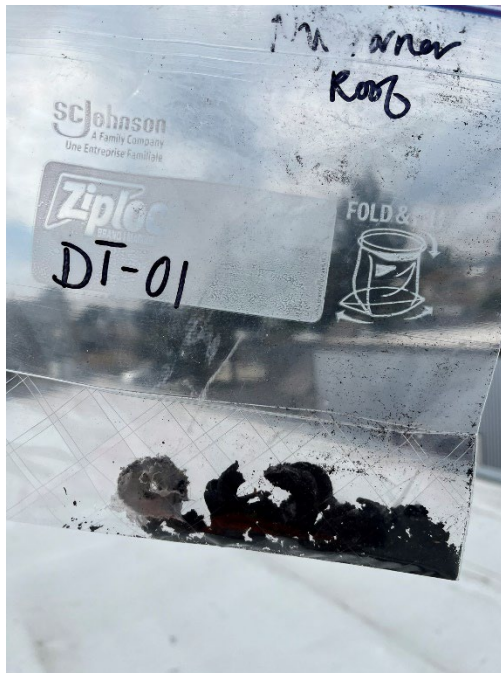
Photo No. 6.

Sample DT-01, non-detect for asbestos.

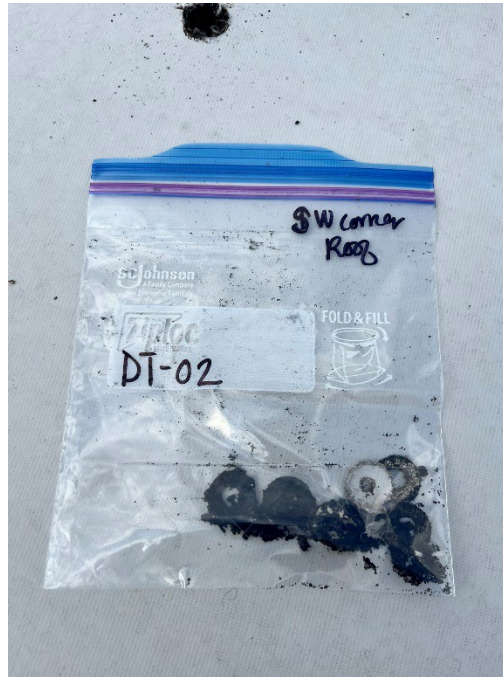
## Photo No. 7.

Sample DT-02, non-detect for asbestos.

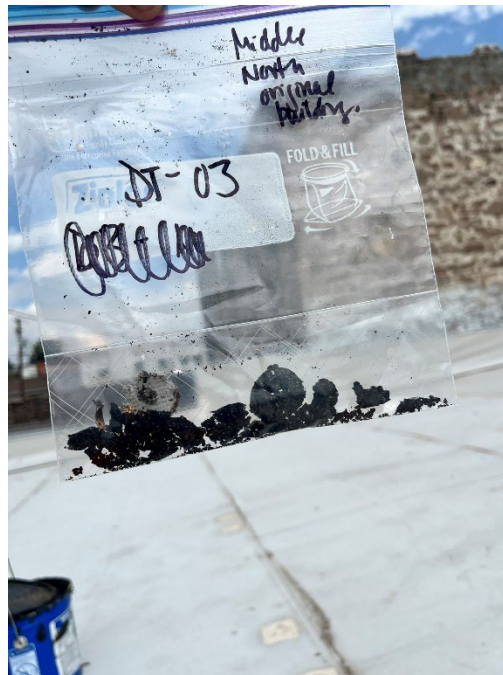
## Photo No. 8.

Sample DT-03, non-detect for asbestos.

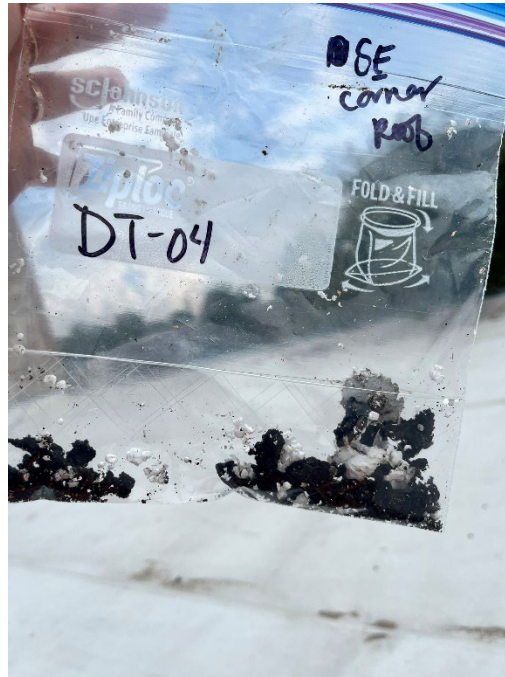
Photo No. 9.

Sample DT-04, non-detect for asbestos.

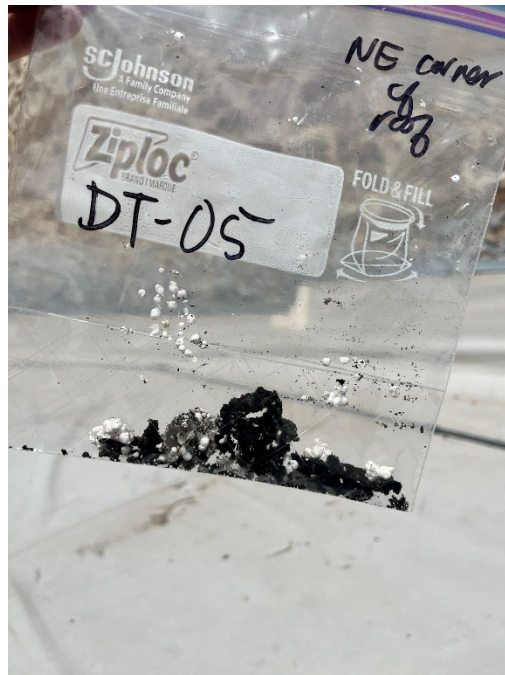
Photo No. 10.

Sample DT-05, non-detect for asbestos.

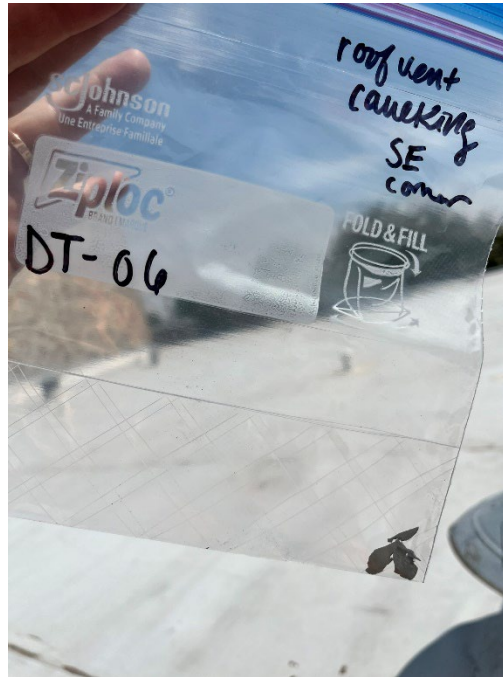
**Photo No. 11.**

Sample DT-06, non-detect for asbestos.

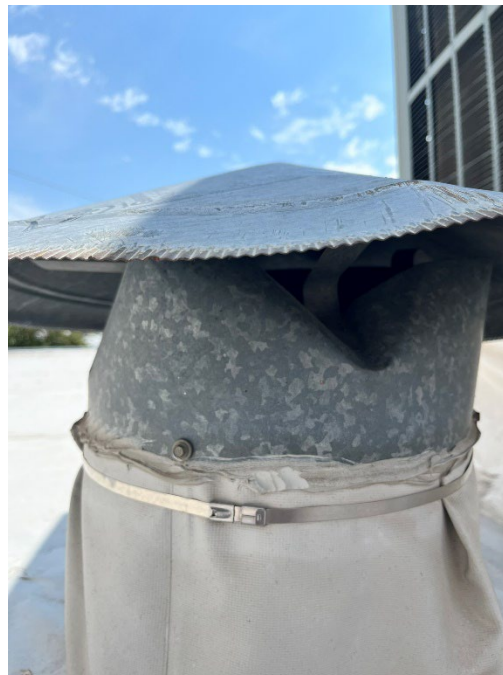
**Photo No. 12.**

Sample DT-06 taken from this vent, non-detect for asbestos.

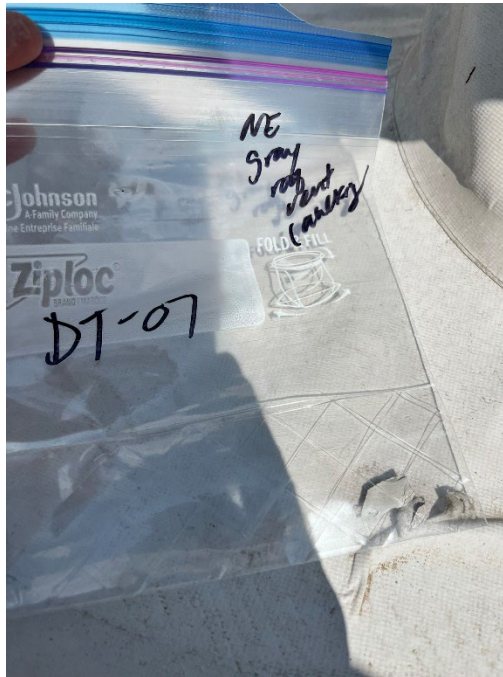
Photo No. 13.

Sample DT-07, non-detect for asbestos.

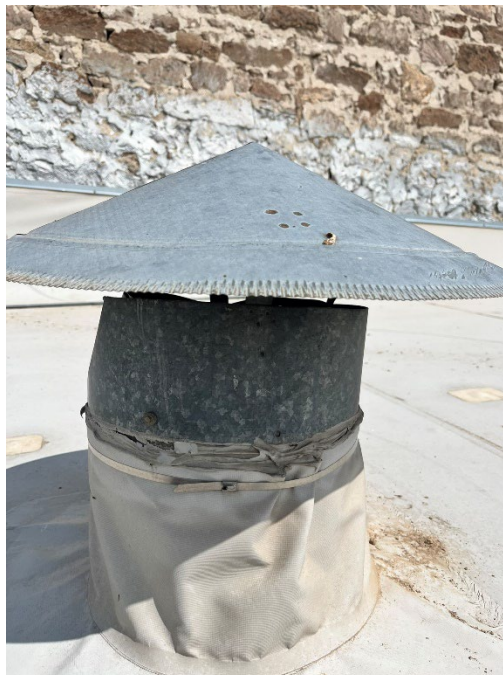
Photo No. 14.

Sample DT-07 taken from this vent, non-detect for asbestos.

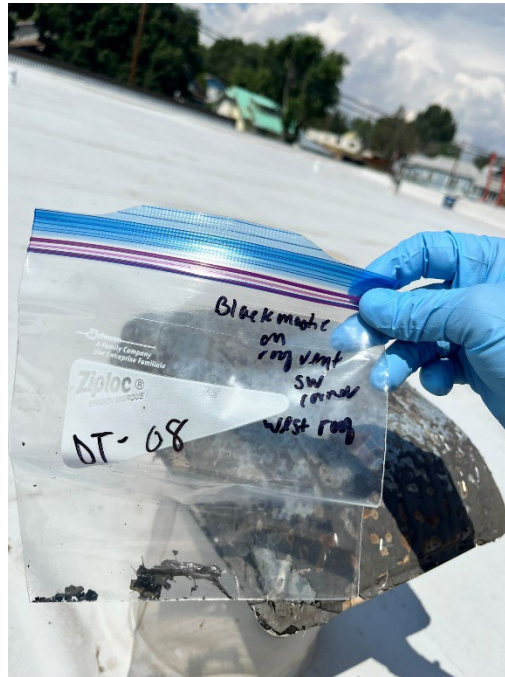
Photo No. 15.

Sample DT-08, non-  
detect for asbestos.

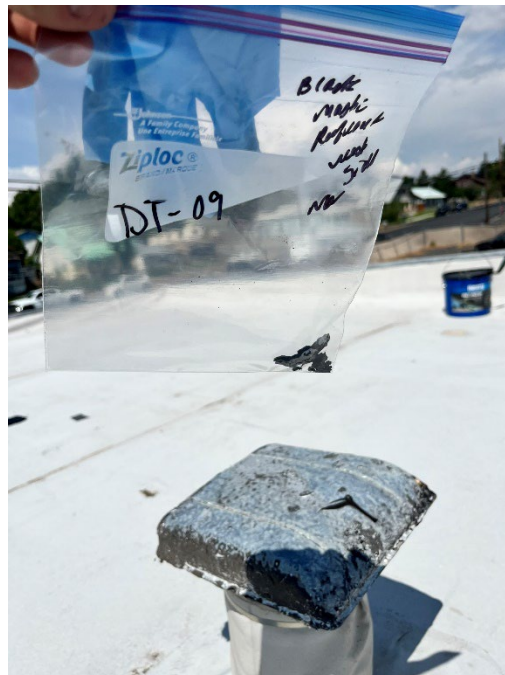
Photo No. 16.

- Sample DT-09: black fibrous mastic/sealant, 14 percent chrysotile asbestos. This material, located on the northwest roof vent, was considered damaged and friable.
- Sample DT-10: black sealant, 22 percent chrysotile asbestos. This material, located on the rooftop chimney, was considered damaged and friable.

| Sample Name | Sample Date | Material Description | Location | Lab Description | Bulk Asbestos | Condition if Detected | Estimated Quantity if Detected |
|---|---|---|---|---|---|---|---|
| | | | | <b>Gray-black asphaltic material</b> | <b>Chrysotile 14%</b> | <b>Fair, friable</b> | 4 vent caps |

| Regulated Material | Material Description | Location Description | Estimated Quantity | Sample/Comment |
|---|---|---|---|---|
| | Black fibrous mastic/sealant | NW roof vent cap | 4 vent caps (approximately 1 SF each) | DT-09. All four of the western roof vent caps have this material. |

Sample DT-09, **asbestos  
detected.**

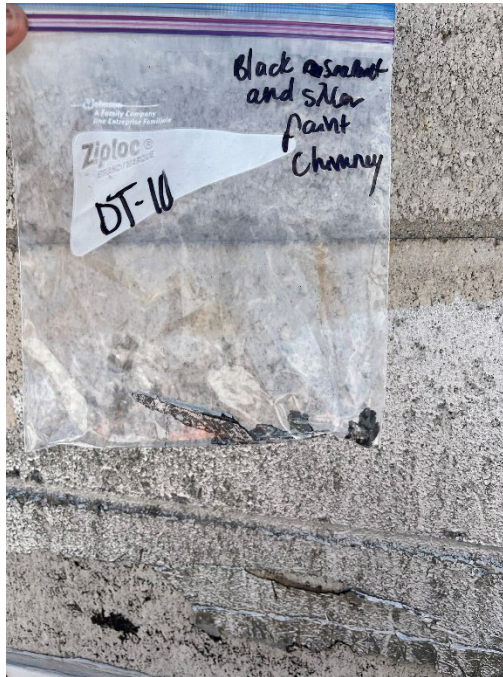
Photo No. 17.

| Sample Name | Sample Date | Material Description | Location | Lab Description | Bulk Asbestos | Condition if Detected | Estimated Quantity if Detected |
|---|---|---|---|---|---|---|---|
| | | | | <b>Crumbly gray-black asphaltic material</b> | <b>Chrysotile 22%</b> | <b>Fair, friable</b> | 5 SF |

| Regulated Material | Material Description | Location Description | Estimated Quantity | Sample/Comment |
|---|---|---|---|---|
| | Black sealant | Chimney | 5 SF | DT-10 |

Sample DT-10, **asbestos detected.**

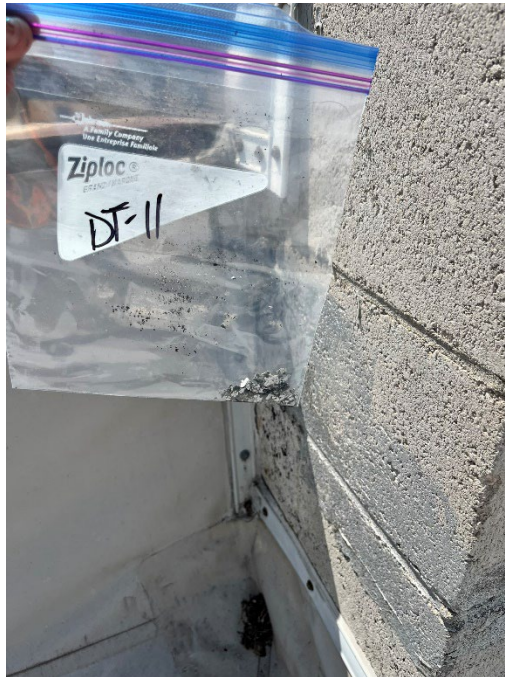
Photo No. 19.

Sample DT-11, non-detect for asbestos.

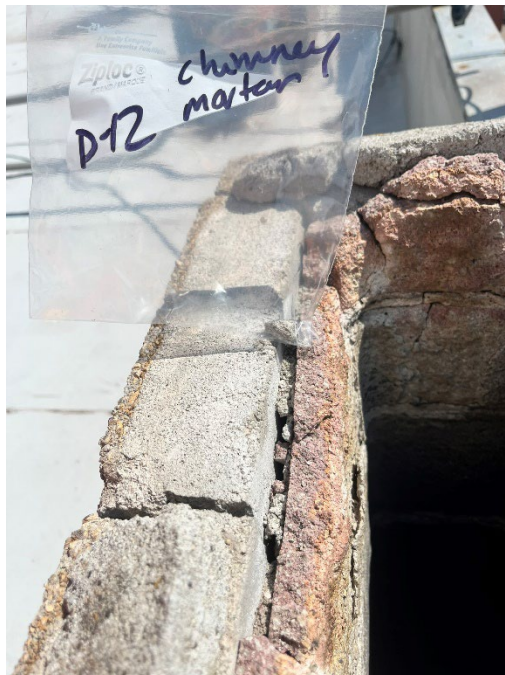
Photo No. 20.

Sample DT-12, non-detect for asbestos.

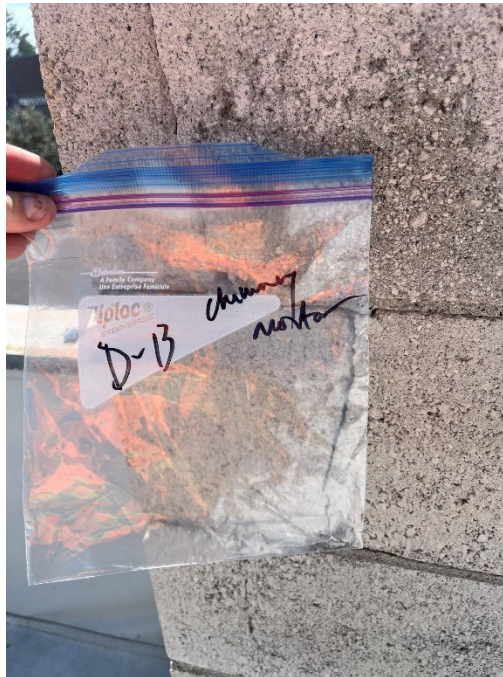
Photo No. 21.

Sample DT-13, non-  
detect for asbestos.
