# Technical Memorandum

From: Chris Clough, Maul Foster & Alongi Project No.: M0785.31.001  
Julie Pace, Maul Foster & Alongi

Re: Limited Pre-Renovation Hazardous Building Materials Survey – Burns Armory

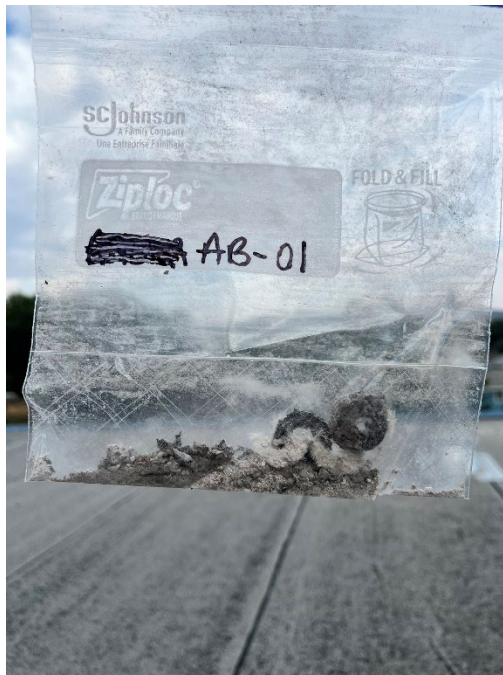
### Roofing core samples (upper-most roof)

Sample AB-01, non-detect for asbestos.

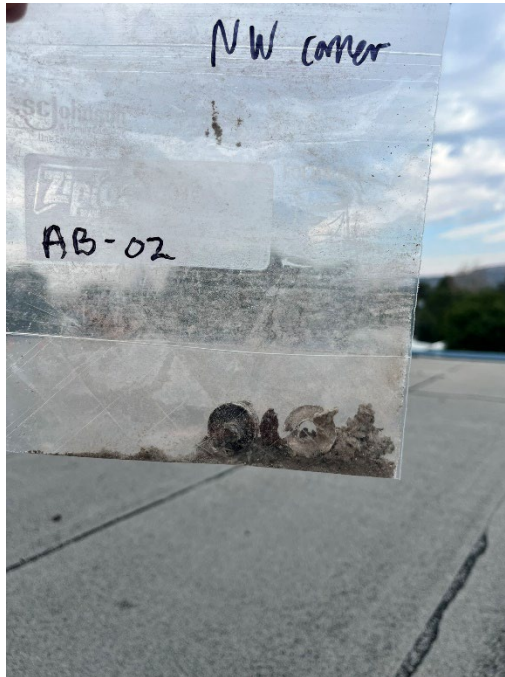
Roofing core samples  
(upper-most roof)

Sample AB-02, non-  
detect for asbestos.

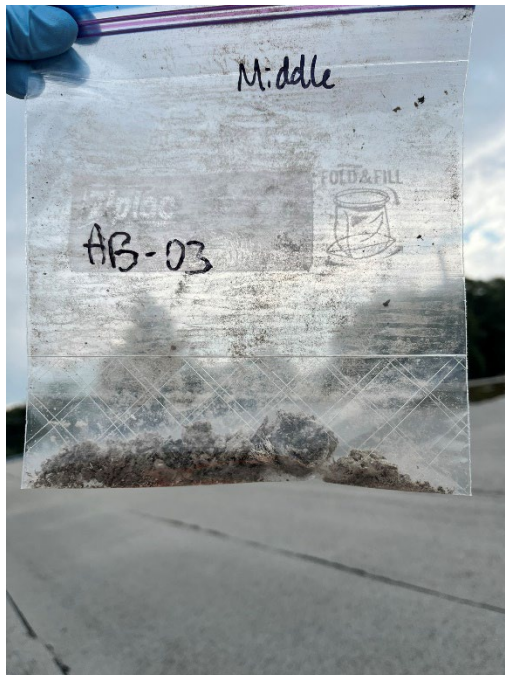
Roofing core samples  
(upper-most roof)

Sample AB-03, non-  
detect for asbestos.

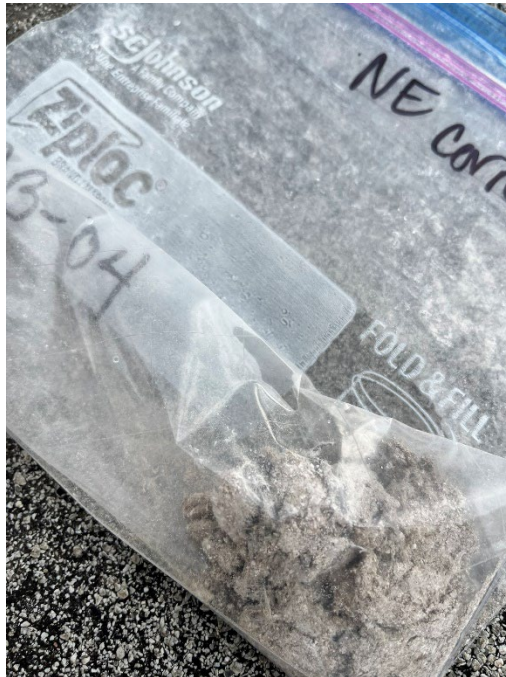
Roofing core samples  
(upper-most roof)

Sample AB-04, non-  
detect for asbestos.

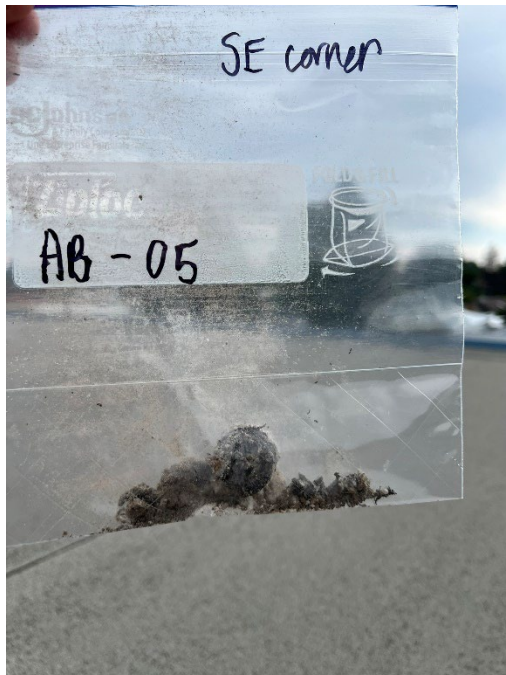
Roofing core samples  
(upper-most roof)

Sample AB-05, non-  
detect for asbestos.

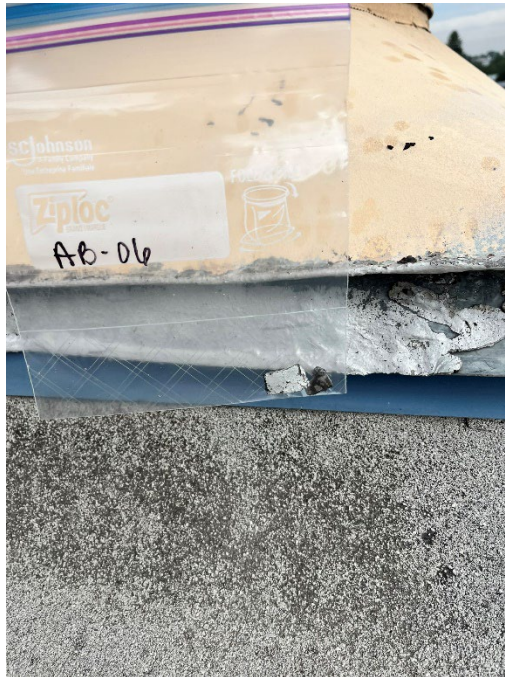
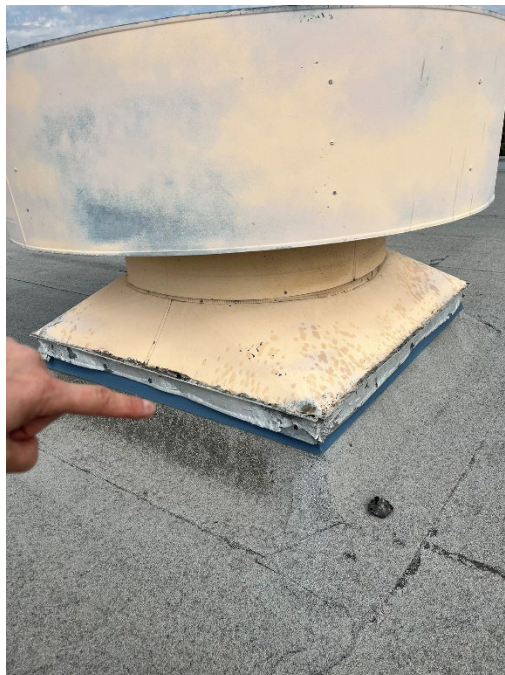
Rooftop vent samples  
(upper-most roof)

- Layer 2 of sample AB-06 contained 14 percent chrysotile asbestos. The laboratory described this layer as black asphaltic material. Based on field observations it is believed that this layer is a sealant on the upper rooftop vents.

Sample AB-06, **asbestos  
detected.**

Based on the presence of ACM and LBP present at the Site, the identified hazardous building materials should be abated by a licensed contractor or safely managed in place consistent with a written operations and maintenance plan to prevent human exposure or release to the environment. Please note that this survey document does not meet the requirements of an abatement specification.

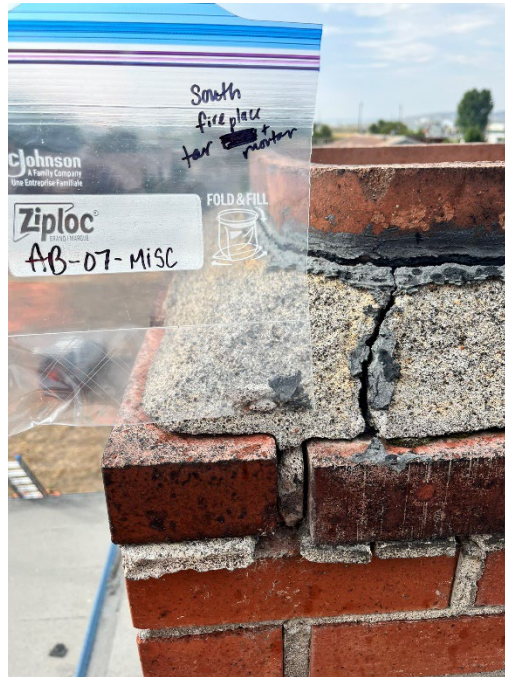
Rooftop chimney  
samples (upper-most  
roof)

- Layer 1 of sample AB-07 contained 16 percent chrysotile asbestos. The laboratory described this layer as black asphaltic material. Based on field observations it is believed that this layer is a tar.

Sample AB-07, **asbestos  
detected.**

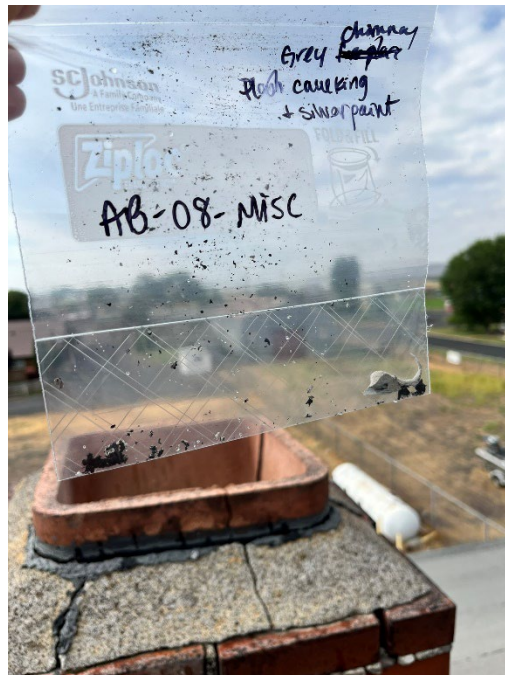
Rooftop chimney  
samples (upper-most  
roof)

Sample AB-08, non-  
detect for asbestos.

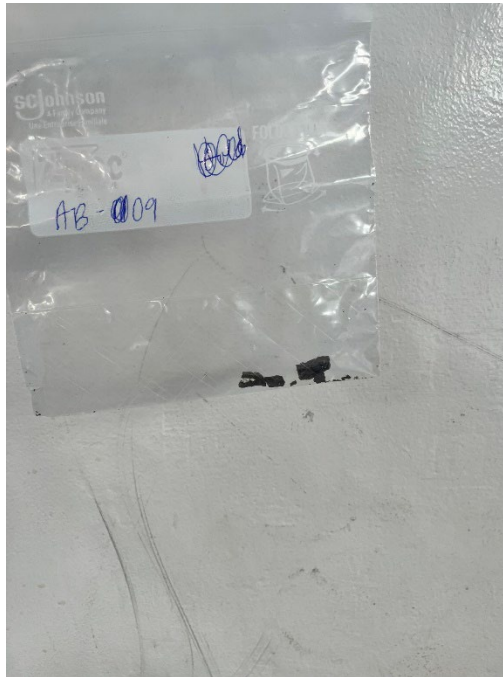
Armory Main Building,  
classroom ceiling

Sample AB-09, non-  
detect for asbestos.

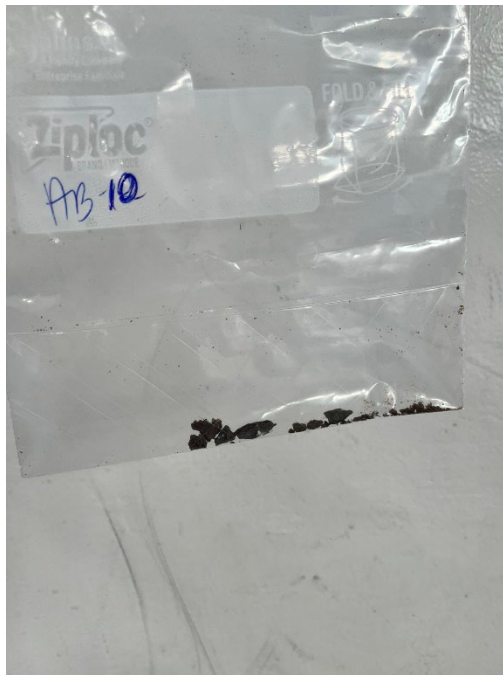
Armory Main Building,  
classroom ceiling

Sample AB-10, non-  
detect for asbestos.

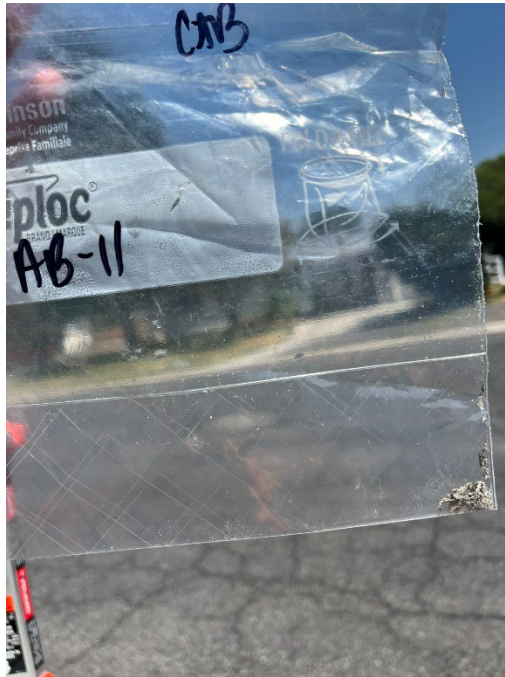
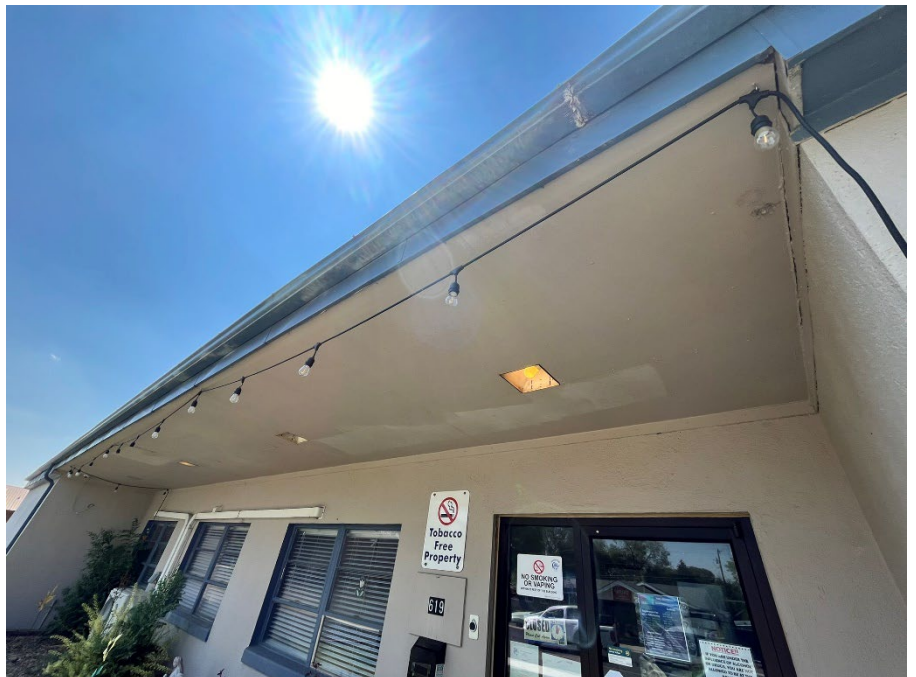
Exterior of Main Armory building, roof soffit.

- Sample AB-11 contained 14 percent chrysotile asbestos. The laboratory described this layer as gray, loose, crumbly material with layered paint. Based on field observations it is believed that this material is cement board soffit (transite).

Sample AB-11, **asbestos detected.**

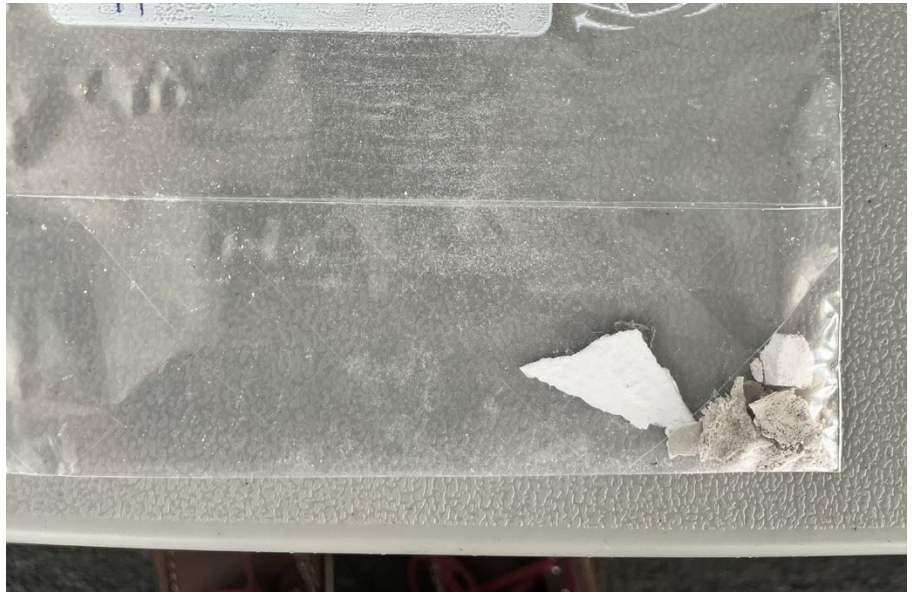
Armory Main Building,  
south office (next to  
classroom)

- Layers 1 and 2 of sample AB-12 contained 3 and 4 percent chrysotile asbestos, respectively. The laboratory described these layers as off-white compacted powdery material with paint, and off-white compacted powdery material with paper. This sample is the layers of wallboard, skim coat, and joint compound.

Sample AB-12, **asbestos  
detected.**

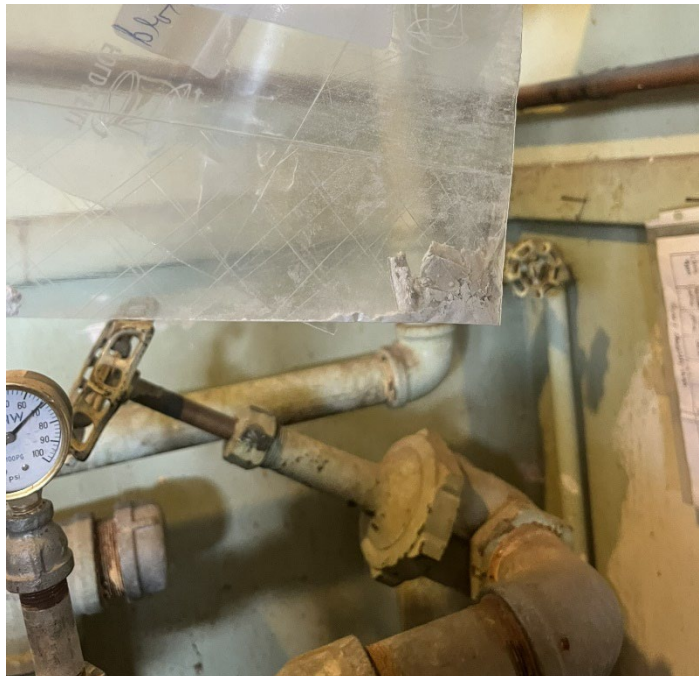
Armory Main Building,  
Janitor's Closet

- Layer 1 of sample AB-13 contained 5 percent chrysotile asbestos. The laboratory described these layers as off-white compacted powdery material with paint. This sample is the layers of wallboard, skim coat, and joint compound.

Sample AB-13, **asbestos  
detected.**

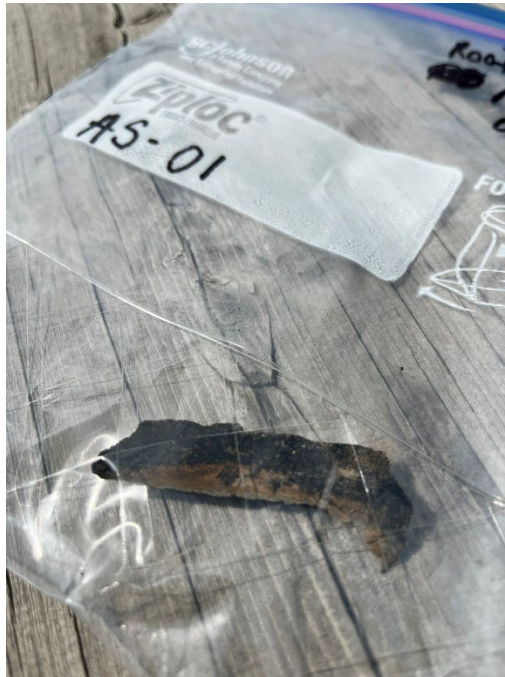
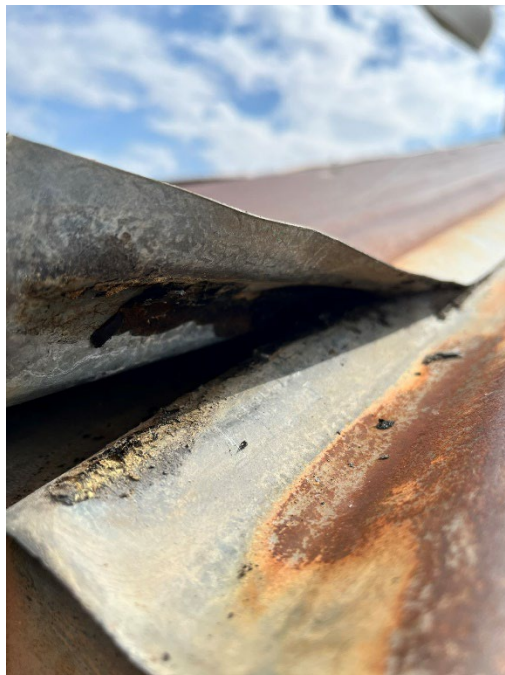
Armory Shed, roofing material

- Sample AS-01 contained 11 percent chrysotile asbestos. The laboratory described this layer as black asphaltic material with debris. Based on field observations it is believed that this material is a mastic.
- Sample AS-02 contained 14 percent chrysotile asbestos. The laboratory described this layer as black asphaltic material with debris. Based on field observations it is believed that this material is a mastic.
- Sample AS-03 contained 32 percent chrysotile asbestos. The laboratory described this layer as black asphaltic material with debris. Based on field observations it is believed that this material is a fibrous sealant and is located on the rooftop flashing. It is also assumed that this material is homogeneous with the mastic along the exterior shed panels that were previously identified in the 2024 PBS report (Attachment F).

Sample AS-01, **asbestos detected.**

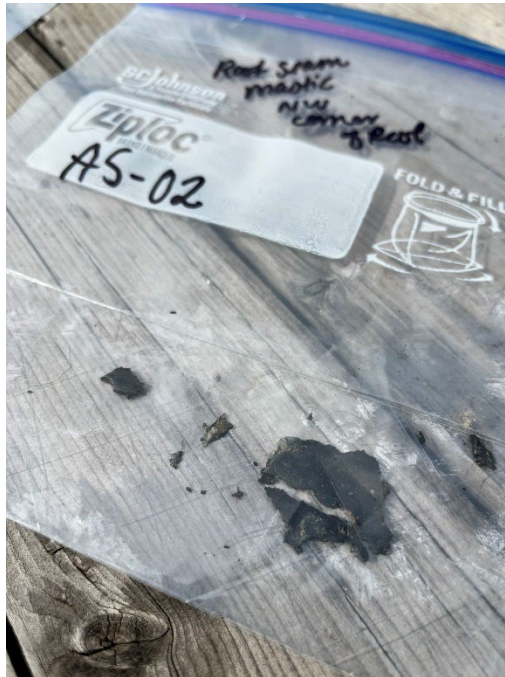
Armory Shed, roofing  
material

Sample AS-02, **asbestos  
detected.**

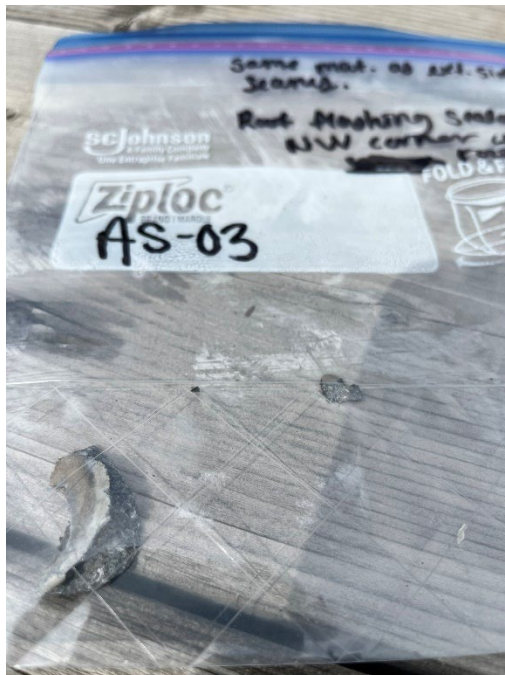
Armory Shed, roof  
flashing (same material  
as exterior siding  
mastic)

Sample AS-03, **asbestos  
detected.**

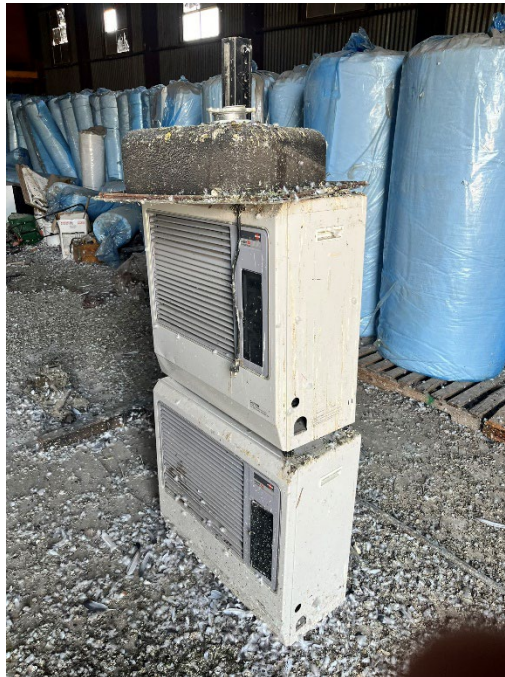
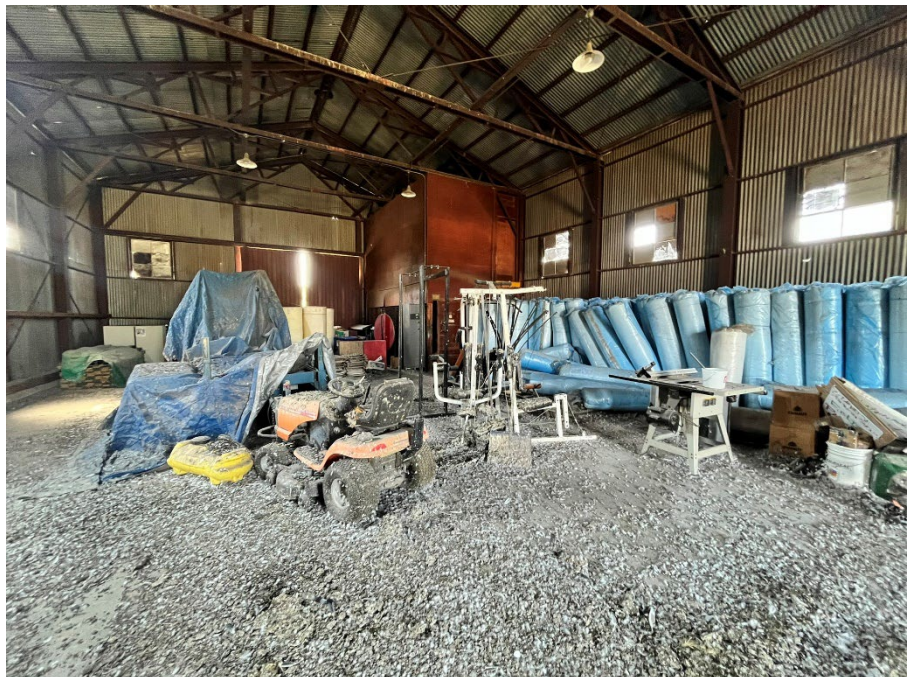
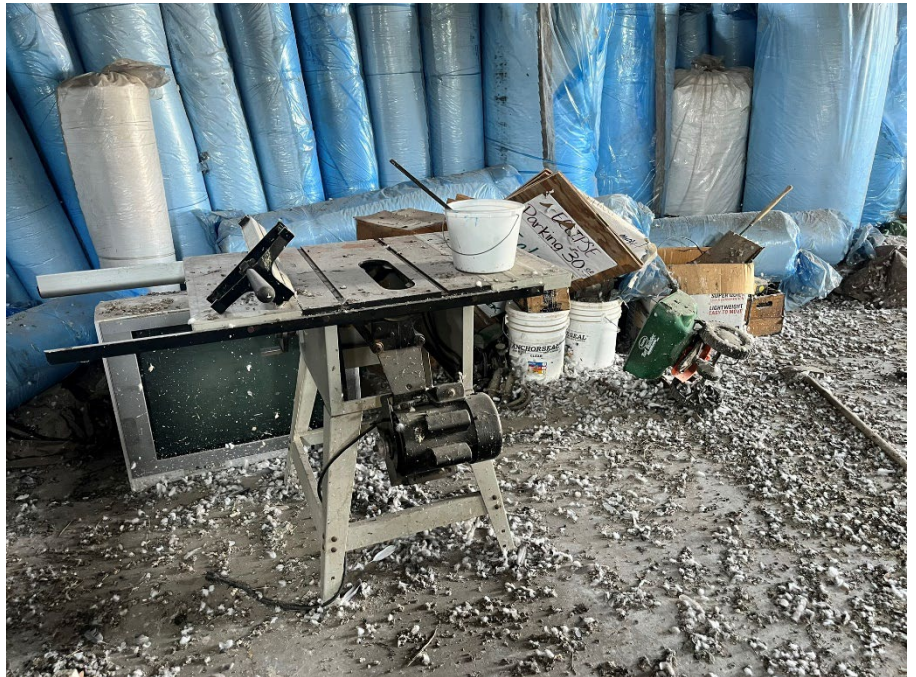
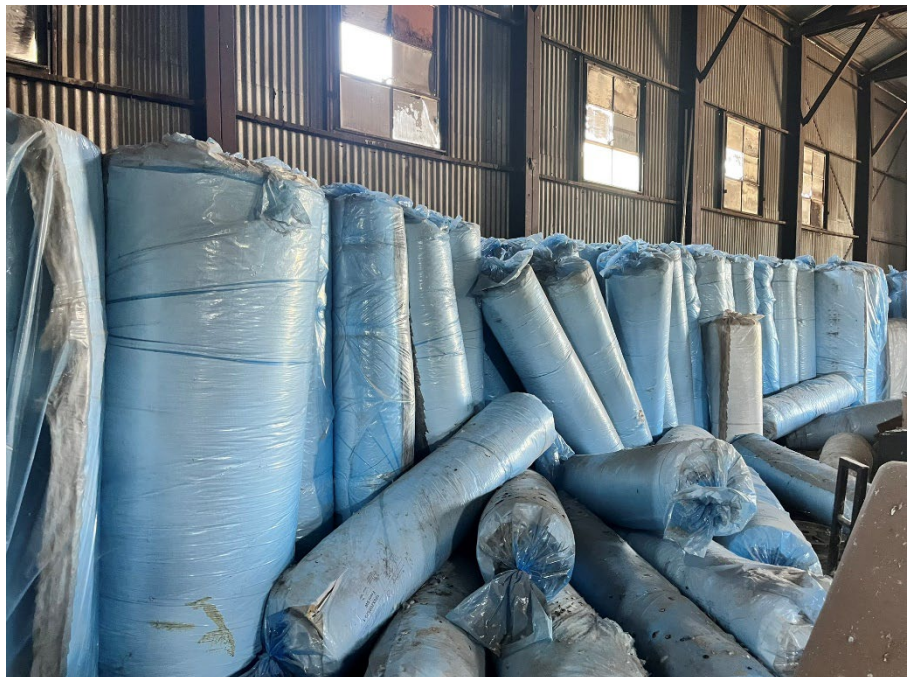
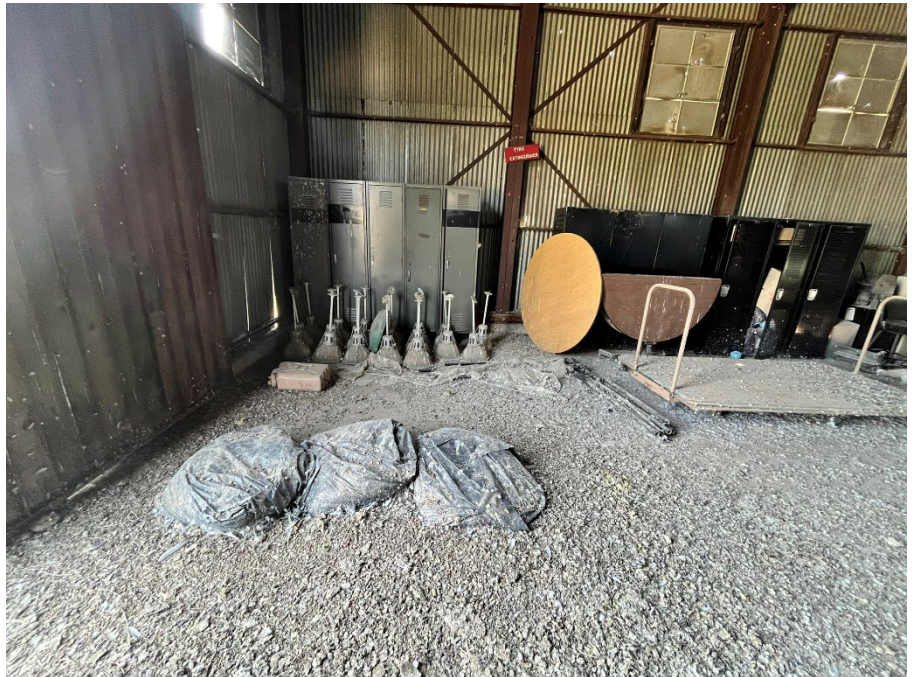
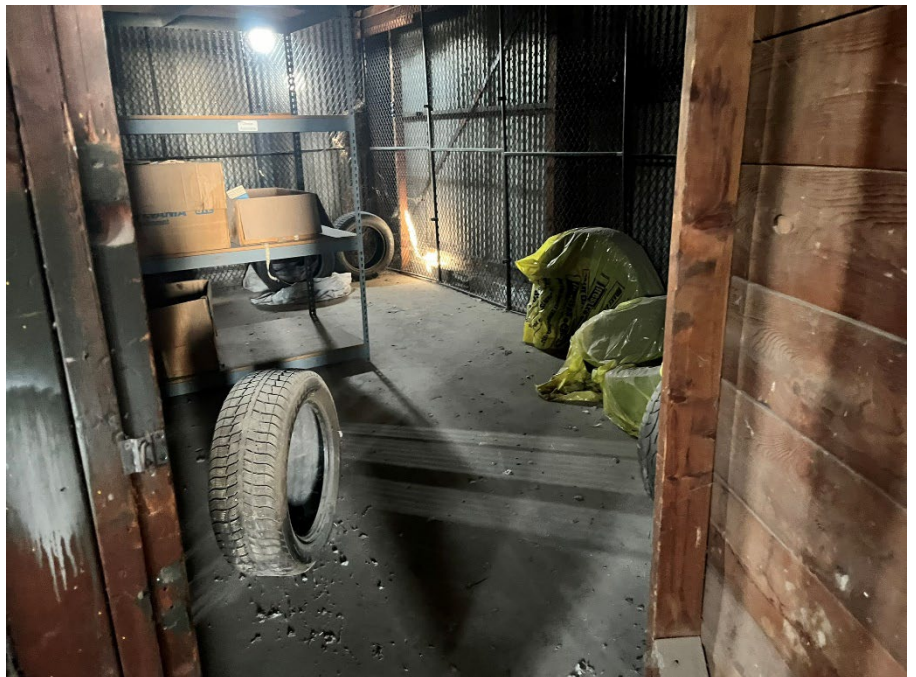
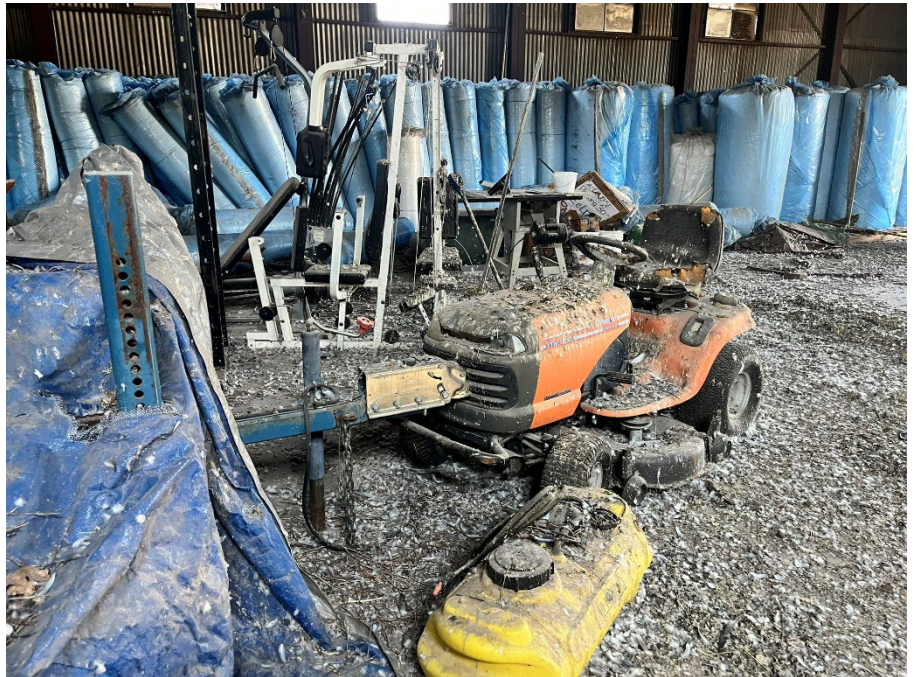
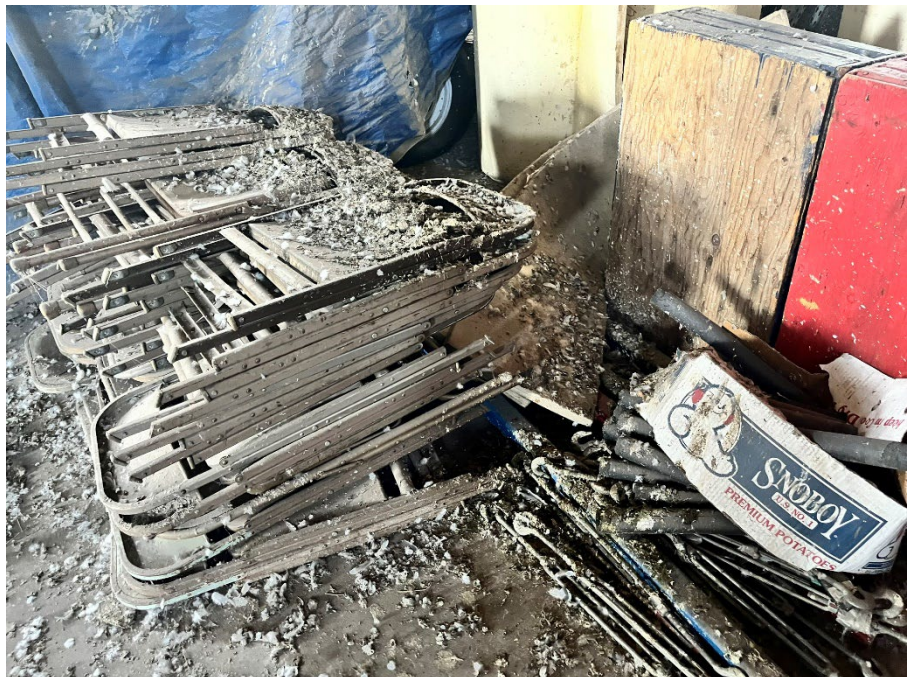
The thickness of the bird droppings ranges from 1 to 5 inches, covering most of the floor, estimated at 3,500 square feet. The back storage room was relatively unaffected. Photographs are included in Attachment B.

Example of items and ground affected by bird droppings.

Example of items affected by bird droppings.
