Matcon Annual Inspection Report for the Taylor Lumber Superfund Site
Stella Jones Company
22125 SW Rock Creek Road, Sheridan, Oregon
Construction date for cap: 2007

Inspection date: March 26, 2024

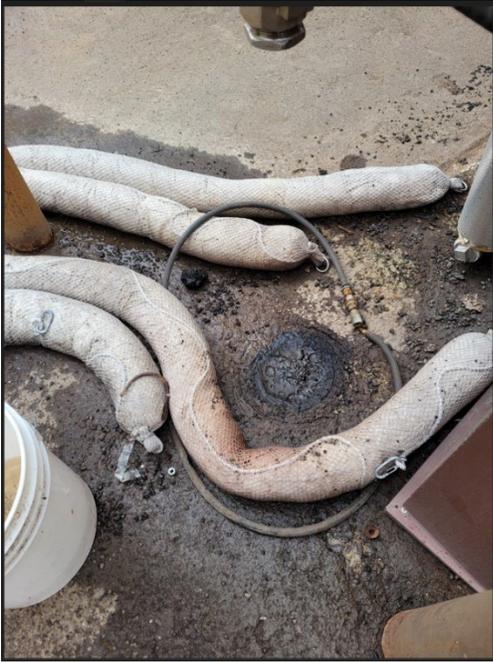
Photo 1:

- a. Recent Repairs: One area of the MatCon was repaired since the last inspection. The condensate discharge from a pipe adjacent to the evaporator created a hole in the MatCon. The condensate is usually collected in a bucket beneath the pipe, but the bucket had been removed allowing the condensate to come in contact with the MatCon (See Photo 1 and 2).

3. The area around the evaporator's non-contact steam line's condensate drain had debris (dirt, mud?) accumulating. This area should be cleaned regularly.

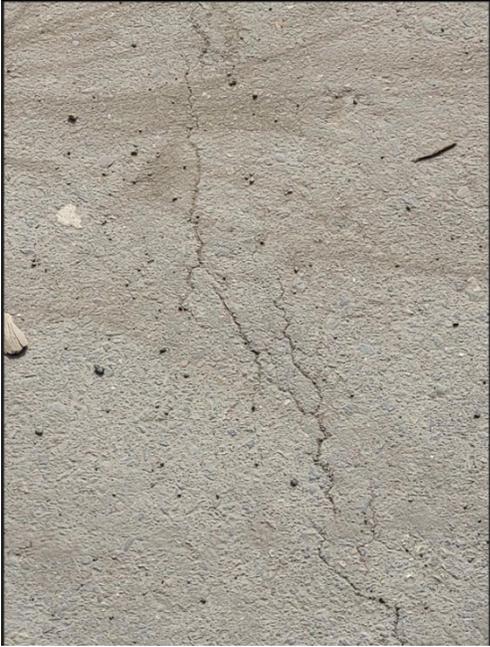
pointed out several locations on the MatCon with numerous localized cracks or cracked seals (around drains) that should be re-surfaced and/or re-sealed as part of the routine maintenance (examples shown in Photo 3 and 4). There was also a large manhole cover near the peeler area that was observed to need MatCon repair and reconstruction to make it flush with the surrounding grade (Photo 5 and 6) .

5. Complete re-surfacing and/or re-sealing of the surfaces indicated by Dr. Rowe during the 4/23/2024 meeting.
6. Provide a plan and schedule for completing 4 and 5 above to DEQ prior to completing the work. This work should be completed prior to October 2024, or by another time proposed and agreed to by DEQ.

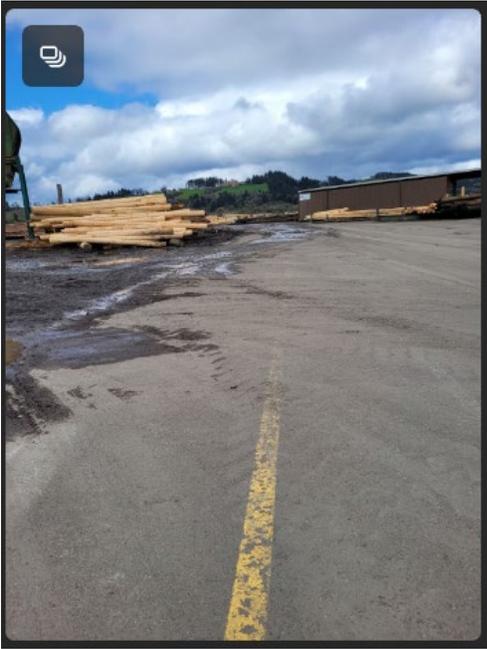
Photo 7

- e. Barrier wall demarcation: The yellow line demarcating the barrier wall was difficult to inspect around the entire site due to the mud and dirt accumulation. Where the line was visible near the peeler, it looked ok, but was starting to fade and wear out (see Photo 7).

2. SJC should follow-up on previous discussions about using a better, more durable paint for the demarcation line such as paint that is used by ODOT for roads, using a double or triple coat of paint, painting more frequently or finding a more permanent way to mark the barrier wall boundary.
