SUBJECT: M Carter Commons (MCC) Development
PPA Consent Order, Exhibit C Scope of Work, Item 7: Hazardous Building Material
Survey Report
3715-3717 N Interstate Ave, Portland, OR 97227

Hazardous Building Materials Survey

3715-3717 N Interstate Ave

November 18, 2024

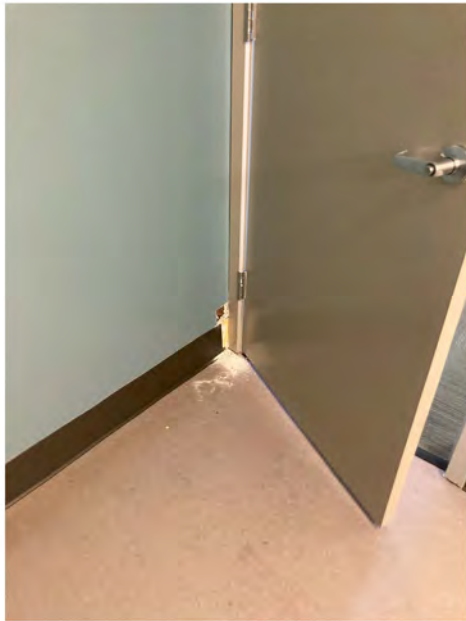
Because the detected asbestos in GWB samples KP5 and KP30 were limited to the joint compound layers, composite samples of all layers identified in each sample were additionally analyzed for asbestos by Point Count. The composited samples KP5 and KP30 were found to contain 0.3% and < 0.1% asbestos, respectively.

Photo 1 - View of sample location KP5 in the medical office restroom. The joint compound on the gypsum wallboard has 2% chrysotile asbestos and Point Count analysis of all layers had < 1% asbestos. (11/10/2023)

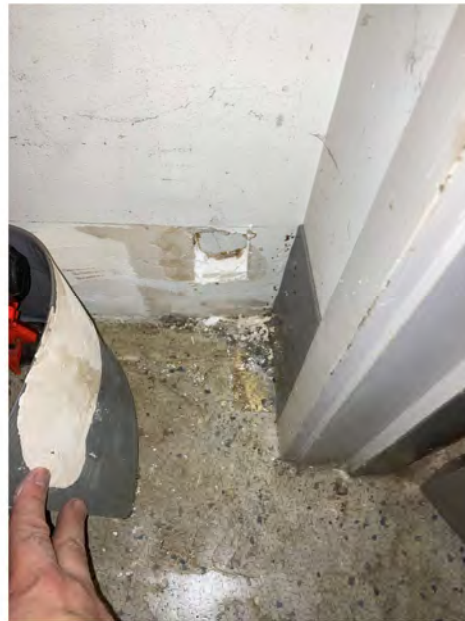
Photo 2 - View of sample location KP30 in the landscape office. The joint compound on the gypsum wallboard has 2% chrysotile asbestos and Point Count analysis of all layers had 0.3% asbestos. (11/10/2023)

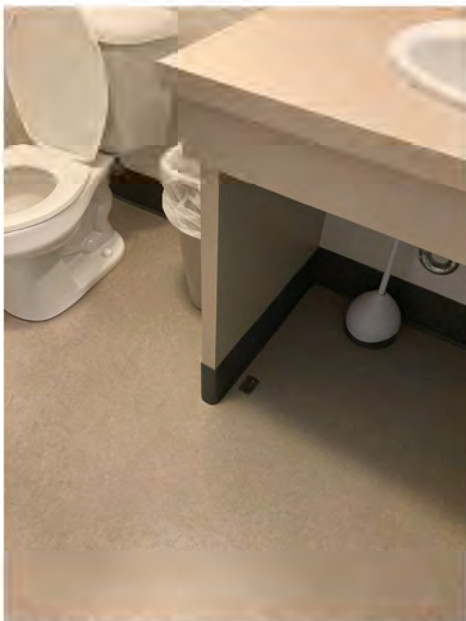
- A black mastic associated with gray patterned sheet vinyl tile flooring in the Medical Office area restroom and breakroom contains 5% chrysotile asbestos. The floor area of the rooms is approximately 112 SF, and the mastic is in good condition but is considered friable.

Photo 3 - View of sample location KP9 in the medical office restroom. The black mastic associated with the gray patterned SVT flooring has 5% chrysotile asbestos. (11/10/2023)

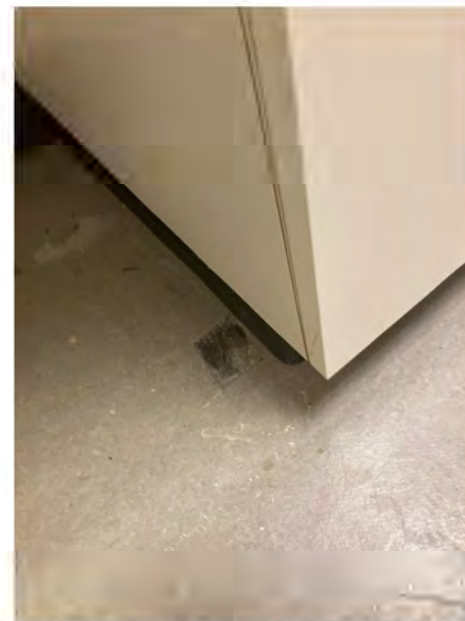
Photo 4 - View of sample location KP10 in the medical office breakroom. The black mastic associated with the gray patterned SVT flooring has 5% chrysotile asbestos. (11/10/2023)

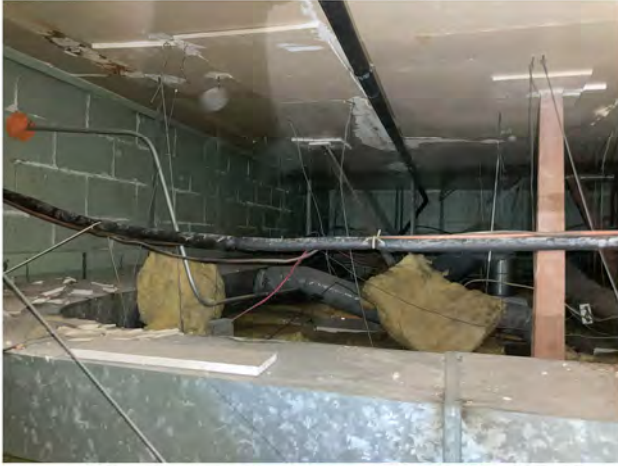
- Masonry Wall Coating – Samples KP49, KP72, and KP73 detected 2-3% chrysotile asbestos in a green-painted crumbly material that coated the CMU wall in the Landscape Electrical Room, Shop, and Restroom (also observed in the Locker Room), and samples KP51, KP74, and KP75 detected 2% chrysotile asbestos in an off-white-painted crumbly material that coated the CMU wall in the Landscape Restroom and Breakroom (also observed in the Office), and in the Medical Office Admin Room (also observed in the Utility Room).

Photo 5 - View of sample locations KP49 (electrical room, back wall) and KP73 (restroom, side wall) taken from above the drop down ceiling. The green crumbly coating material on the CMU walls has 2-3% chrysotile asbestos. (11/10/2023)

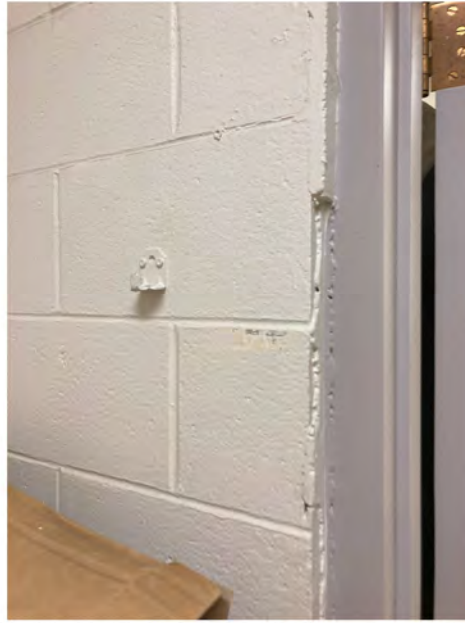
Photo 6 - View of sample location KP51 in the landscape restroom. The white crumbly coating material on the CMU walls has 2% chrysotile asbestos. (11/10/2023)

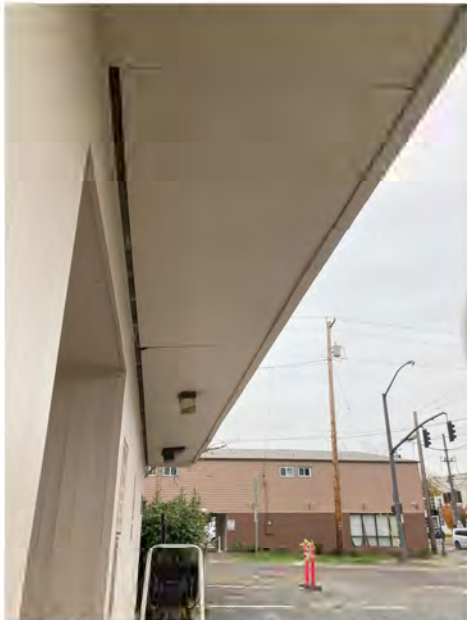
Photo 7 - View of sample location KP63 on the east side of the building. The cement board soffit material has 37% chrysotile asbestos. (11/10/2023)

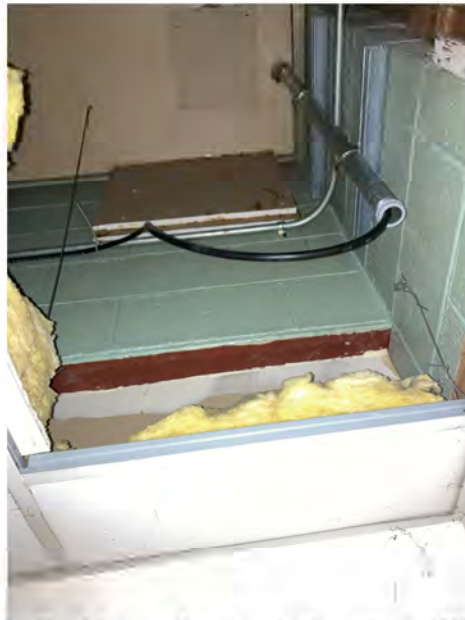
Photo 8 - View of sample location KP72 in the landscape shop. The green crumbly coating material on the CMU walls has 2% chrysotile asbestos. (10/29/2024)

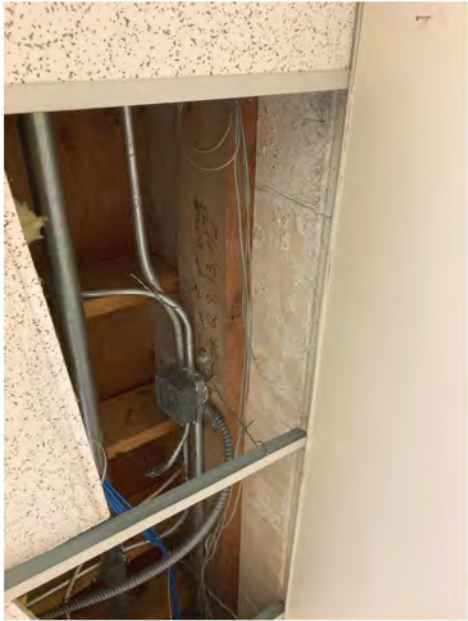
Photo 9 - View of sample location KP74 in the landscape breakroom. The off-white crumbly coating material on the CMU walls has 2% chrysotile asbestos. (10/29/2024)

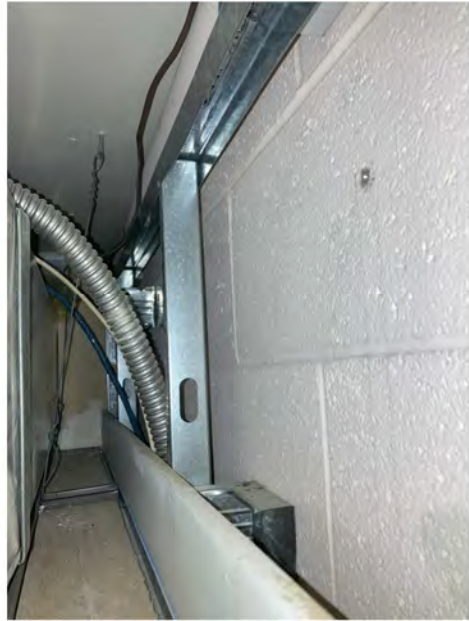
Photo 10 - View of sample location KP75 in the medical office admin area. The off-white crumbly coating material on the CMU wall has 2% chrysotile asbestos. (10/29/2024)

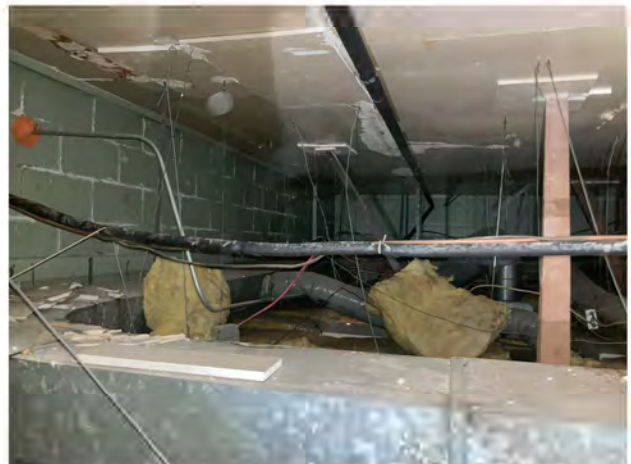
The four follow-up CMU paint coating samples (i.e., for samples KP9p and KP10p) were composited into two samples for TCLP lead analysis. The green painted coating (samples KP15p & KP16p) had a leachable lead concentration of 3.3 milligrams per liter (mg/L), which is below its hazardous waste criterion. Leachable lead was not detected in the off-white painted coating (samples KP17p & KP18p).

Photo 8 - View of sample location KP9p, a green paint on wood and CMU walls in the landscape shop area. (11/10/2023)

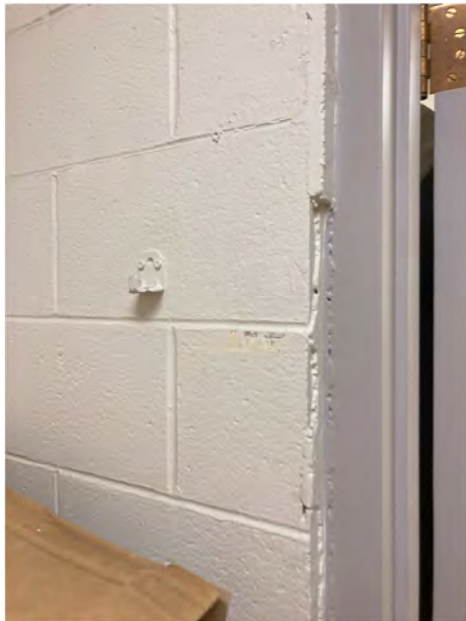
Photo 9 - View of sample location KP10p, an off-white paint on wood and CMU walls in the landscape area restroom. (11/10/2023)

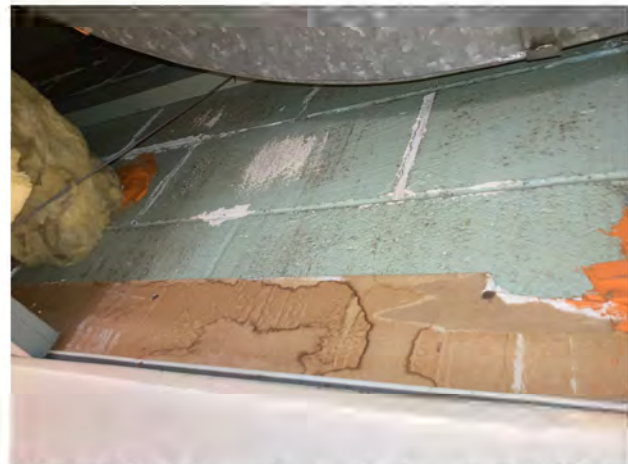
- Only one of three samples collected of the green-painted CMU coating is considered to be a lead-based paint (KP15p - 0.72%).
 - Eight of the coating samples had lead concentrations that exceeded the TCLP trigger thresholds. Two paint samples (KP7p and KP13p) had enough material remaining for follow-up TCLP analysis and the 4 follow-up CMU coating samples were composited into 2 samples for TCLP analysis. Only the composite sample for the green painted coating (samples KP15p & KP16p) had a leachable lead concentration of 3.3 mg/L, which is below its hazardous waste criterion. Leachable lead was not detected in the remaining samples.

Photo 12 - View of sample location KP15p, a green paint on wood and CMU walls in the landscape area shop. (10/29/2024)

- Worker safety and environmental protection requirements apply to all construction activities that may disturb lead in paint coatings at any concentration. While not required, we recommend the demolition work be performed by a Lead Safe Contractor for the proper removal and disposal of the materials.

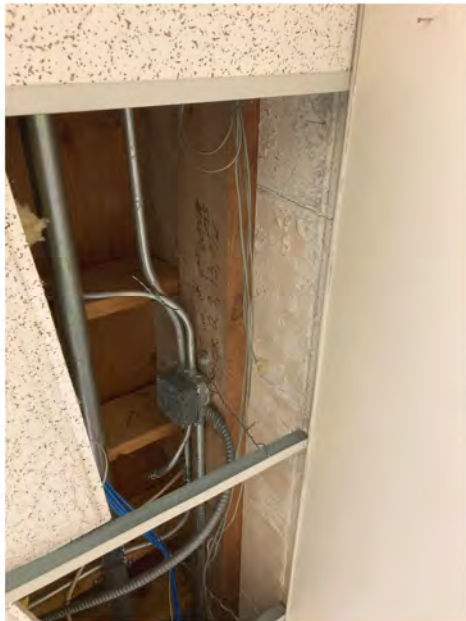
Photo 13 - View of sample location KP17p, an off-white paint on wood and CMU walls in the landscape area breakroom (10/29/2024)
