Re: Annual Site Activity Summary Report—2020

Zidell Waterfront Property, 3121 SW Moody Avenue, Portland, OR

2020 Annual Site Inspection Summary

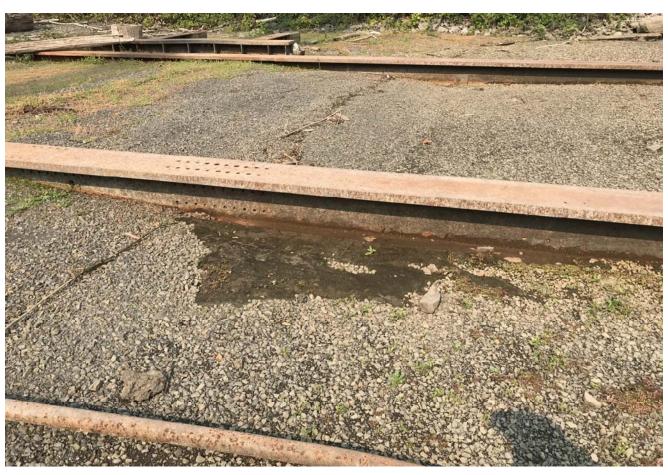
One small area of reactive core mat (RCM) (approximately 6 to 8 square feet) is visible adjacent to the center rail at the upper edge of the constructed limit. Since the RCM is still well anchored, this condition does not appear to be an issue. The condition will be evaluated in 2021 to determine if repair action (e.g. gravel placement/raking) is warranted.

Minor area of exposed RCM adjacent to center rail, area is stable

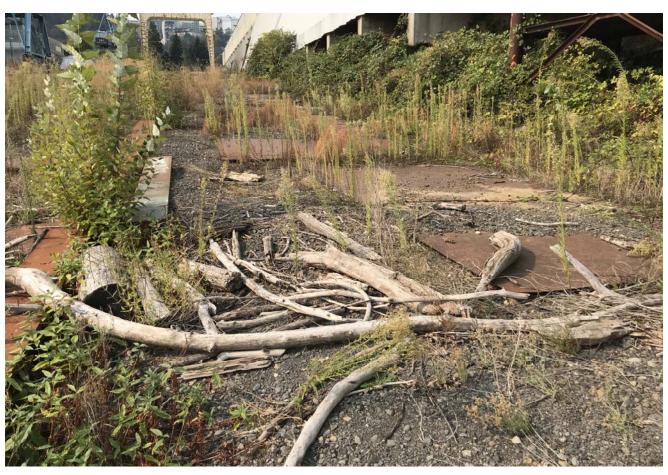
Debris buildup and vegetation growth in the slipway

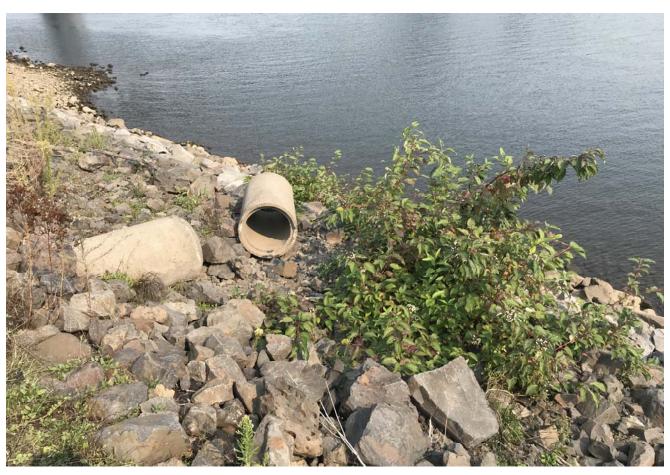
Stormwater outfall pipe segment separated, no change since previous inspections

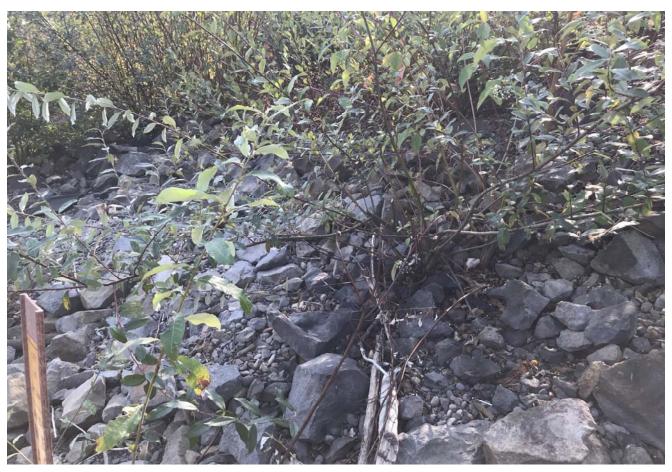
STA: 13+75 - 2018 Bank repair area

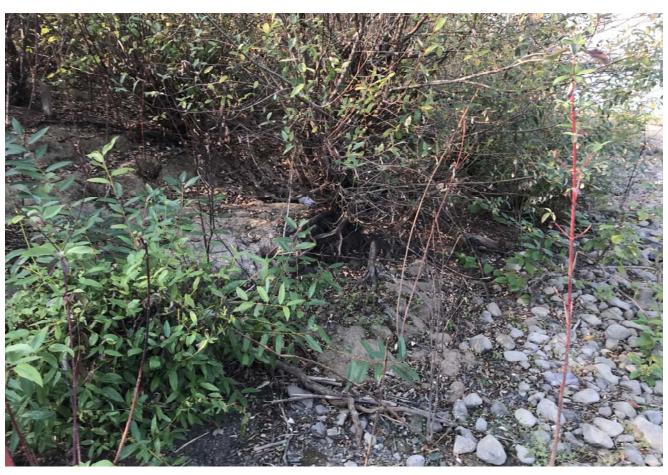
The bank appears to be in good shape above elevation of 10 feet up to STA: 19+50. Lower bank erosion has been noted from STA: 19+50 to 26+00 at various locations (approximately 60 percent of the bank line) from elevation 11 feet to 18 feet, as shown in the photo log. 2018 repair areas appear to be stable, with vegetation well-established. Habitat gravel on the repair areas appears to have remained on top of the rock armor.

STA: 24+25 - Lower bank erosion elevation 11'-18'

- Bank repair below elevation 18 feet is recommended in areas of continued erosion north
 of the Tilikum Crossing. The 2018 bank repair continues to be effective, and each
 inspection conducted since then has found successive increases in vegetative
 establishment.
- Monitor erosion areas above the rock armor beneath the Ross Island Bridge. The bank appears stable; however, additional erosion would be detrimental to cap stability.
- Continue to monitor vegetation on the lower bank areas of the Downstream Reach. Irrigation of the bank vegetation, primarily newer plantings, should continue during dry periods in summer and fall.
- Monitor the small, exposed RCM area in the slipway. If gravel displacement continues, raking or placement of additional gravel may be required.

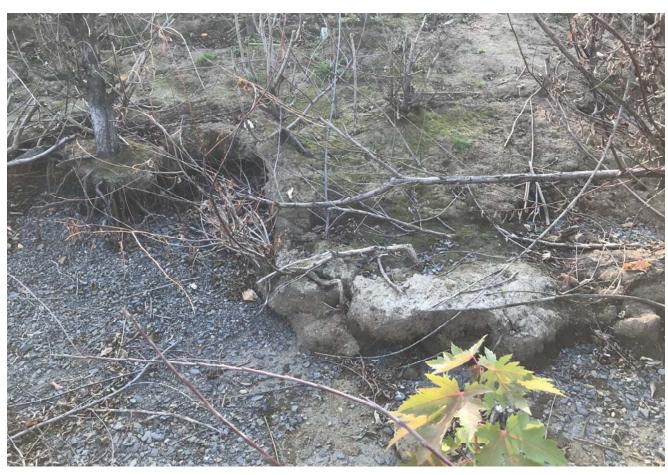
STA: 25+75 - Lower bank erosion below elevation 16'

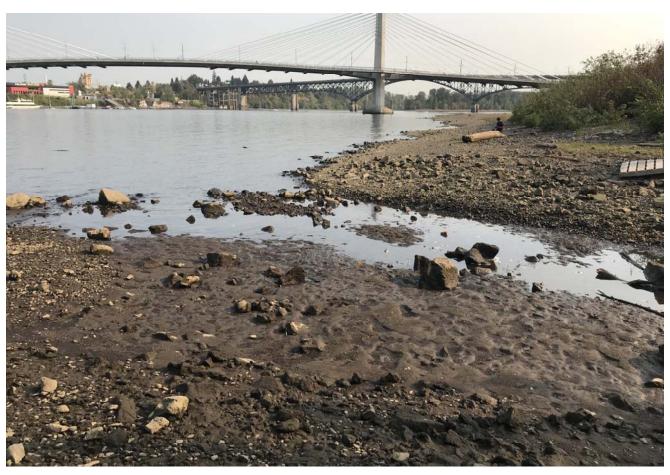
- Minimal discharge from City of Portland outfall 07b (near the Marquam Bridge) was observed. Discharge appeared to be murky, with bubbles, sediment, and discoloration.
- Debris (trash, clothing, etc.) from vagrant activity was observed at various locations on the bank; however, as a result of increased monitoring and security measures, the site is cleaner than during the 2019 inspection.

City of Portland outfall 07b flow path, looking southeast
