Re: Annual Site Activity Summary Report—2018
Zidell Waterfront Property, 3121 SW Moody Avenue, Portland, OR
ECSI No. 689

2018 ANNUAL INSPECTION SUMMARY

RE: 2018 Annual Site Inspection Summary

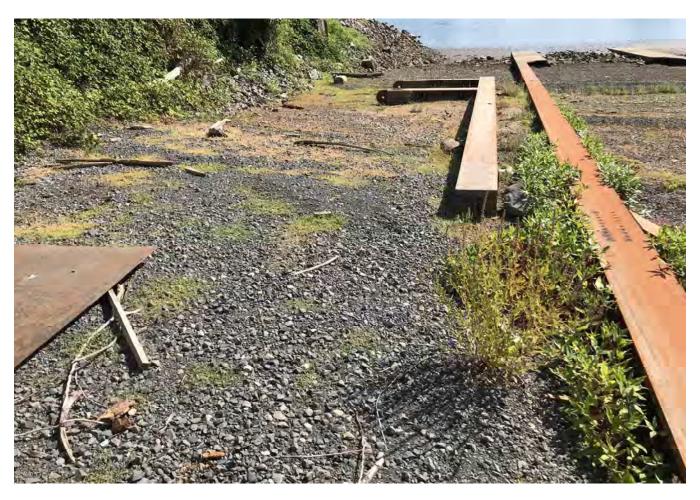
Vegetation, woody debris, and gravel in slipway ramp looking east.

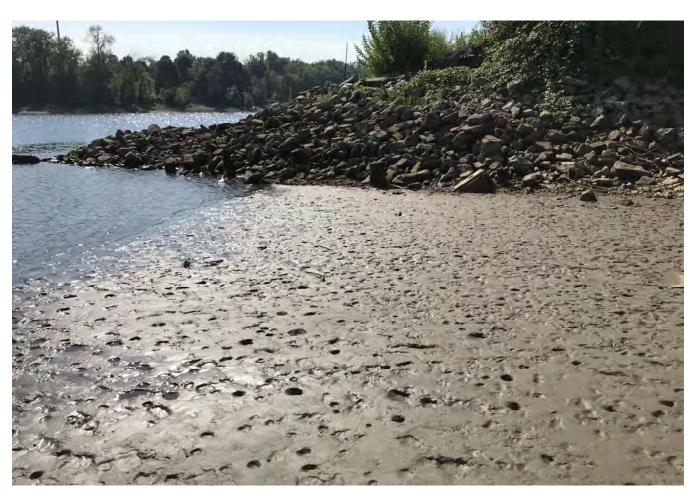
Sediment cap is in generally good condition; sediment build up was observed in the slipway.

Sediment buildup in the slipway ramp looking east.

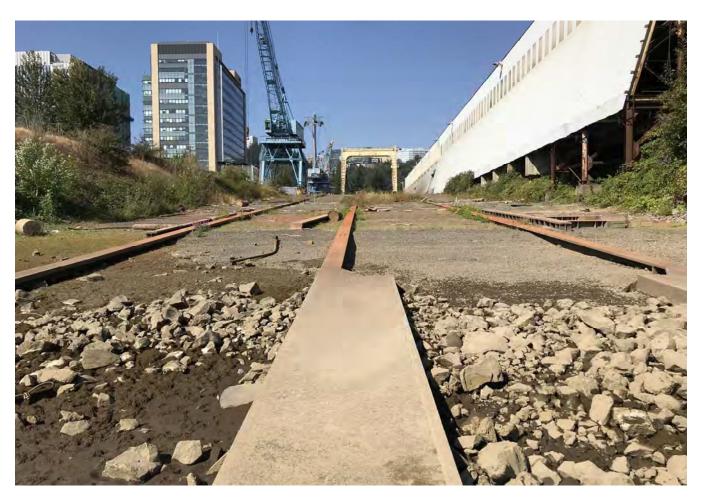
Sediment buildup in the slipway ramp looking northeast.

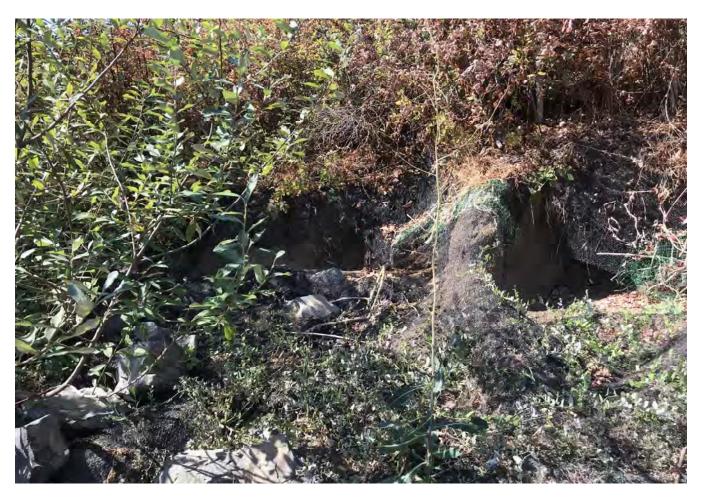
Spots of erosion were observed between elevations of 15 and 18 feet at STA: 6+25 and 6+75, coinciding with the north and south edges of the Ross Island Bridge. Bank armor appears stable.

STA: 6+00 - Bank erosion above rock armor.

STA: 6+00 - Bank erosion above edge of rock armor.

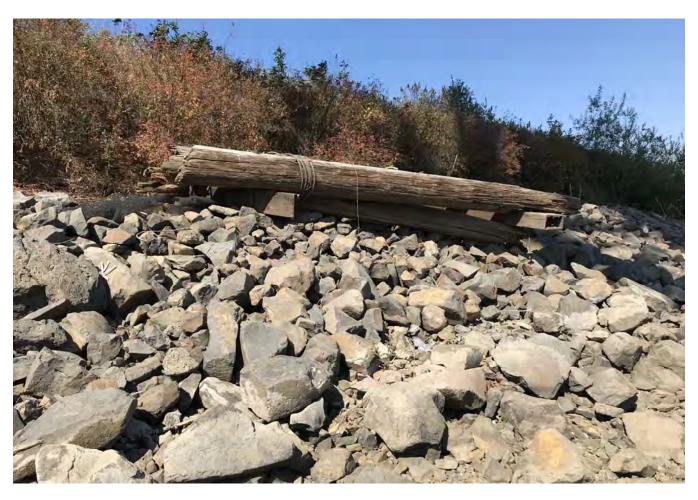
STA: 6+25 - Bank erosion above top of rock armor.

- 1. Bank repair is planned for the erosion areas noted in the North Bridge and Downstream Reaches. This work should be completed during low water to ensure access and better work conditions. We anticipate that this will address all significant areas with observed erosion.
- 2. Continue to monitor vegetation on the lower bank areas of the Downstream Reach. Continued irrigation of the bank vegetation, primarily newer plantings, should continue during dry periods in summer and fall.
- 3. Reinspect vegetation in the lower elevations of the Slipway and Bridge Reaches

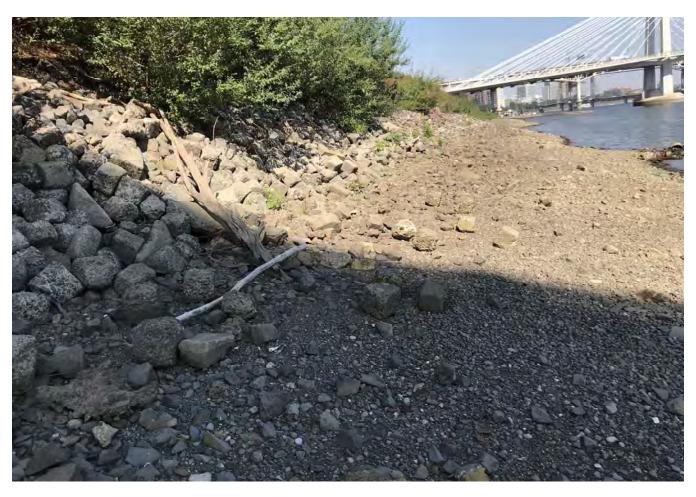
Bank erosion was observed between the top of the rock armor and elevation above 18 feet. Some demarcation fabric is visible along the top of the rock armor enhancement area. Some rock armor from the armor enhancement area appears to have moved from the bank to approximately 25 feet over the sediment cap.

STA: 7+25 - Ballast stones from bank repair area located over sediment cap.

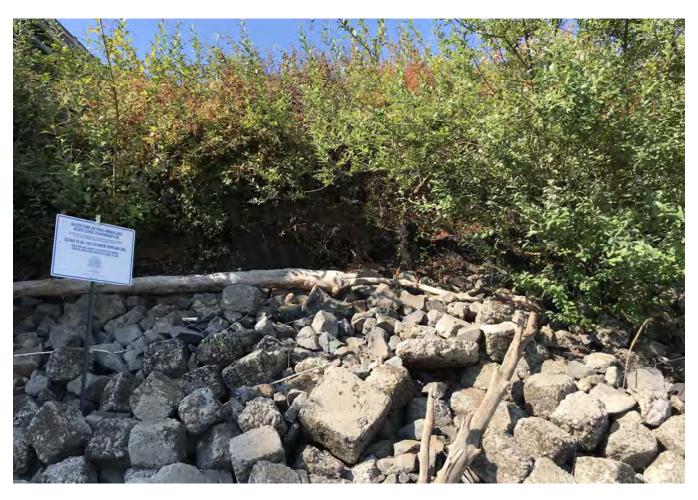
STA: 7+25 - Ballast stones from bank repair area migrating over sediment cap.

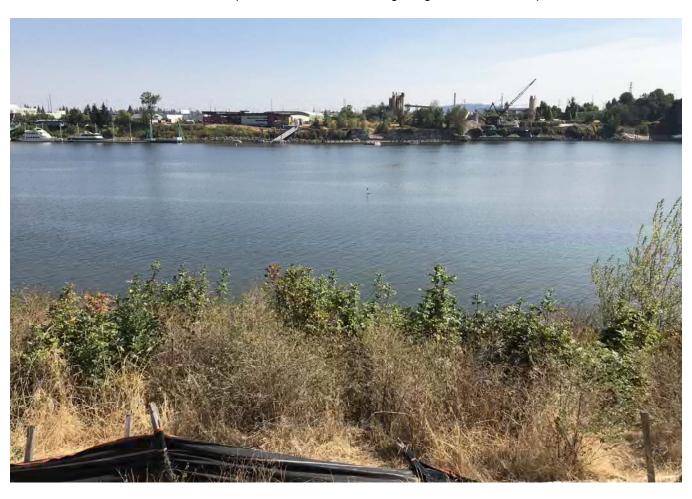
STA: 9+00 - Bank repair area ballast stones migrating over sediment cap area.

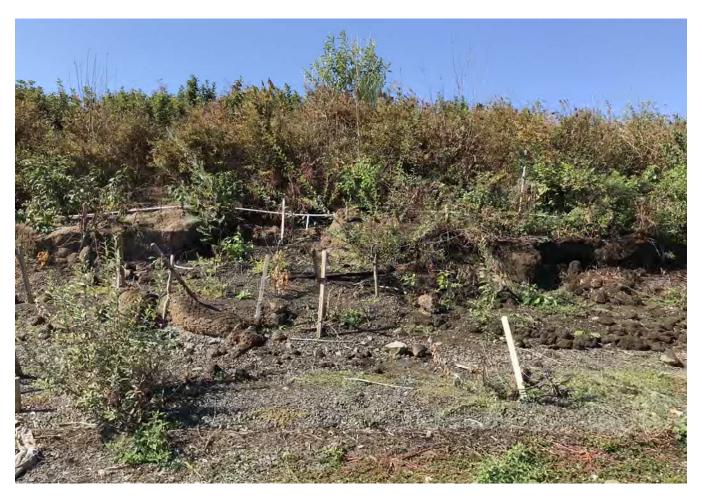
The bank appears to be in good shape above elevation of 18 feet with no notable condition changes since the previous inspection. Fairly significant erosion was observed at the locations of bank vegetation loss noted above.

STA: 12+50 - Bank erosion and access restriction sign looking southwest.

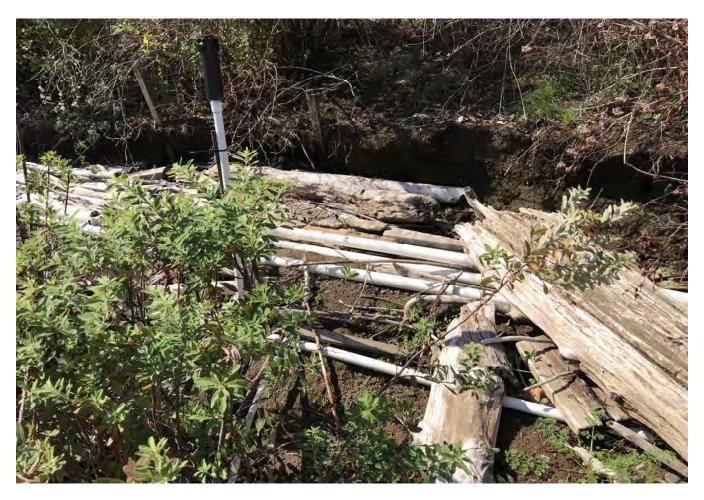
STA: 20+50 - Erosion on lower bank around irrigation lines.

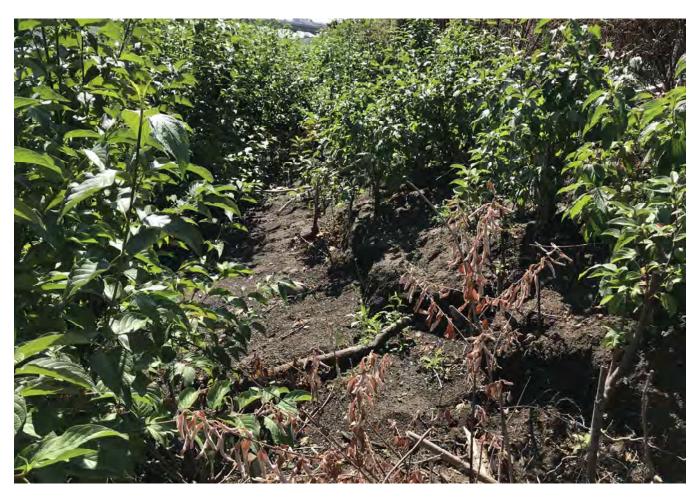
STA: 26+50 - Minor bank erosion on lower bank; with topsoil still in place.

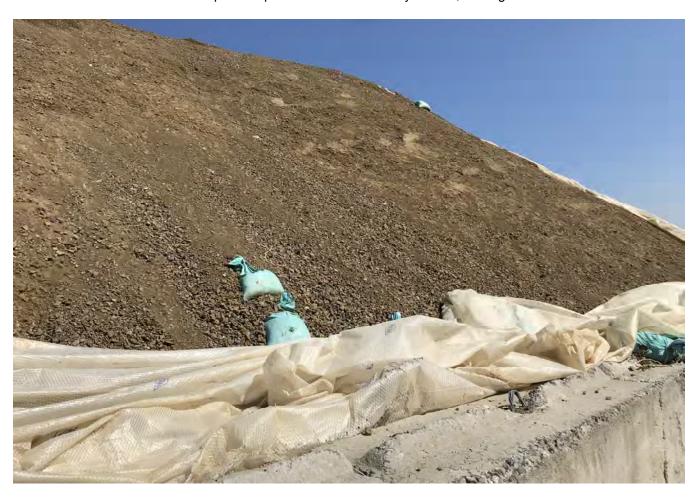
Geotextile cover not secured on gravel stockpiles on site.
