Re: Annual Site Activity Summary Report—2023

Zidell Waterfront Property, 3121 SW Moody Avenue, Portland, OR

2023 ANNUAL SITE INSPECTION SUMMARY

2023 Annual Site Inspection Summary

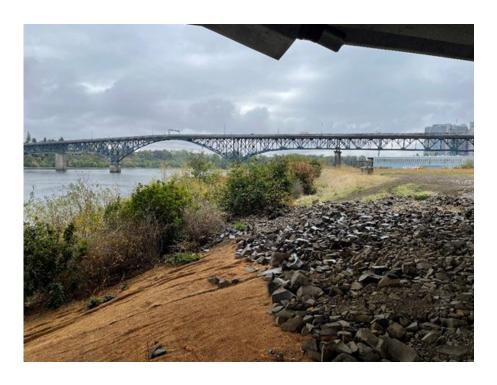
Photo No. 150.

Vegetation coverage is dense above elevation of 10 feet in most areas. A human started fire has caused damage to vegetation in the bank area underneath the Tilikum Crossing bridge envelope. The 2022 repair areas are revegetating through the newly placed rock armor. The majority of live stakes planted in 2022 are growing, though some appear to have been pulled as a result of human activity. Overall, vegetative coverage is good.

A higher homeless population along the downstream reach of the cap has led to more human activity and damage, including encampments, presence of debris, damage to plants, and fire damage to the bank in an area located below the Tilikum Crossing.

STA 17+00: Burnt brush located beneath Tilikum Crossing. Surface soil is protected by bridge deck.

• Repair and replace burned coir matting as needed.

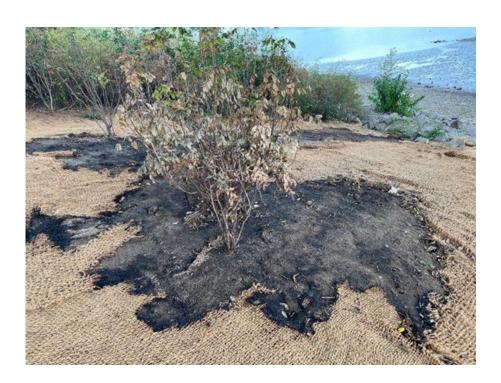
Photo No. 152.

STA 17+00: Top of rock armor looking west towards burnt area.

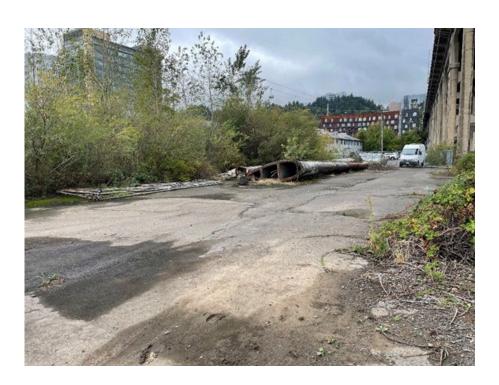
Photo No. 246.

The upland gravel cap north of the Ross Island Bridge appears in good condition. No changes to the asphalt cap were observed to the south of the Ross Island Bridge. A possible leak from the city water works main on the Ross Island Bridge has created a constant puddle located below the south side of the bridge. Equipment and materials were removed from the operational areas following closure of barge building operations. The building's interior is secured and was not accessible during the inspection.

Puddle from suspected water works pipe leak at Ross Island Bridge, looking east.
