Re: Annual Site Activity Summary Report—2021

Zidell Waterfront Property, 3121 SW Moody Avenue, Portland, OR

**ECSI No. 689**

RE: 2021 Annual Site Inspection Summary

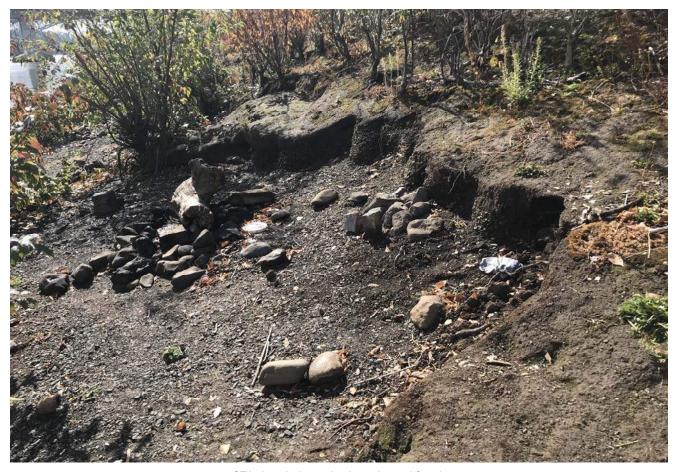
The bank appears to be in good shape above an elevation of 10 feet up to STA: 19+50. Lower bank erosion has been noted from STA: 19+50 to 26+00 at various locations (consistent with the 2020 inspection) from 11- to 18-foot elevation, as shown in the photo log. New or increased bank cap thinning and/or erosion was observed in the downstream reach at several locations downstream of the Tilikum Crossing. Most areas experiencing increased erosion compared to the 2020 inspection are from STA 24+00 to 26+00. Existing dense vegetation is maintaining some stability, though exposed rooting is visible at several locations.

STA: 25+50 - Lower bank erosion and fire pit

- Complete planned bank repair below elevation 18 feet in areas of erosion downstream of the Tilikum Crossing. The 2018 bank repair continues to be effective, and each inspection conducted since implementation has found successive increases in vegetative establishment.
- Monitor erosion areas above the rock armor beneath the Ross Island Bridge. The bank appears stable compared to the 2020 inspection; however, changes could occur from severe weather events.
- Continue to monitor vegetation on the lower bank areas of the Downstream Reach for additional effects following the excessive heat and drought conditions endured in 2021.

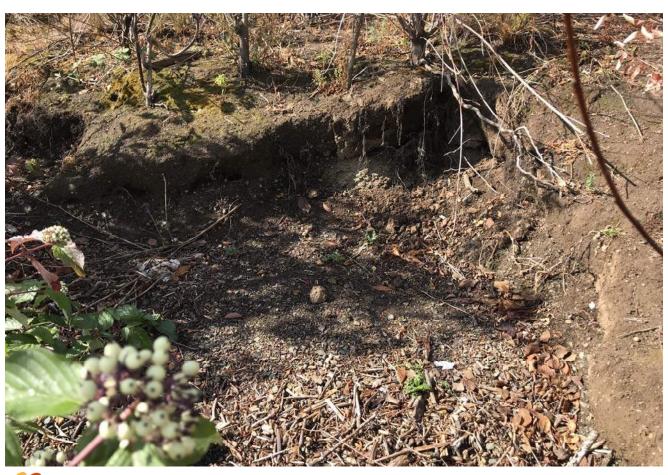
STA: 25+00 - Lower bank erosion

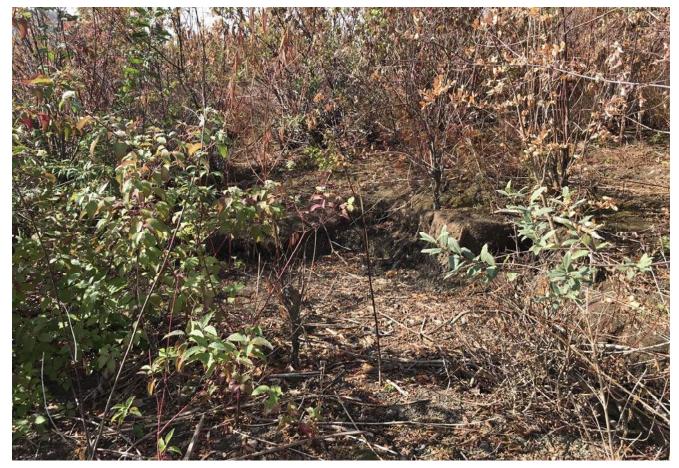
STA: 24+00 - Lower bank erosion to approximate elevation 17'

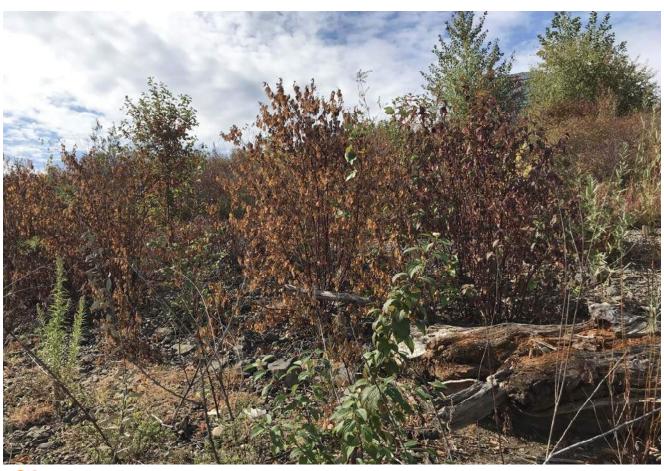
Vegetation coverage is dense above elevation of 10 feet in most areas. On the bank area underneath the Tilikum Crossing bridge envelope, vegetation coverage has decreased compared to the previous inspection and has localized spots of minor erosion where water drips from the overhead bridge structure. The 2018 repair areas are revegetating vigorously through the newly placed rock armor, and live stakes installed on lower portions of the bank have become established. Some vegetative stressing was noted due to persistent hot and dry conditions in 2021.

Lower bank repair area (2018), vegetation stress

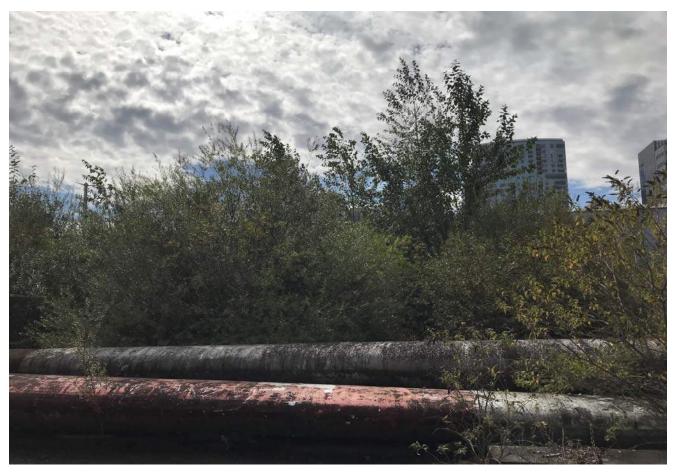
Live stakes planted in fall 2018 on the lower bank in the Downstream Reach appear to be growing well at most locations. The stormwater infiltration facility has dense growth along its slopes and bottom.

Infiltration facility, north edge looking south

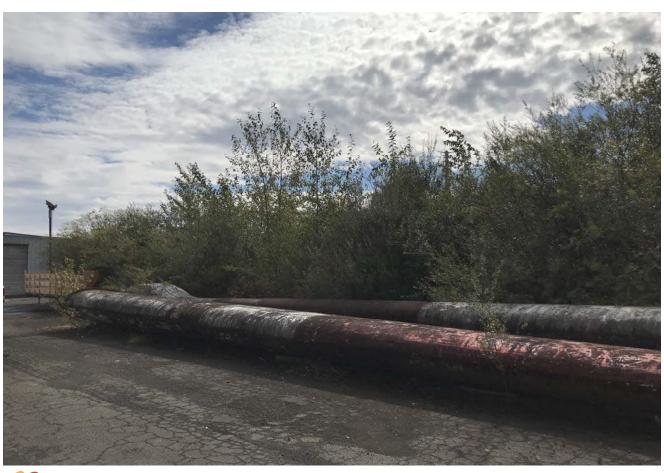
$In filtration \ facility, \ north \ edge \ looking \ southeast$

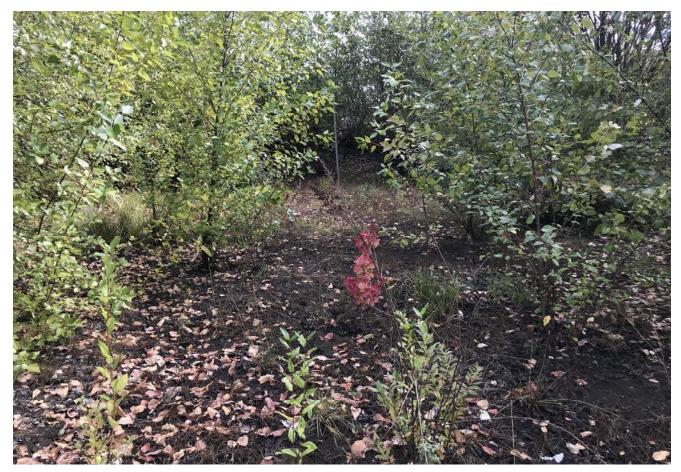
Infiltration facility bottom, looking east

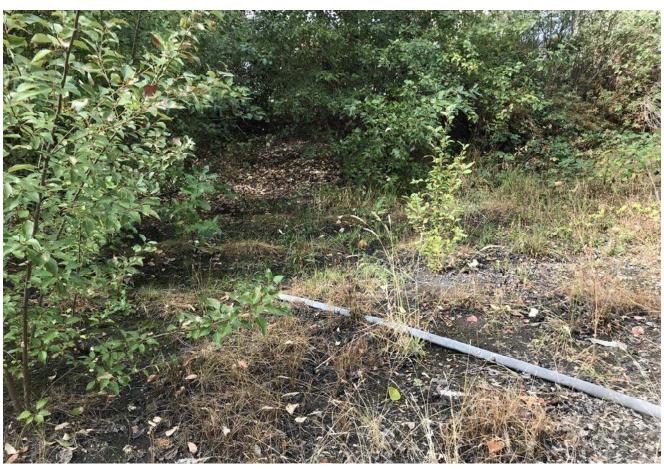
Infiltration facility bottom, looking northeast
