River Terrace Town Center—SW Roy Rogers Road

Date and Time of Inspection: 12/30/24 14:00

ANNUAL CAP INSPECTION REPORT

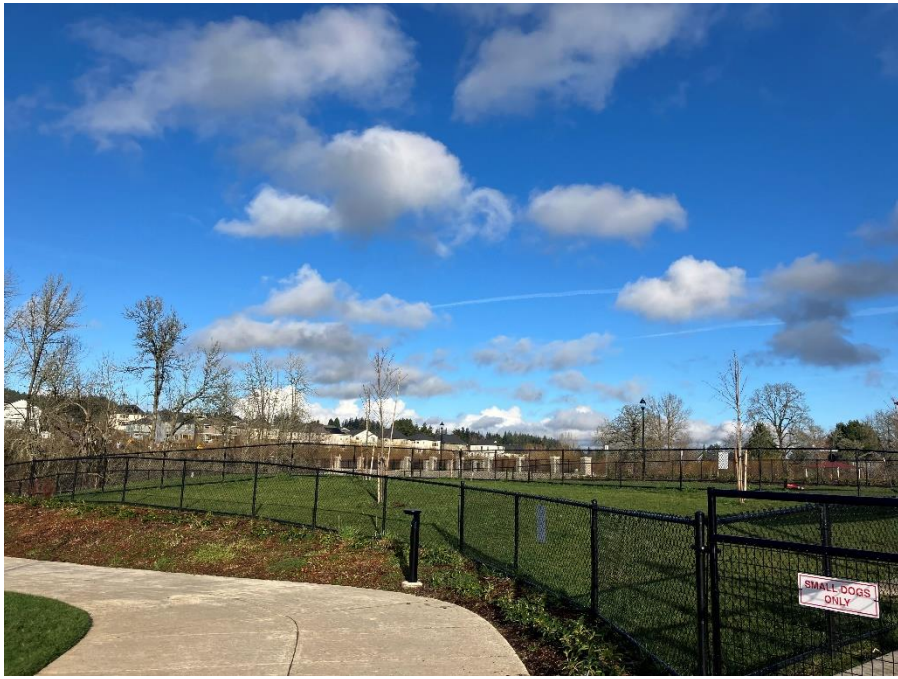
PHOTO I.D. 1: WEST PORTION OF DISPOSAL CELL #2. PHOTOGRAPH TAKEN FACING NORTHEAST.

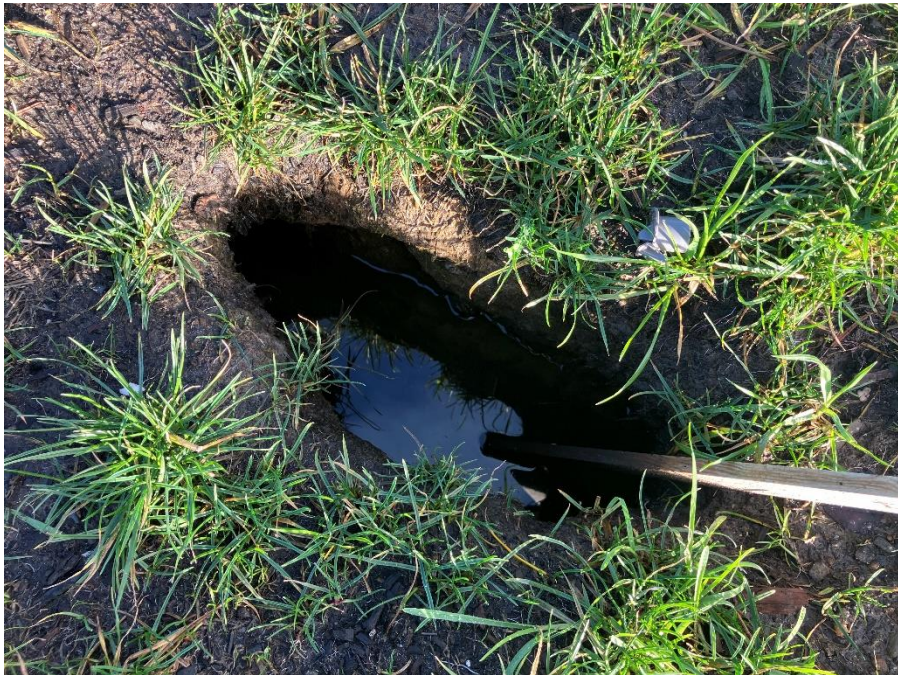
Any suspect features, such as major cracks, ruts, damage, settlement, or removed vegetation:
Several tire ruts were observed in Disposal Cell #1. Several small holes with standing water located within the grass areas of the dog parks, including an approximately 2.5-foot-deep hole filled with water from a broken subsurface irrigation line, were observed in Disposal Cell #2. A minor area of erosion was also observed on the landscaped northwest slope of Disposal Cell #2. The holes and minor area of erosion were repaired on January 14, 2025.

PHOTO I.D. 2: HOLE IN SOIL CAP FROM BROKEN IRRIGATION LINE WITHIN THE SMALL DOG PARK IN DISPOSAL CELL #2.

Repairs to the areas of concern observed in Disposal Cell #2 were conducted on January 14, 2025. Repairs consisted of repairing a broken subsurface irrigation line and filling the holes that were observed with additional clean fill. Additional soil and landscaping materials were also used to repair the minor erosion observed in the landscaped area, and to fill a low spot of ponded water. Photographic documentation of the repairs is included in the attached figures and summarized in the Photographic Log on the following page.

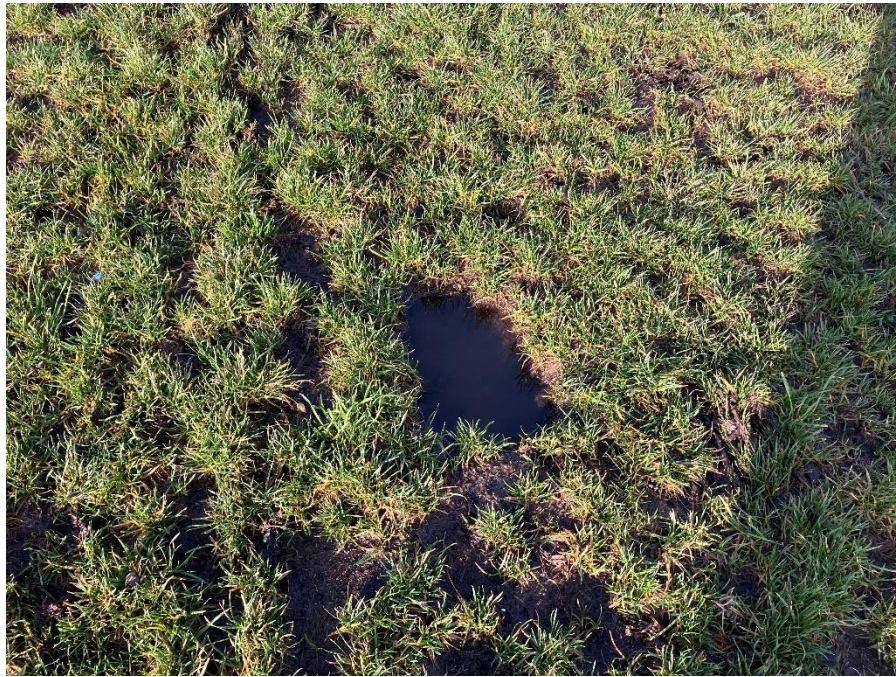
PHOTO I.D. 3: HOLE IN SOIL CAP WITHIN THE LARGE DOG PARK IN DISPOSAL CELL #2.

Any observations of areas where maintenance is required to maintain the integrity of the cap?
The small holes and eroded landscaping within Disposal Cell #2 were repaired on January 14, 2025. The tire ruts in Disposal Cell #1 will be repaired during upcoming construction activities and placement of final cover.

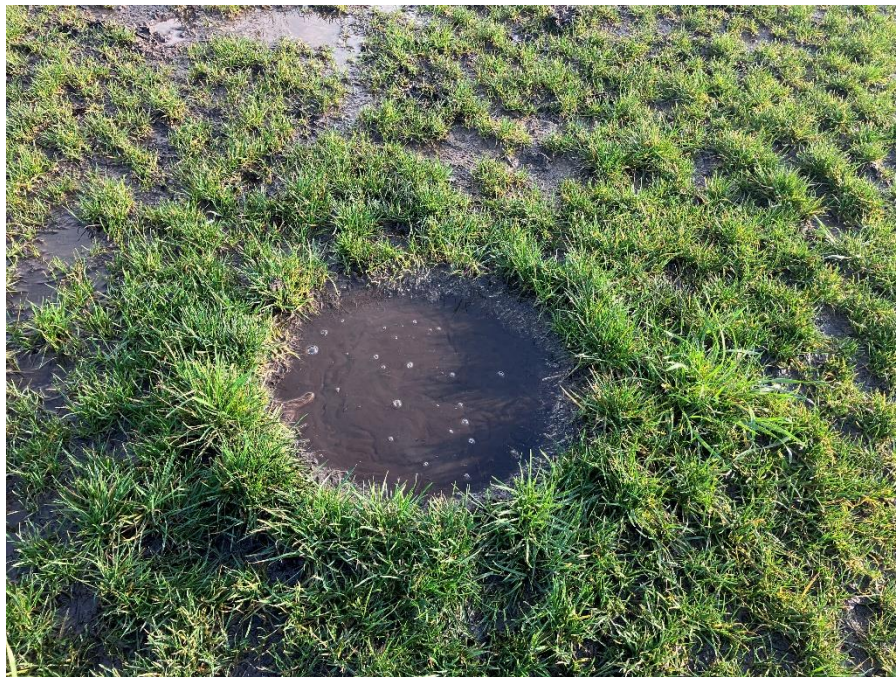
PHOTO I.D. 4: HOLE IN SOIL CAP WITHIN THE LARGE DOG PARK IN DISPOSAL CELL #2.

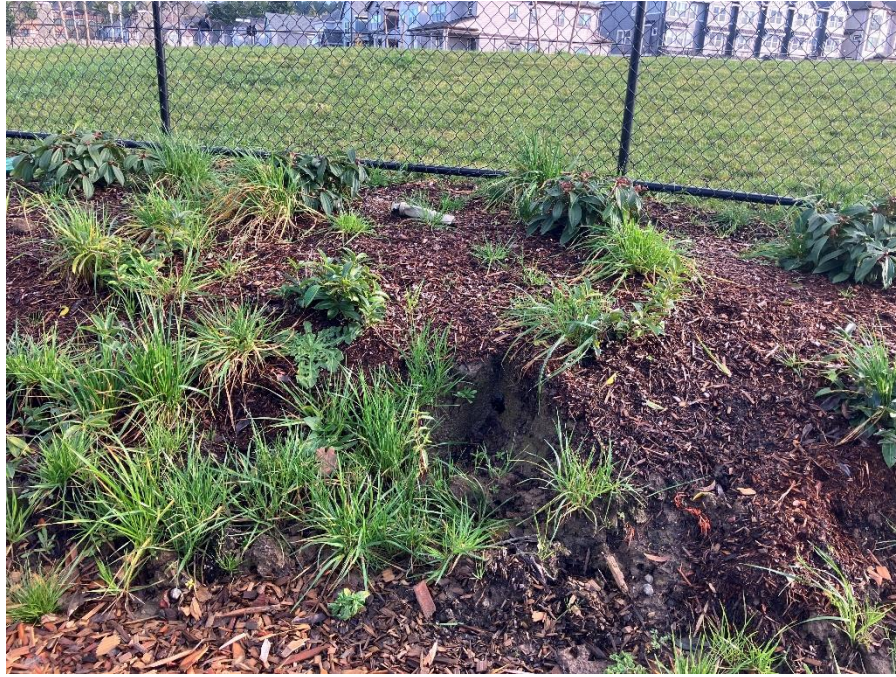
PHOTO I.D. 5: EROSION IN LANDSCAPING ALONG THE NORTHWEST SLOPE OF DISPOSAL CELL #2. PHOTOGRAPH TAKEN FACING SOUTHWEST.

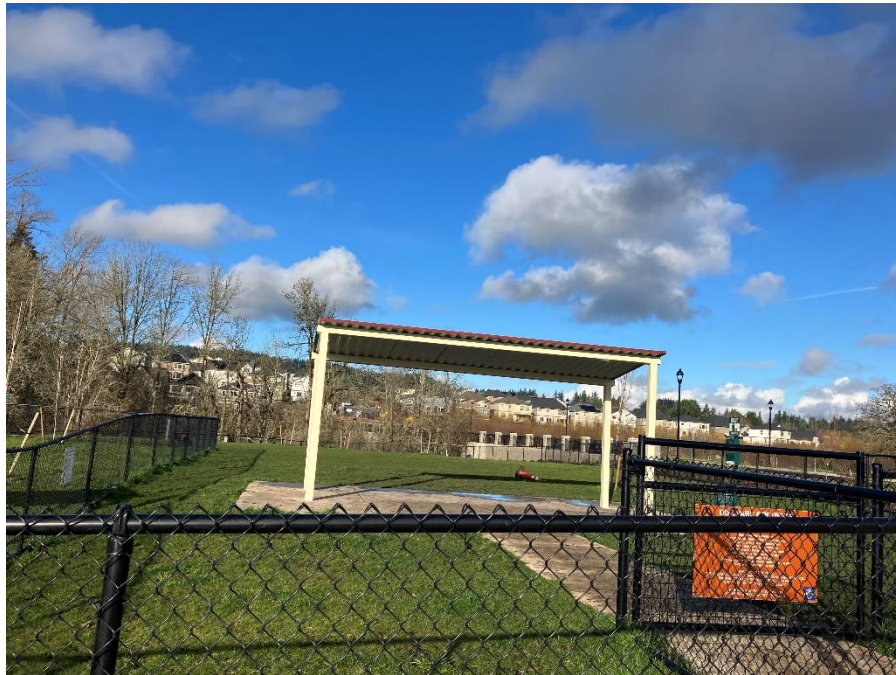
PHOTO I.D. 6: EAST PORTION OF DISPOSAL CELL #1. PHOTOGRAPH TAKEN FACING NORTH.

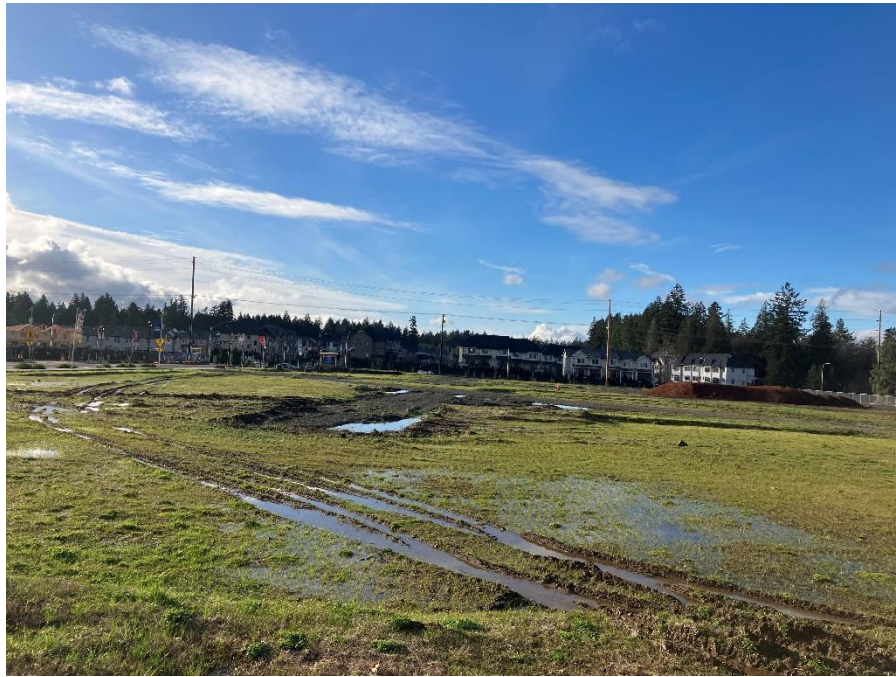
PHOTO I.D. 7: VIEW OF DISPOSAL CELL #1 WITH TIRE RUTS. PHOTOGRAPH TAKEN FACING WEST.

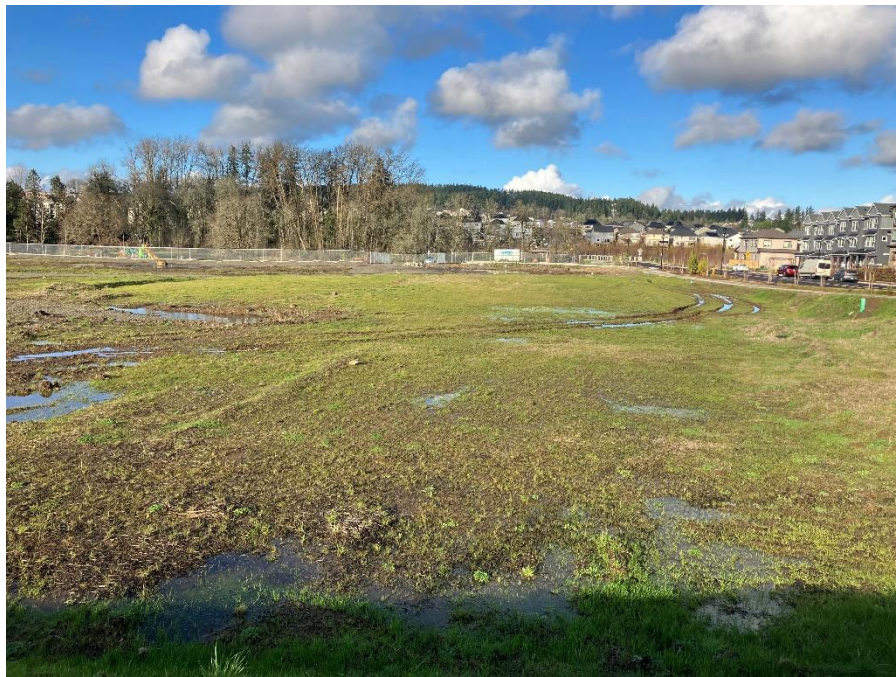
PHOTO I.D. 8: VIEW OF DISPOSAL CELL #1 WITH TIRE RUTS. PHOTOGRAPH TAKEN FACING NORTH.
