## Bors Property (ECSI #901) NFA Evaluation

PREPARED FOR: Oregon Department of Environmental Quality

DATE: May 18, 2017

PROJECT NUMBER: 693919.01.05

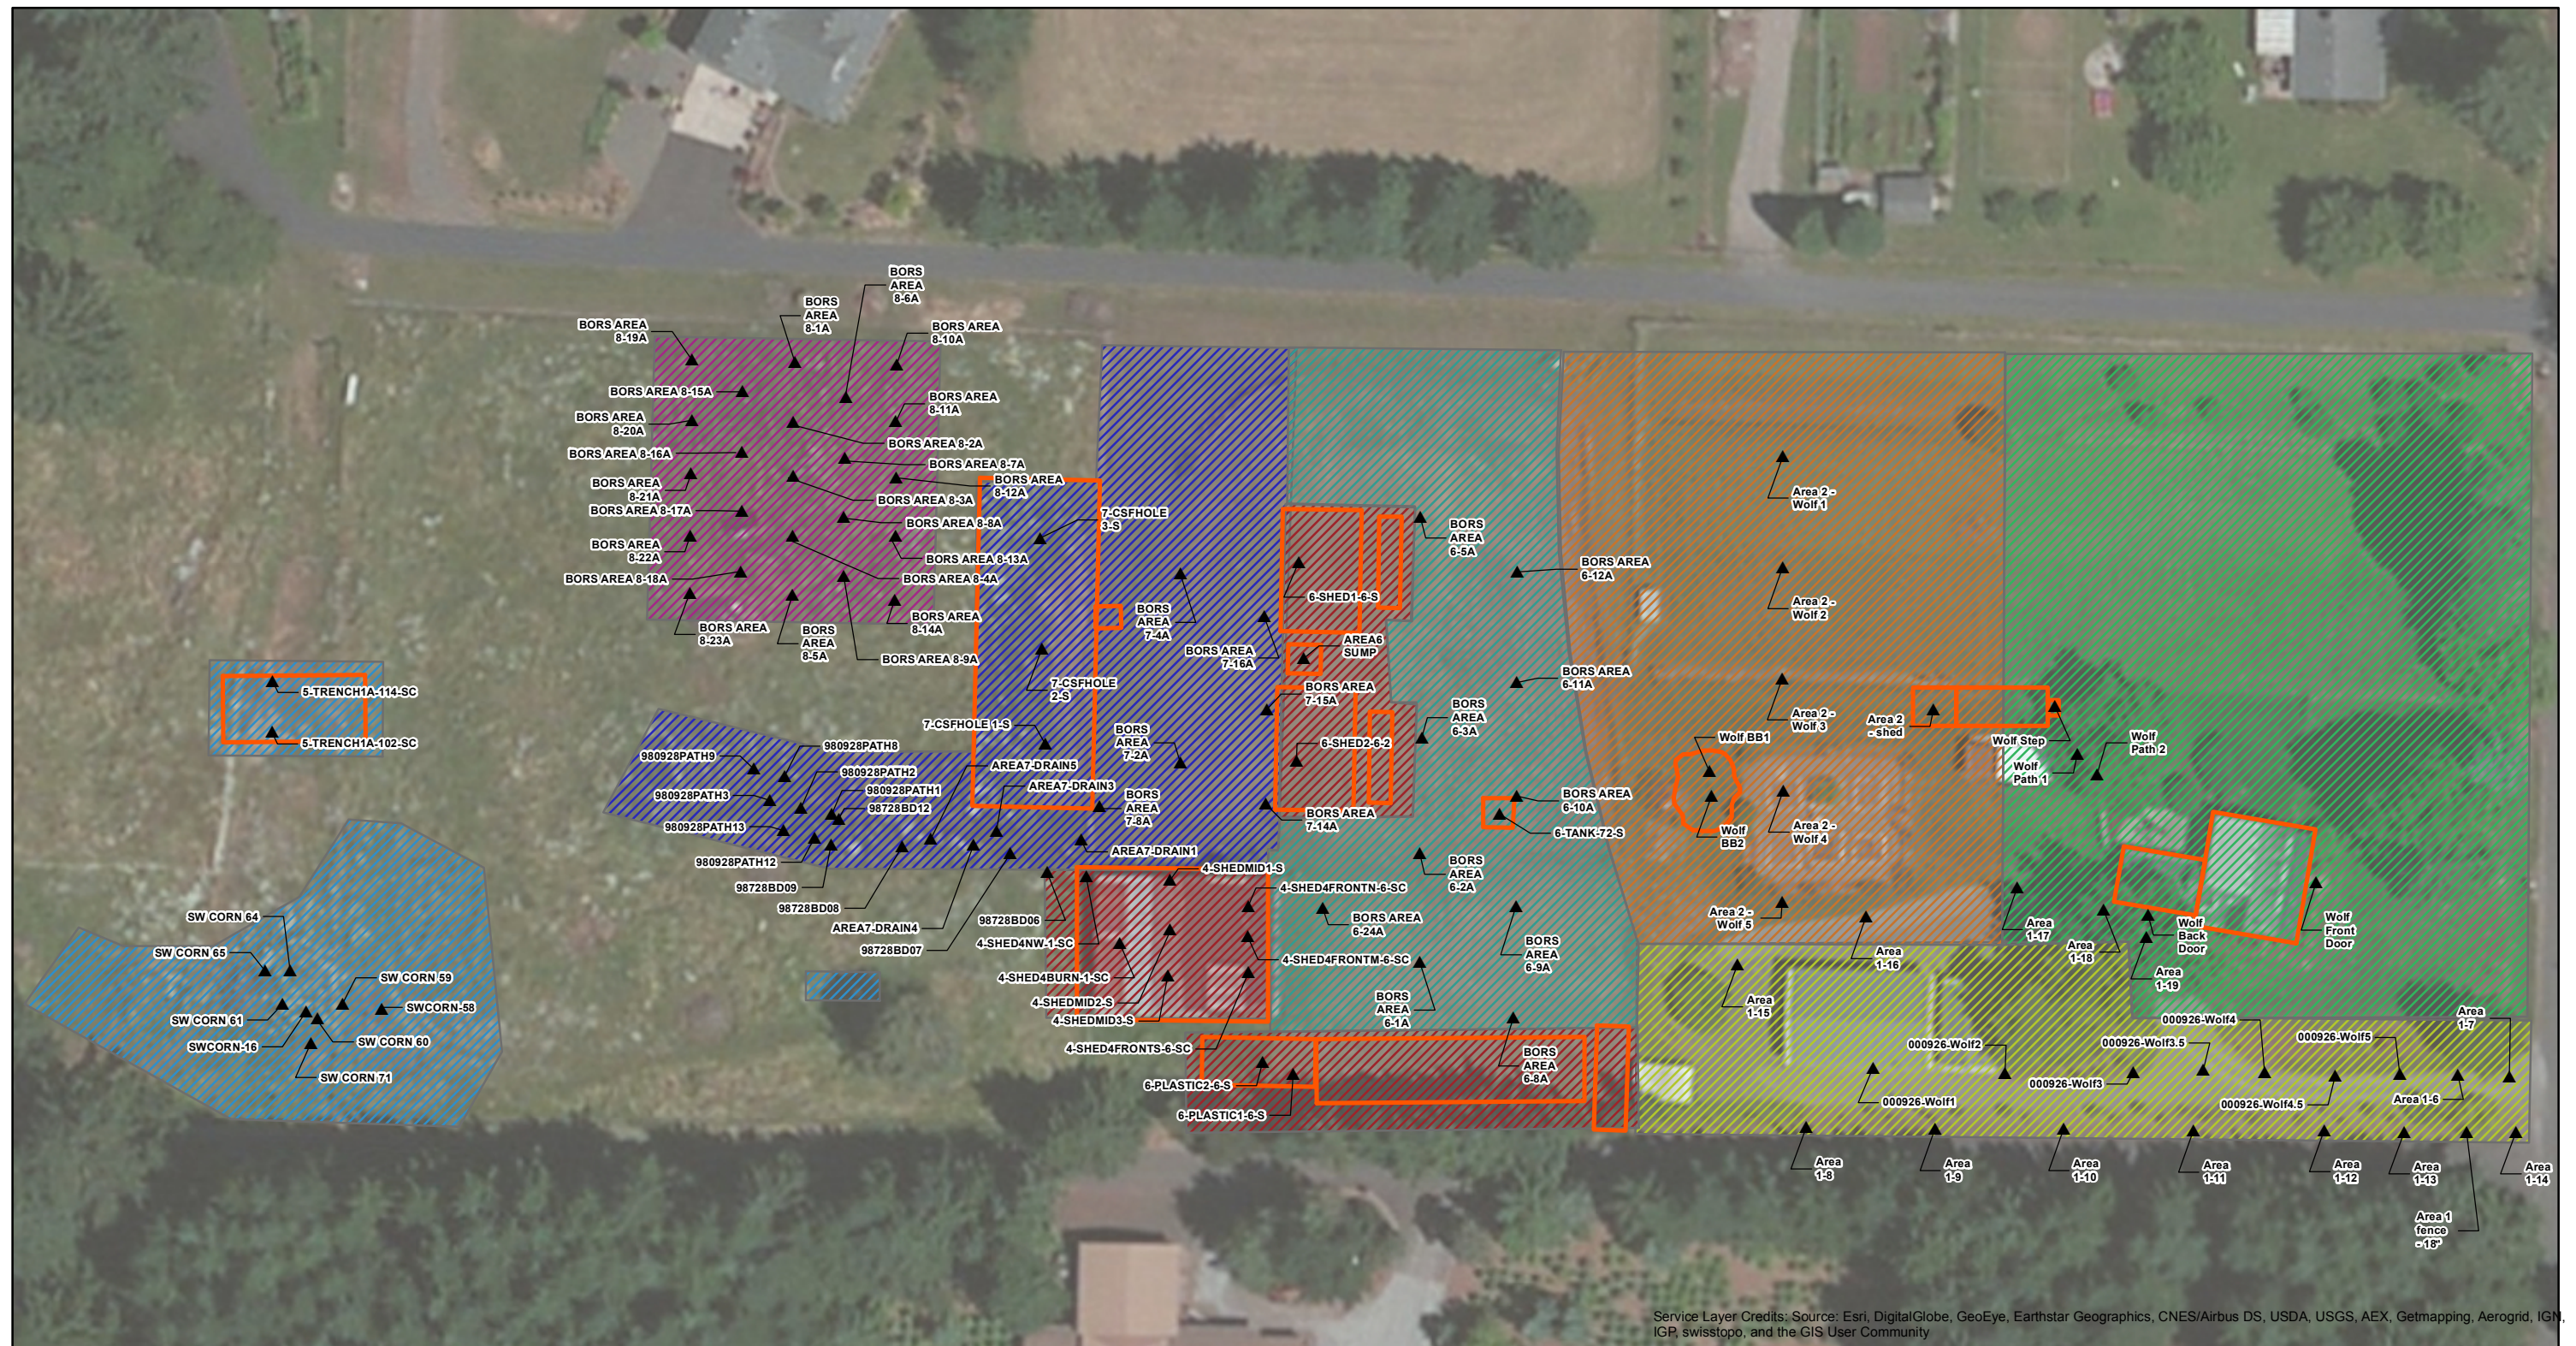
**FIGURE 3**  
**Confirmation Soil Sample Locations**  
 Bors Property Evaluation  
 Oregon City, Oregon

To determine soil conditions existing at the site following remediation, confirmation soil sample data following remedial activities and data from areas with no follow-up remediation were compiled and mapped (Table 1 and Figures 3 and 4). Sample data were obtained from the following sources:

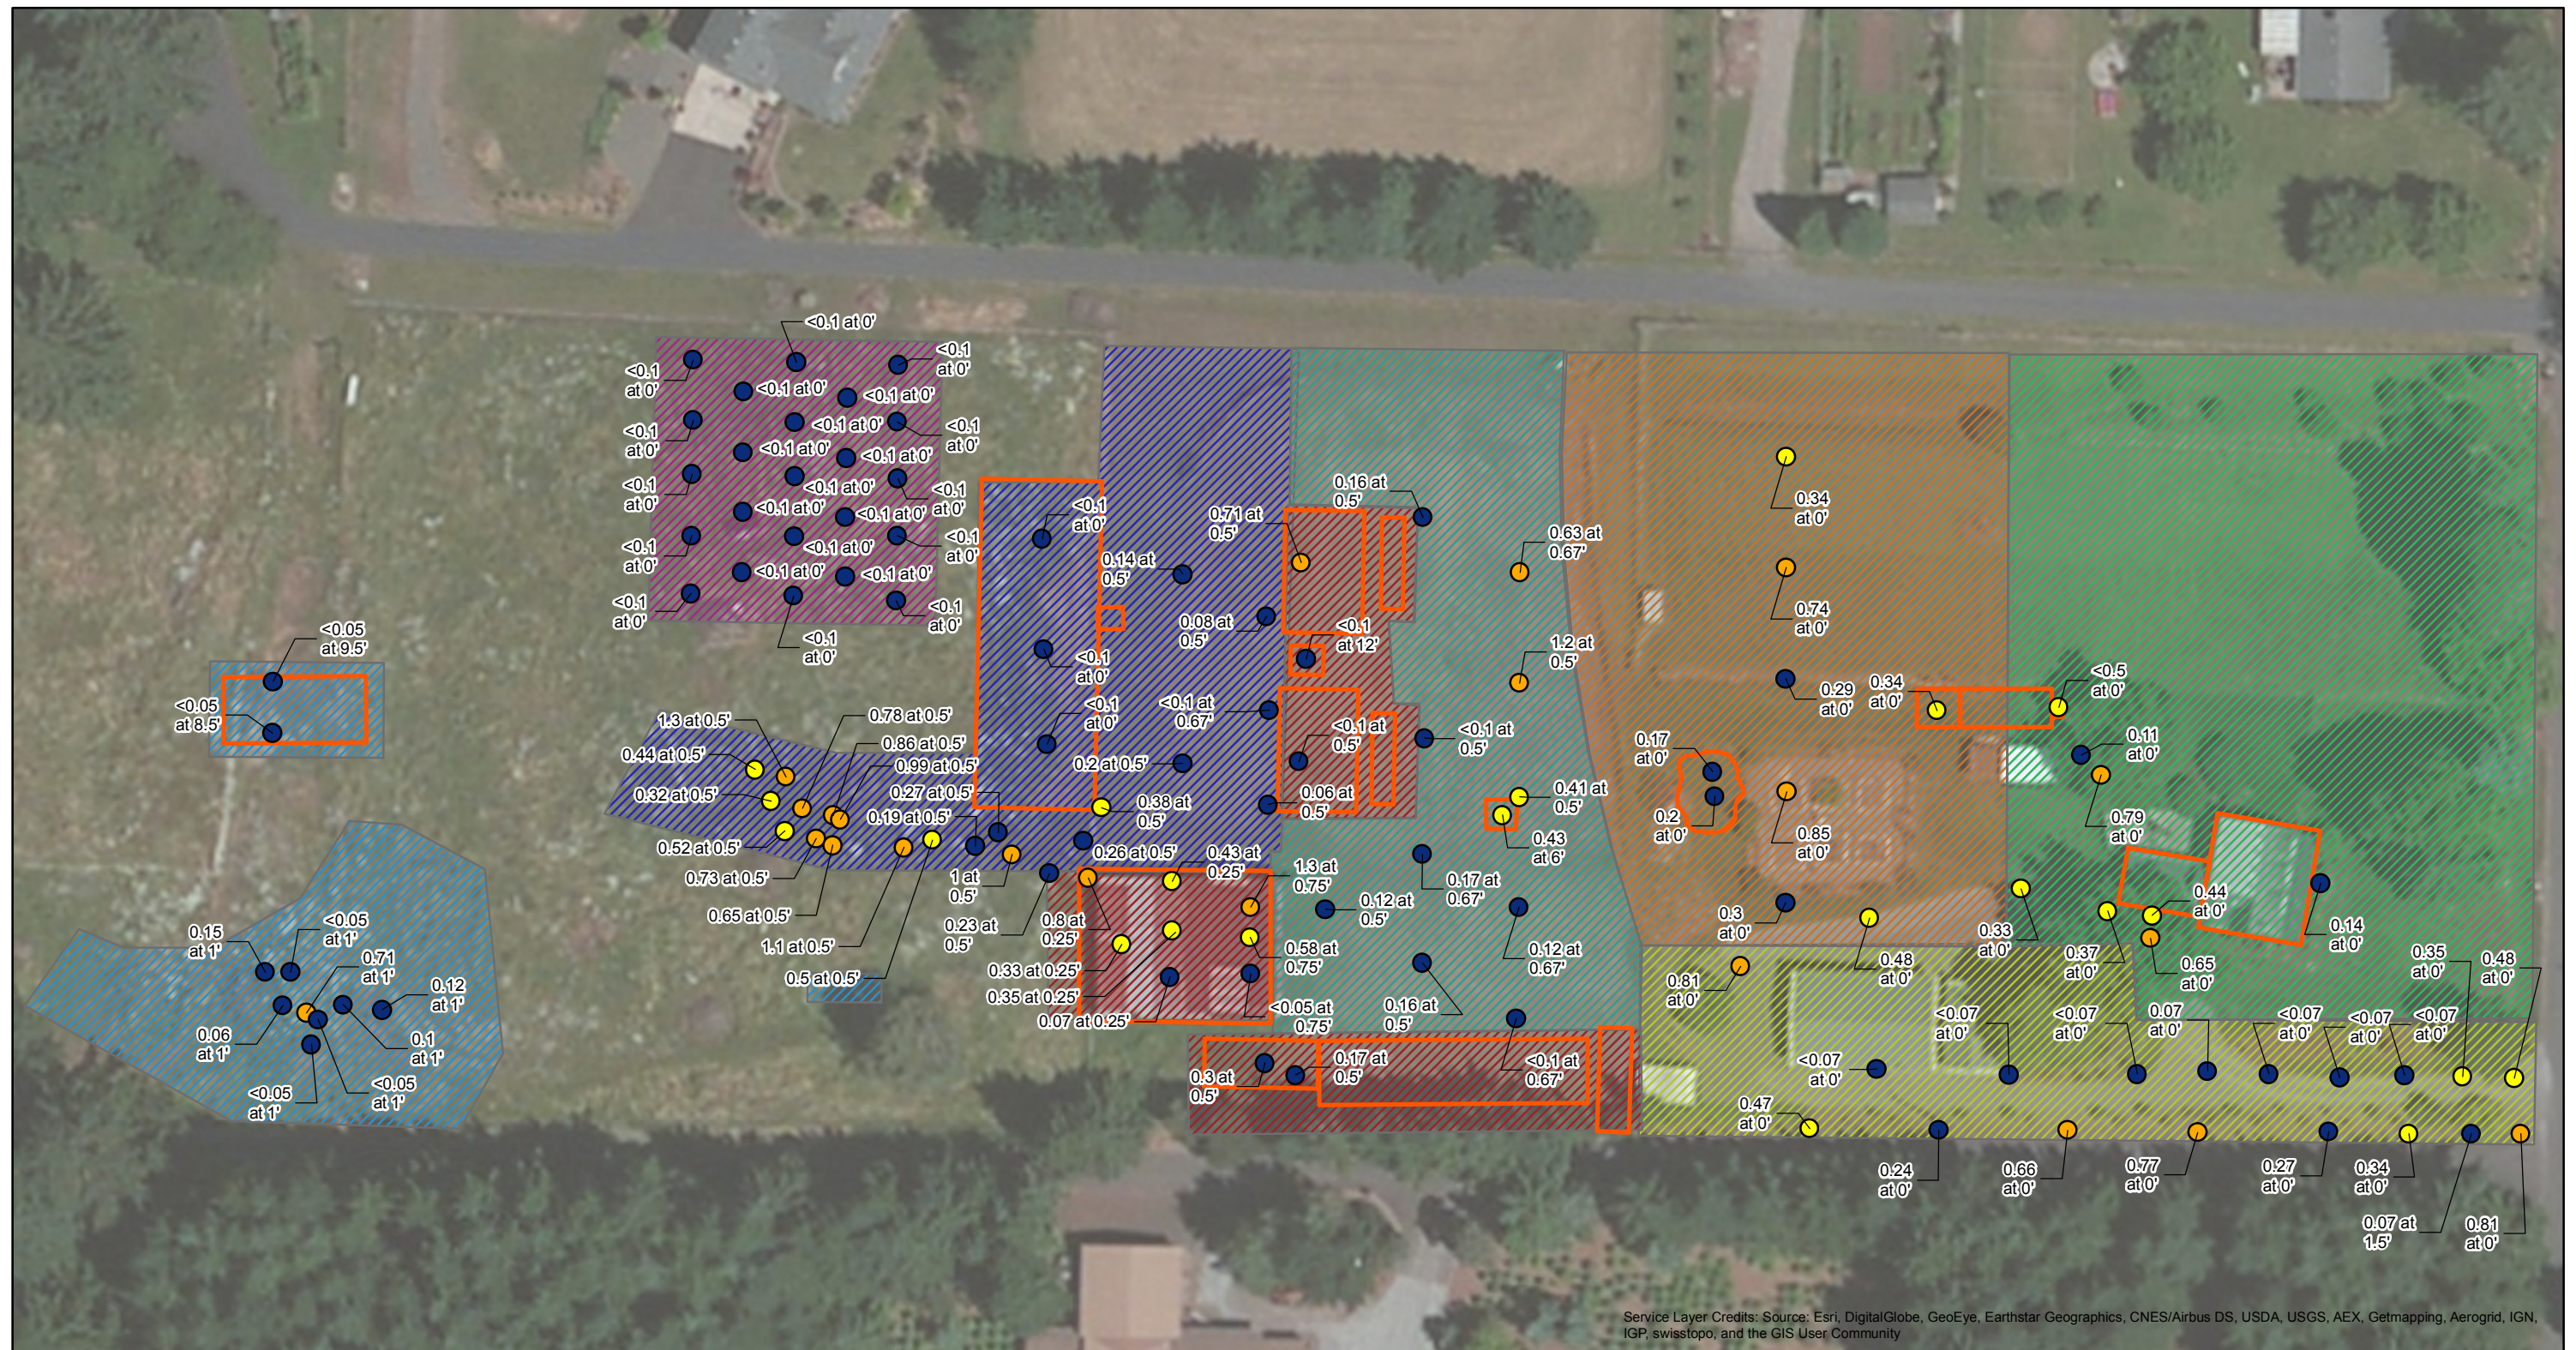
**FIGURE 5**  
**Confirmation Soil Sample PCB Concentrations**  
 Bors Property Evaluation  
 Oregon City, Oregon

The 90% UCL representing existing site conditions was calculated to be 0.31 ppm. Figures 5 and 6 show individual PCB concentrations for each confirmation sample location in comparison to the 90% UCL computed from this risk evaluation.

In addition to the finding of no unacceptable exposure risk for the property, the detected PCB levels at all individual sample locations (maximum of 1.3 ppm) were well below the DEQ Hot Spot concentration
