Matcon Annual Inspection Report for the Taylor Lumber Superfund Site
Stella Jones Company
22125 SW Rock Creek Road, Sheridan, Oregon
Construction date for cap: 2007

Inspection date: December 18, 2024

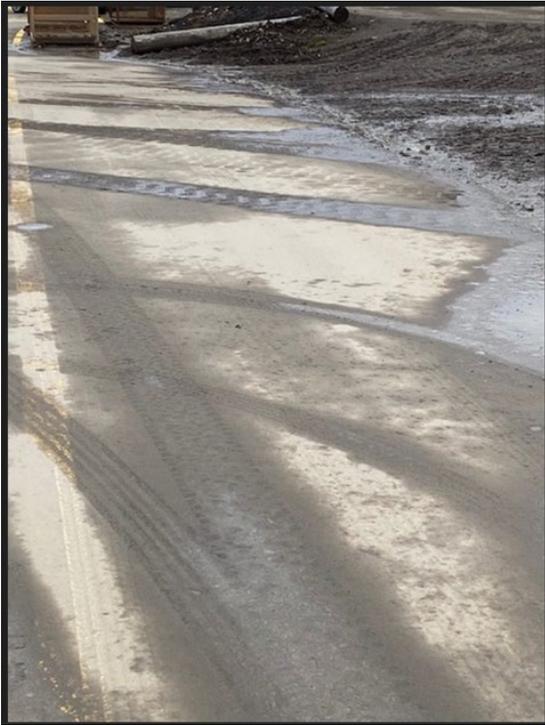
- a. Eruption cracks and surface damage: No major cracks or eruptions were observed during the site walk.
- b. Cap margins and edges: Inspection of the cap margin showed the edges appeared to be holding up well. Although some mud was visible due to the days traffic, there was little gravel build up at the edges. (Photos 1 through 4)

Photo 1: Cap margin near peeler on SW corner of cap.

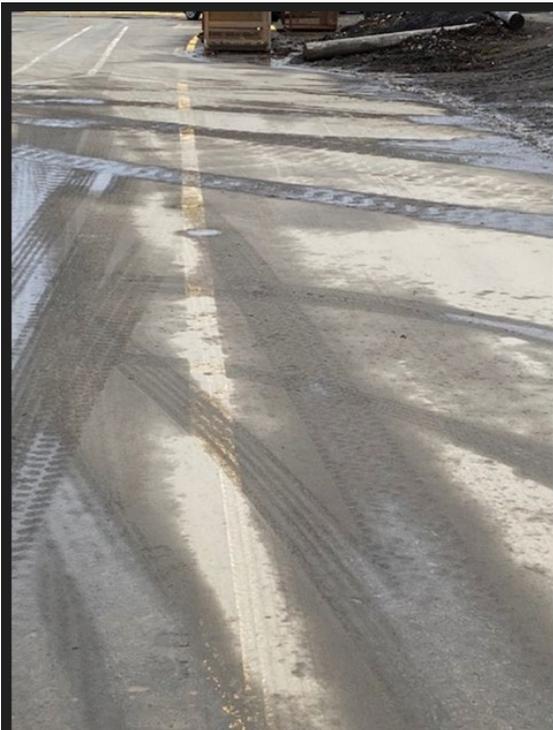
- d. Barrier wall demarcation: The barrier wall marking was observed around the site. The line was mostly visible, except where some minor mud covered it due to the current vehicle site traffic. (Photos 2 through 4)

Photo 2: Looking east, cap margin and barrier wall line near peeler area on SW corner of cap.

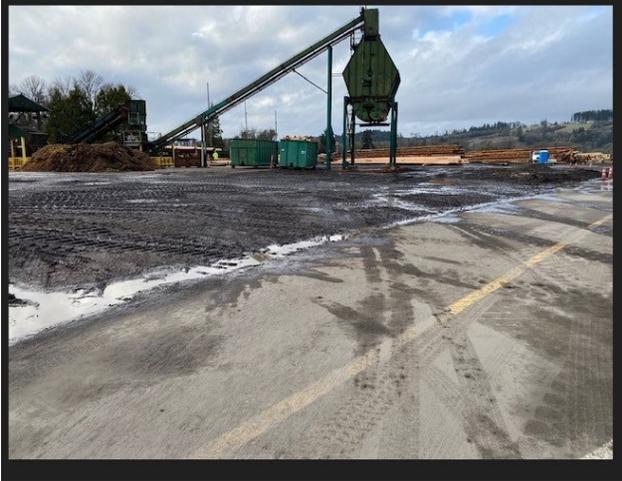
Photo 3: Looking west, cap margin and barrier wall line on the SW corner of cap adjacent to peeler area.

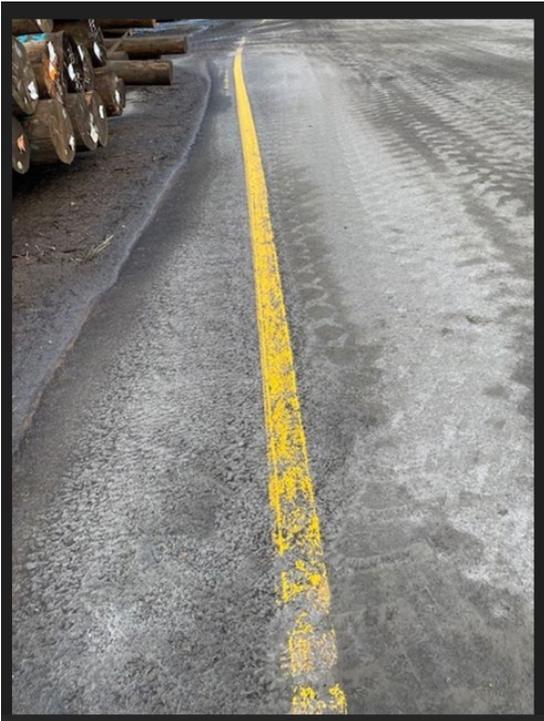
Photo 4: Cap margin and barrier wall line on the north side of the site.

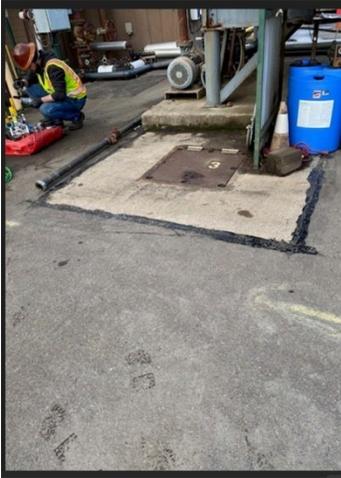
- c. Repairs: Sealing of cracks to address Corrective Action #5 was observed and photographed at various locations during the site walk. It appeared that the areas noted during the 3/26/2024 inspection were adequately sealed. (Photos 5 through 9)

Photo 5: Sealing around PW-03.

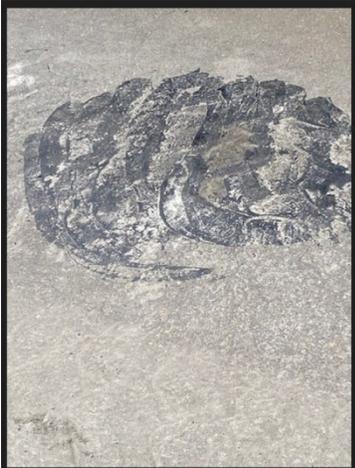
Photo 6: Sealing of multiple cracks over an area.

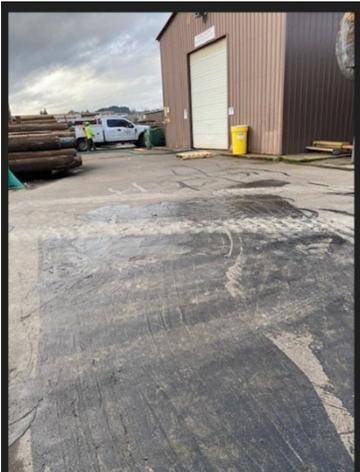
Photo 7: Sealing of a large area of multiple cracks near maintenance shed.

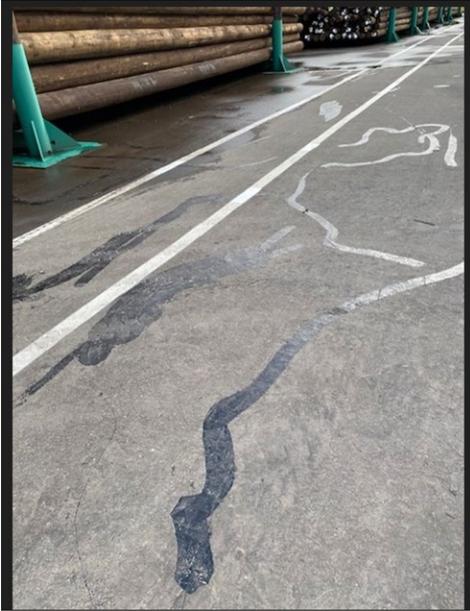
Photo 8: Sealing of miscellaneous individual cracks.

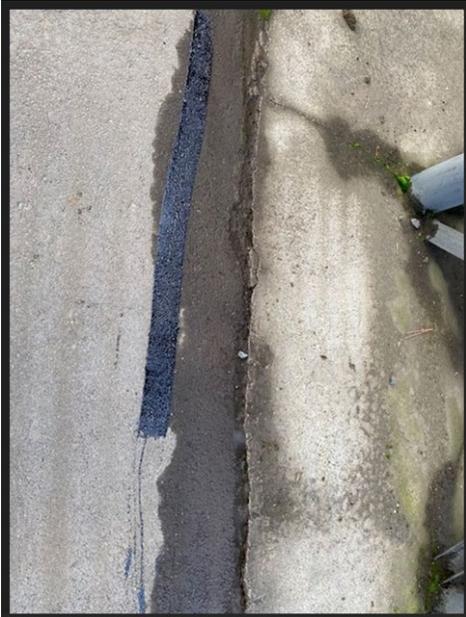
Photo 9: Water tank pad south, area needing to be sealed.

1. Provide MatCon sweeping logs in each annual (EAR)
2. Provide waste characterization documentation and disposal documentation for the MatCon sweepings in each EAR
3. Complete the sealing around the water tank pad where it was previously missed.
4. Provide the name and manufacturer of the approved MatCon sealant that was used.
5. Provide the name and equipment used by the hired contractor to help with the MatCon sweeping.

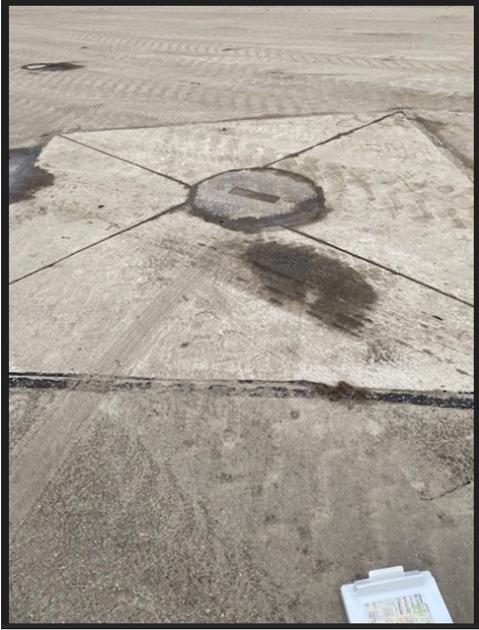
- e. Other Repairs: The cracked manhole cover on the south part of the cap area was repaired so that it is now flush with the ground surface. The area around the concrete cap was sealed to the MatCon. (Photo 10)

Photo 10: New manhole cover and pad.
