MEMORANDUM

Date: November 14, 2024

Re: North Ridge Estates Superfund Site
2024 Repository Repairs & Follow-Up Inspections

**Apex Photograph Log – Follow-Up Inspections
(November 11, 2024)**

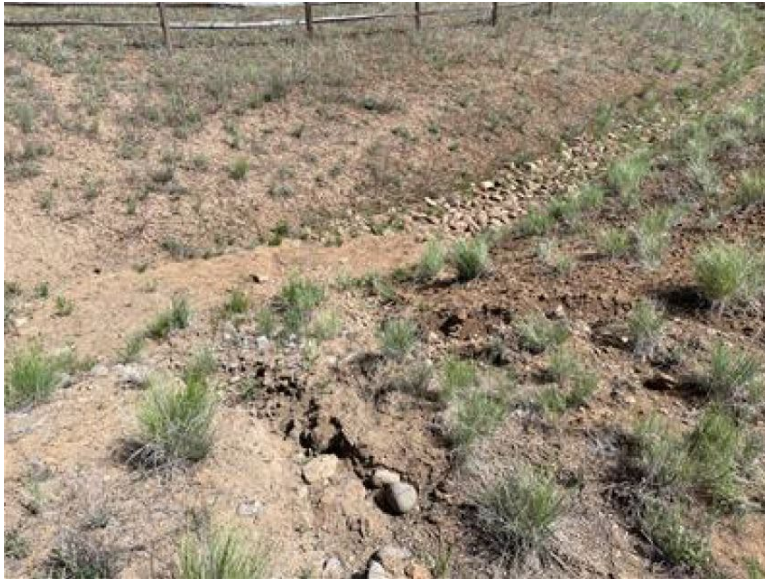
- Memorial Park Repository (Parcels MBK-D, L)
 - **Collect before and after photos of all completed repairs.**
 - Gully (approx. 6-8" deep) on west corner of Parcel MBK-D: grade side slopes and backfill/armor with 1" quarry rock to prevent additional erosion (see photo below).

- Backfill a gully (approximately 6 to 8 inches deep) near the west corner of Parcel MBK-D, grade the gully side slopes, and backfill/armor with 1-inch quarry rock to prevent additional erosion; and

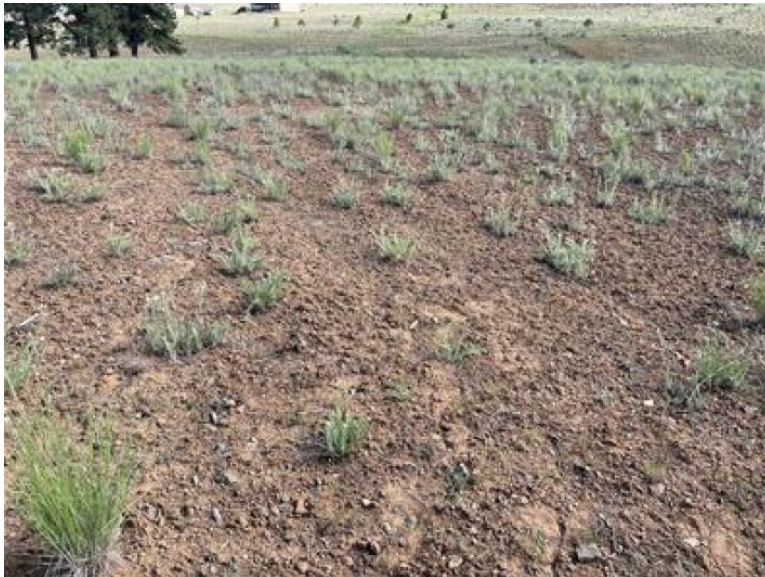
- Sparse vegetation (approx. 500 sq. ft.) on west central area of Parcel L (top of repository): reseed with native grass to re-establish vegetation and prevent additional erosion (see photo below).

- Repair sparse vegetation (approximately 500 square feet) on the west central area of Parcel L and reseed with native grass to re-establish vegetation and prevent additional erosion.

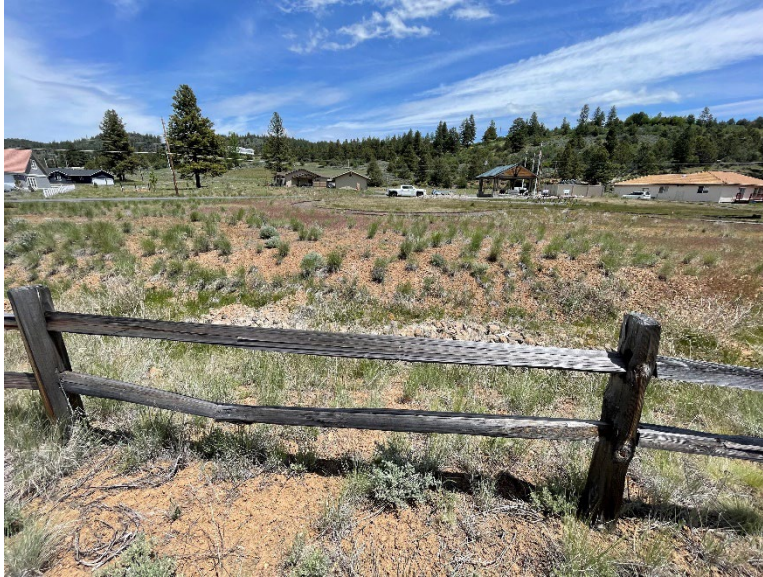
- Swimming Pool Repository (Parcels AI, AL, MBK-E, AG)
 - Broken sections of split rail fencing near the east and south corners of Parcel AG: replace broken split rails (2) to prevent unauthorized access to the repository (see photo below).

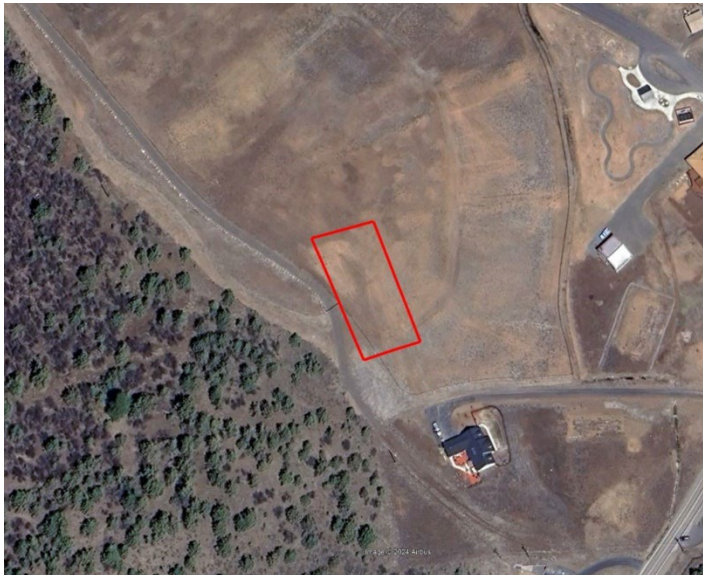
- Gully (approx. 4-6" deep, 150 ft long) near south corner of Parcel AG: grade side slopes and backfill/armor with 1" quarry rock to prevent additional erosion (see aerial photo below).

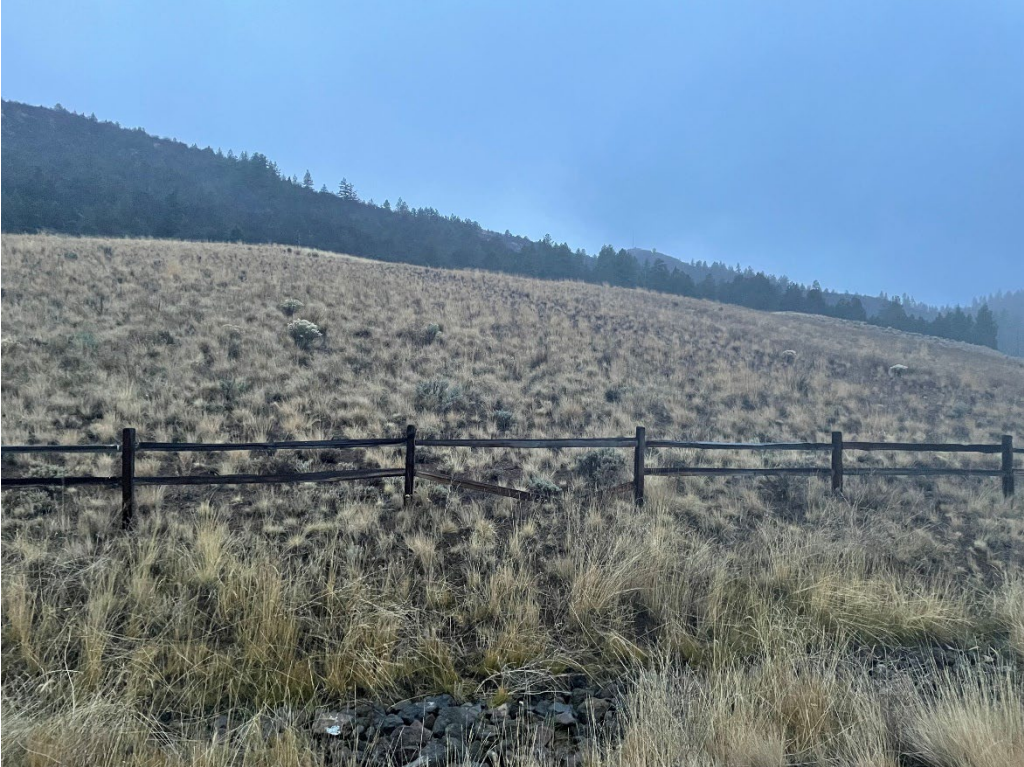
Swimming Pool Repository – No repairs made to split rail fencing near the east corner of Parcel AG.

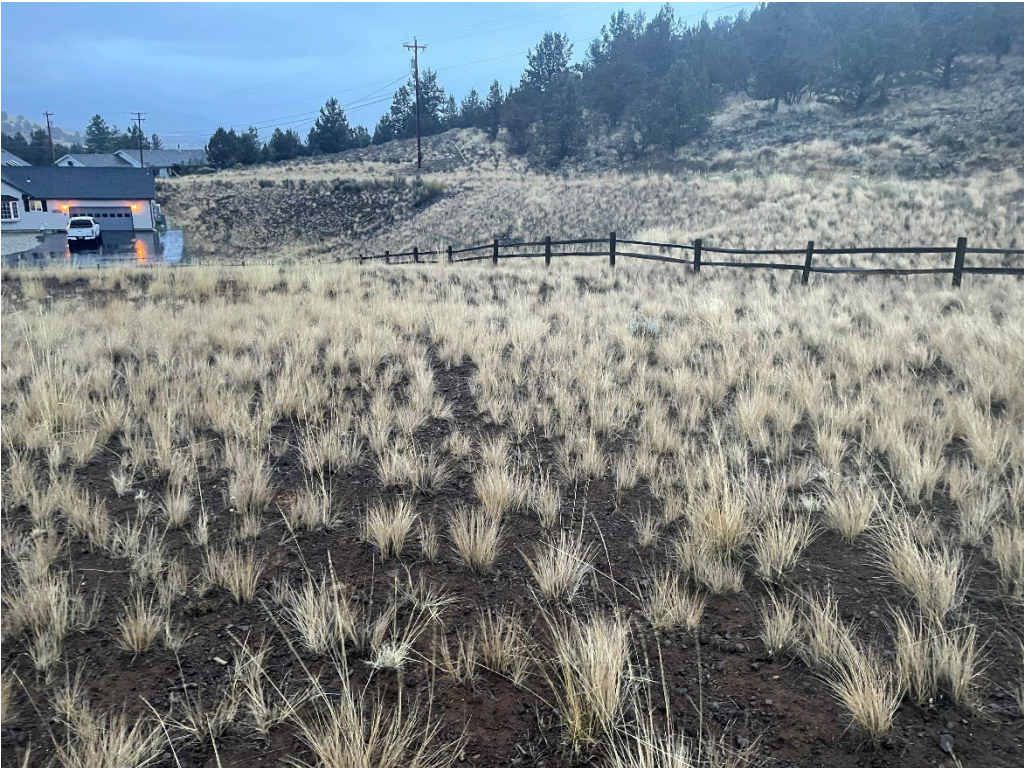
Swimming Pool Repository – No repairs made to gully near south corner of Parcel AG.

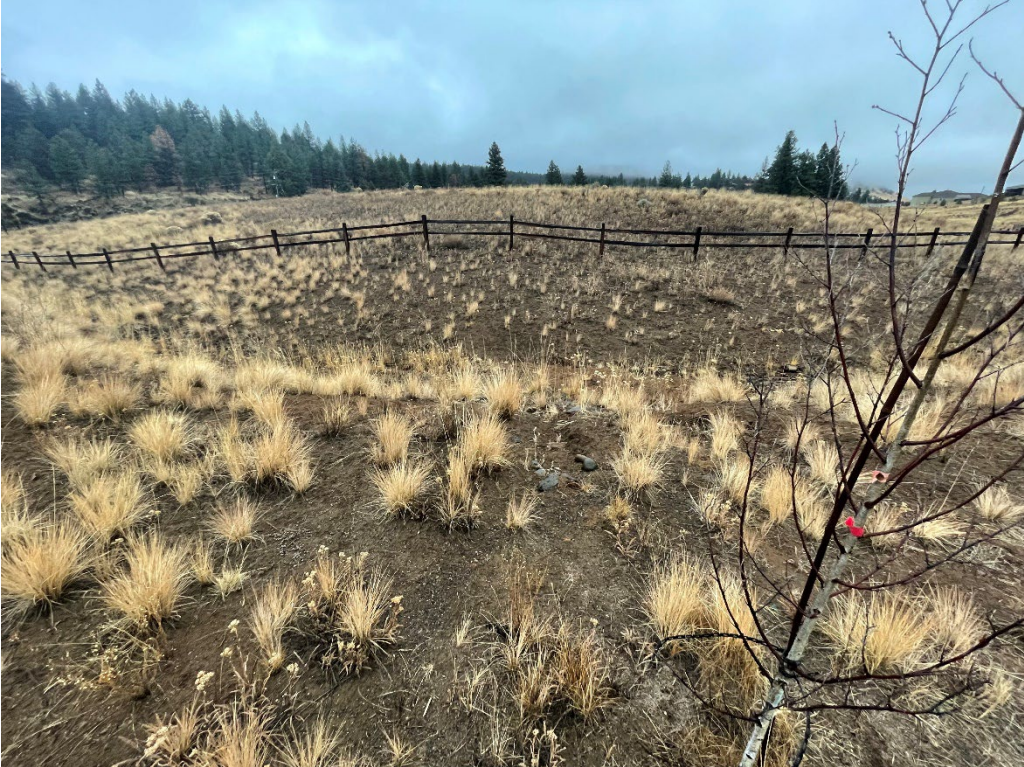
Memorial Park Repository – No repairs made to gully on west corner of Parcel MBK-D.

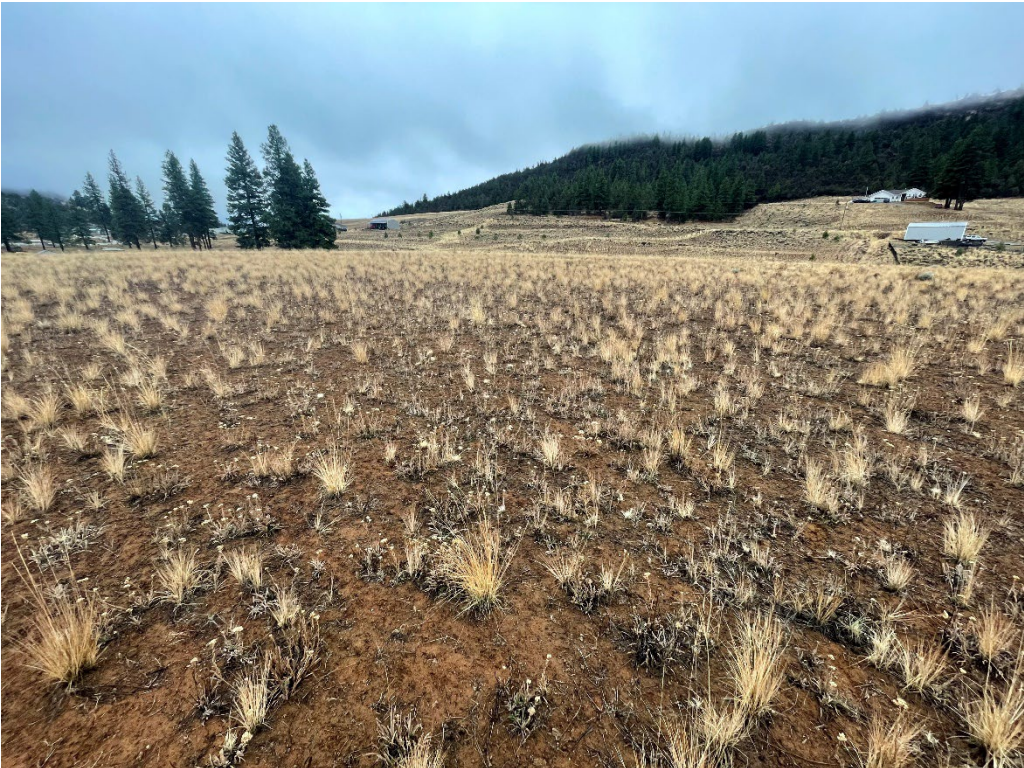
Memorial Park Repository – No repairs made to sparse vegetation on west central area of Parcel L.

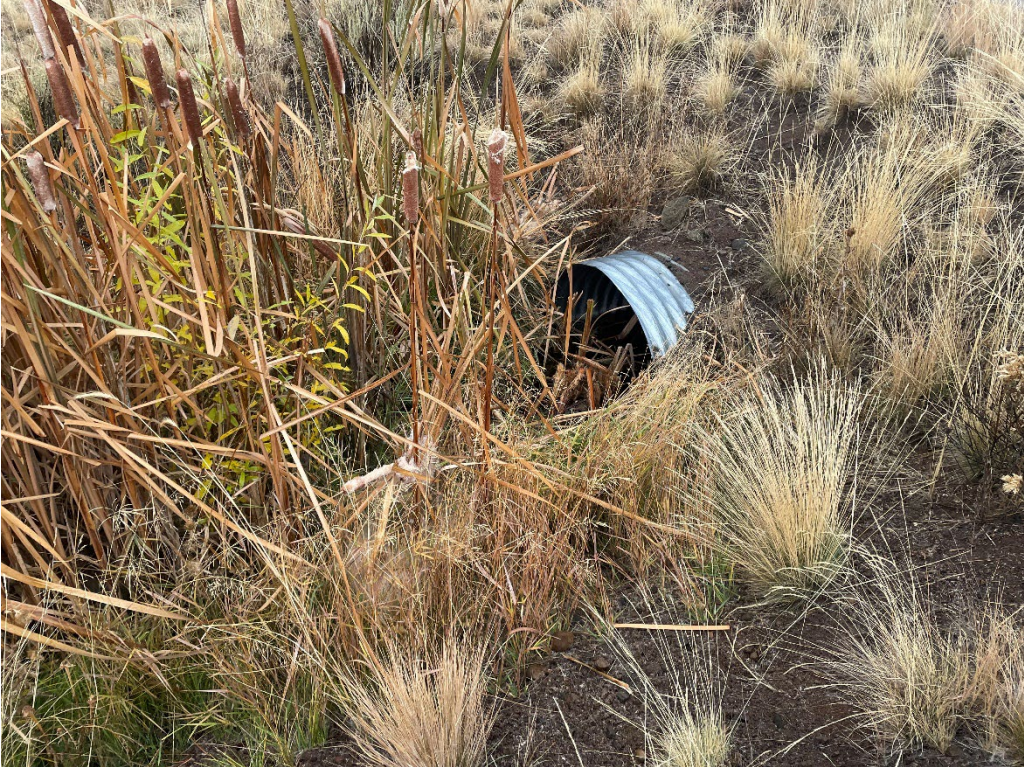
Parcel AP – Some vegetation blockage but culvert has generally unrestricted capacity.

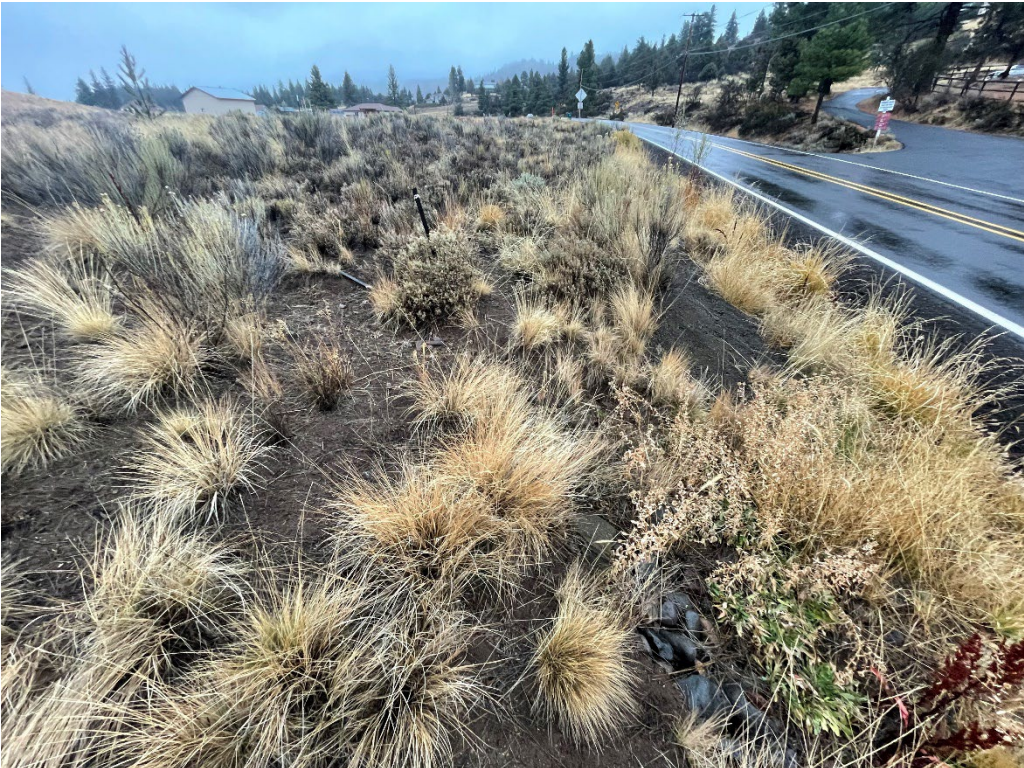
Parcel AP – No repairs made to gully near southeast corner of parcel.

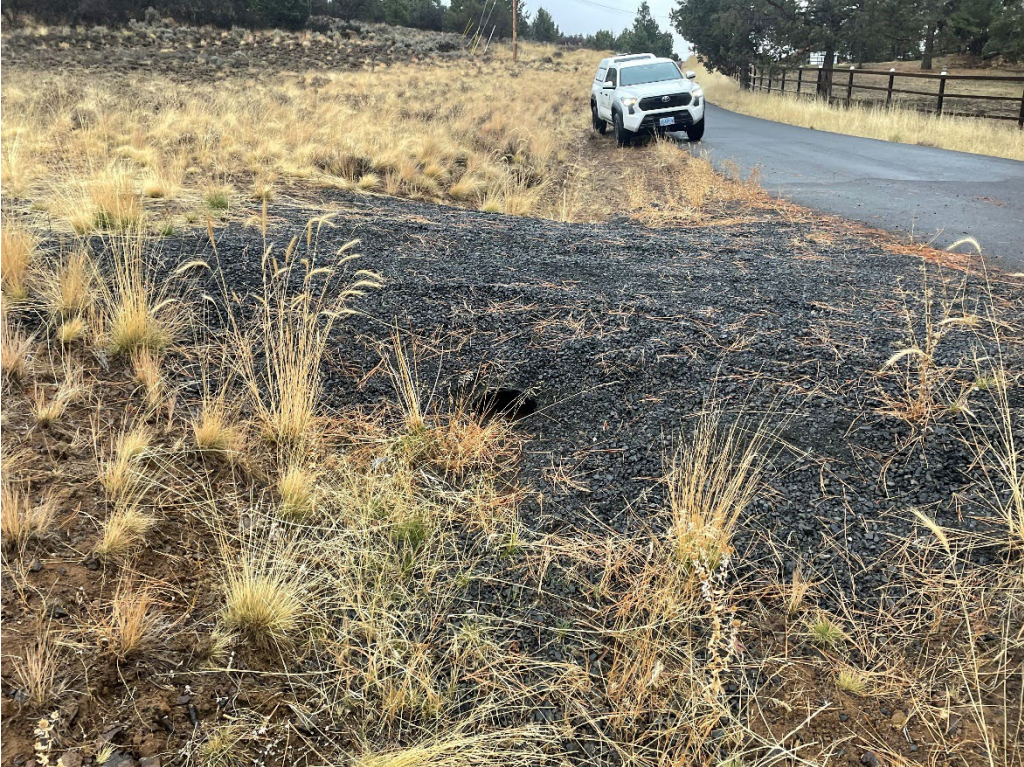
Parcel AR – Minor gravel blockage but culvert has generally unrestricted capacity.

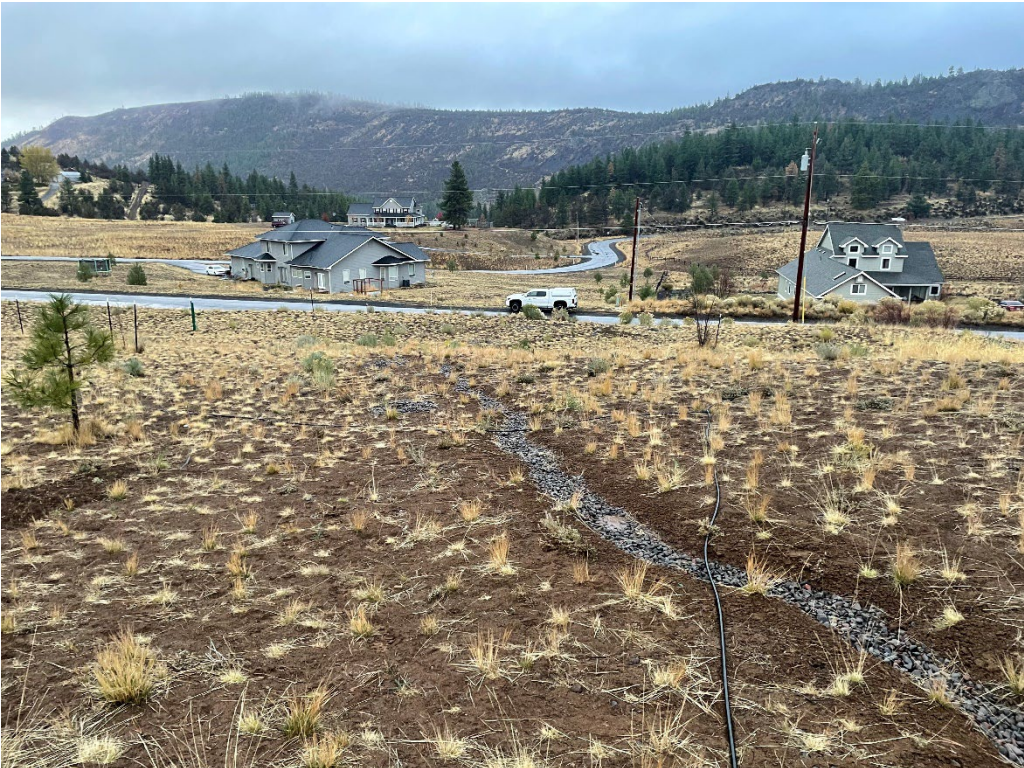
Parcel C – Gullies sufficiently armored with river rock.

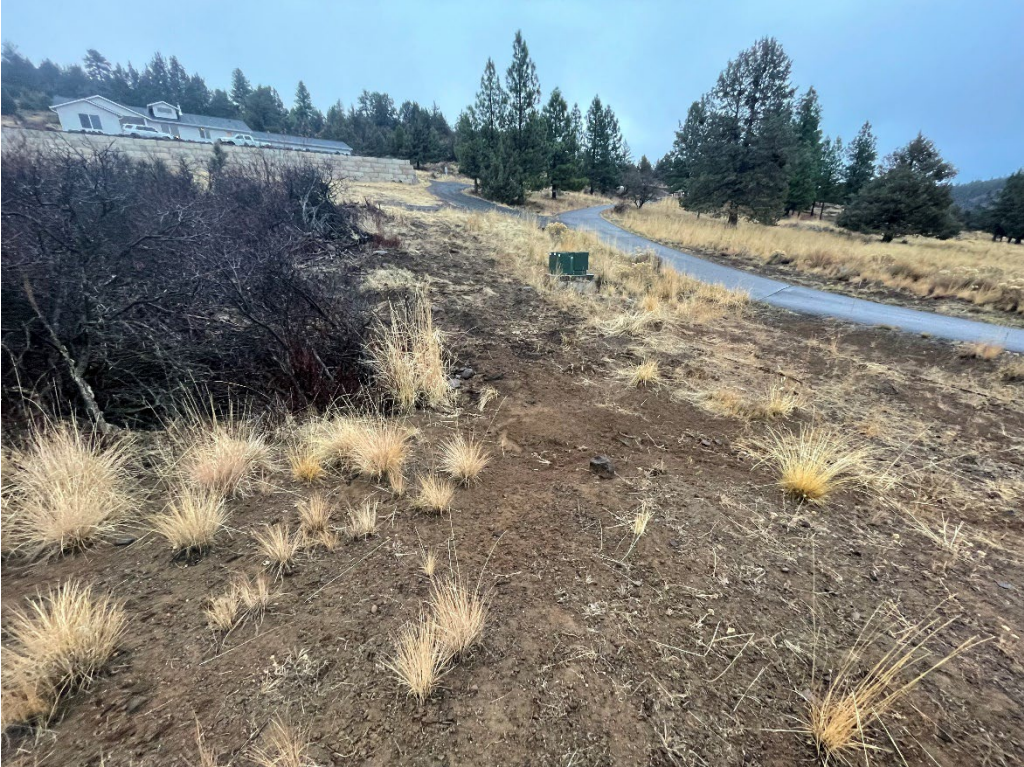
Parcel H – Gully near north edge of Lot H2 backfilled with soil and graded on slope.

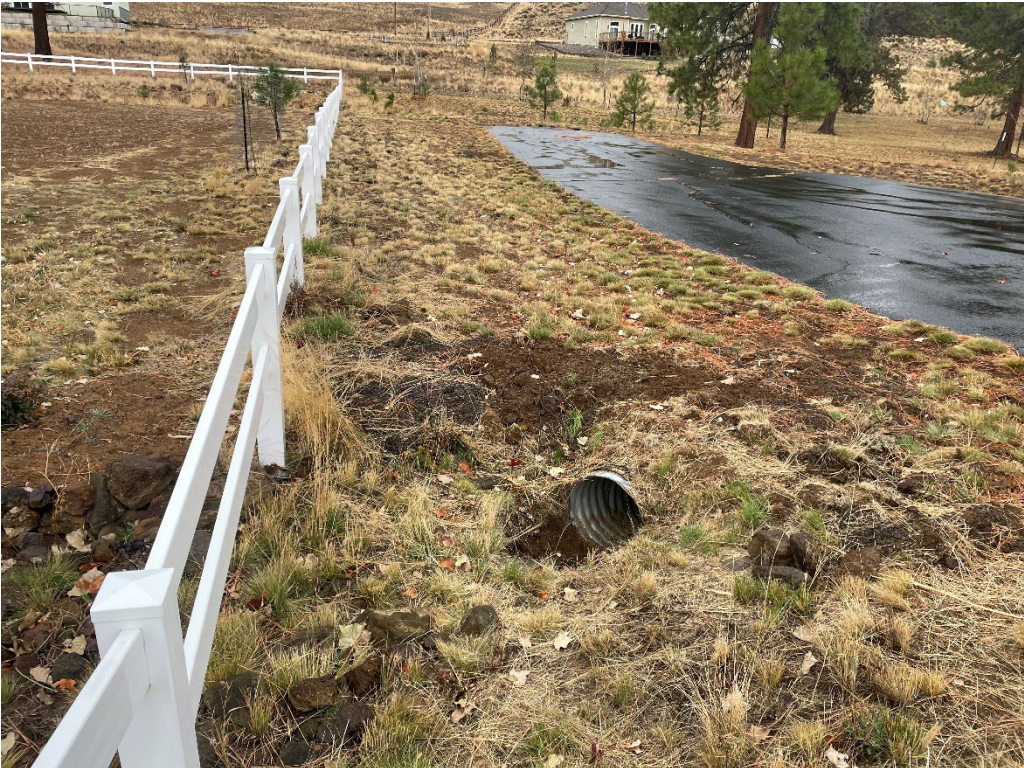
Parcel M – Culvert blockage removed to enable unrestricted capacity.

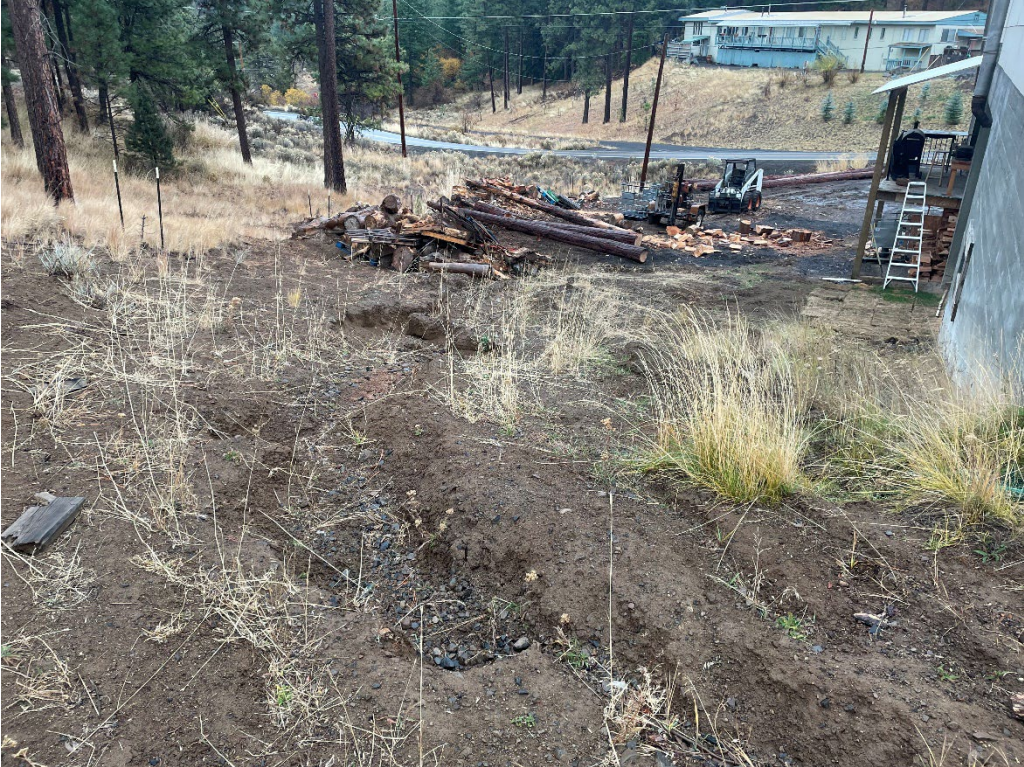
Parcel MBK-G – No repairs made to gully on north side of warehouse.

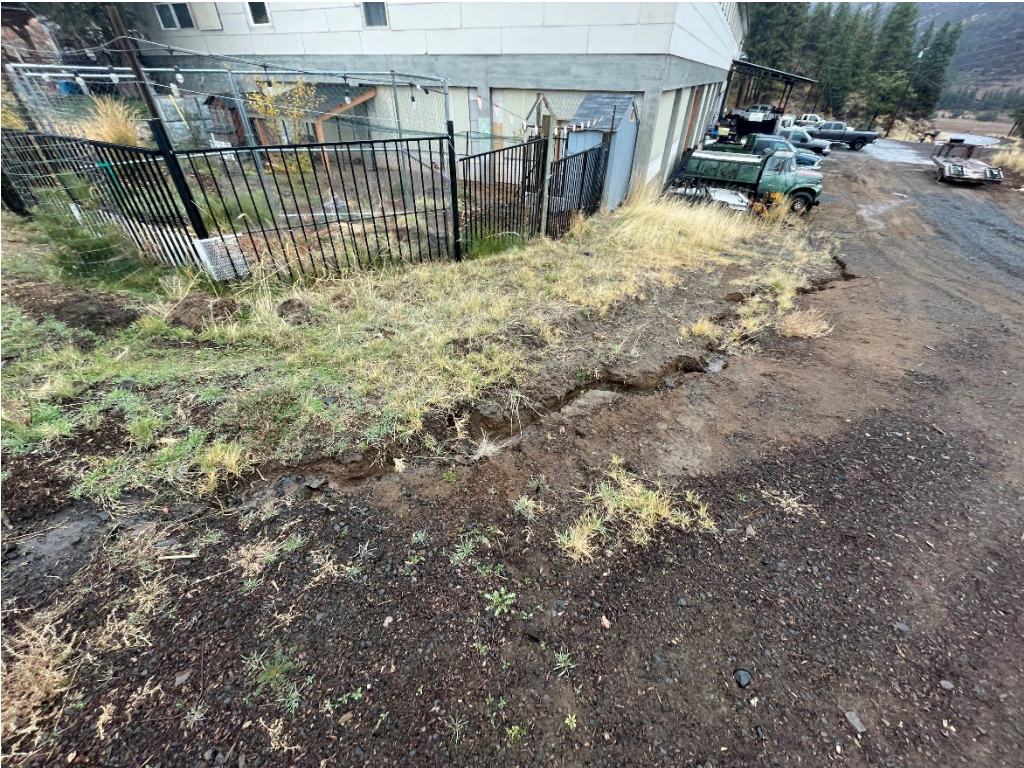
Parcel MBK-G – No repairs made to gully near southeast corner of warehouse.

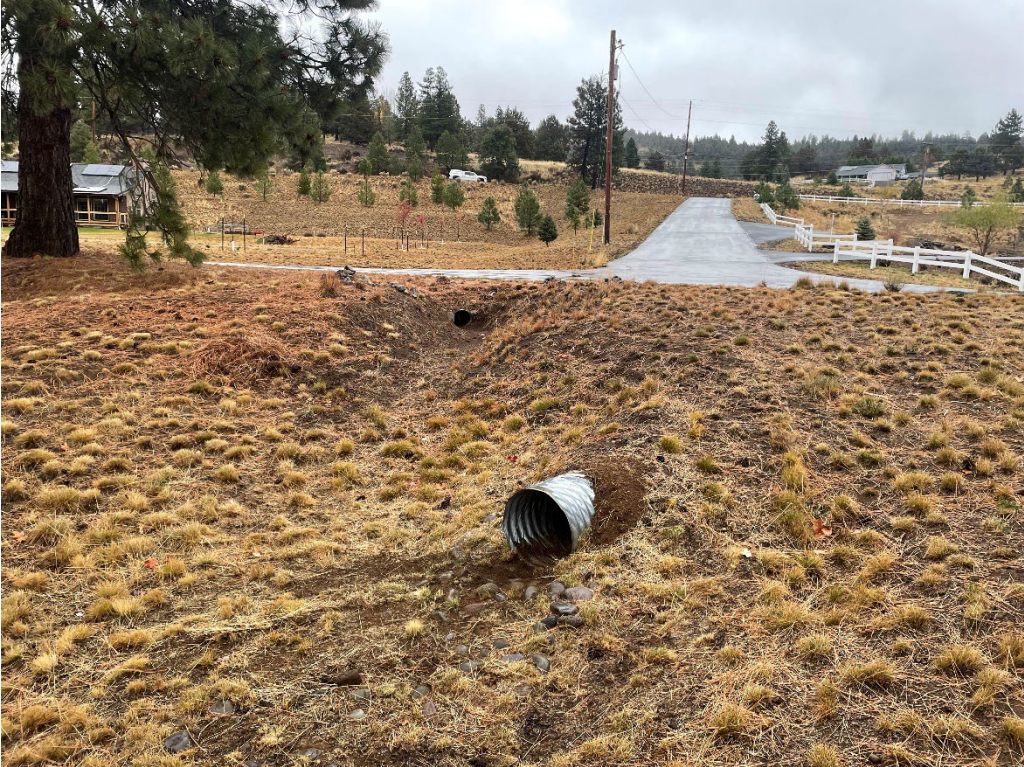
Parcel N – Culvert blockage removed to enable unrestricted capacity.

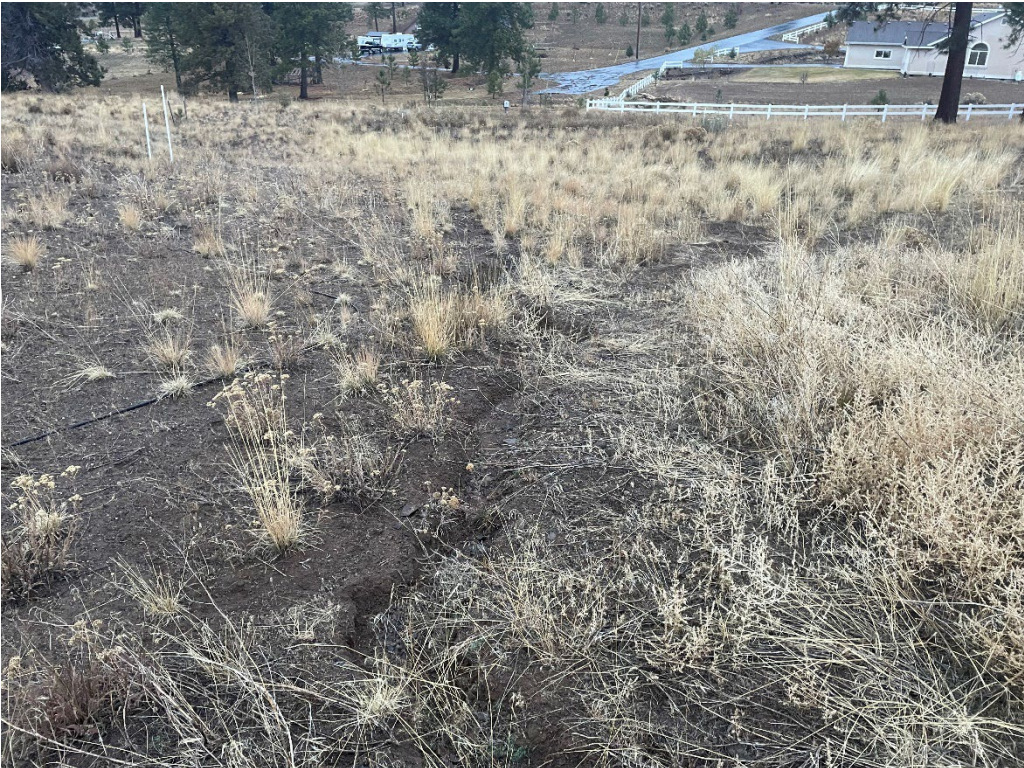
Parcel R – No repairs made to gully near west edge of parcel.
