Memorandum

Date: December 9, 2024
To: Sarah Van Glubt – Oregon Department of Environmental Quality
Cc: John O'Donovan, P.E. - BES Coordinated Site Assessment Program
From: Brian Marcum, P.E. - BES Coordinated Site Assessment Program
RE: ECSI #404 - Guilds Lake Landfill 2024 Annual Cap Inspection

2024 Cap Inspection

ECSI #404 Guilds Lake Landfill – 2024 Annual Cap Inspection

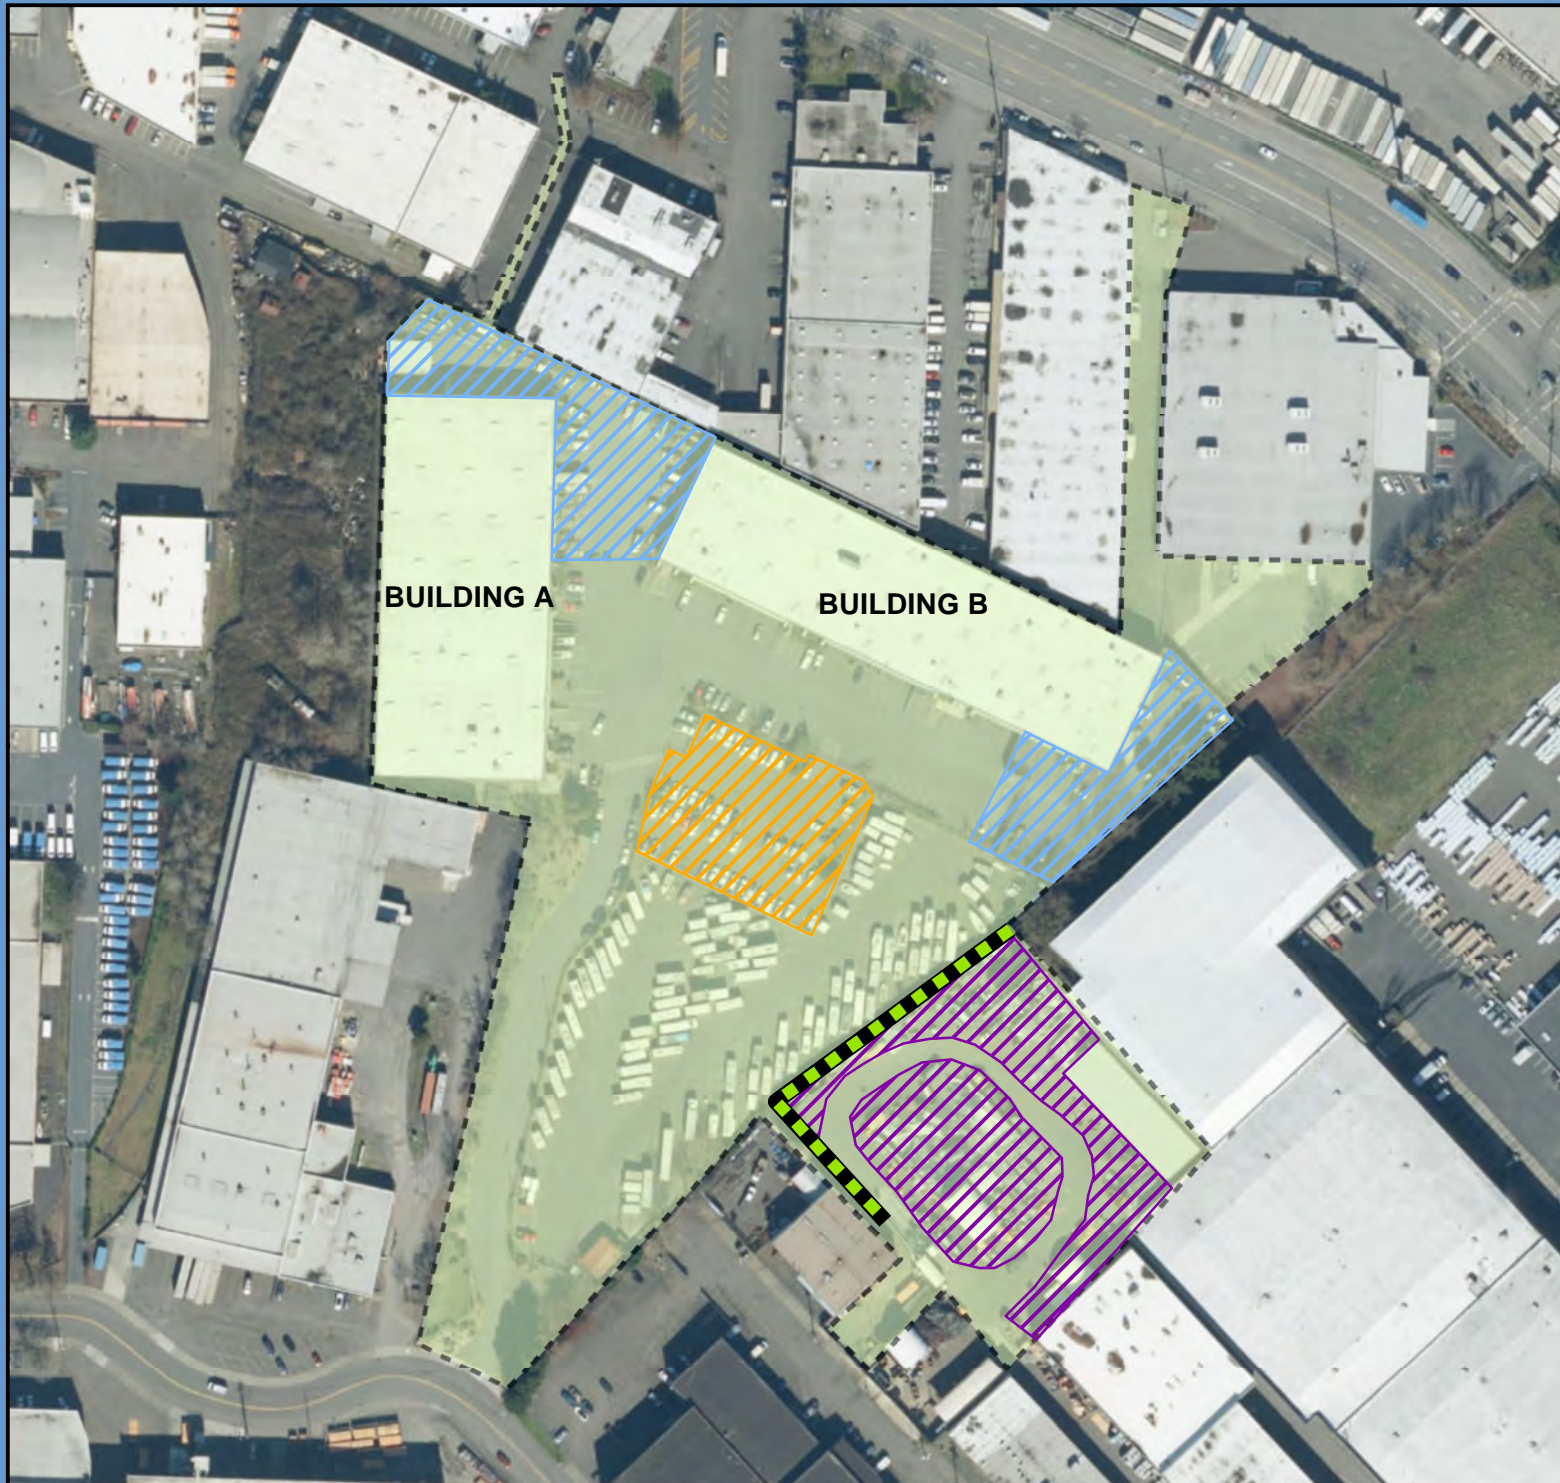
Figure 1. Site Area

On December 4, 2024, staff from the BES, CSA Program inspected the cap at the Guilds Lake Landfill site. The integrity of the cap was assessed per the requirements of the Inspection Maintenance and Monitoring Plan (IMMP [CH2MHILL 1998]). The inspection was conducted to document any degraded conditions and to assess the overall integrity of the site cap. The entire cap, including fenced and unfenced areas, and gabion wall were visually inspected. Cap features are presented in Figure 1.

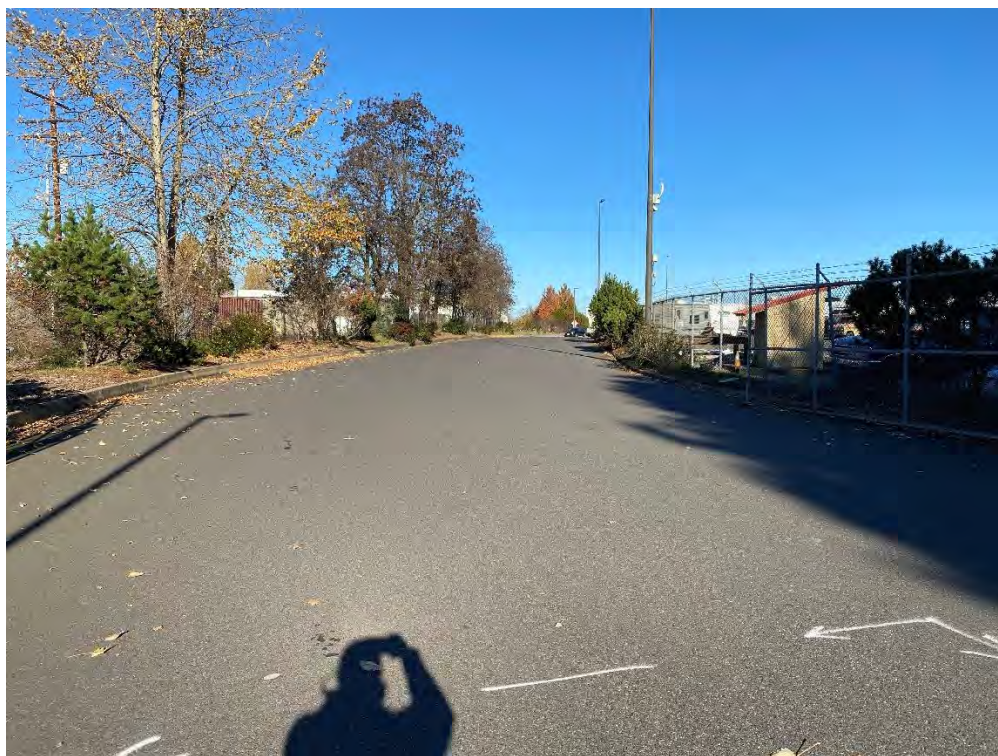
Photo 1 – Entrance Road Looking North

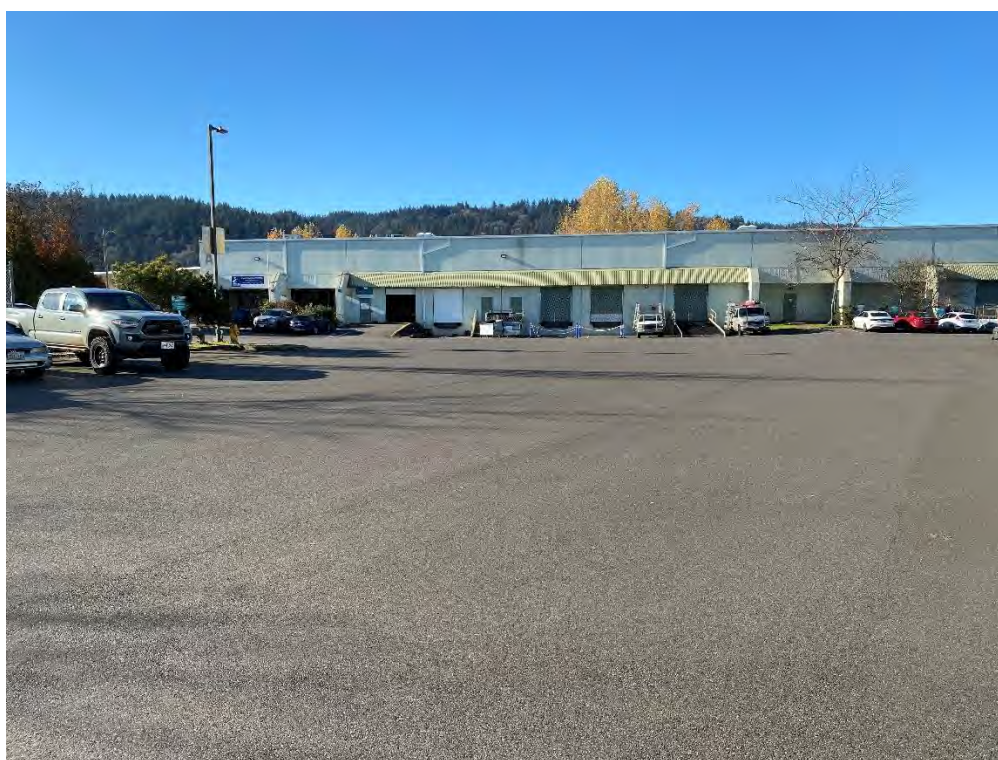
Photo 2 – Main Lot Looking West

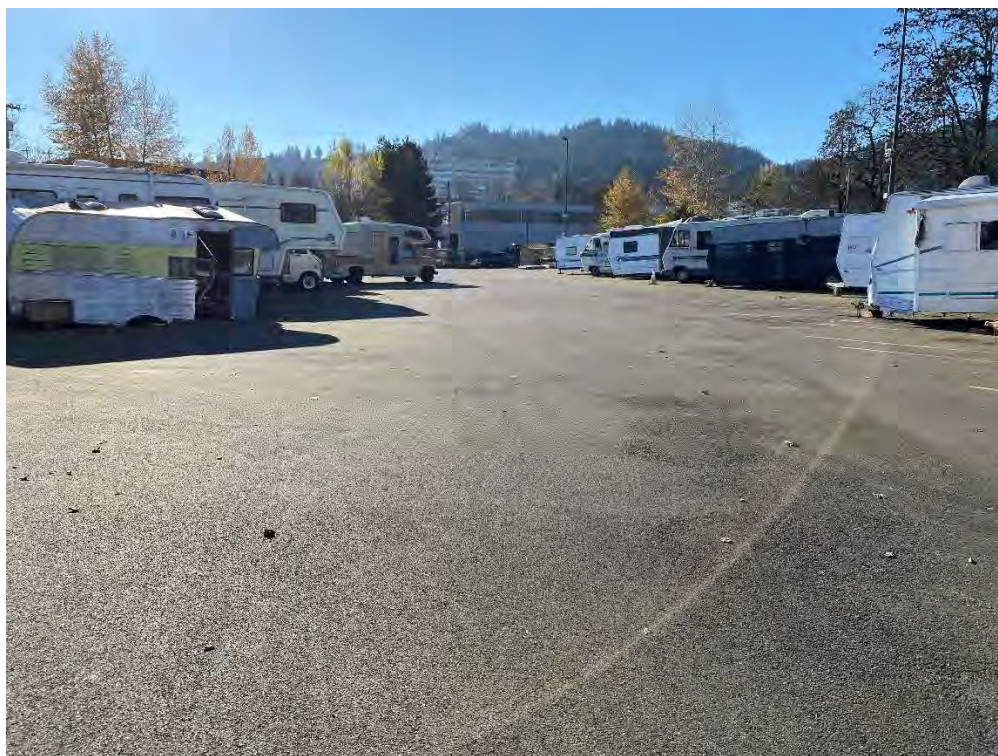
Photo 3 – Fenced Lot Looking South

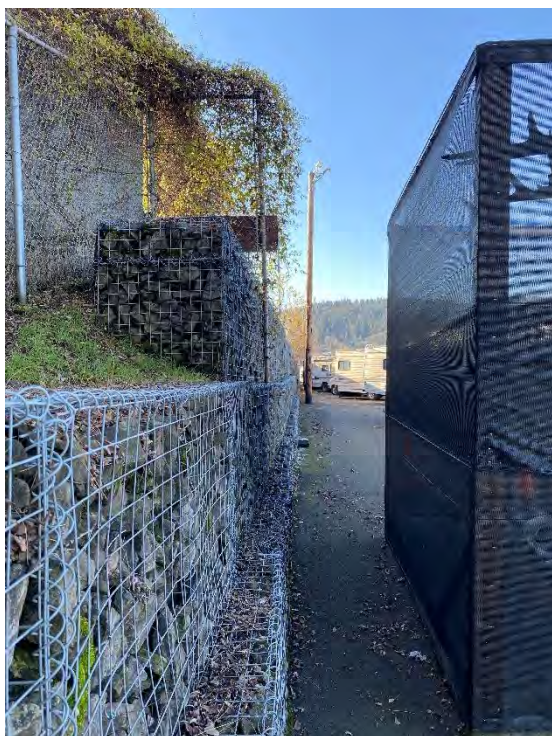
The gabion wall is in good condition, operating as designed, and does not have any wire damage or aggregate loss. An oblique protrusion is present in one section; however, the protrusion has been present for some time and does not appear to be shifting. The remainder of the wall appears plumb. Depending on the results of subsequent inspections, repair of this section may be required in the future.

Photo 4 – Gabion Wall Looking South

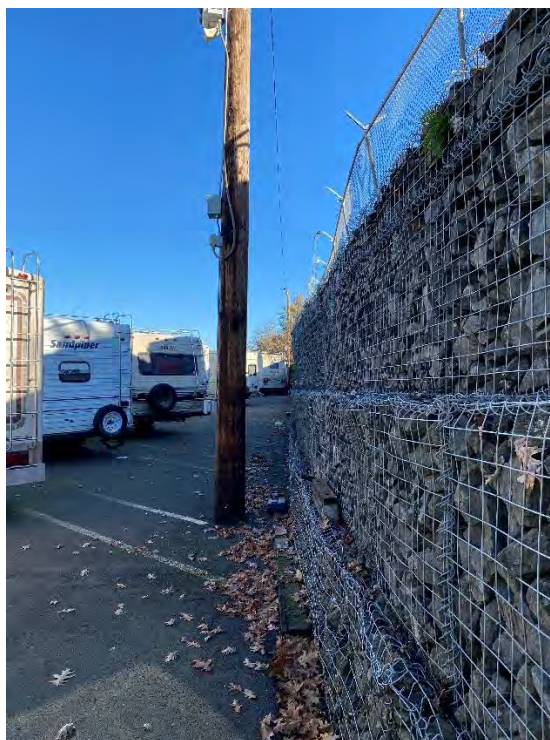
Photo 5 - Gabion Wall Looking North

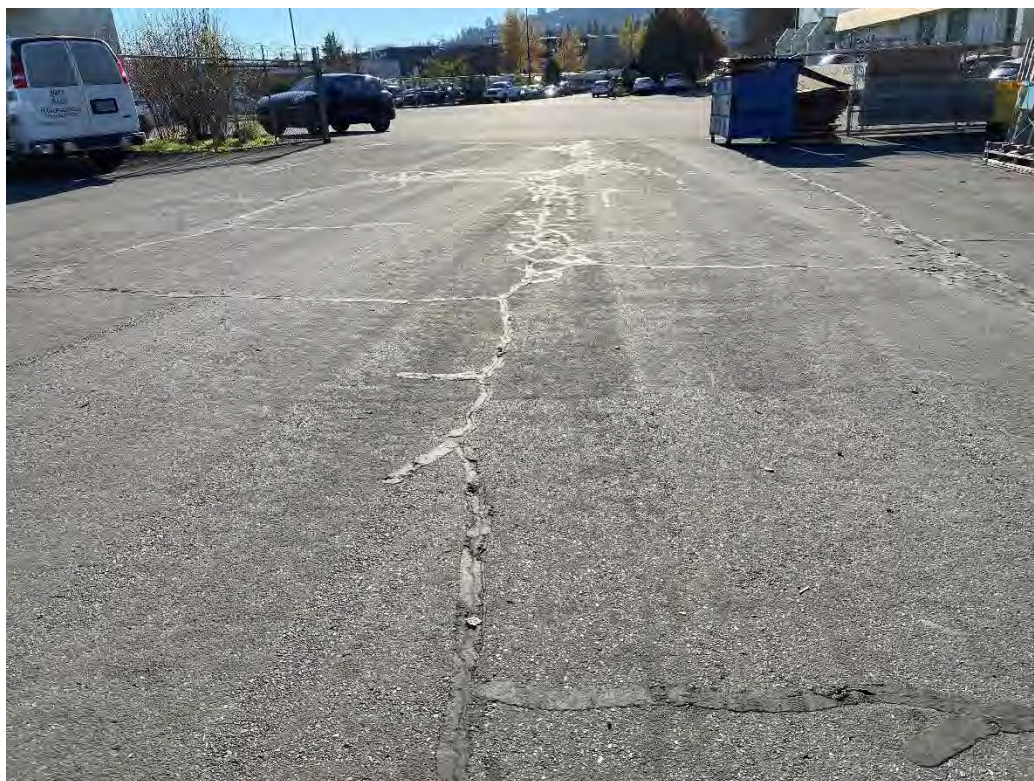
On October 5, 2024, a BES contractor applied crack sealant in the fenced areas of the site that were not repaved in 2019. Prior to sealant placement, the cracks were cleaned with an air lance to remove debris and if warranted based on the size of the crack, a foam backer was installed to ensure proper sealant placement. In general, the crack sealant application was successful; however, there are several small sections of sealant within the fenced area at Culver Glass where the sealant did not take. BES is working with the contractor to correct the deficiencies.

Photo 6 – Sealed Cracks in NW of Site Looking South

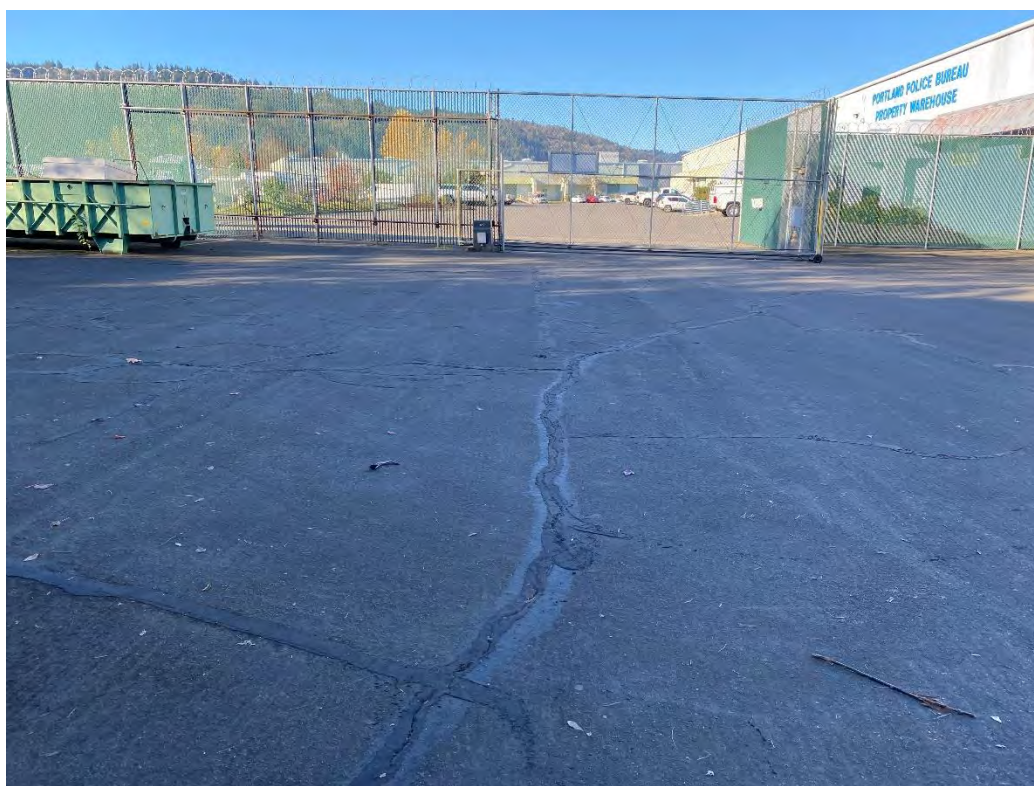
Photo 7 – Sealed Cracks in NE of Site Looking West

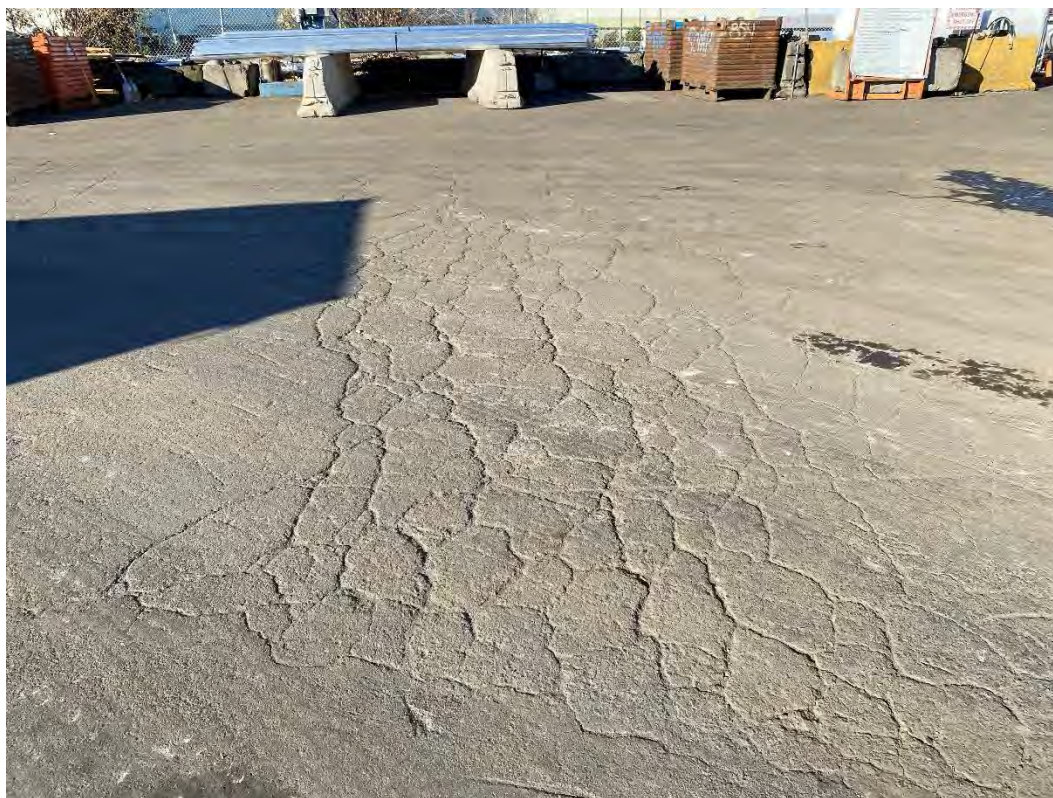
Overall, the cap is in very good condition. Most of the asphalt cap was repaved in the summer and fall of 2019. The 2019 paved area is in excellent condition and shows no evidence of surface cracking or excessive wear. Areas that were not repaved in 2019 were sealed in 2024 and appear to be in good condition. Asphalt cracking at the Calbag Metals portion of the site, behind the gabion wall, is widespread and is attributed to cyclical truck and equipment loading and materials staging. Although cracks are present at Calbag Metals, the cracks do not penetrate the 4-inch thick layer of asphalt that was placed during the 1995 remedy construction.

Photo 8 – Cracking on Calbag Metals Lot Looking West, outside of area paved in 2019

Overall, the cap is in very good condition. Asphalt cracking noted in previous inspections has been sealed and is in good condition. More extensive asphalt repairs at Calbag Metals will be required in the next 2 - 4 years. BES is currently working to secure funding to complete the paving during the 2025-2026 fiscal year.

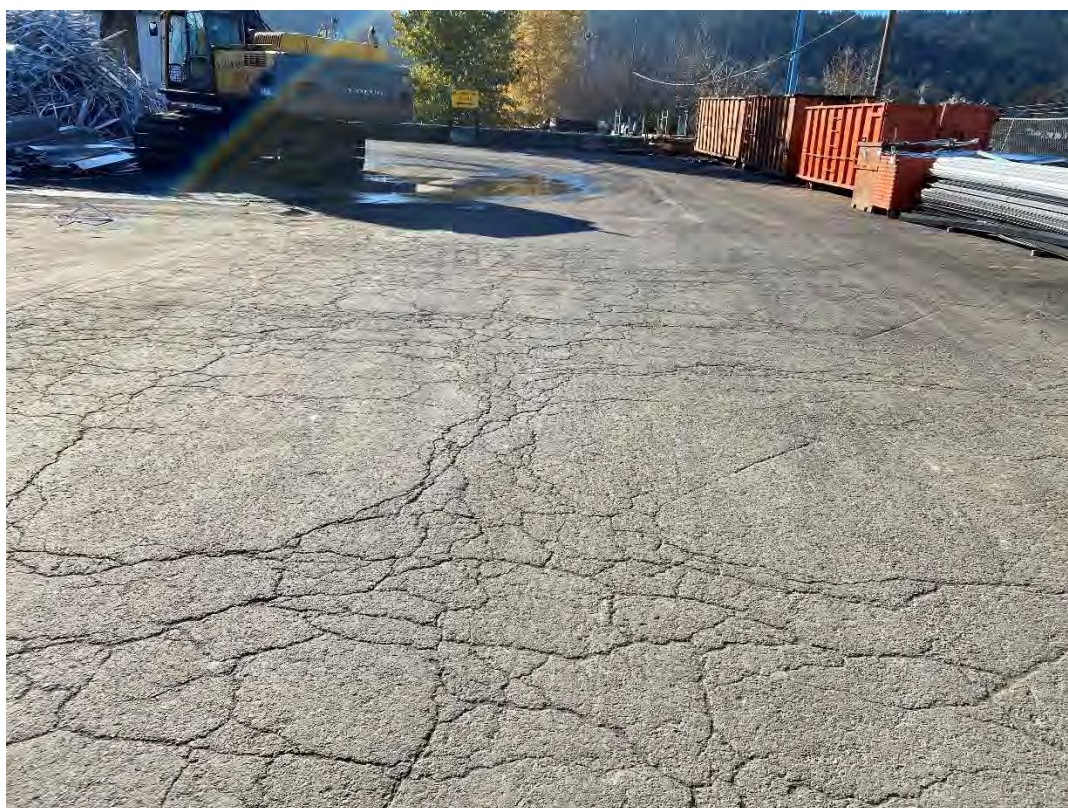
Photo 9 – Cracking on Calbag Metals Lot Looking SW, outside of area paved in 2019

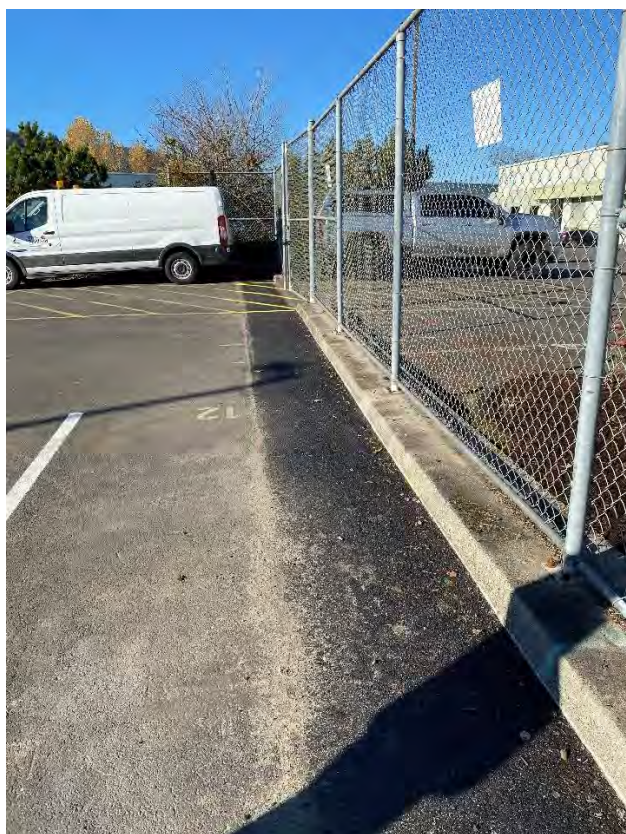
Between August 29 and October 1, 2024, belowground construction of a new electric vehicle (EV) charging facility was completed. Construction involved the excavation of contaminated soil for the installation of electrical conduit and equipment, placement of controlled density fill to limit potential vapor migration within utility trenches, pavement replacement, and cap repairs in landscaped areas. BES is working with PGE and their contractor to place a new transformer, install the vehicle chargers, and make the final electrical connections to the new charging stations, which is expected to be complete before the end of 2024. A summary report documenting the construction activities will be submitted under separate cover once the final electrical inspections are completed. Repaved and landscaped areas associated with this project were in good condition during the inspection.

Photo 10 – Repaved Area in EV Station

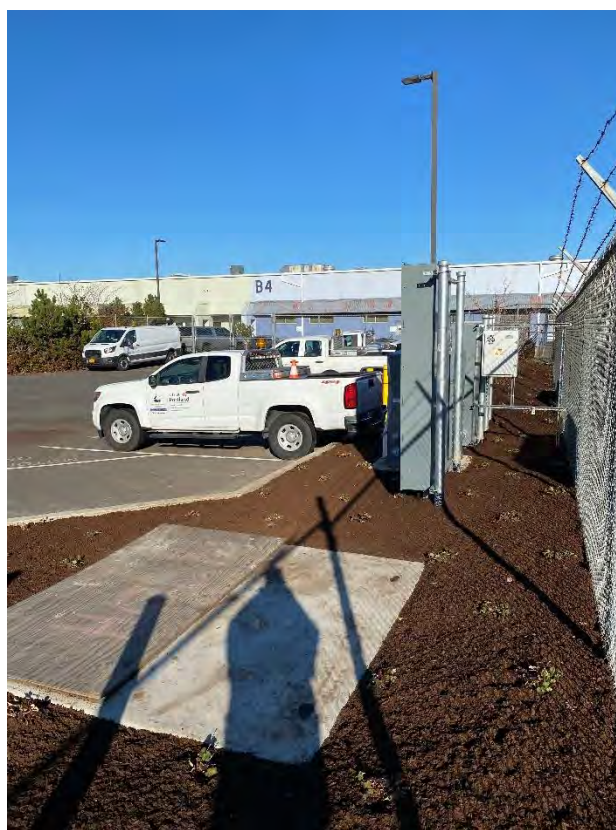
Photo 11 – Landscaped Area in EV Station

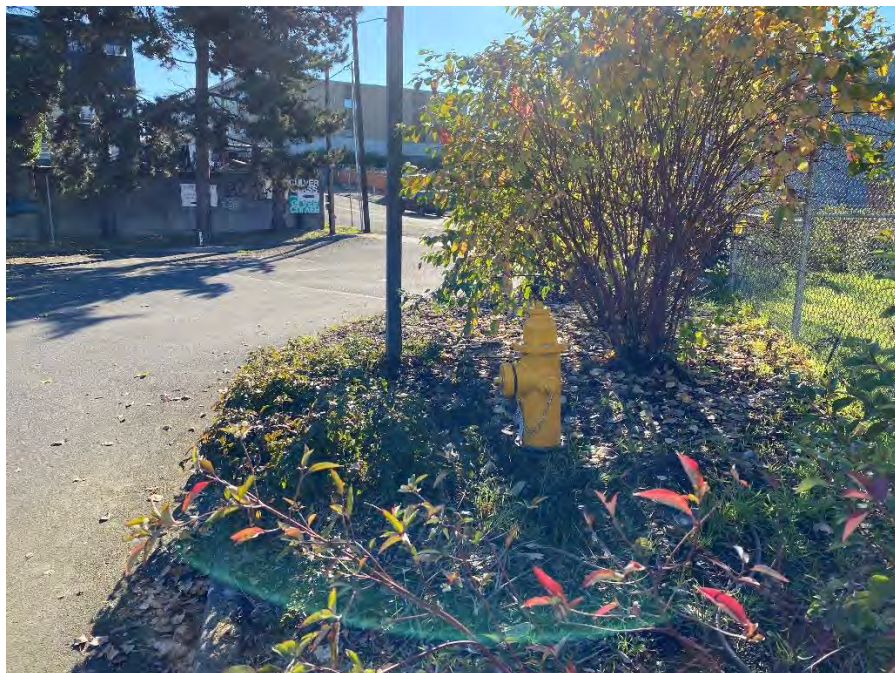
In August 2024, a BES contractor replaced a leaking fire hydrant near the entrance to the site. The work required removing topsoil, exposing/cutting through the geotextile liner, and excavating contaminated soil to install the new hydrant assembly. Contaminated soil from below the liner was replaced as backfill once the new hydrant was installed, and the stockpiled topsoil was replaced above the liner.

Photo 12 – New Hydrant at Entrance
