Report on an Underground Storage Tank Removal and Investigation:

Dralle International Truck, Inc. Site  
595 East First Street  
Gladstone, OR

Volume II: Site Cleanup

by  
Northwest Environmental Corporation  
Portland, OR

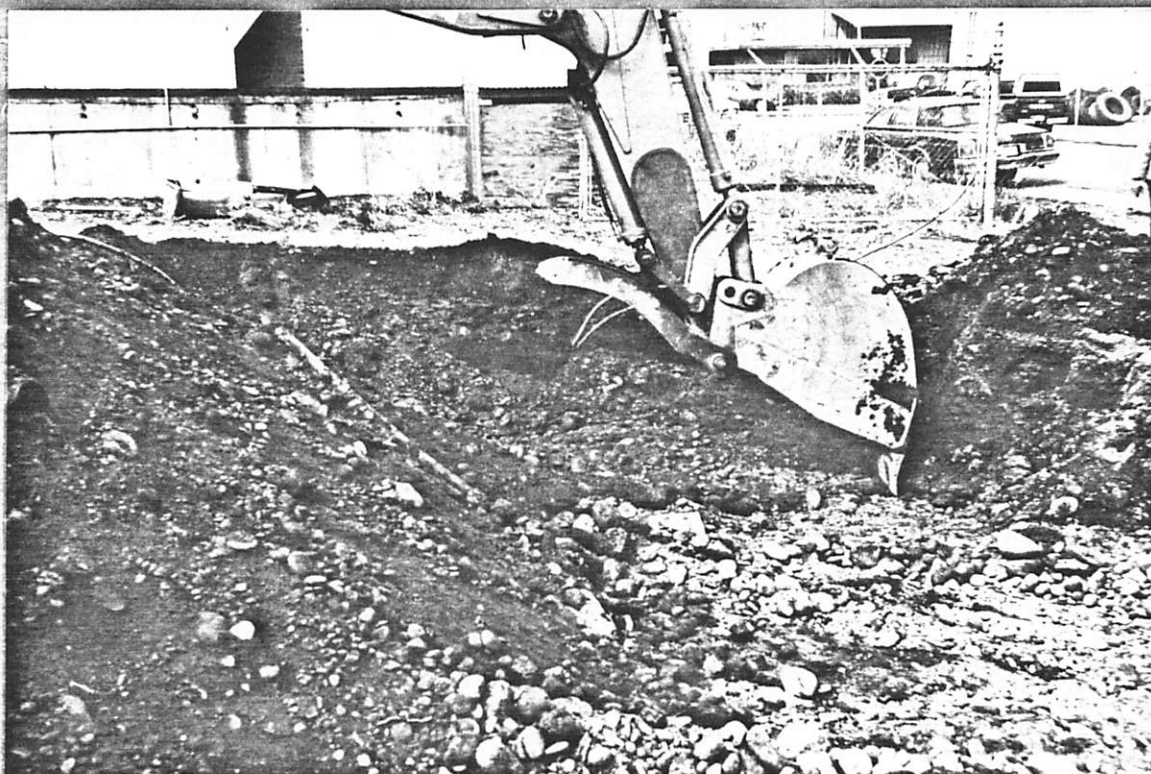
Expansion of the Original UST Excavation Pit to Remove Contamination

Once the soils from the UST excavation were transferred to the aeration stockpile, the pit was enlarged in all directions to removed additional contaminated material. Material from the enlarged pit was transferred to the aeration pile using the front-end loader. The excavation and soil transfer was continued until it was assumed that gasoline-free soil had been reached, based only on odor and appearance.

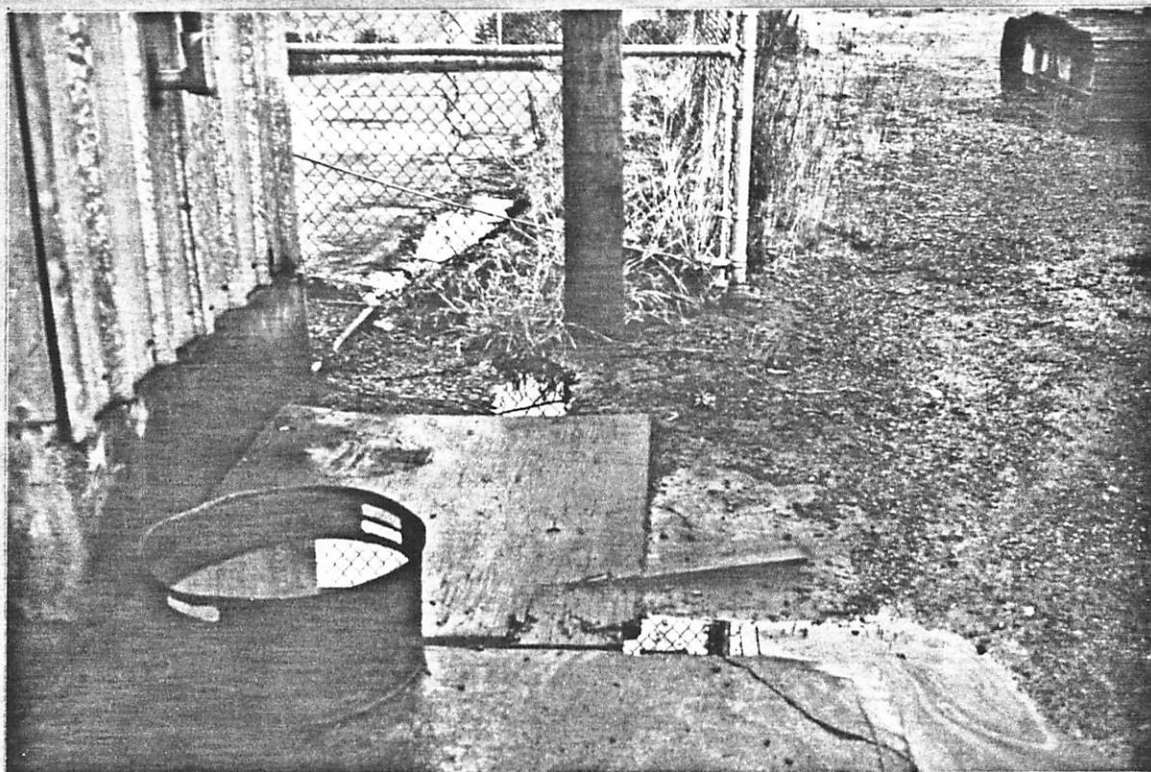
At the western corner of the shop building, heavy oil contamination was observed to the west and southwest of a concrete entrance pad. This oil had saturated the surface soil to a depth of at least 18 inches, based on the excavation of a small test pit. The oil also had flowed to the west, under the perimeter fence and onto the adjacent property. This contamination was interpreted as originating from the shop operation because of its location. The contaminated area most likely was used for the convenient disposal of used motor oil. It should be emphasized that this assumed source for the oil is not supported by records or previous employee interviews. It is based solely on site observations by Northwest Environmental Corporation employees.

Oil-Contaminated Soil Near the Rear Shop Door Before Excavation

Oil contamination near the shop building, mentioned previously, was next excavated. This required that a second pit be excavated in front of the shop building and about 15 feet west of the shop building (see Appendix A sketch) to a depth of approximately 3-4 feet. This material was transferred to the oil-contaminated soil stockpile for later off-site disposal. The area outside the property perimeter fence was excavated to a depth of about 2 feet and parallel (westerly direction) to the fence. Excavated material from outside the fence was transferred to the oil-contaminated soil stockpile. The stockpile was covered with six mil polyethylene sheeting to prevent rain from washing oil out of the soil.

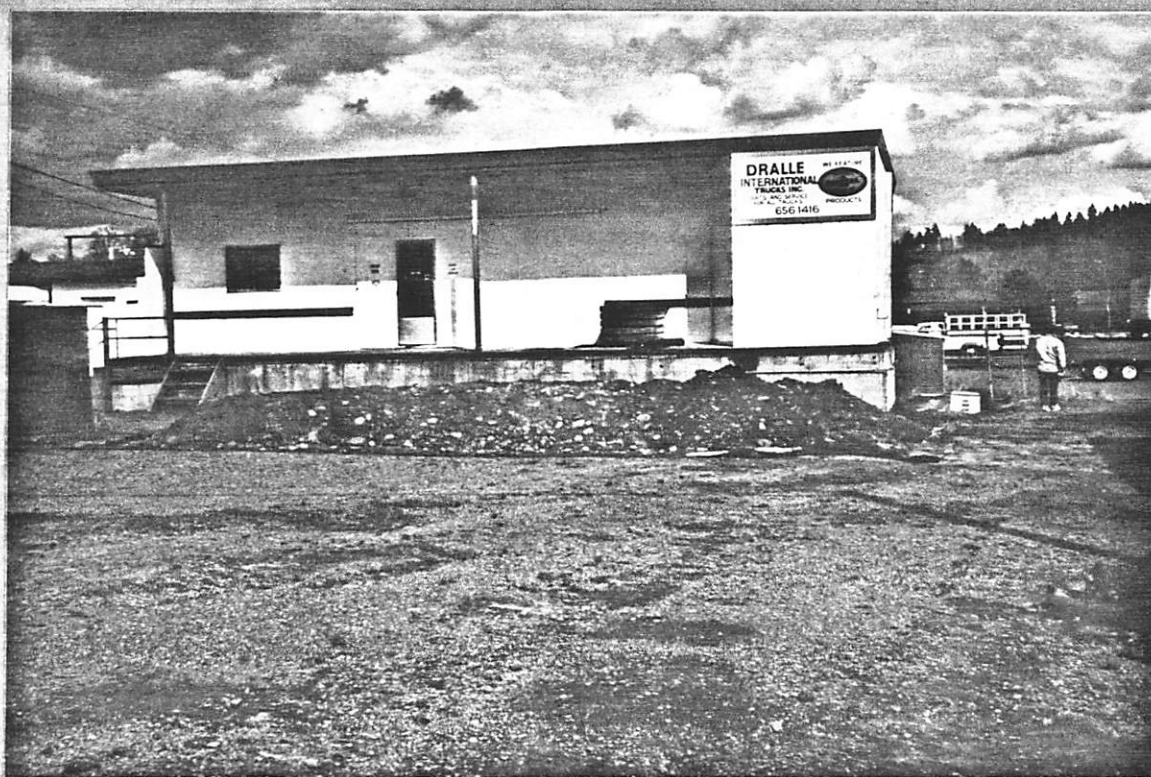
Aeration Stockpile for Gasoline-Contaminated Soil--Early Stages of Construction

Soil excavated for the UST removal was transferred to the aeration stockpile shown in the Appendix A site sketch. The expectation was that after sufficient time had elapsed for the gasoline to evaporate from the soil, it could be removed to a solid waste landfill or returned to the on-site excavation. A trackhoe and a tractor with a front-end loader were used to transfer the material. It was placed over six mil polyethylene sheeting in adjoining rows to a depth of 3-4 feet (see photo in Appendix D).

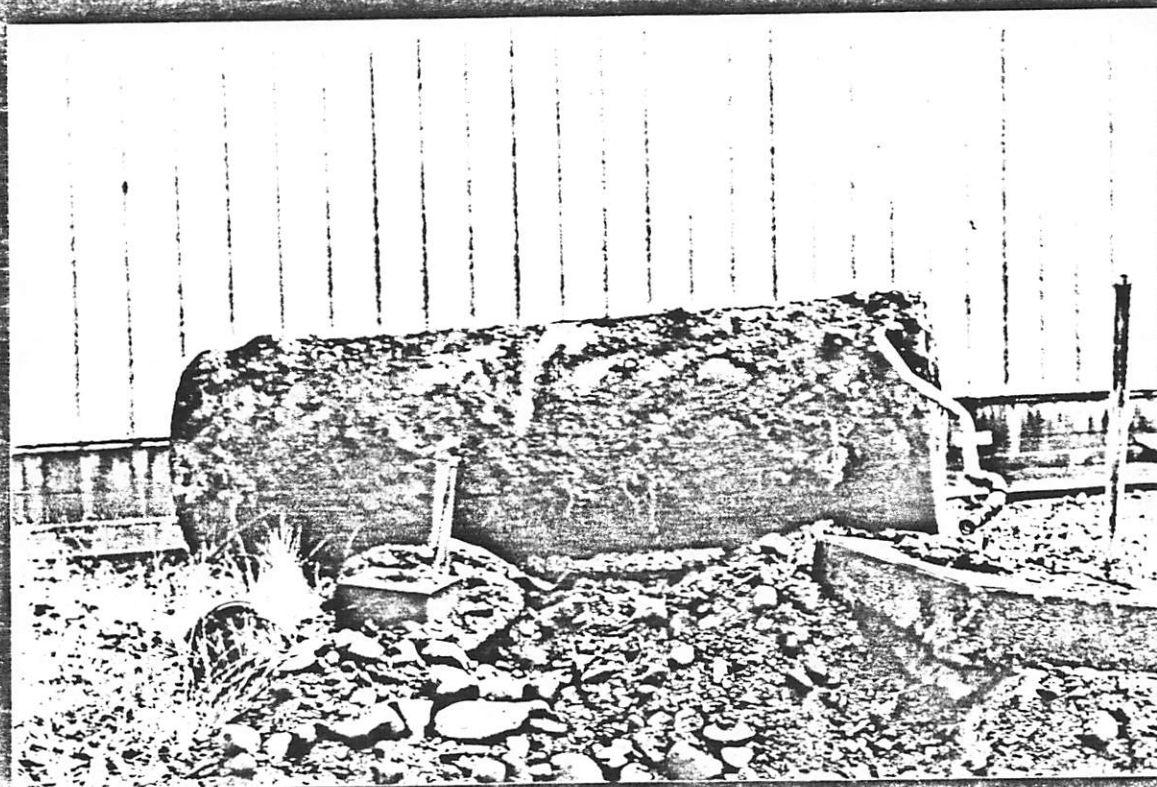
The 1200-gallon, mild-steel tank was visibly corroded and had fill material cemented to it by the corrosion. Its dimensions were 12 feet long by 4 feet in diameter. It was rolled over such that the bottom could be inspected. No obvious holes were observed in the tank. When installed, the tank was set directly onto cobbles rather than a sand backfill. This arrangement could easily lead to point stresses on the tank which could, in turn, lead to leaks. While no holes were observed, the tank was susceptible to leaks caused by this improper installation. Photos at the end of this report (Appendix D) document the condition of the tank.

Top View of Removed Tank

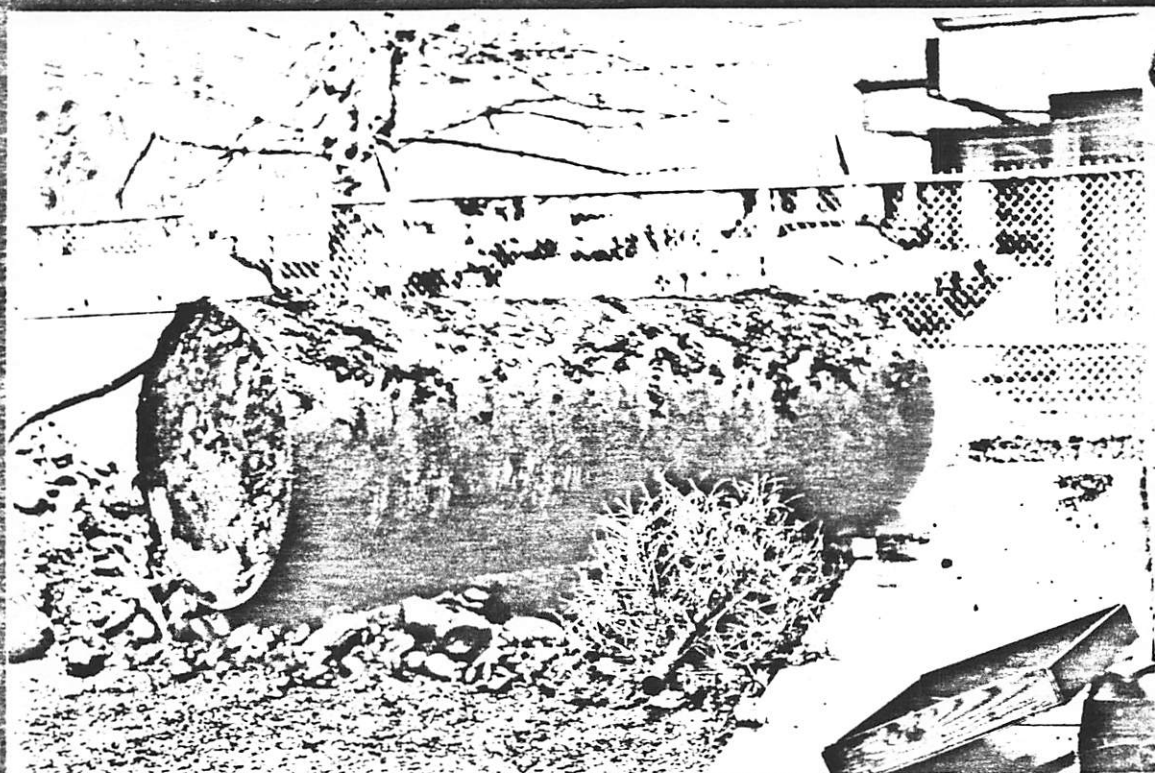
Bottom View of Removed Tank

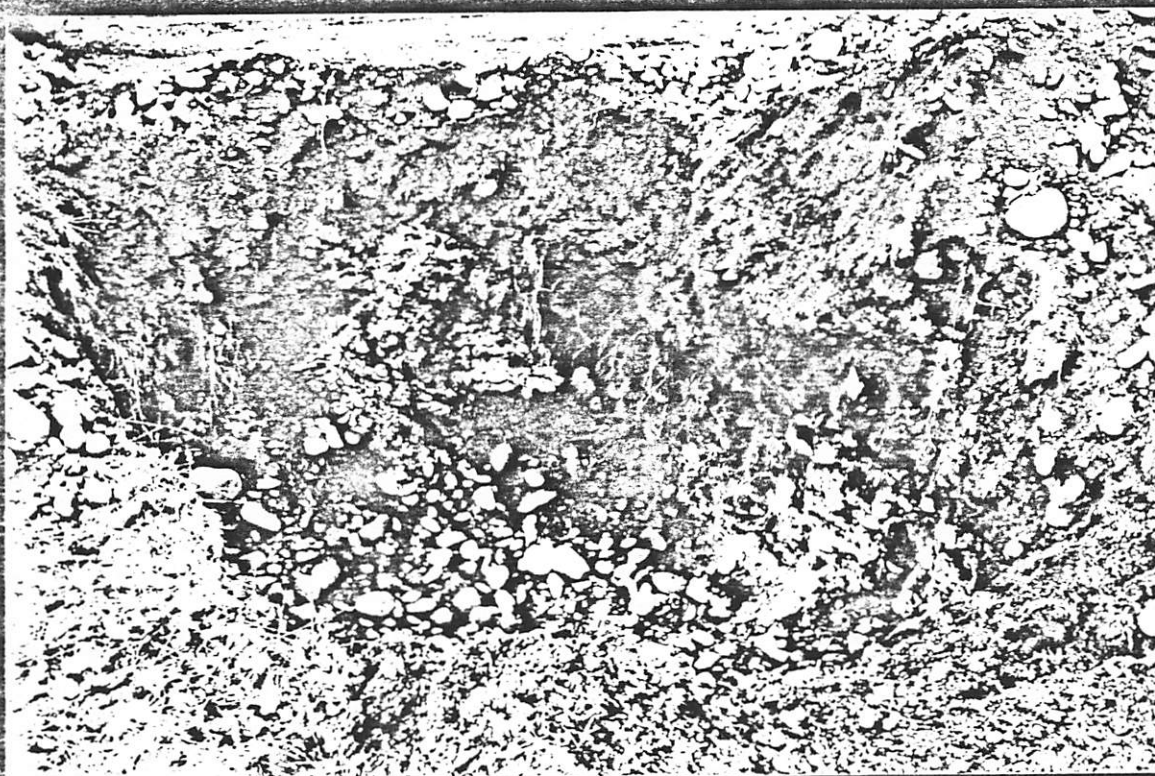
View of Excavation Pit, Looking West

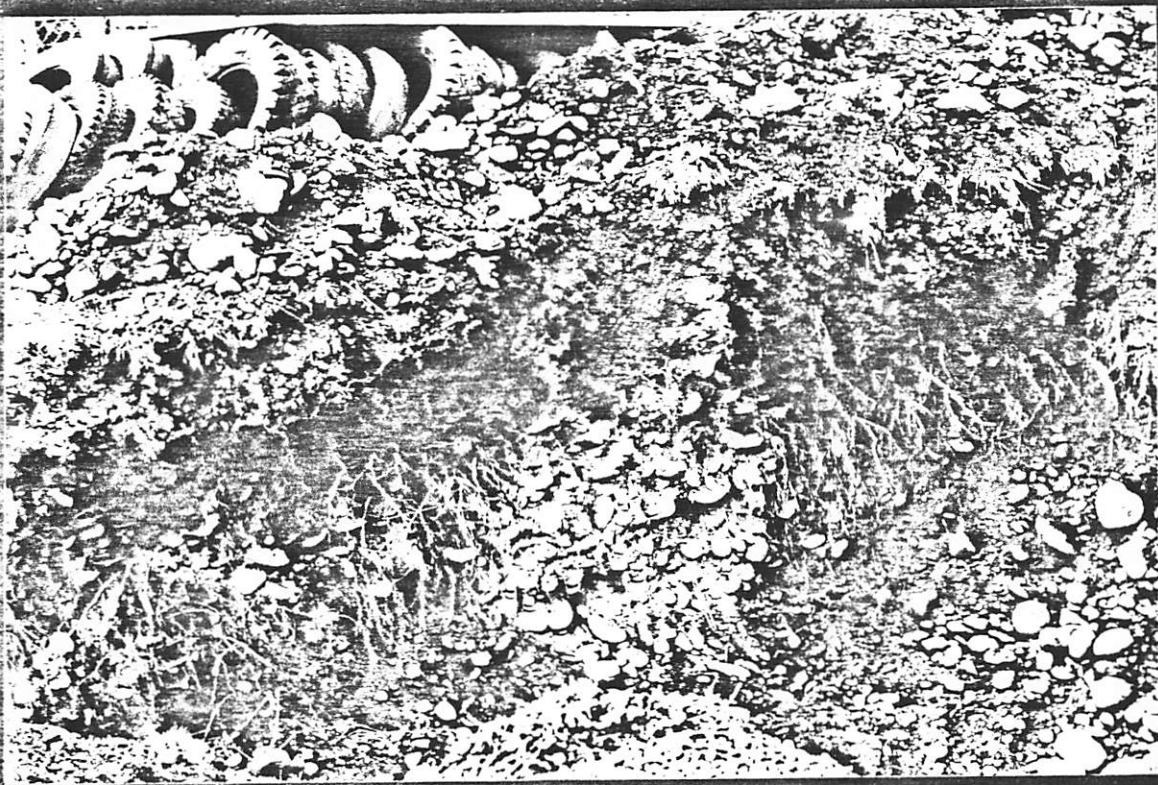
The walls of the excavation pit showed obvious oil contamination over much of the pit's perimeter. The oil was observed to a depth of nearly three feet at some locations. Gasoline odor was strongest in the vicinity of the pump pad. Oil and gas appeared to be mixed at this location and, in some cases, the soil was apparently saturated with this combination of hydrocarbons. The photos in Appendix D document the condition of the pit walls. At a depth of over three feet, little contamination was visually observed. Except for some soils at the south end of the pit, the subsurface material consisted

↑ View of South Wall of Pit,  
Showing Oil Contamination  
in Upper 2 Feet of Soil

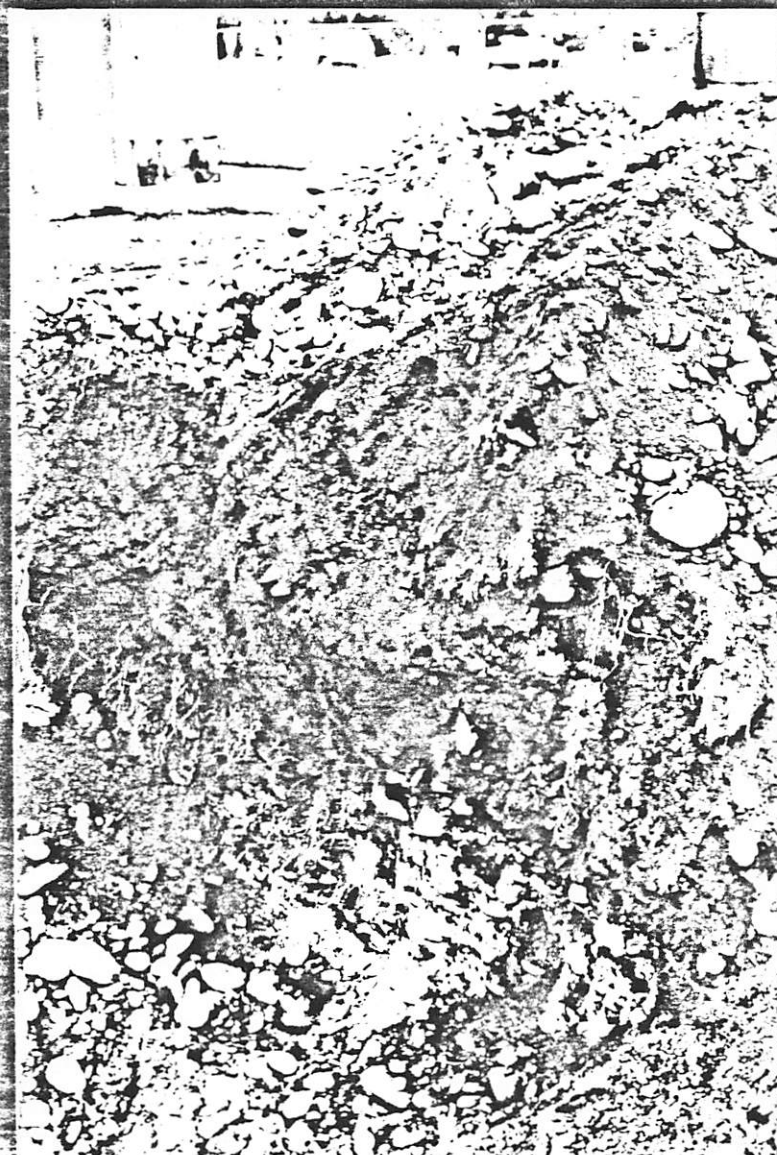
← View of North Wall of Pit,  
Showing Oil Contamination  
in Upper 2 Feet of Soil

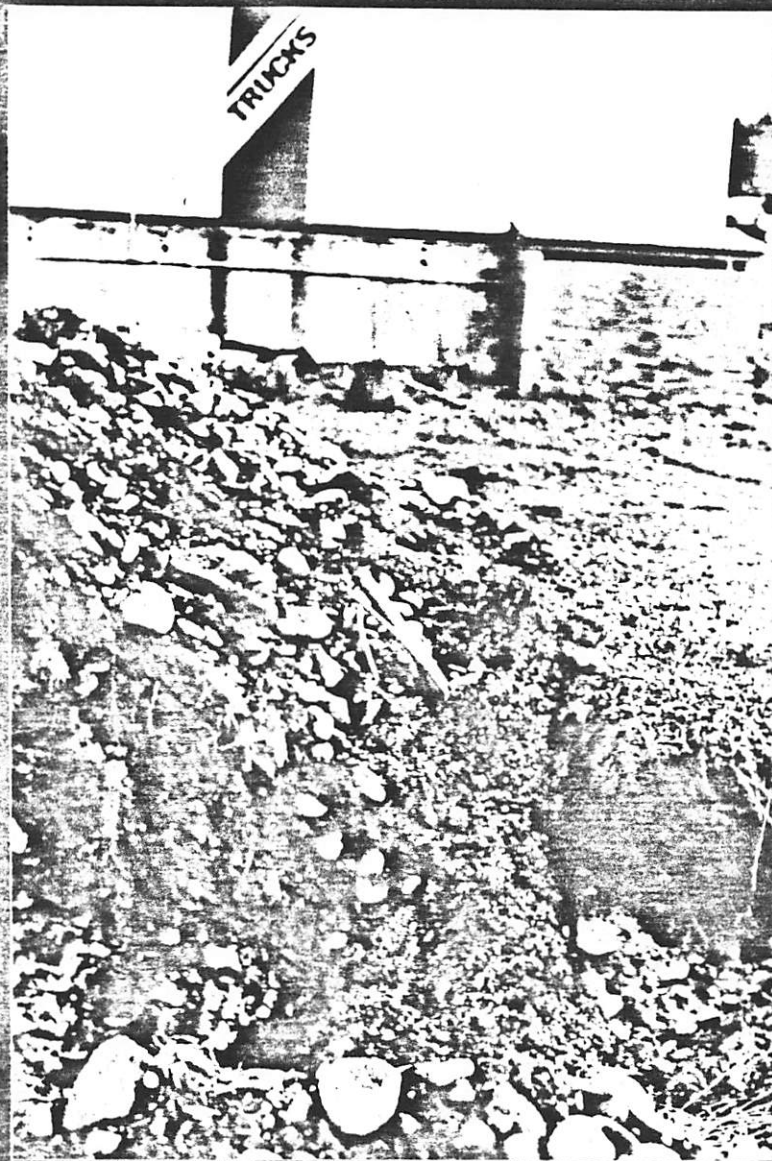
View Looking North,  
Showing Soil Under  
Pump Area →

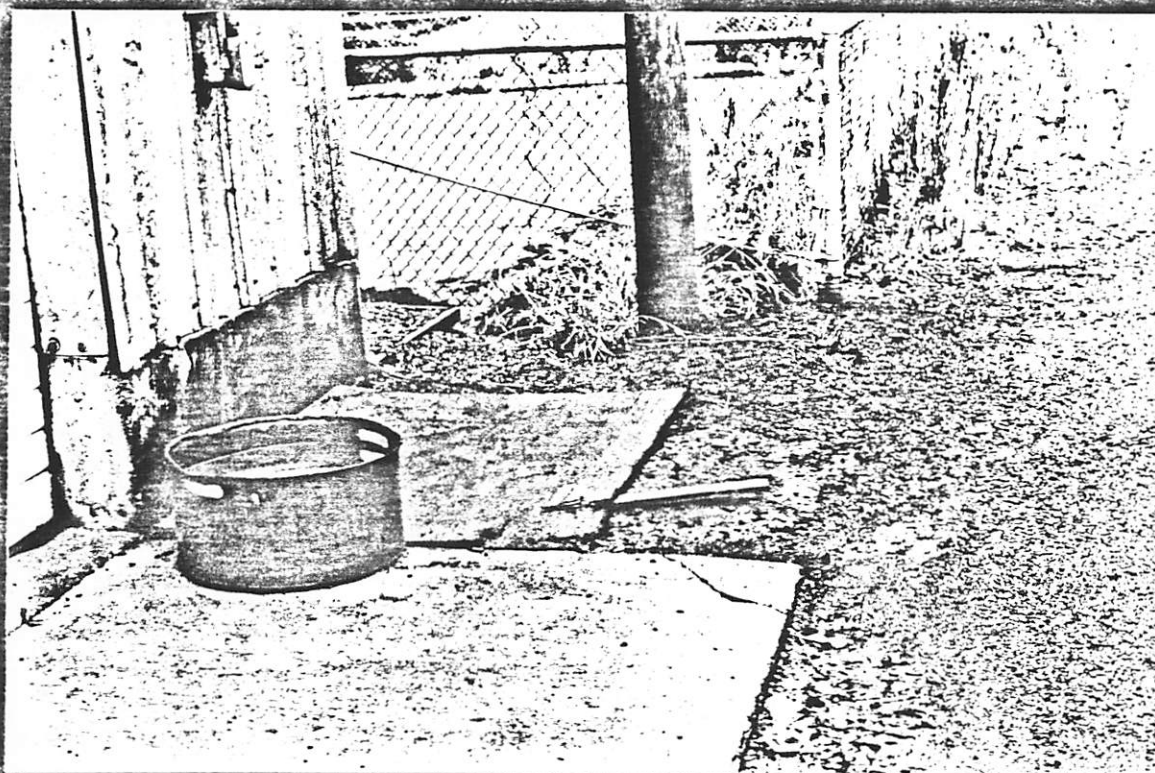
At the northwest corner of the shop building, heavy oil contamination was observed to the west of a concrete entrance pad. This oil had saturated the surface soil to a depth of at least 18 inches, based on the excavation of a small test pit. The oil also had flowed to the west, under the perimeter fence and onto the adjacent property. This contamination is interpreted as originating from the shop operation because of its location. The contaminated area was most likely used for the convenient disposal of used motor oil. It should be emphasized that this assumed source for the oil is not supported by records or previous employee interviews. It is based solely on site observations by Northwest Environmental Corporation employees.

↓ View of Oil Contamination  
Near Shop Door

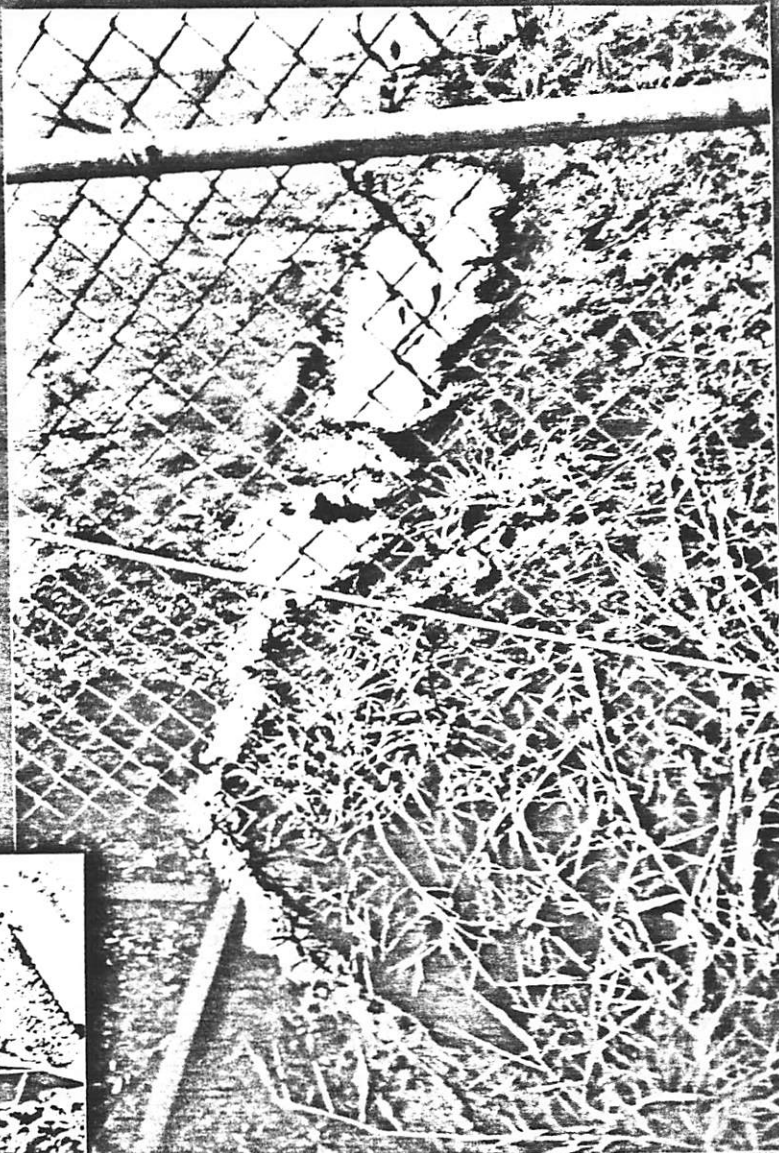
View of Oil Contamination  
Flowing onto Adjacent Property,  
Source Near Shop Door →

Ubiquitous surface and near surface contamination of the site proximate to the UST and shop is suspected to be caused by local surface disposal of used oil and sloppy operation of the used oil tanks. The oil-contaminated soils should be analyzed for the presence of PCB's, and then removed from the site to an appropriate disposal site. It does not appear that much of this oil has migrated below approximately three feet into the subsurface soils. The surface oil contamination near the shop seems to have been more concentrated and should be excavated to clean soil, both on-site and on the adjacent property.

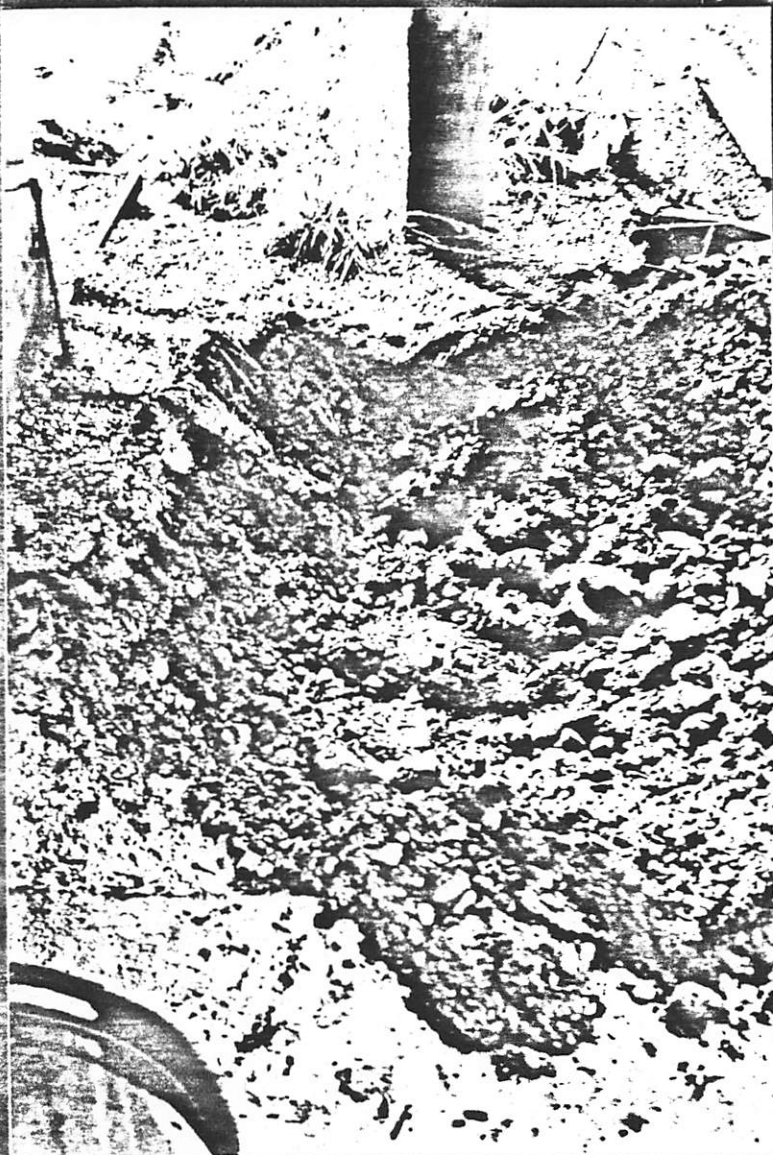
View of Small Excavation  
Pit, in Oil Contamination  
Near Shop Door ←

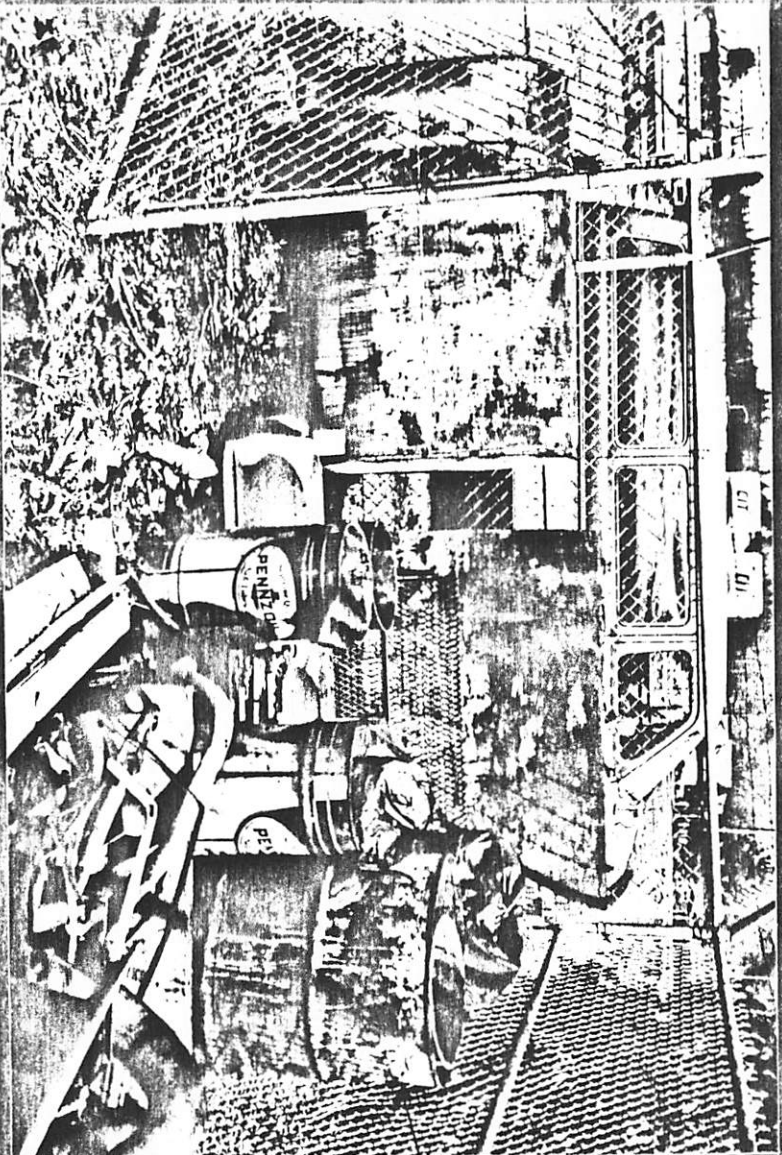
View of Used Oil Tanks  
and Garbage

The pile of used tires, scrap iron, discarded auto parts, seven auto batteries, and miscellaneous garbage should be removed from the site to facilitate excavation of oil contamination in that area. There was no visual evidence that the batteries had leaked. When removed, they should be examined more carefully for leaks. If leaks are found, the soil under the batteries may have to be tested for sulfate and lead contamination

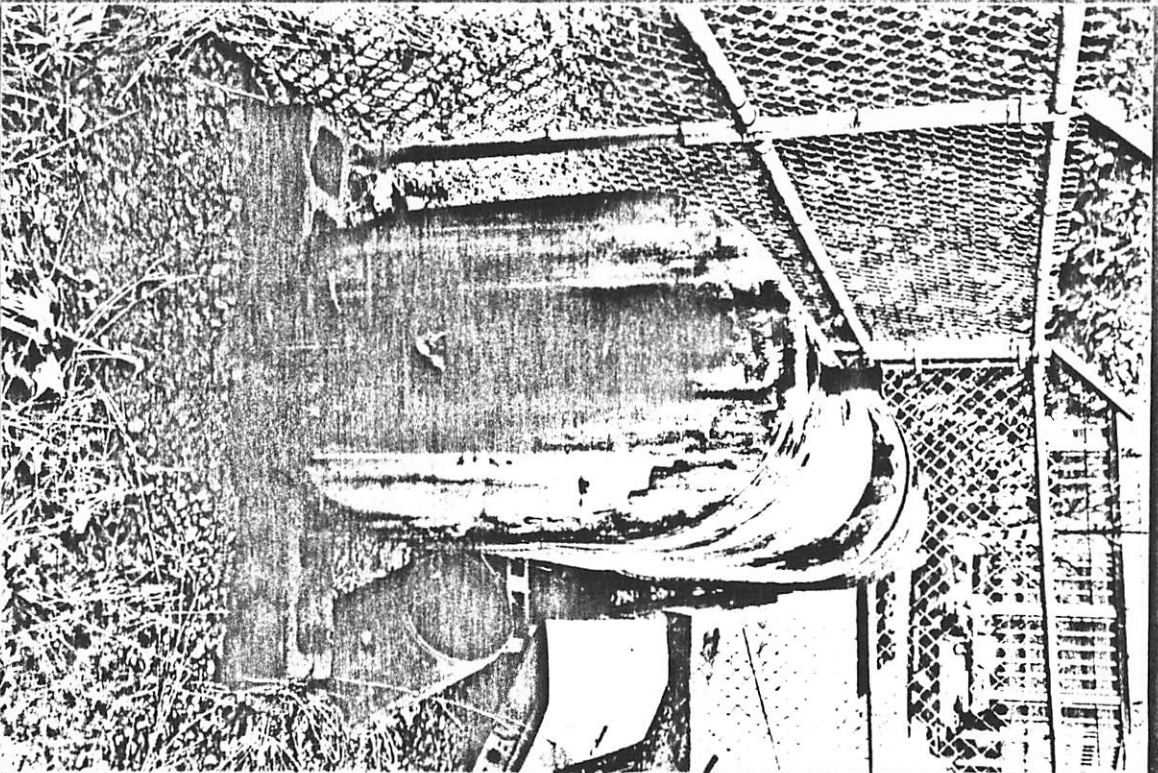
View of Oil Contamination  
Near Used Oil Tanks

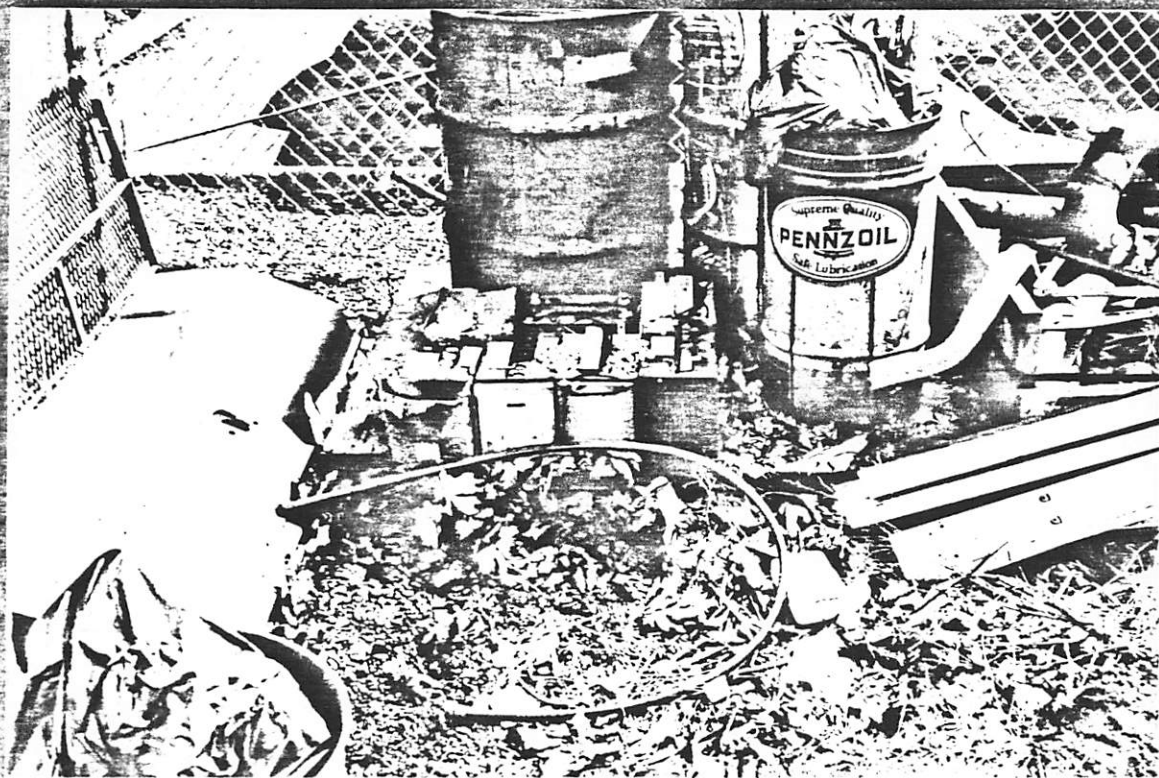
View of Used Auto Batteries

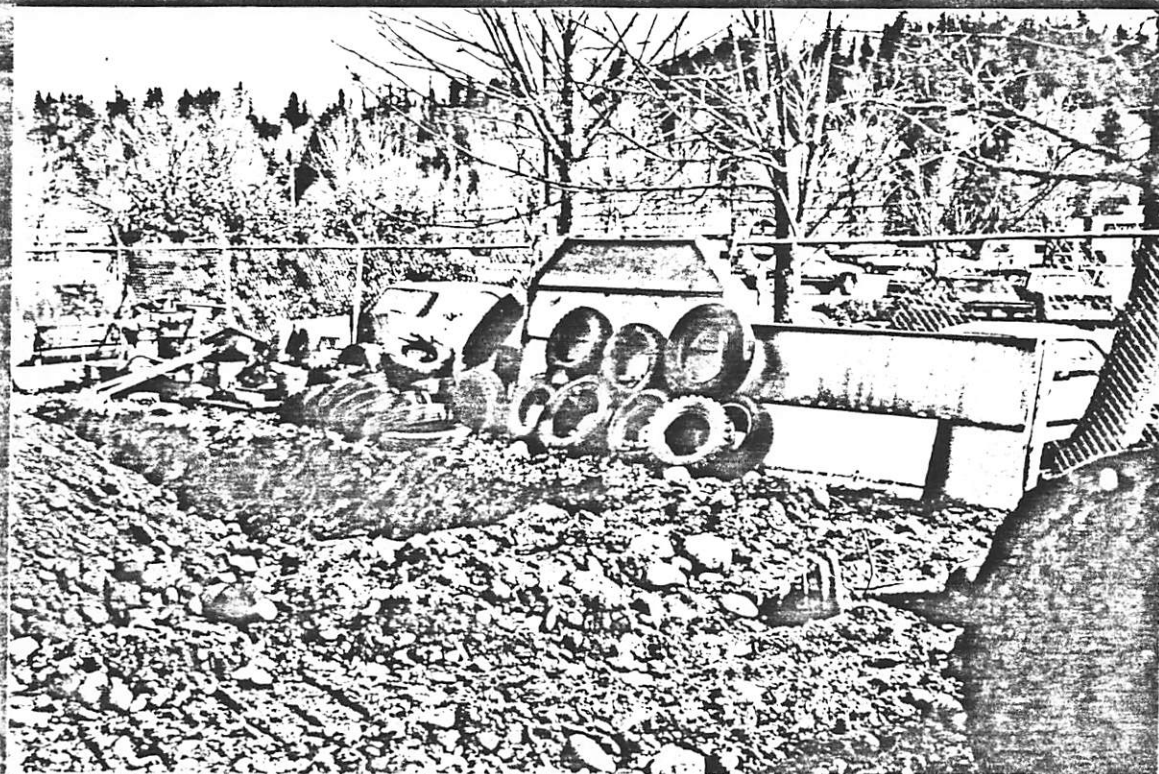
Overview of Refuse Along South Perimeter Fence
