Re: Riverbank Monitoring Report  
Swan Island Upland Facility - Operable Unit 5  
Portland, Oregon  
ECSI No. 271  
1115-25

Apex Companies, LLC (Apex) prepared this *Riverbank Monitoring Report* on behalf of the Port of Portland (Port) for the Swan Island Upland Facility – Operable Unit 5 (OU5; Figures 1 and 2). This report documents monitoring of the OU5 riverbank completed on December 19, 2023 according to the *Revised Riverbank Monitoring Work Plan* (Work Plan; Apex, 2018).

**ATTACHMENT B  
2023 PHOTOGRAPH LOG**

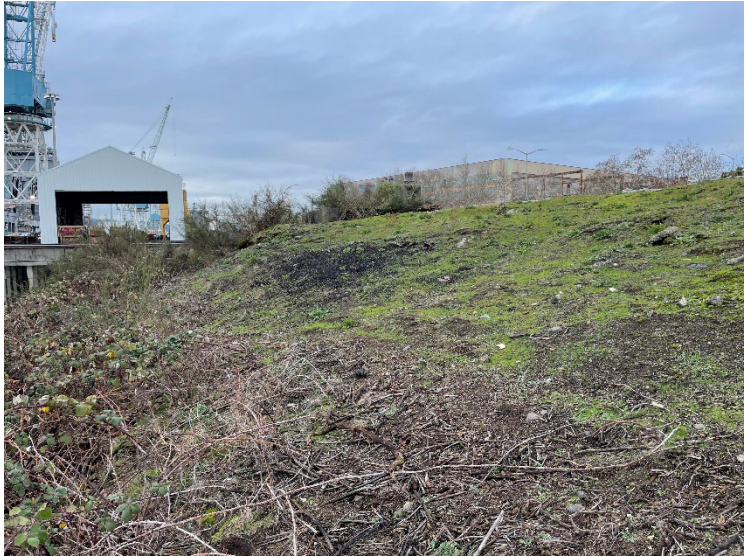
| <b>Photo Station:</b> B | A photograph showing a grassy, eroded hillside. In the background, there is a white building with a dark roof and a crane. The sky is overcast and grey. |

| <b>Description:</b><br><br>Existing erosional feature B adjacent to Vigor Industries. | |

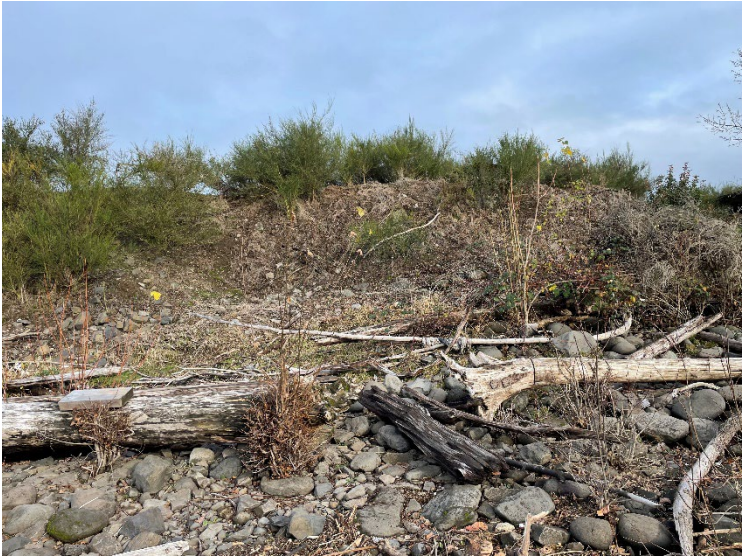
| <b>Photo Station:</b> E | |

| <b>Description:</b><br><br>Existing erosional feature E (depression in riverbank) adjacent to Vigor Industries. | |

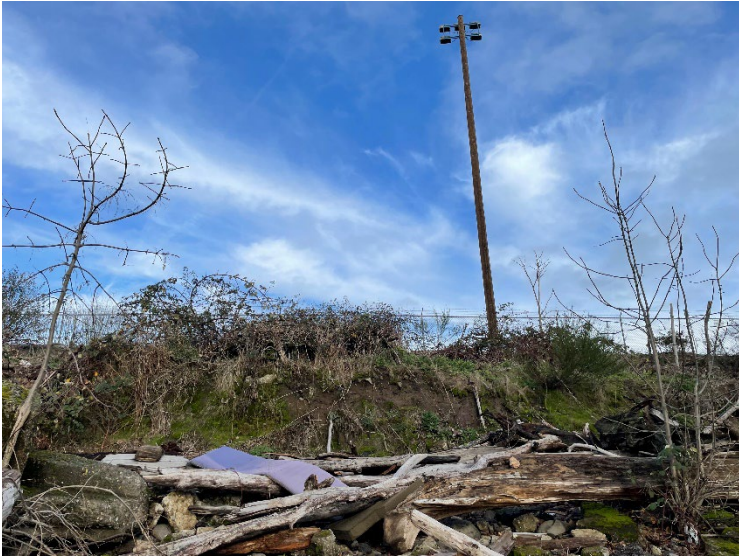
| <b>Description:</b><br><br>Erosional feature I (erosion scarp) adjacent to Cemex leasehold. | |

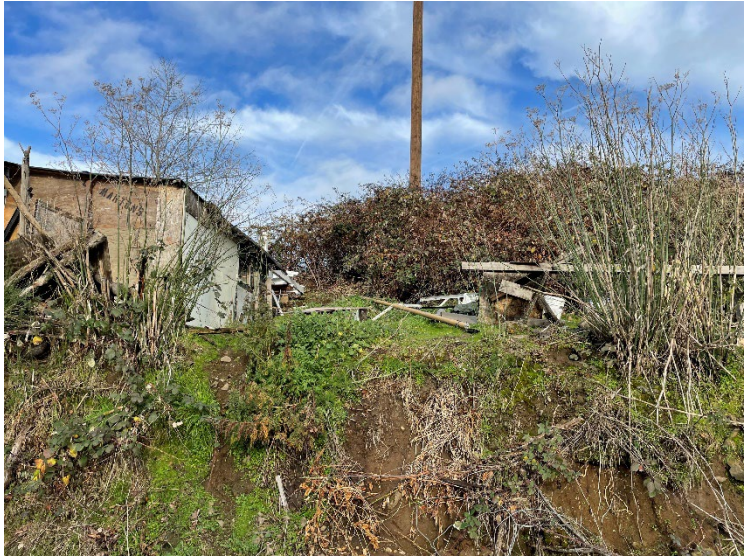
| <b>Description:</b><br><br>Existing erosional feature JB (center of erosion scarp) adjacent to Cemex leasehold. | |

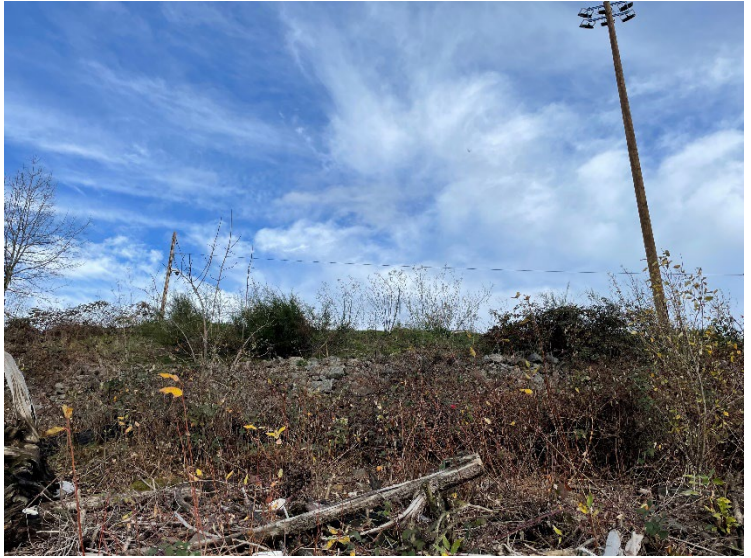
| <b>Photo Station:</b> J1 | |

| <b>Description:</b><br><br>Erosional feature J1 (repaired former erosion scarp) rip rap at west end of Daimler leasehold.<br><br>Note: Rip rap in place and silt fence still visible. | |

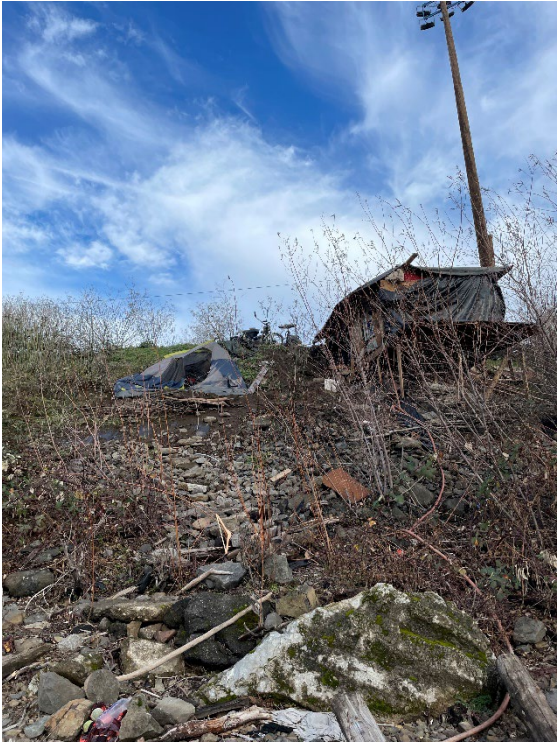
| <b>Photo Station:</b> L | |

**New Erosional Features.** The riverbank was inspected for new erosional features including scouring, scarps, slides, erodible soil, soft ground, depressions, or other changes. In general, no significant changes due to natural erosion were observed during the 2023 inspection event. However, the previously observed location of unauthorized steps show some erosion with exposure of filter fabric at the northern edge of J1. The exposure of filter fabric and depletion of rip rap observed at location L also appeared to be recent.

| SOURCE CONTROL INSPECTION CHECKLIST | | | | |
|---|---|---|---|---|
| | Is filter fabric visible?<br><i>Collect GPS coordinates and photos where visible.</i> | Yes <input checked="" type="checkbox"/> No <input type="checkbox"/> | Minor exposure of filter fabric and depleted rip rap was observed at location L. | Yes <input type="checkbox"/> No <input checked="" type="checkbox"/><br><br>Riverbank <input type="checkbox"/> |

| <b>Description:</b><br><br>Erosional feature L (repaired former erosion scarp) rip rap adjacent to Daimler leasehold.<br><br>Note: Exposed filter fabric and depleted rip rap. | |

No corrective action is proposed at this time. No significant changes have been observed as a result of natural erosion and the minor exposed bank repair demarcation and filter fabric layers will be addressed in coordination of in-water remedy activities. However, minor disturbance has been observed on the riverbank as a result of unauthorized encampment activities and will be addressed at a future time.

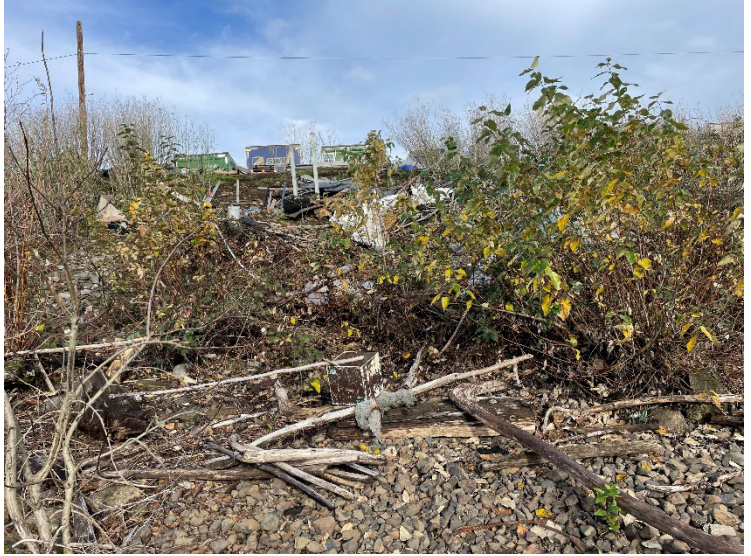
| <b>Photo Station:</b> M | |

| <b>Description:</b><br><br>Erosional feature M (repaired former erosion scarp) rip rap adjacent to Daimler leasehold.<br><br>Note: Area of former unauthorized encampment structures. | |

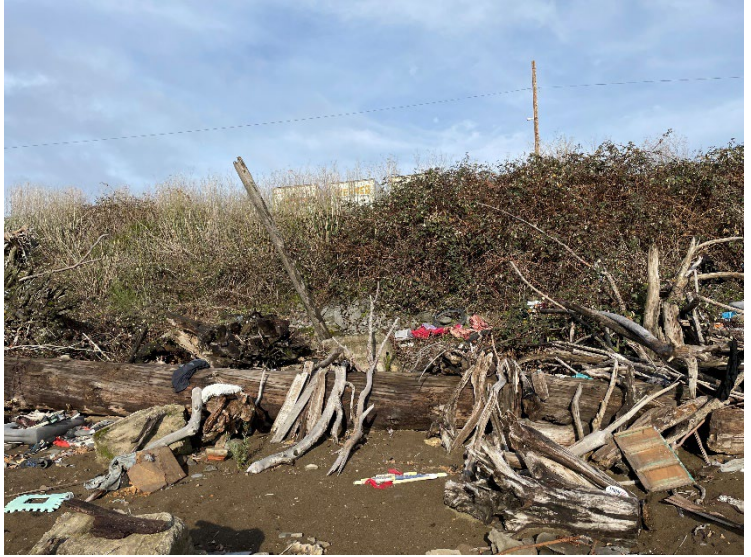
| <b>Photo Station:</b> N | |

| <b>Description:</b><br><br>Erosional feature N (repaired former erosion scarp) rip rap adjacent to Daimler leasehold. | |

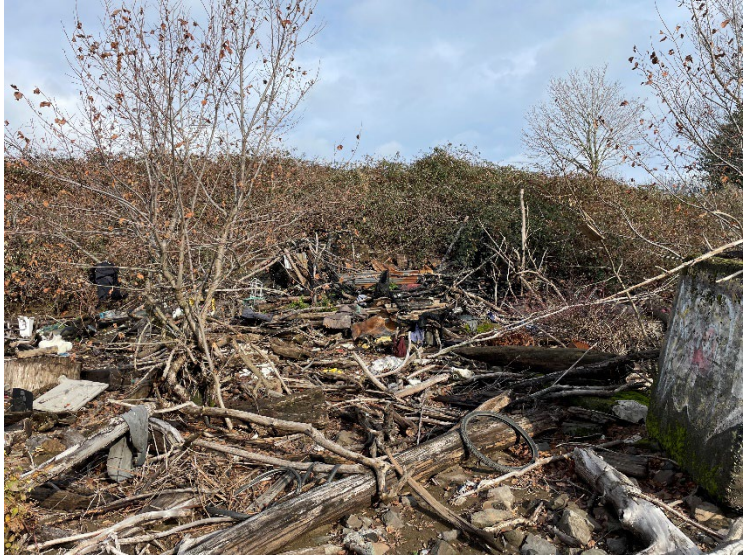
| <b>Photo Station:</b> O | |

| <b>Description:</b><br><br>Erosional feature O (depression in riverbank) adjacent to Daimler leasehold.<br><br>Note: Burned former unauthorized encampment structures. Large concrete blocks in the area. | |

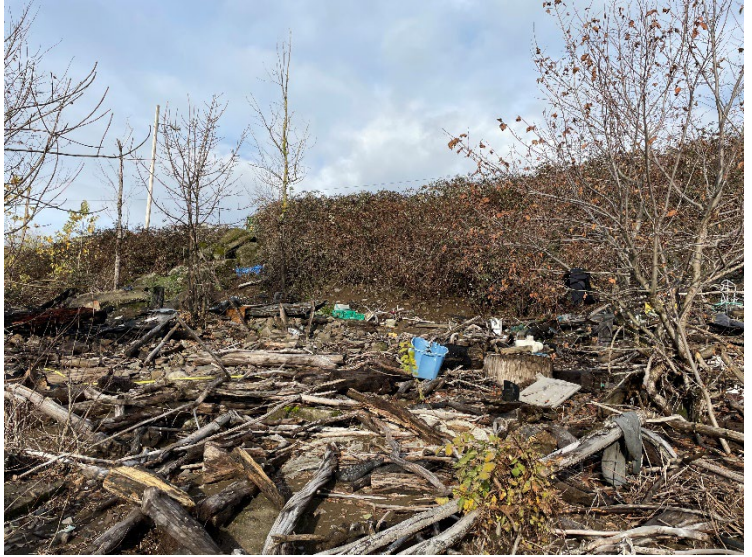
| <b>Photo Station:</b> O | |

| <b>Description:</b><br><br>Erosional feature O (depression in riverbank) adjacent to Daimler leasehold.<br><br>Note: Burned former unauthorized encampment structures. Large concrete blocks in the area. | |

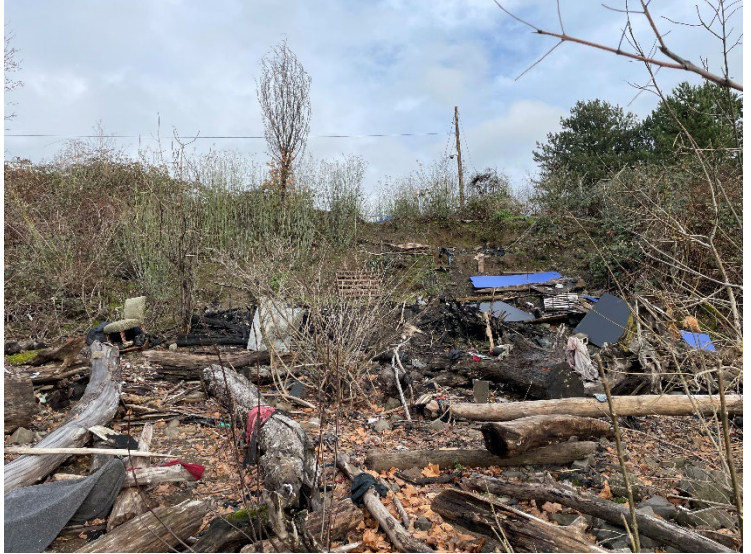
| <b>Photo Station:</b> P | |

| <b>Description:</b><br><br>Erosional feature P (erosion scarp) near east end of Daimler leasehold.<br><br>Note: Burned former unauthorized encampment structures. | |

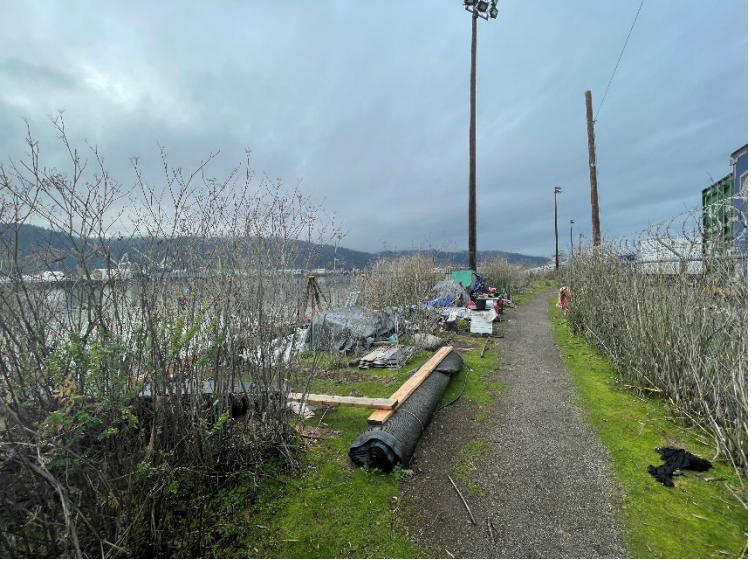
| <b>Description:</b><br><br>Top of bank near features M and N.<br><br>Note: Observed unauthorized encampment structures and litter. | |

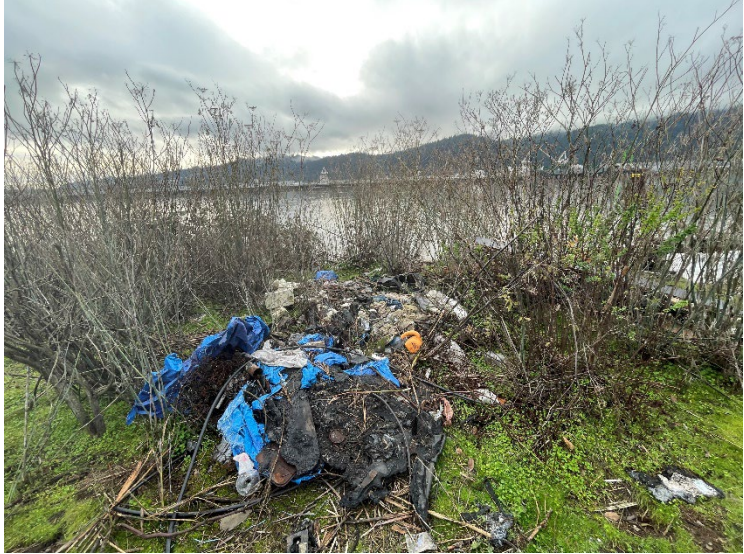
| <b>Description:</b><br><br>Top of bank near features M and N.<br><br>Note: Observed burned unauthorized encampment litter. | |

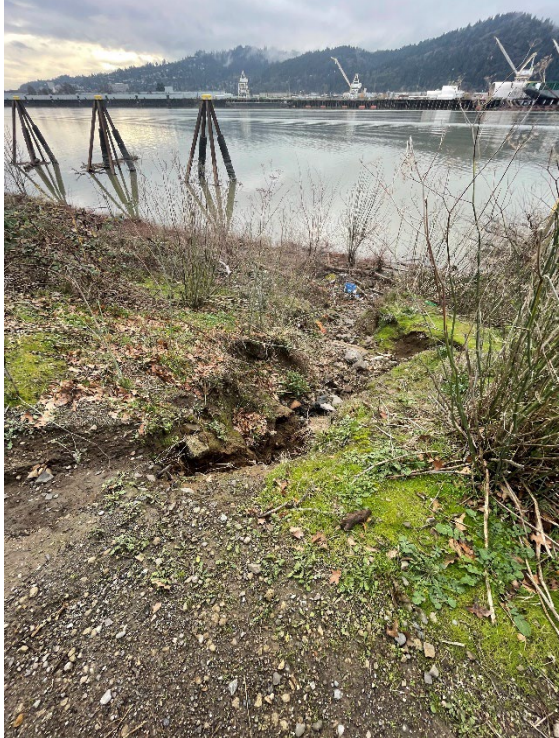
| <b>Description:</b><br><br>Previously noted location of the unauthorized installed steps at the north end of J1.<br><br>Note: Erosional features with exposure of filter fabric at the northern edge of the repaired scarp J1. The steps appear to have mostly disappeared. | |

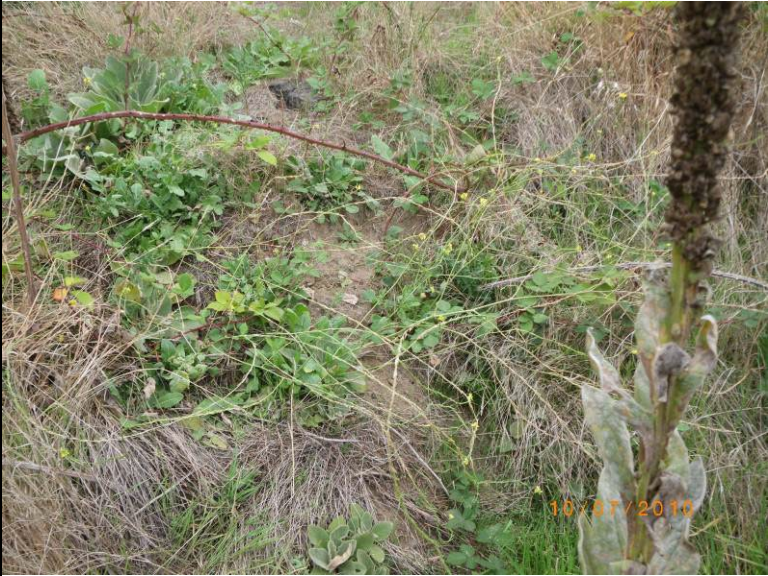
| <b>Photo Station:</b> B | |

| <b>Description:</b><br><br>Feature B – Bare ground approximately 1 foot in diameter. | |

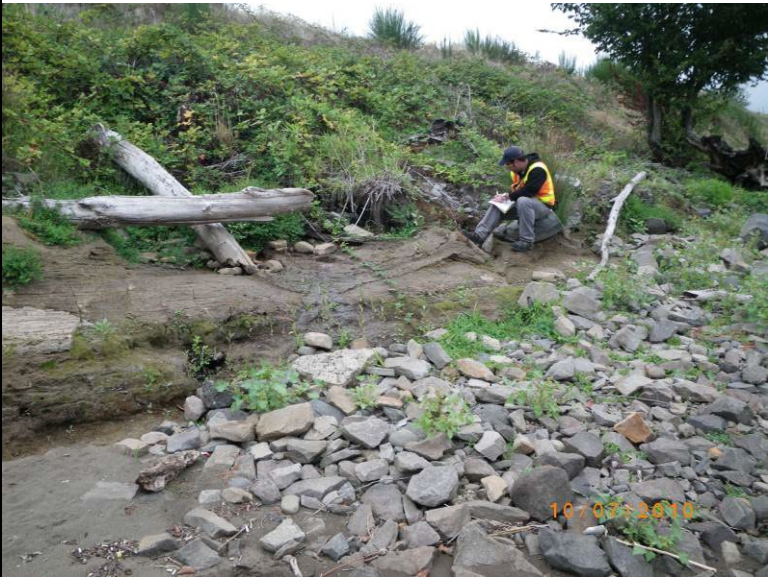
| <b>Photo Station:</b> D | |

| <b>Description:</b><br><br>Southeast end of Feature D – Bare ground below Outfall WR-399 with dimensions of approximately 3 feet by 80 feet. | |

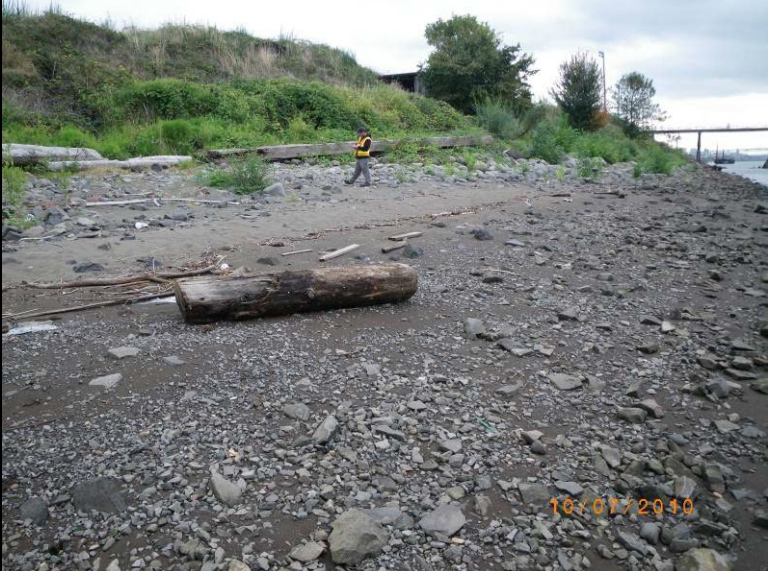
| <b>Description:</b><br><br>Feature E – Depression in riverbank to left of individual in photograph. Width is approximately 30 feet. Topography is hummocky and surface is densely vegetated. | |

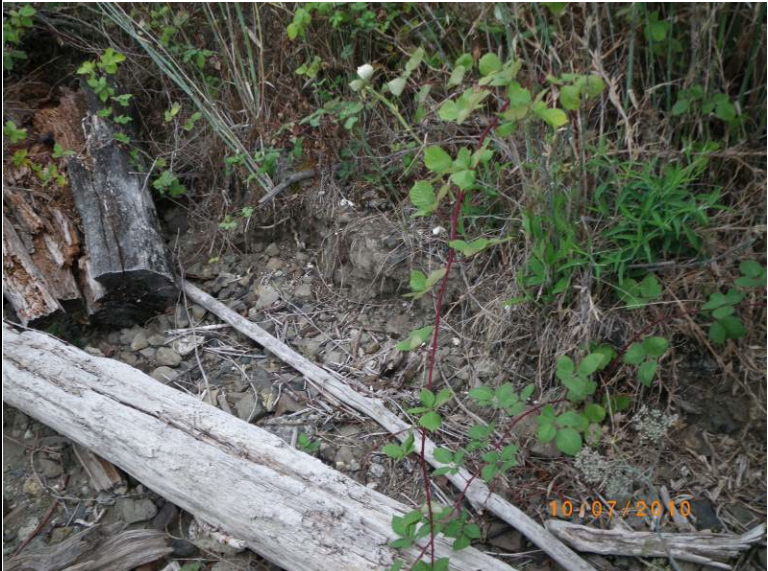
| <b>Photo Station:</b> I | |

| <b>Description:</b><br><br>Feature I – Erosion scarp 35 feet long and up to 1.5 feet high. | |

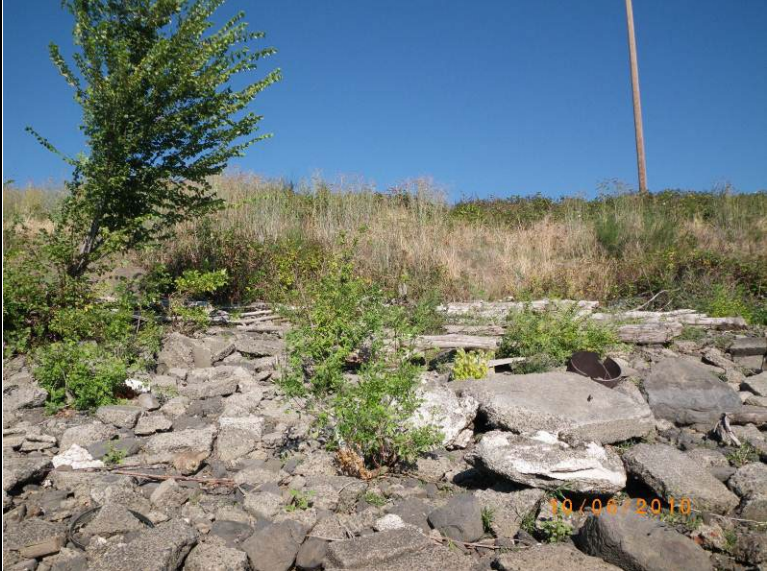
| <b>Photo Station:</b> JA | |

| <b>Description:</b><br><br>Feature J – Erosion scarp 635 feet in length. Height is variable up to 6.6 feet. This photograph shows a minimal height scarp (hidden in vegetation). | |

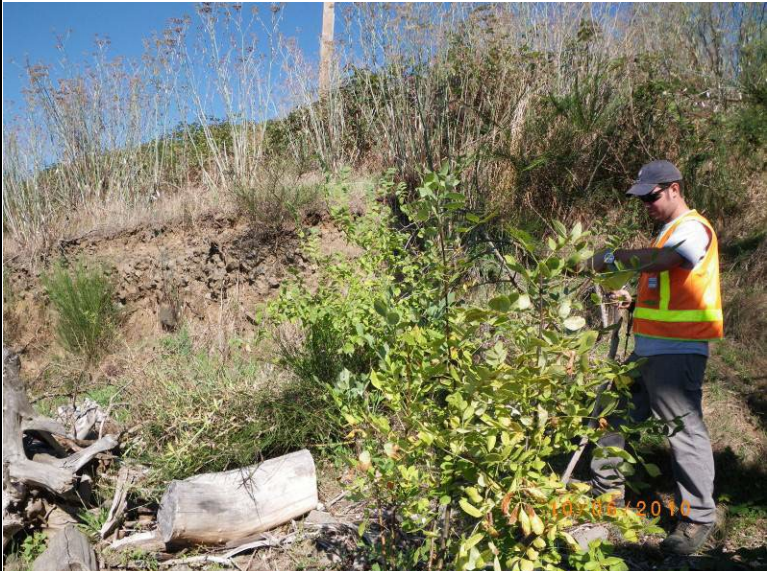
| <b>Photo Station:</b> JC | |

| <b>Description:</b><br><br>Feature J – Erosion scarp 635 feet in length. Height is variable up to 6.6 feet. This photograph shows a maximal scarp. | |

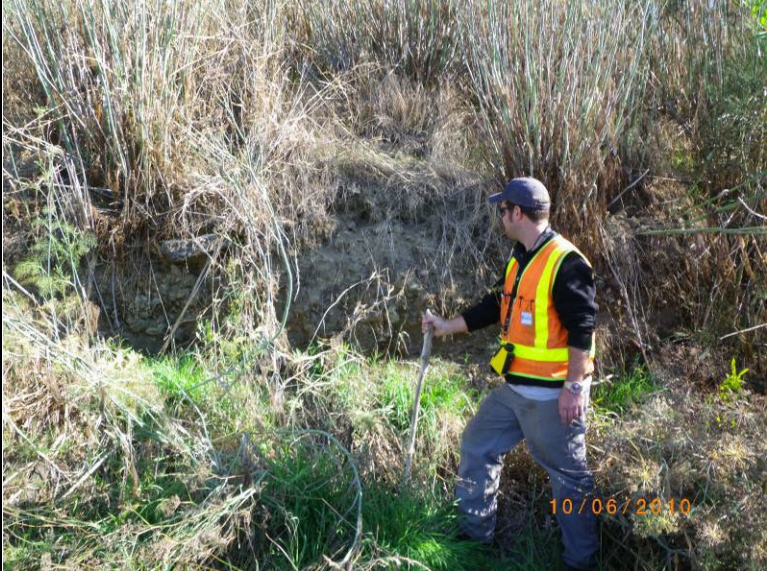
| <b>Photo Station:</b> L | |

| <b>Description:</b><br><br>Feature L – Erosion scarp 56 feet long and up to 3 feet high. | |

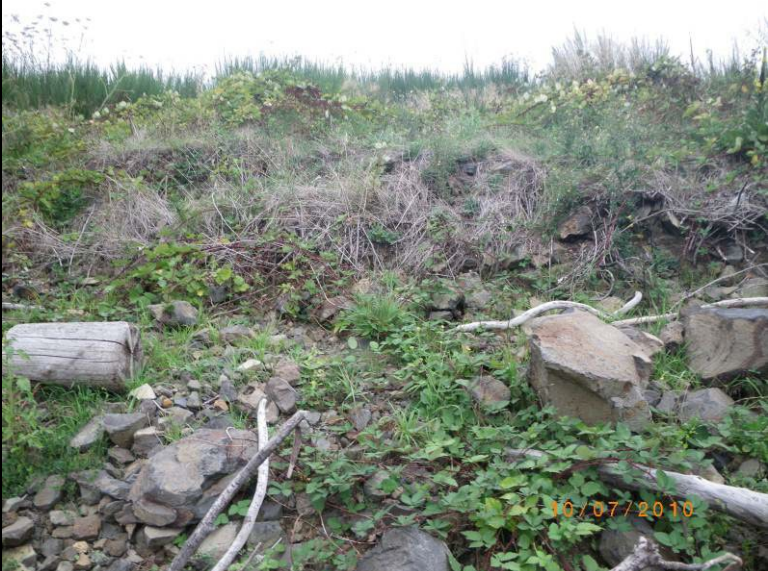
| <b>Photo Station:</b> M | |

| <b>Description:</b><br><br>Feature M - Erosion scarp 53 feet long and up to 2.7 feet high. | |

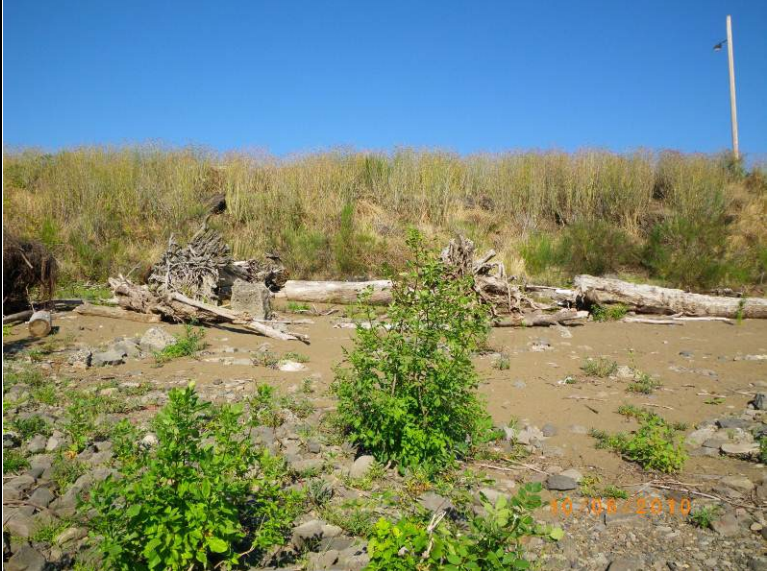
| <b>Description:</b><br><br>Feature N – Erosion scarp within depression in riverbank. Erosion scarp is 49 feet long and up to 2 feet high. Depression width is approximately 80 feet. Topography is hummocky and surface is densely vegetated. | |

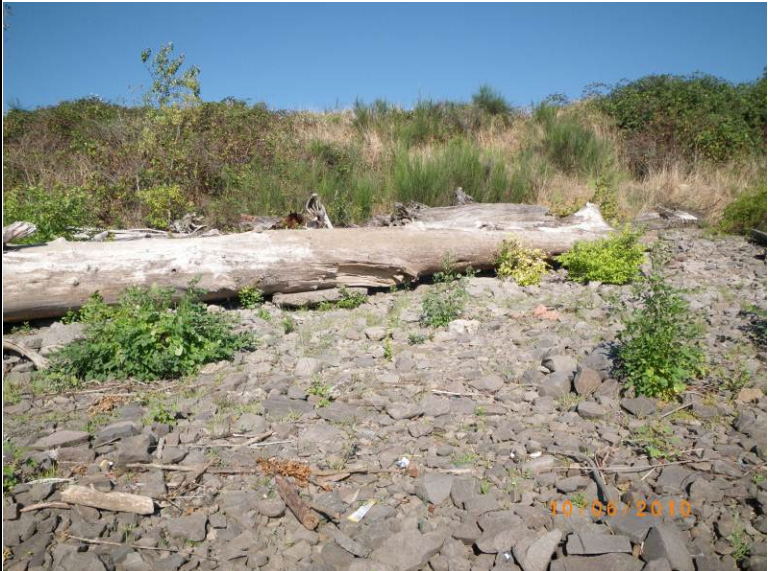
| <b>Description:</b><br><br>Feature O – Depression in riverbank. Width is approximately 50 feet. Topography is hummocky and surface is densely vegetated. | |
