Re: Riverbank Monitoring Report  
Swan Island Upland Facility - Operable Unit 5  
Portland, Oregon  
ECSI No. 271  
1115-25

Apex Companies, LLC (Apex) prepared this *Riverbank Monitoring Report* on behalf of the Port of Portland (Port) for the Swan Island Upland Facility – Operable Unit 5 (OU5; Figures 1 and 2). This report documents monitoring of the OU5 riverbank completed on October 28, 2021 and December 13, 2022 according to the *Revised Riverbank Monitoring Work Plan* (Work Plan; Apex, 2018).

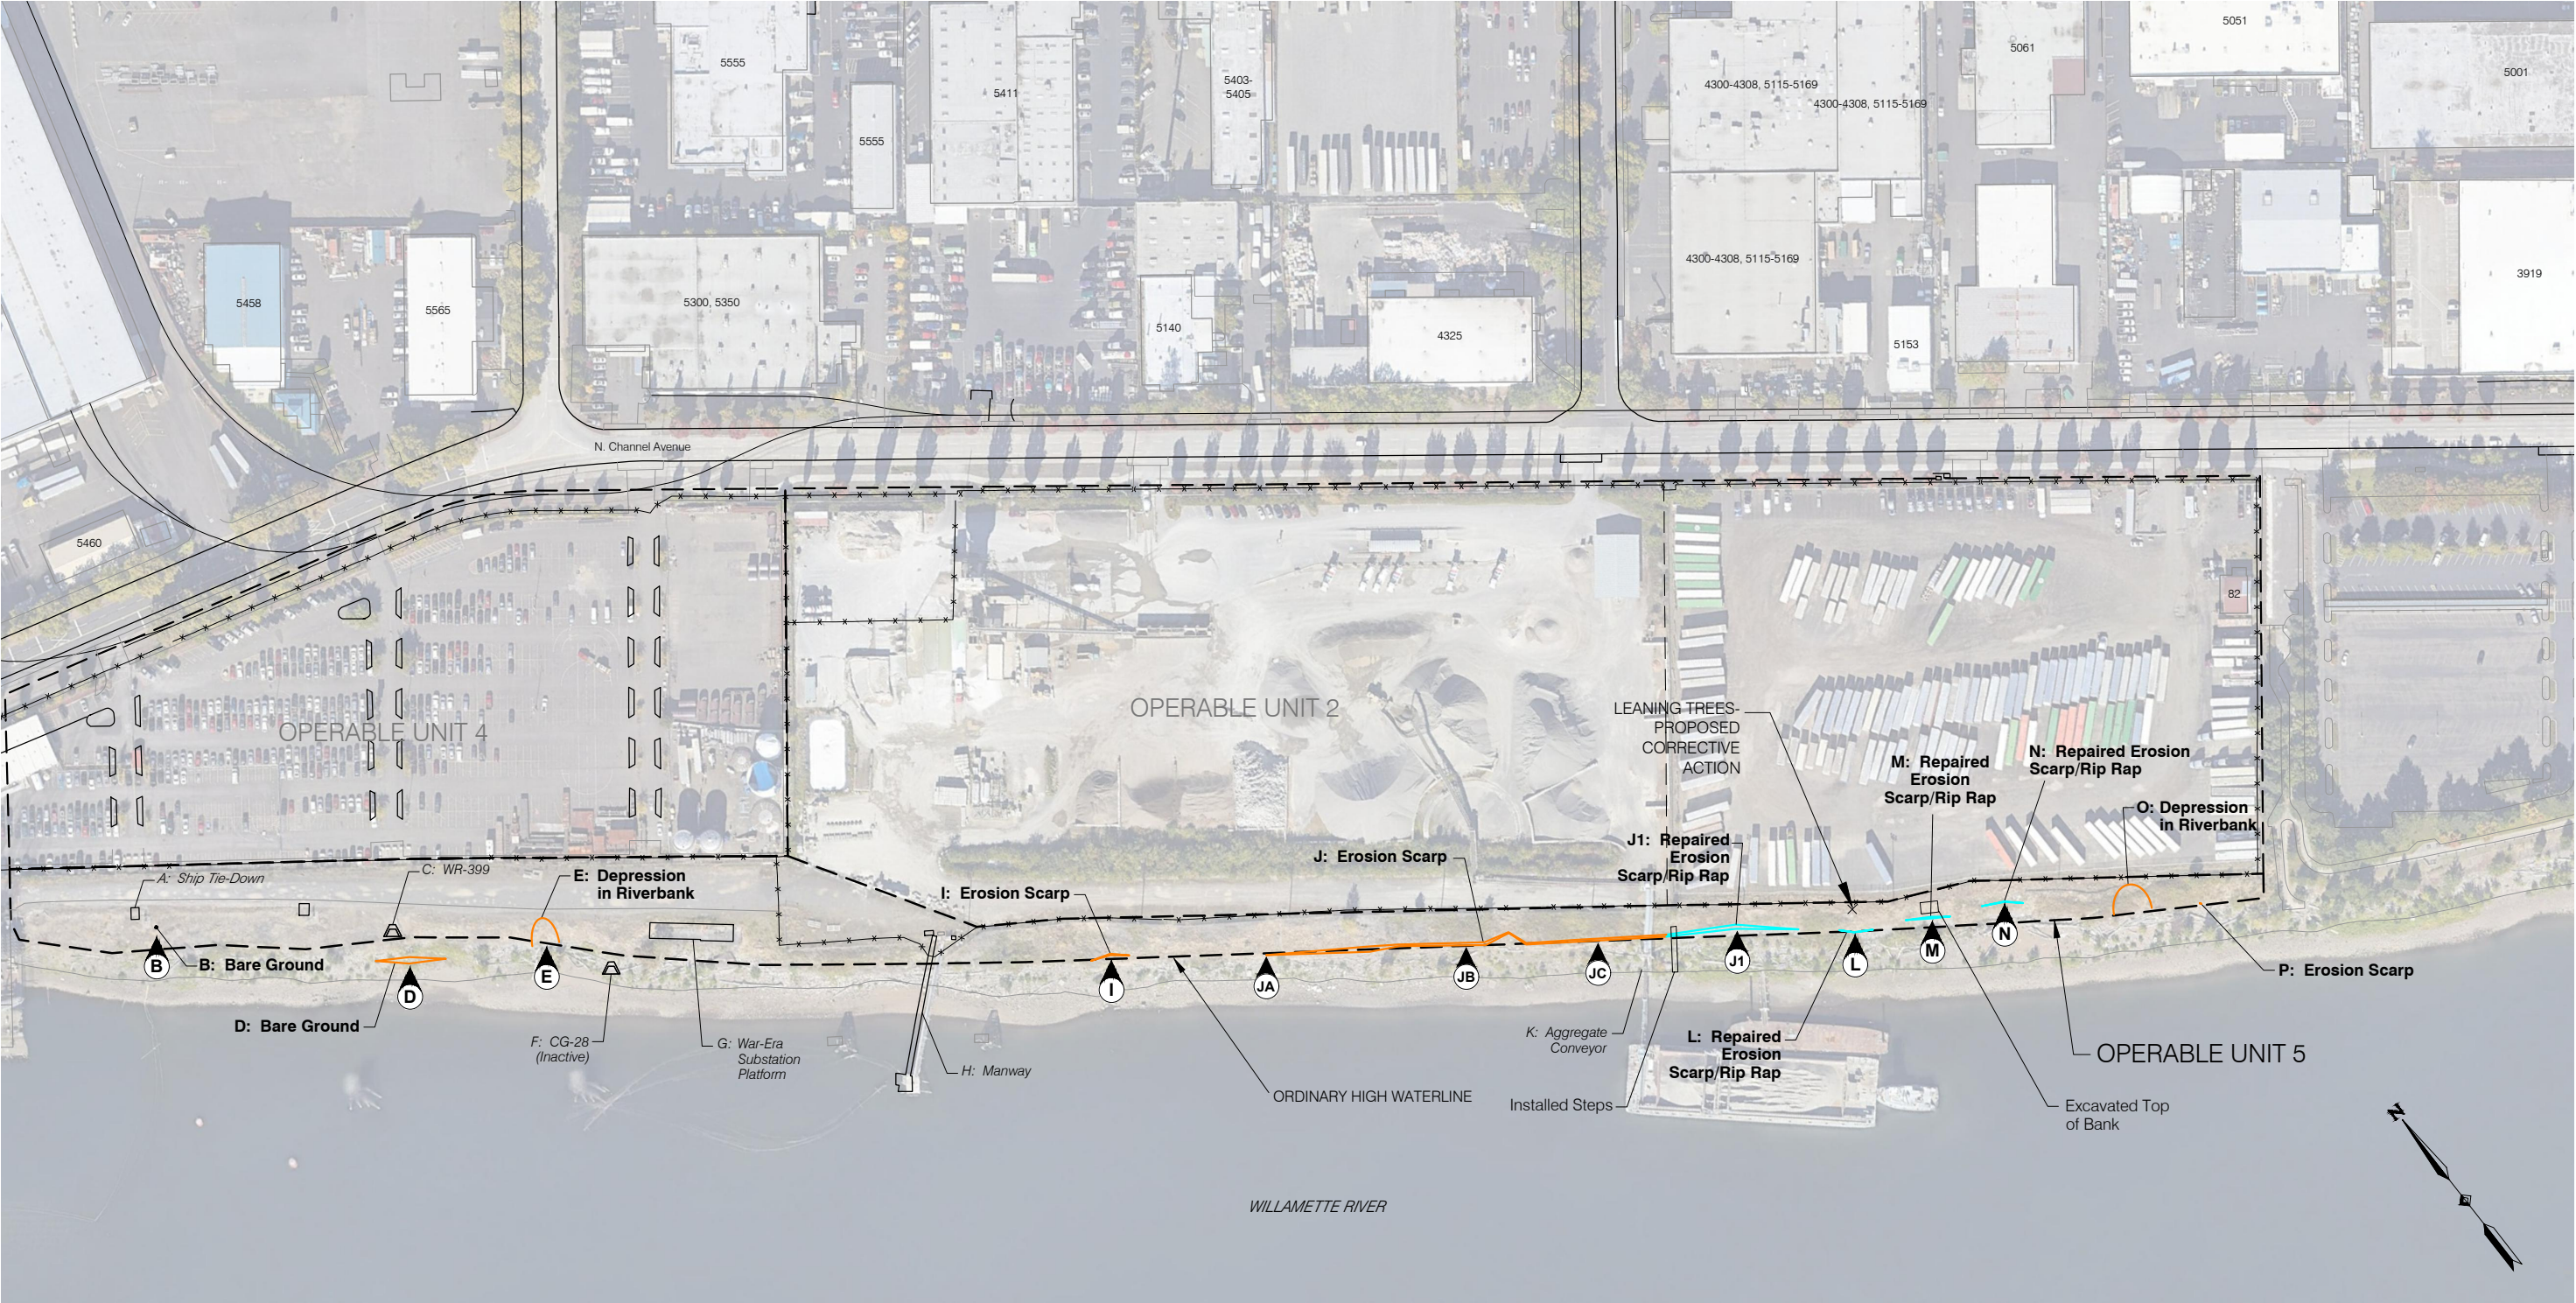
### Erosional Features

**Rip Rap.** The rip rap coverage at repaired scarp locations J1, L, M, and N as shown on Figure 3 was consistent with the locations of the scarps as verified by utilizing previous inspection photos and land-marks along the riverbank. North of location J1 and south of location JC, a trail which leads from the bottom of the riverbank slope to the top of the riverbank was observed. Rip rap and soil have been moved/repositioned in this area to accommodate the trail; visible soil, filter fabric, and/or the orange demarcation layer were not observed with the exception of minor exposures along the edge of the rip rap. Stairs constructed of wood, piping and other debris were also observed north of location J1. No other disturbances of rip rap in areas outside the scarp repair was identified.

**Existing Erosional Features.** Existing erosional features B, D, E, I, and J were inspected for any change in size or location. Representative photographs in Attachment B show the existing conditions of these features. No significant changes in these features were observed during the 2021 or 2022 inspection events.

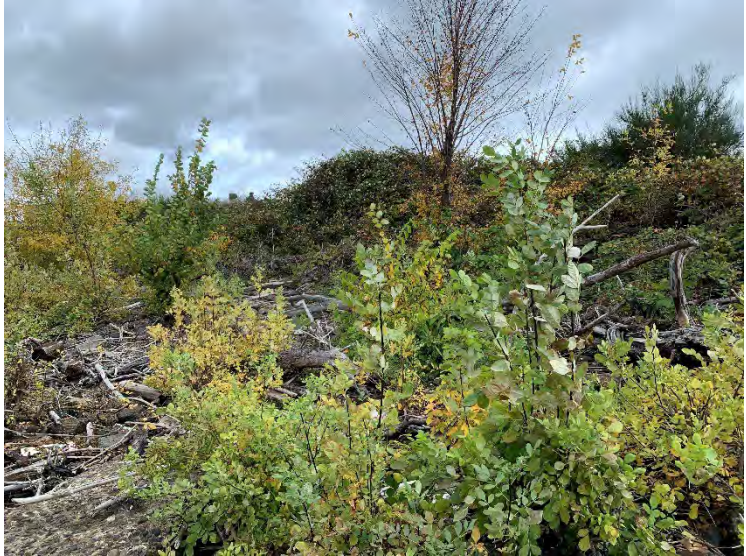
| <b>Photo Station:</b> B | |

| <b>Description:</b><br><br>Existing erosional feature B adjacent to Vigor Industries. | |

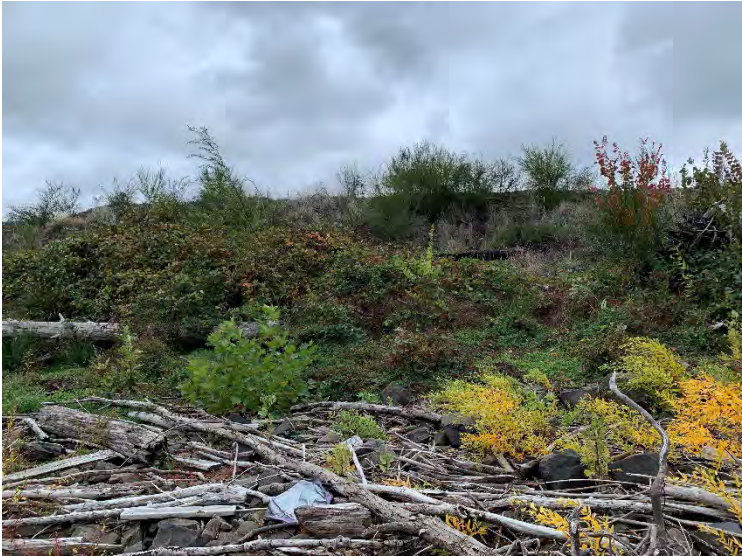
| <b>Photo Station:</b> D | |

| <b>Description:</b><br><br>Existing erosional feature D adjacent to Vigor Industries. | |

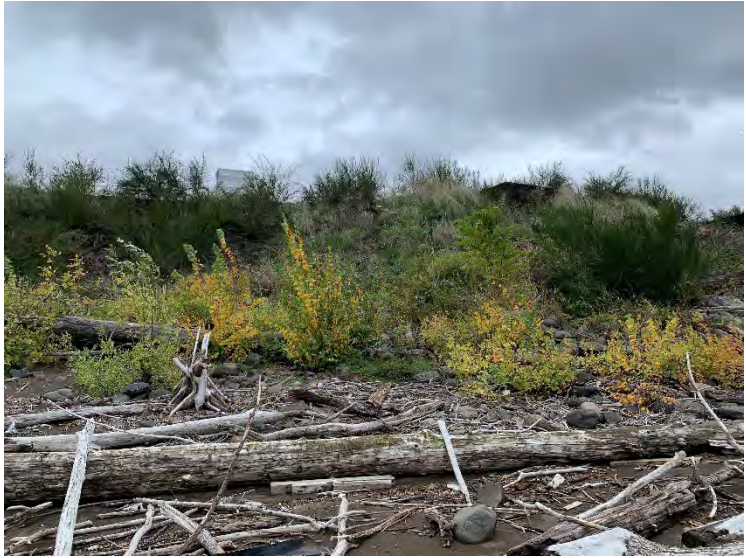
| <b>Photo Station:</b> E | |

| <b>Description:</b><br><br>Existing erosional feature E (depression in riverbank) adjacent to Vigor Industries. | |

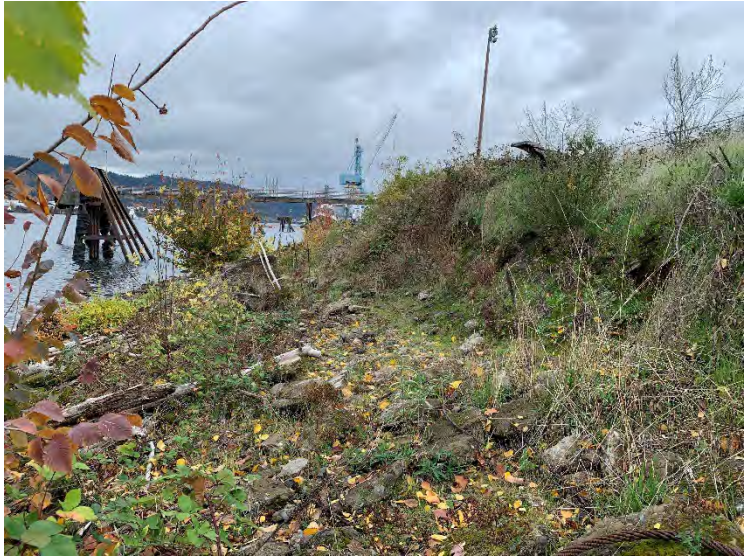
| <b>Photo Station:</b> I | |

| <b>Description:</b><br><br>Erosional feature I (erosion scarp) adjacent to Cemex leasehold. | |

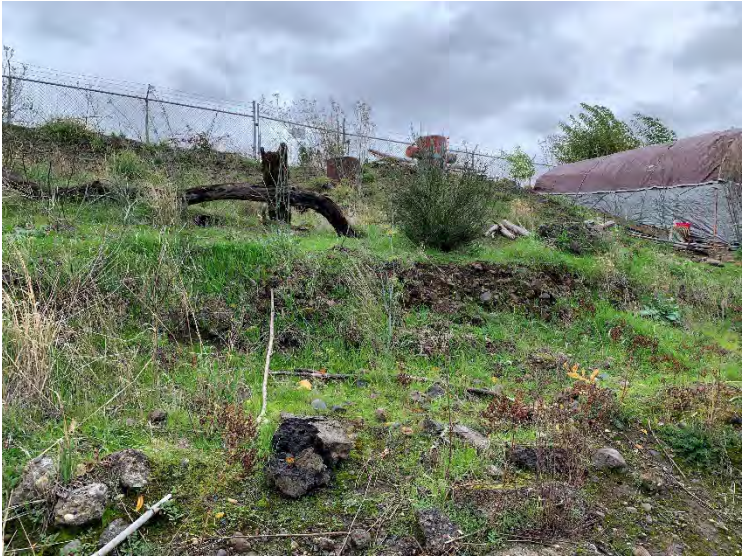
| <b>Photo Station:</b> JA | |

| <b>Description:</b><br><br>Existing erosional feature JA (west end of erosion scarp) adjacent to Cemex leasehold. | |

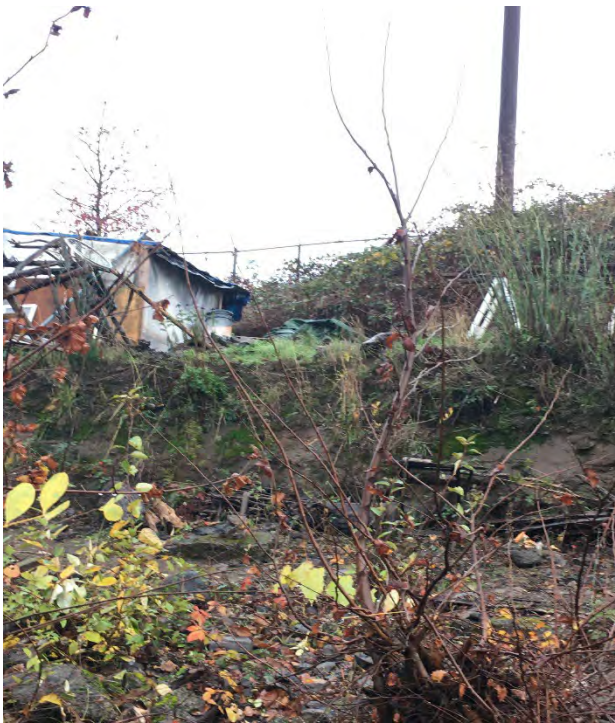
| <b>Photo Station:</b> JB | |

| <b>Description:</b><br><br>Existing erosional feature JB (center of erosion scarp) adjacent to Cemex leasehold. | |

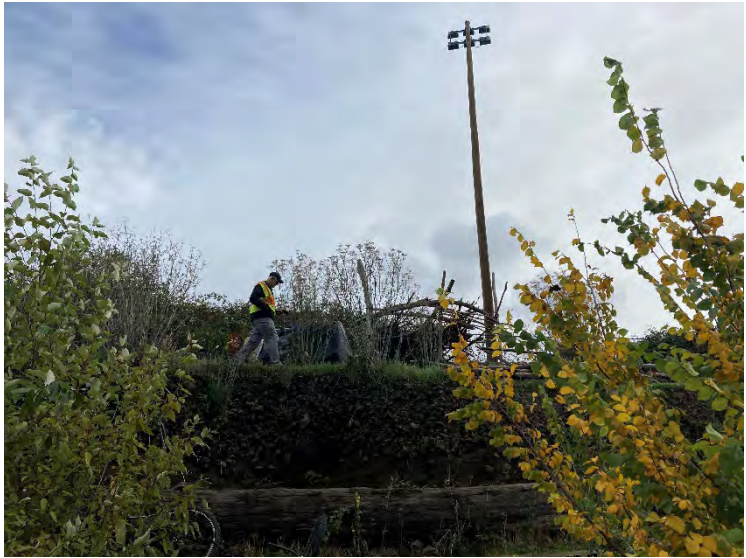
| <b>Description:</b><br><br>Existing erosional feature JC (east end of erosion scarp) adjacent to Cemex leasehold. | |

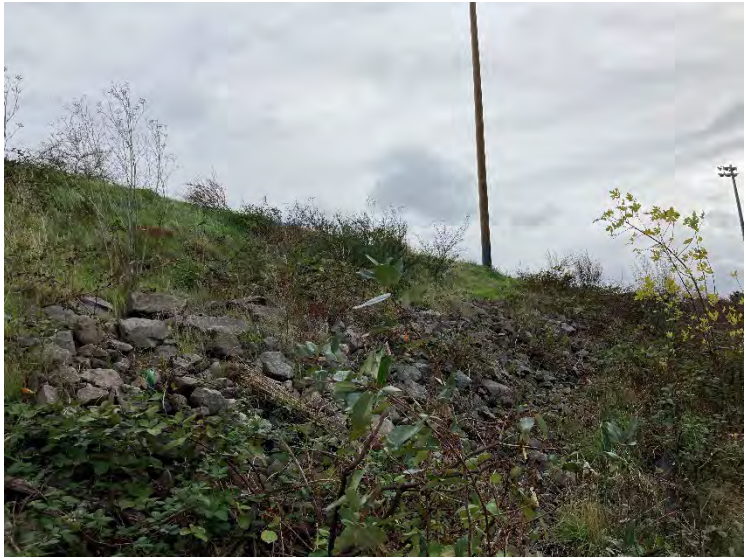
| <b>Photo Station:</b> J1 | |

| <b>Description:</b><br><br>Erosional feature J1 (repaired former erosion scarp) rip rap at west end of Daimler leasehold. | |

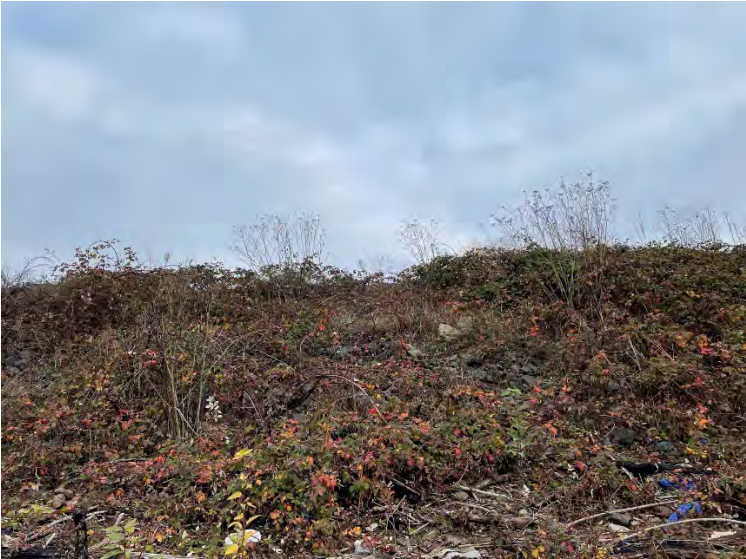
| <b>Photo Station:</b> J1 | |

| <b>Description:</b><br><br>Erosional feature J1 (repaired former erosion scarp) rip rap at west end of Daimler leasehold. | |

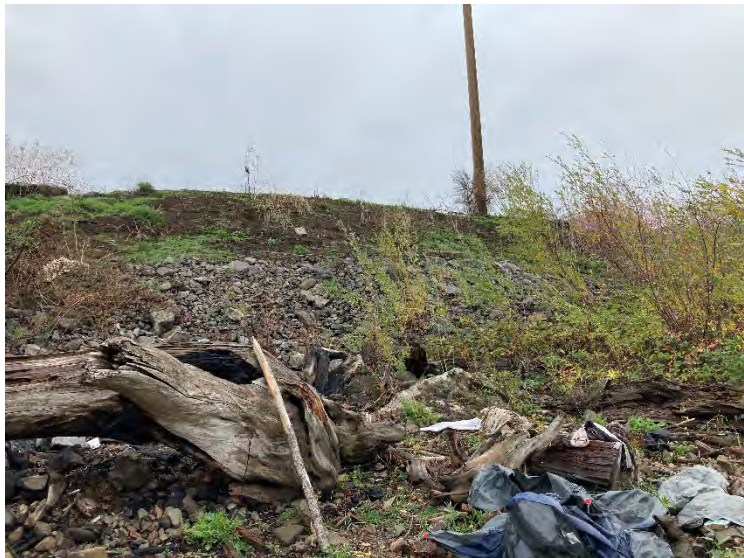
| <b>Photo Station:</b> L | |

| <b>Description:</b><br><br>Erosional feature L (repaired former erosion scarp) rip rap adjacent to Daimler leasehold. | |

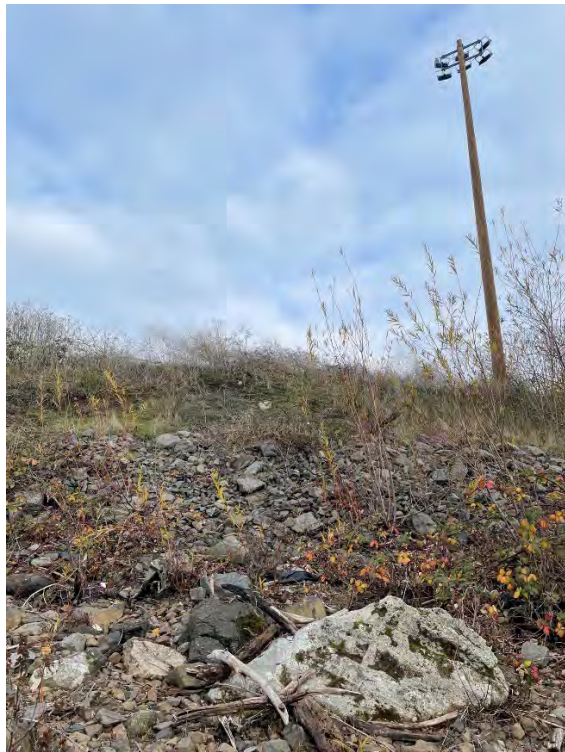
| <b>Photo Station:</b> L | |

| <b>Description:</b><br><br>Erosional feature L (repaired former erosion scarp) rip rap adjacent to Daimler leasehold. | |

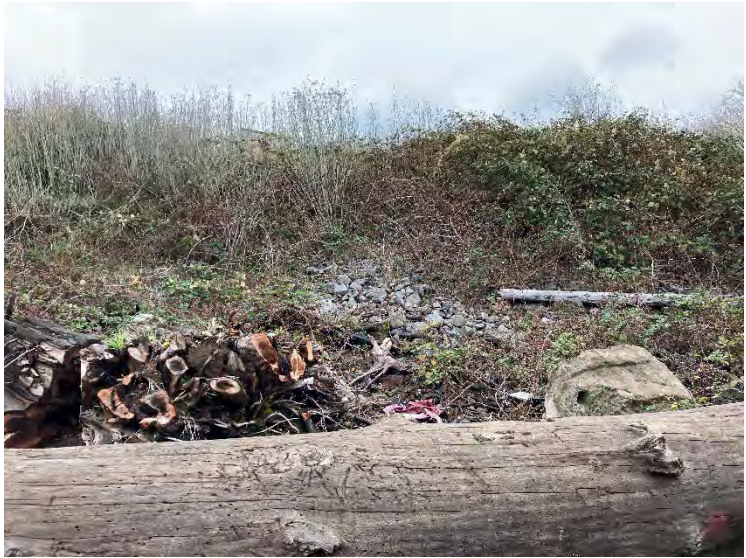
| <b>Photo Station:</b> N | |

| <b>Description:</b><br><br>Erosional feature N (repaired former erosion scarp) rip rap adjacent to Daimler leasehold. | |

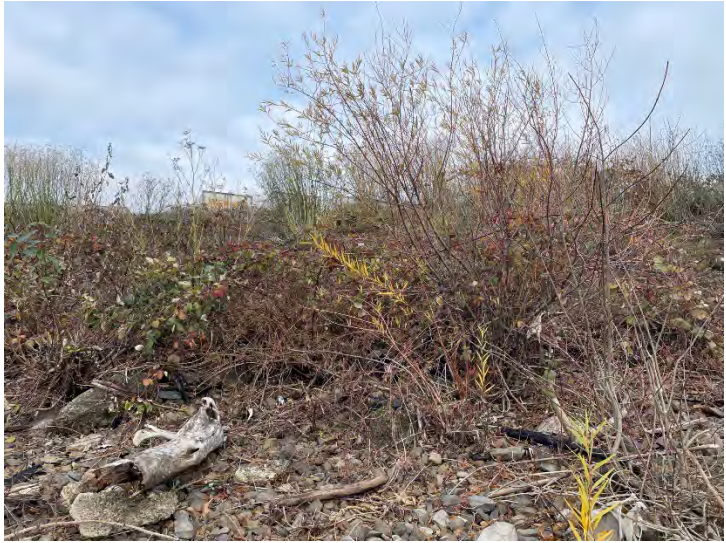
| <b>Photo Station:</b> N | |

| <b>Description:</b><br><br>Erosional feature N (repaired former erosion scarp) rip rap adjacent to Daimler leasehold. | |

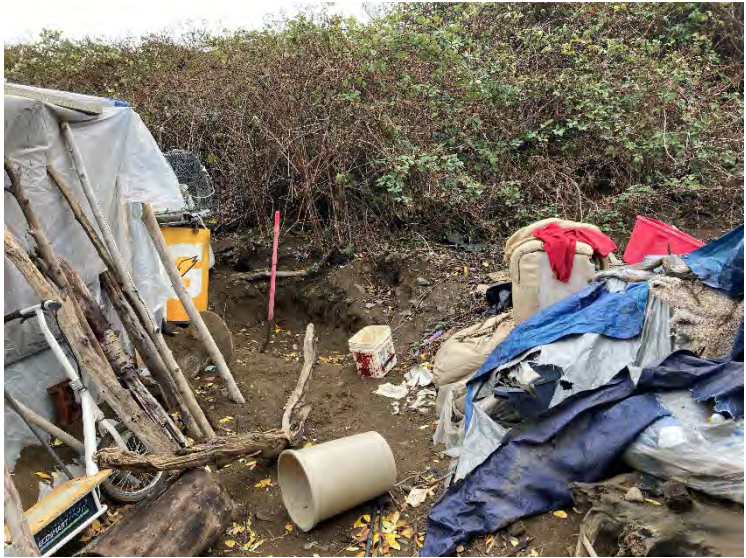
| <b>Photo Station:</b> O | |

| <b>Description:</b><br><br>Erosional feature O (depression in riverbank) adjacent to Daimler leasehold. Observable unhooused encampment activities. | |

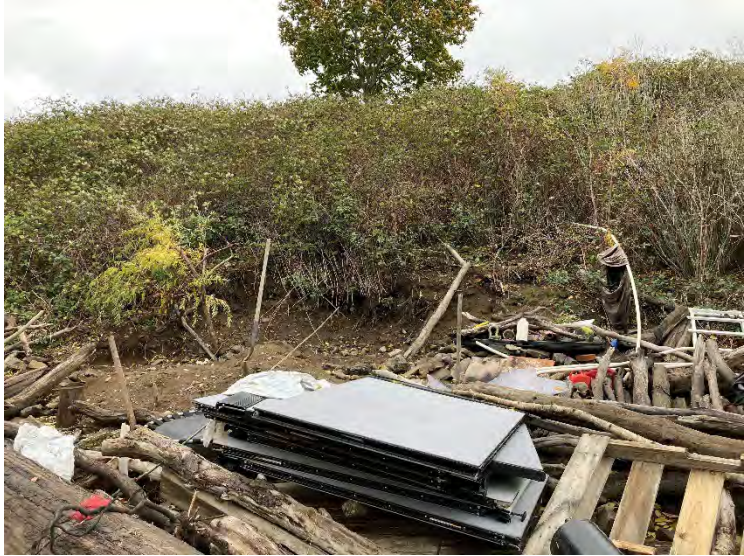
| <b>Photo Station:</b> P | |

| <b>Description:</b><br><br>Erosional feature P. Observable unhooused encampment activities. | |

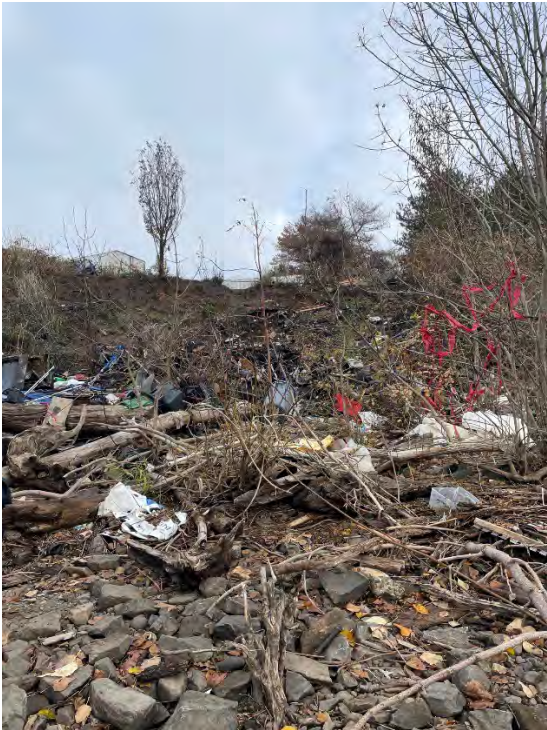
| <b>Photo Station:</b> P | |

| <b>Description:</b><br><br>Erosional feature P. Observable unhooused encampment activities. Area was burned during summer of 2022. | |

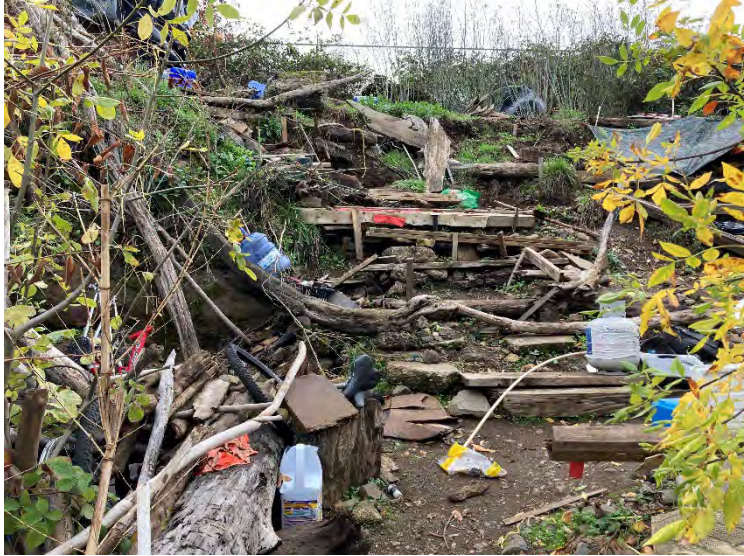
| <b>Photo Station:</b> NA | |

| <b>Description:</b><br><br>Steps installed at the north end of J1. | |

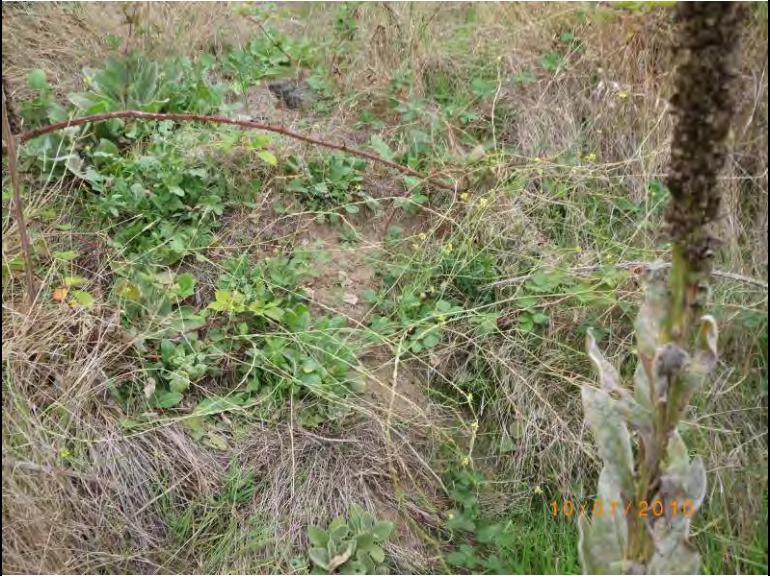
| <b>Photo Station:</b> B | |

| <b>Description:</b><br><br>Feature B – Bare ground approximately 1 foot in diameter. | |

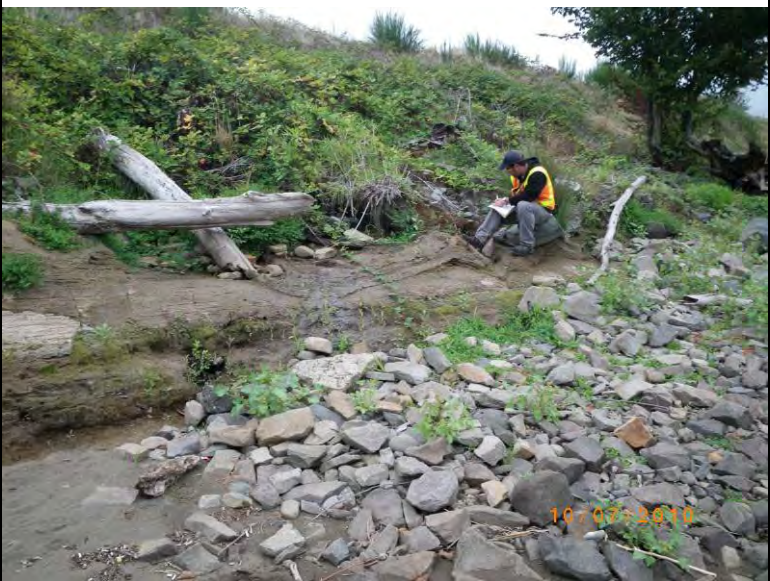
| <b>Photo Station:</b> D | |

| <b>Description:</b><br><br>Southeast end of Feature D – Bare ground below Outfall WR-399 with dimensions of approximately 3 feet by 80 feet. | |

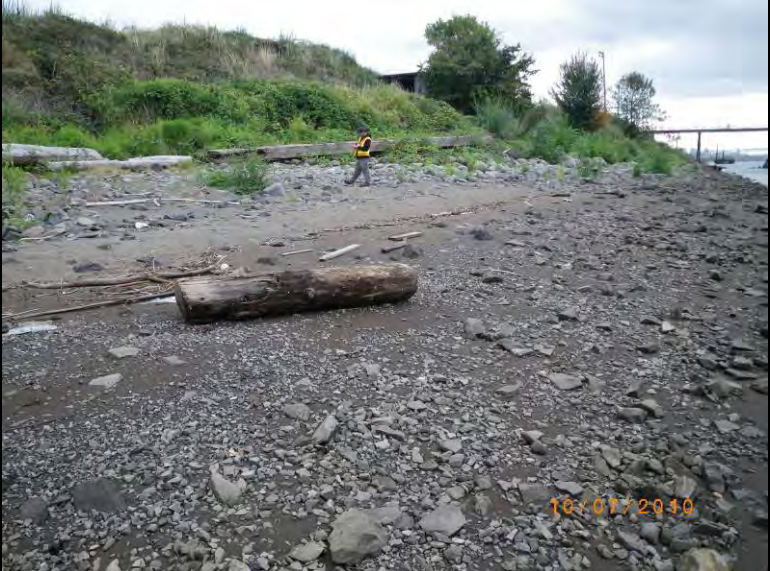
| <b>Photo Station:</b> E | |

| <b>Description:</b><br><br>Feature E – Depression in riverbank to left of individual in photograph. Width is approximately 30 feet. Topography is hummocky and surface is densely vegetated. | |

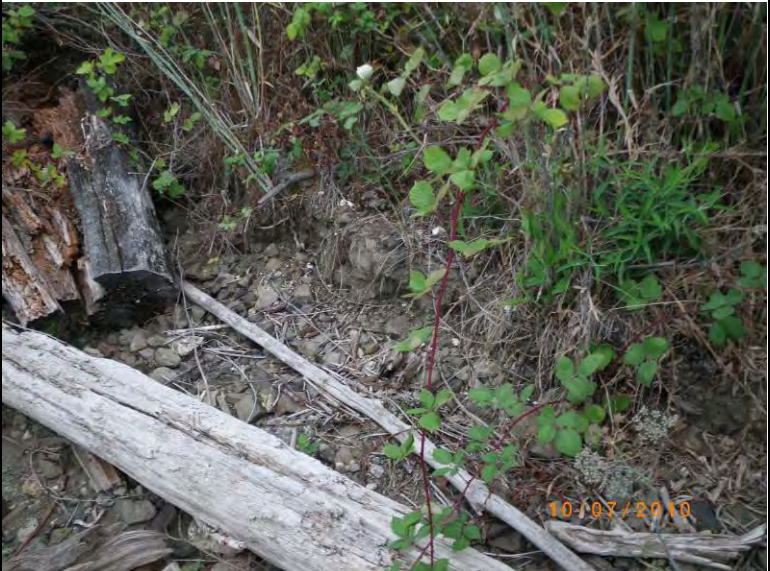
| <b>Photo Station:</b> I | |

| <b>Description:</b><br><br>Feature I – Erosion scarp 35 feet long and up to 1.5 feet high. | |

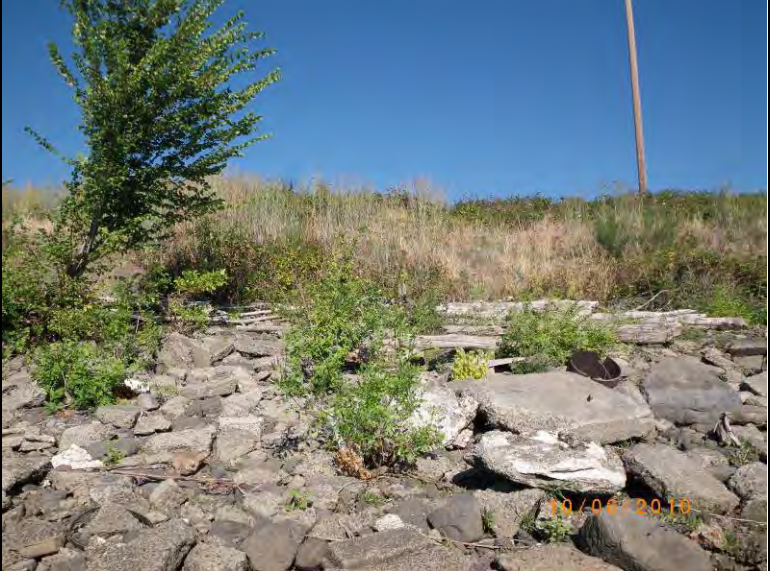
| <b>Photo Station:</b> JA | |

| <b>Description:</b><br><br>Feature J – Erosion scarp 635 feet in length. Height is variable up to 6.6 feet. This photograph shows a minimal height scarp (hidden in vegetation). | |

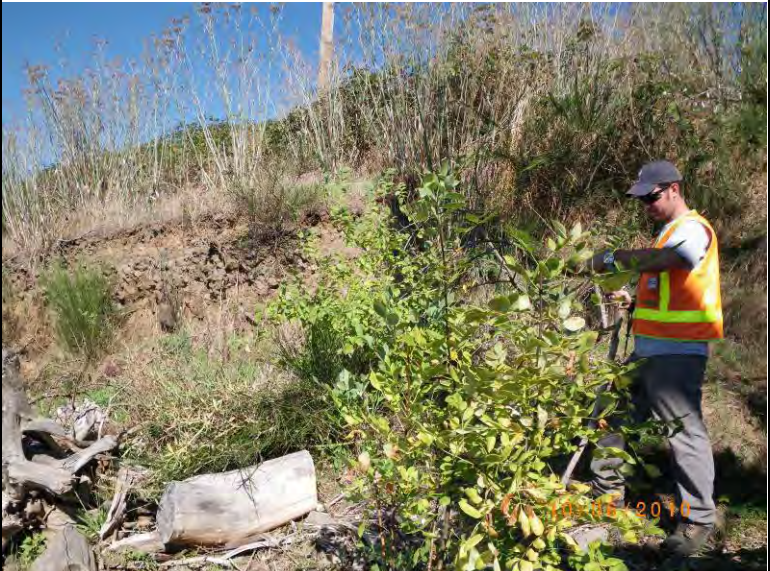
| <b>Photo Station:</b> JC | |

| <b>Description:</b><br><br>Feature J – Erosion scarp 635 feet in length. Height is variable up to 6.6 feet. This photograph shows a maximal scarp. | |

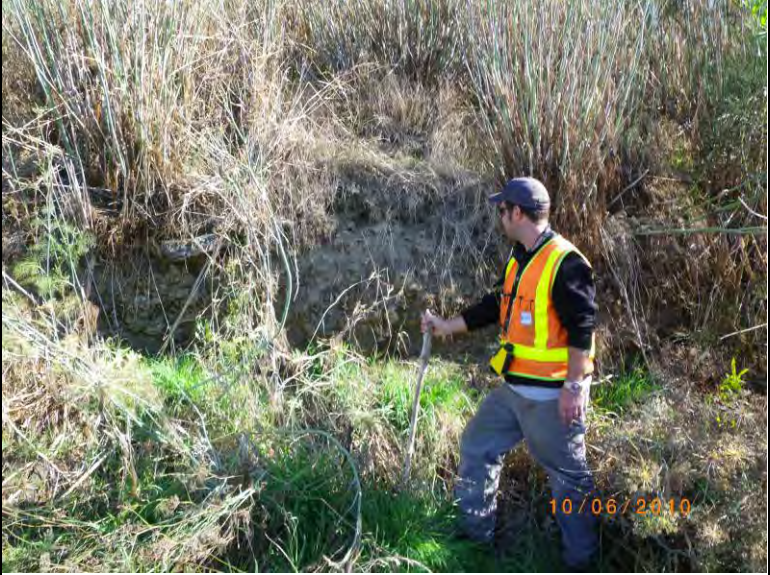
| <b>Photo Station:</b> L | |

| <b>Description:</b><br><br>Feature L – Erosion scarp 56 feet long and up to 3 feet high. | |

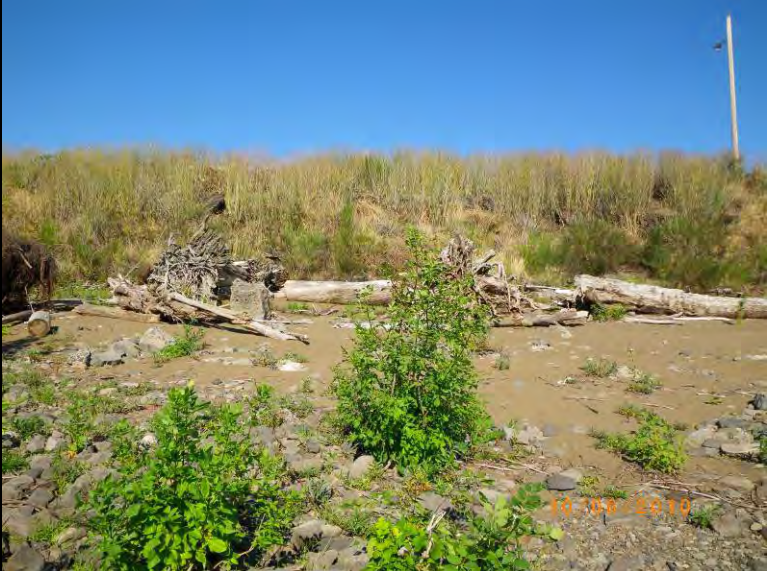
| <b>Description:</b><br><br>Feature N – Erosion scarp within depression in riverbank. Erosion scarp is 49 feet long and up to 2 feet high. Depression width is approximately 80 feet. Topography is hummocky and surface is densely vegetated. | |

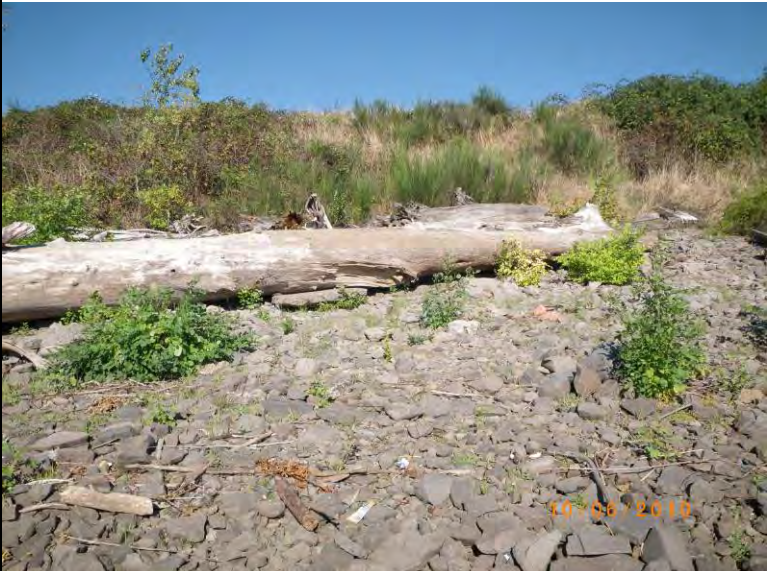
| <b>Description:</b><br><br>Feature O – Depression in riverbank. Width is approximately 50 feet. Topography is hummocky and surface is densely vegetated. | |

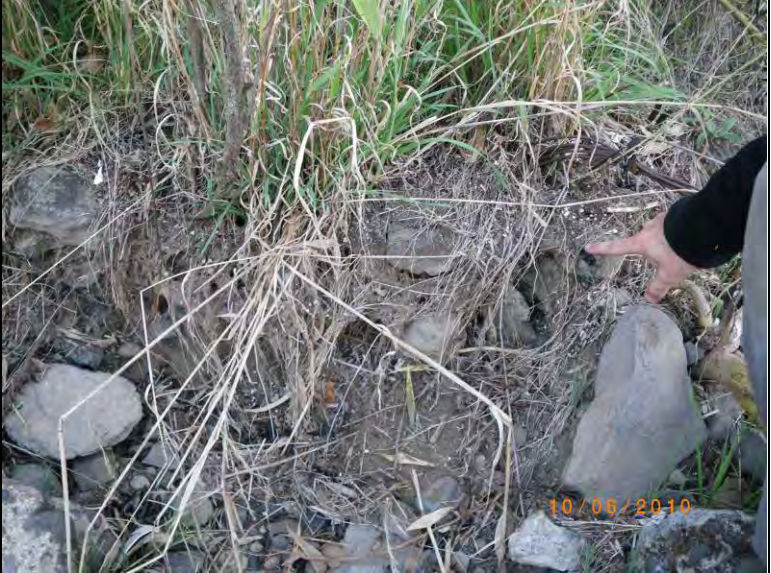
| <b>Photo Station:</b> P | |

| <b>Description:</b><br><br>Feature P – Erosion scarp 2.1 feet long and up to 1.1 feet high. | |
