Attached is a copy of the Annual Cap Inspection Report for Tanner Springs Park (ESCI ID 1080). Please feel free to contact me if you have any questions.

Site: Tanner Springs Park

Inspection Date: 10/22/2024

Tanner Springs Park
Annual Cap Inspection
Photo Locations Map

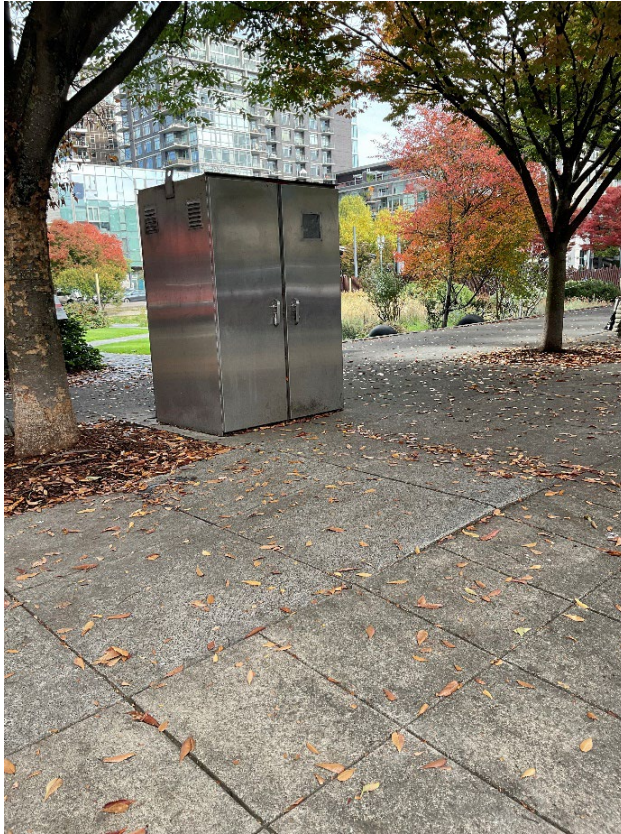
Photo Point #15

Several minor serviceable cracks in concrete were documented in the attached photo log and accompanying map. These cracks were documented in previous years inspection reports and have not changed in thickness. Several areas of minor separation (0.5 to 1.5 inches) were noted within the cobblestone path (photo points 6-8 and 11-14). Weathering has impacted caulked seams in the cobblestone paths and caulking was missing in a few places; however, the caulked seams were in fair condition. None of these cracks have compromised the cap or have allowed subsurface soil to be exposed. No patching is currently recommended. Photo point (15) is located where a concrete sidewalk panel is being lifted due to street tree roots. This inspection found no changes from last year at photo point (15).
