Site: The Fields Neighborhood Park

Inspection Date: 10/22/2024

# Fields Park Annual Cap Inspection Photo Points

## The Fields Park - 2024 Annual Cap Inspection Photo Log

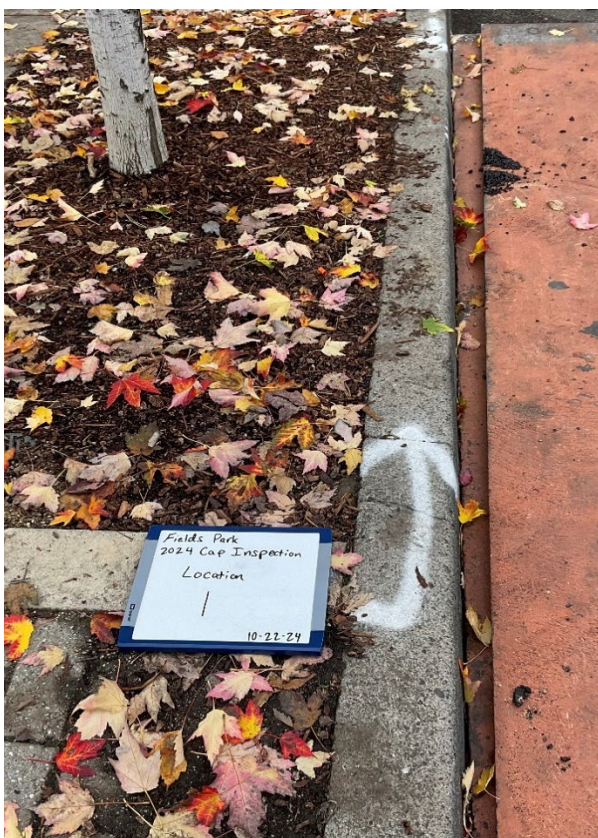
**Photo Point #1**

Minor surficial cracking and evidence of settling was observed in the concrete sidewalks on the perimeter of the park (photo points 1-3, 6-13, and 18). The minor cracks (generally <0.5 inches) were observed in previous inspections and do not penetrate the cap. Separation at the cracks was not observed. One (1) brick pathway is separating laterally, but the slight separation is limited to the uppermost brick layer and does not penetrate the sand pathway bedding. The separation does not penetrate the cap and the movement has not changed in several years (photo point #4).

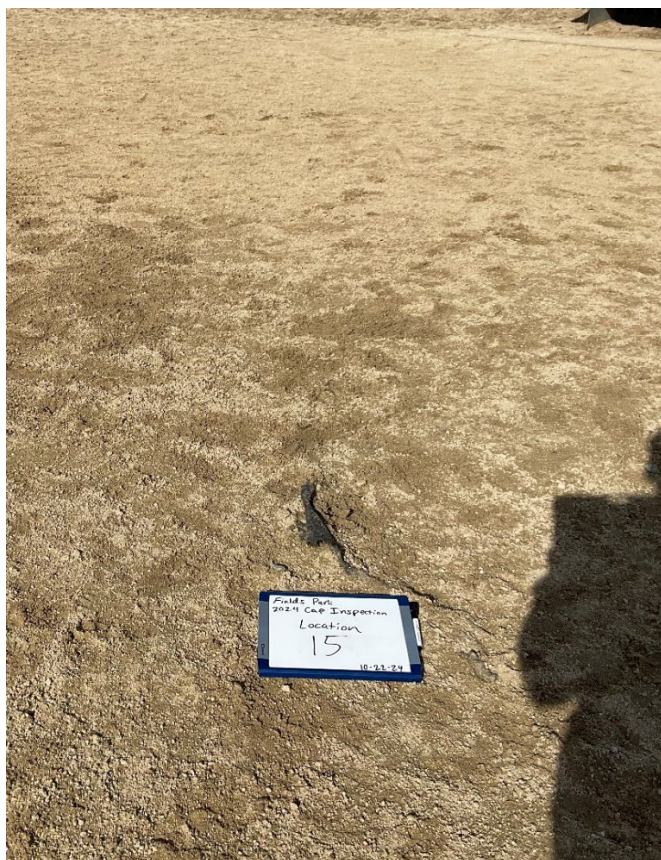
Landscaped areas, including the central grass area, other areas with plantings, as well as the dog off-leash area in the northern end of the park and the children's playground in the southern end of the park, were inspected for holes, cracks, and visual evidence of exposed demarcation geotextile fabric. No damage was observed in the landscaped areas. A minor dug hole (< 4 inches deep) was observed in the off-leash dog area, but the hole was surficial in nature and did not penetrate the cap.

**Photo Point #15 (off-leash dog park area)**

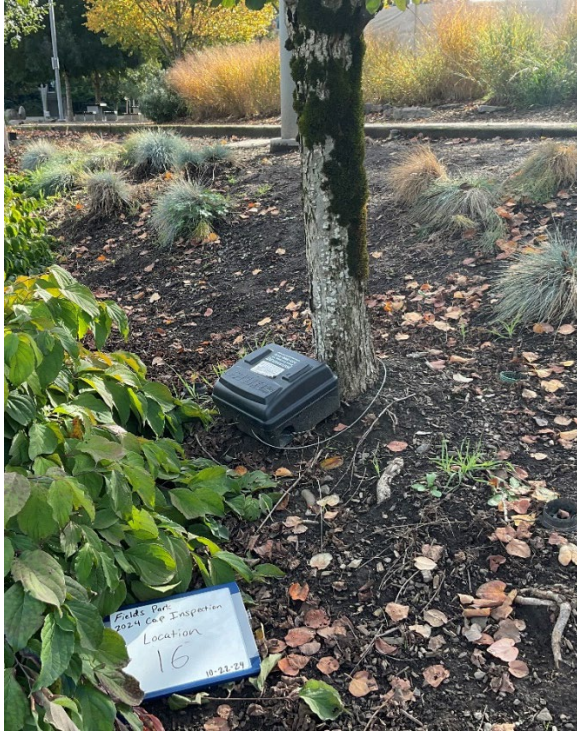
The children's playground was in excellent condition and no damage was observed. Evidence of animal burrows were not observed this year and Parks staff continues to control for rodents in the park (photo point 16). See attached Photo Log for copies of the current year inspection photos.

**Photo Point #16 (rodent hole monitoring/vector control, many located around park)**

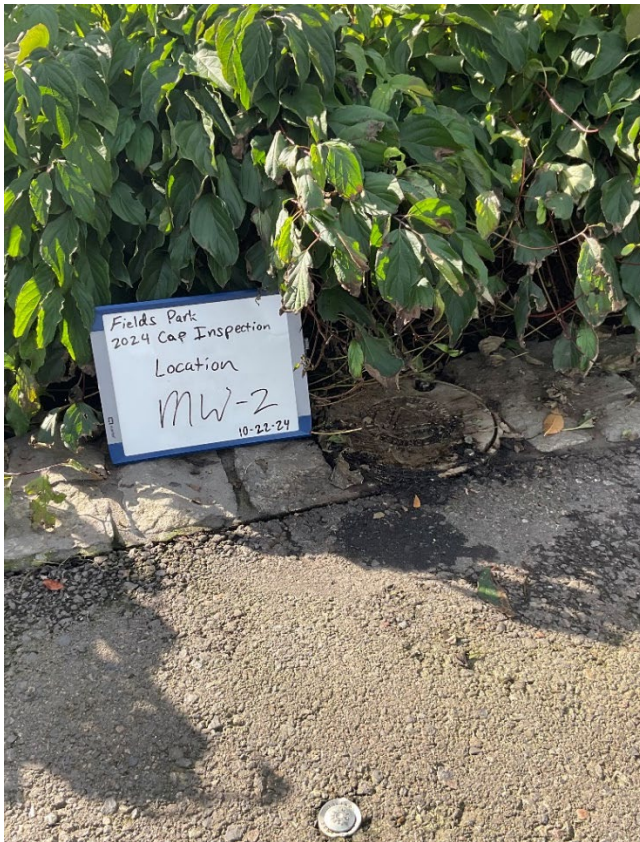
### Monitoring Well #2

Monitoring wells 2, 3, and 4 were decommissioned in December 2023 by a Burlington Northern Santa Fe (BNSF) contractor. The monument for monitoring well 3 has been completely removed and replaced with a new concrete sidewalk panel. Monitoring wells 2 and 4 have been grouted in place and the monuments remain. The remaining monuments were in good condition. See attached Photo Log for current year inspection photos. Parks will continue to monitor these locations in the future.
